# AN ARCHAEOLOGICAL IMPACT ASSESSMENT OF A PORTION OF LAND AT THE CITRUSDAL HOT SPRING

February 2002

**Archaeology Contracts Office**

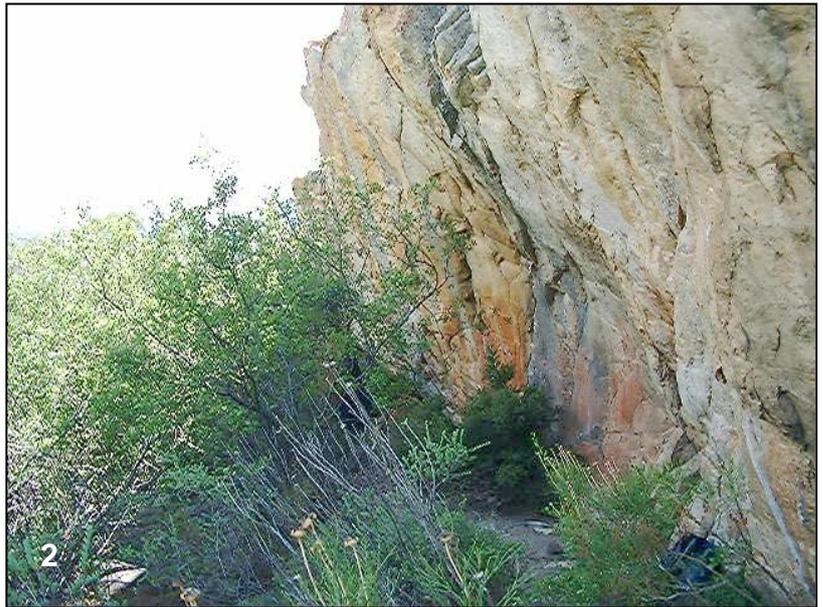
This is the main site located at 32°44'20.7"S and 19°02'27.4"E. The site consists of a slightly overhanging, west facing rock face, approximately 4-5 meters in height, and approximately 15-20 meters wide (Plate 2). A flat floor some 4-5 meters wide made this an attractive site for the precolonial inhabitants of the area, and is the only site with a

“level” floor and good paintable rock surface in the searched area. The site would not provide much cover during rain and as a result many of the paintings are faded, or covered by a white deposit, probably a buildup of dissolved minerals leaching from above.

The rock wall in CHS1a  
looking north

5.4 At site CHS1a, the public should be prevented from coming within three (3) meters of the painted rock surface. This could be achieved by the use of appropriate barrier material. Placement of photographic reproductions or drawings of the various key images on signage at the site, would very likely make viewing more interesting and informative.

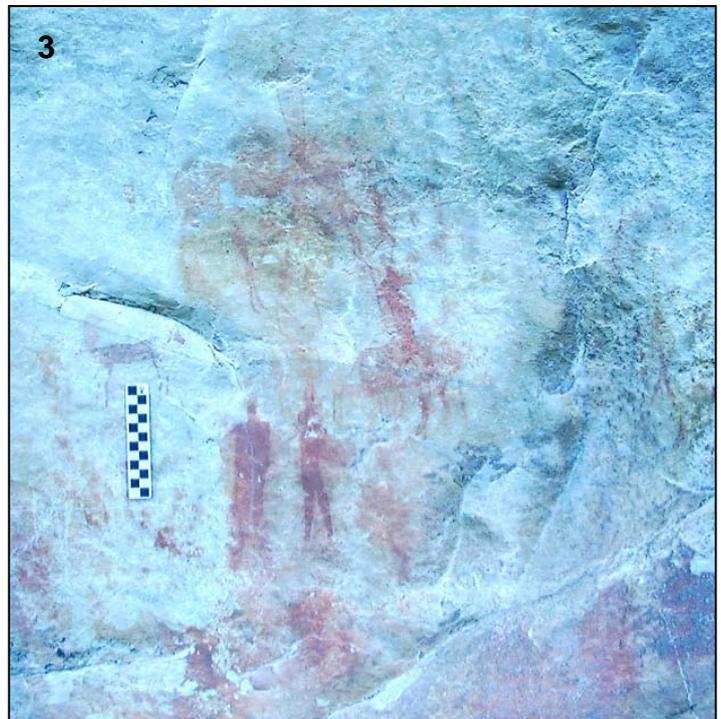
While this study will not describe the paintings in detail, it should be noted that the main panel contains amongst others: several human figures, animals – both eland and a smaller antelope possibly *Raphicerus sp.*, a line of human figures some of which have lower legs crossed, and a largish hollow-bodied figure without legs (see Plate 3). Traces of both white and yellow pigments are still discernible in places.

Crude graffiti is present on the main panel. This has been executed by scratching with a stone. A kite-shaped design, several vertical lines, and scratching over the face of a human figure were noted.

Main rock art  
panel in CHS1a

5.3 Rock paintings should be recorded in detail before sites are made accessible to the public. Both photographic and written descriptions should be made so that a record exists in the event of vandalism. This record also provides a baseline for assessment of impact through public access.
