**PROPOSED REZONING AND DEVELOPMENT OF REMAINDER PORTION VYF-  
BRAKKEFONTEIN 220, HARTENBOS HEUWELS, MOSSEL BAY**

**ARCHAEOLOGICAL HERITAGE IMPACT ASSESSMENT**

**FINAL REPORT**

June 2005

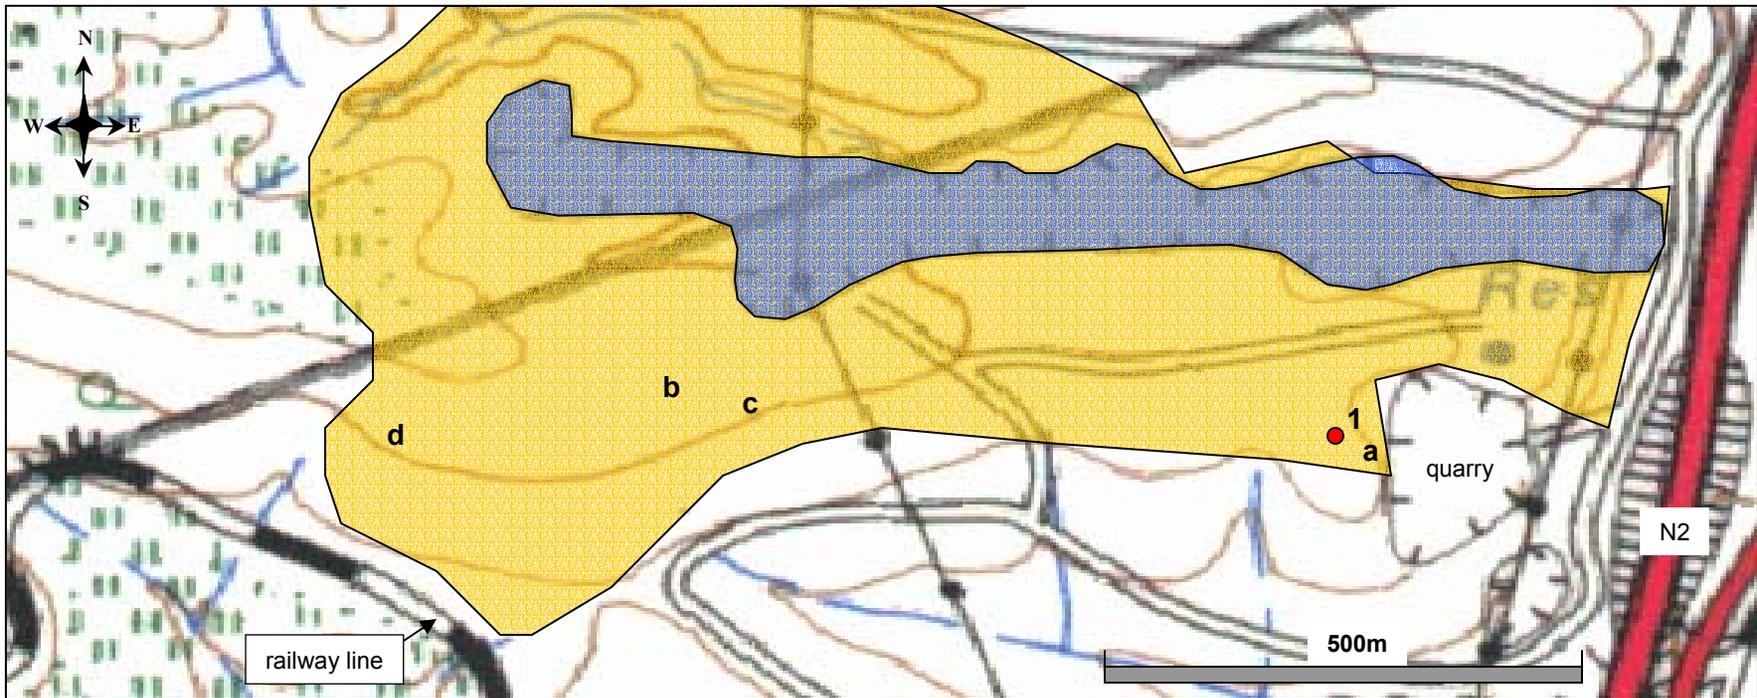
1. The only archaeological occurrence that may be in reasonable proximity to its original place of deposition is an isolated MSA stone artefact in quartzite (Plate 6). This artefact was located at S34.13476 E22.09742 in a patchily vegetated area close to the southeastern boundary fence (red dot [1] in Figure 3). This artefact was not in association with other archaeological materials. Due to former farming activities and vehicular traffic, it is possible that the artefact is in secondary context.

Figure 3. Enlarged area as indicated in Figure 2. The area covered during the AIA is shaded orange and includes the area shaded blue. The red dot represents GPS coordinates for an isolated MSA stone artefact (details in text and plates). Severely damaged and eroded area is indicated with blue shading.

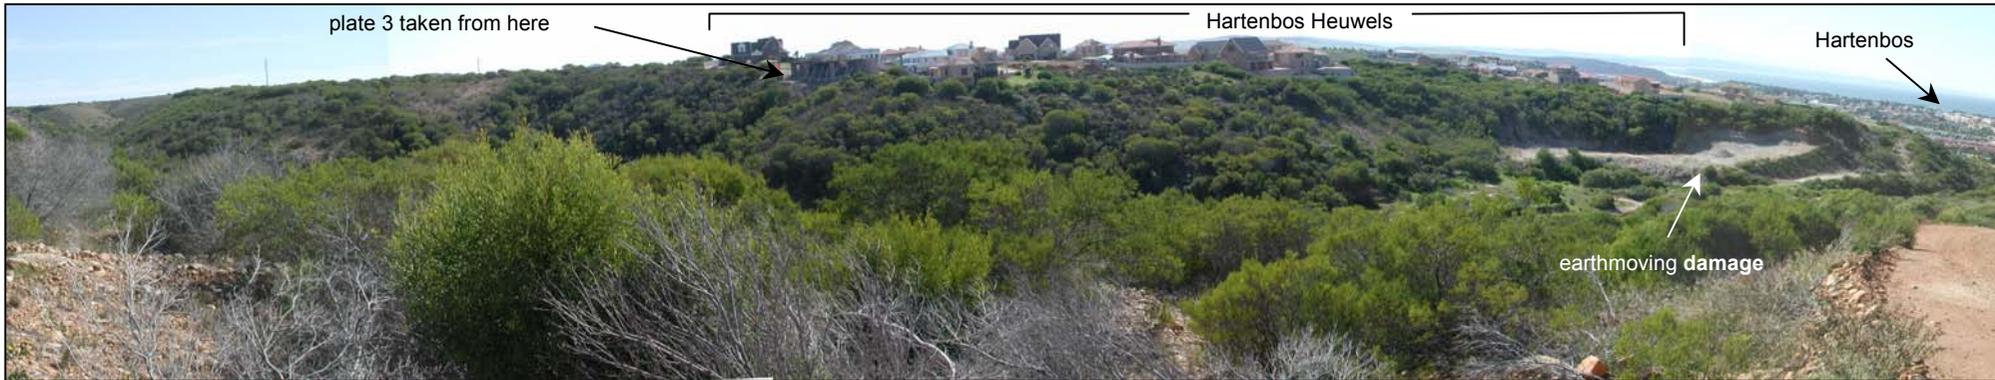
The topography includes rolling hills and valleys as well as an extensively damaged valley in the northern half of the study area (Plates 1 & 3). The damage appears to be the result of substantial earthmoving activities and subsequent erosion. Apparently the central plateau was recently “brush cut” and probably ploughed in recent history (Plate 4). Traces of Enon Conglomerate appear across most of the area and makes up the immediate substrate (Plate 4). The central part of the property is a plateau with an east-west trajectory and slopes descend to the north and south of it.

A basic description of certain aspects of the study area and access to it are given in section 1.3 above. As mentioned above, the northern part of the property - roughly 25% of the total area – is heavily damaged by earthmoving activities and subsequent erosion

Plate 1. View toward the northern boundary of the study area showing the damaged valley and the location of Hartenbos and Hartenbos Heuwels. The gravel road at the right is the access road used to get onto the plateau in the centre of the property. Dense stands of alien Rooikranz are visible in the valley and foreground.

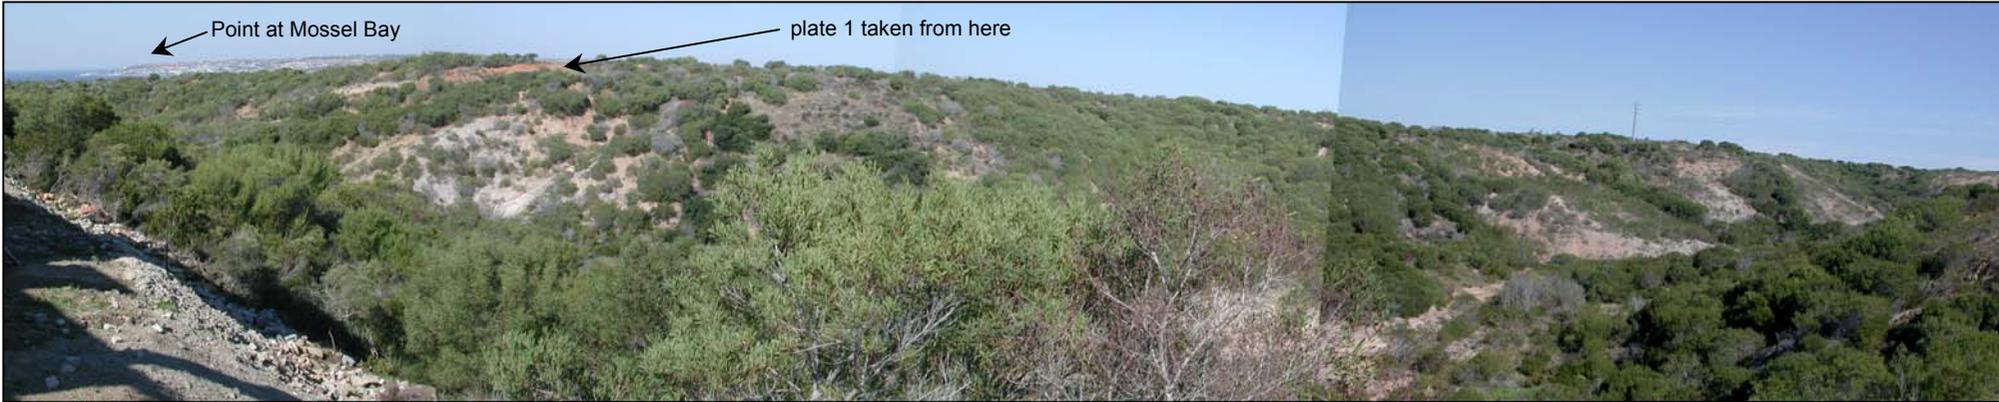
(see Figure 3 and Plates 1 & 3). The large plateau, roughly in the centre of the property, is also disturbed by former farming activities and numerous vehicle tracks and roads were seen (Plate 4).

Plate 3. View toward the south with the central plateau in the background. Large areas of disturbance and erosion can be seen in the valley and northern slopes of the plateau. Dense stands of alien Rooikranz are visible in the valley and foreground.

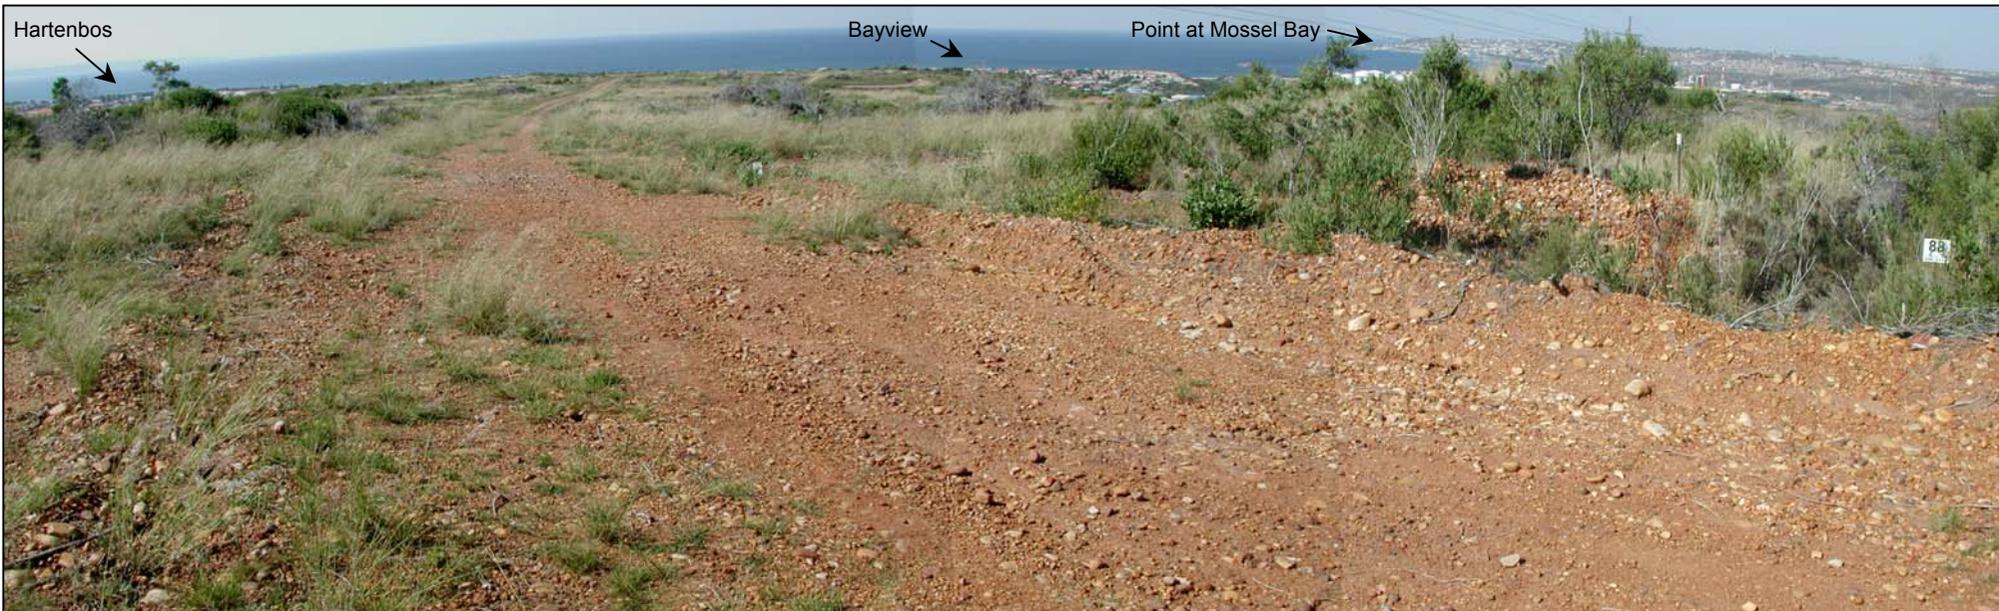
Plate 4. View toward the east standing atop the central plateau with Hartenbos, Bayview and the point at Mossel Bay indicated. In the foreground the gravel road is littered with Enon-derived, water worn cobbles. Numerous vehicle tracks occur on the brush cut plateau.

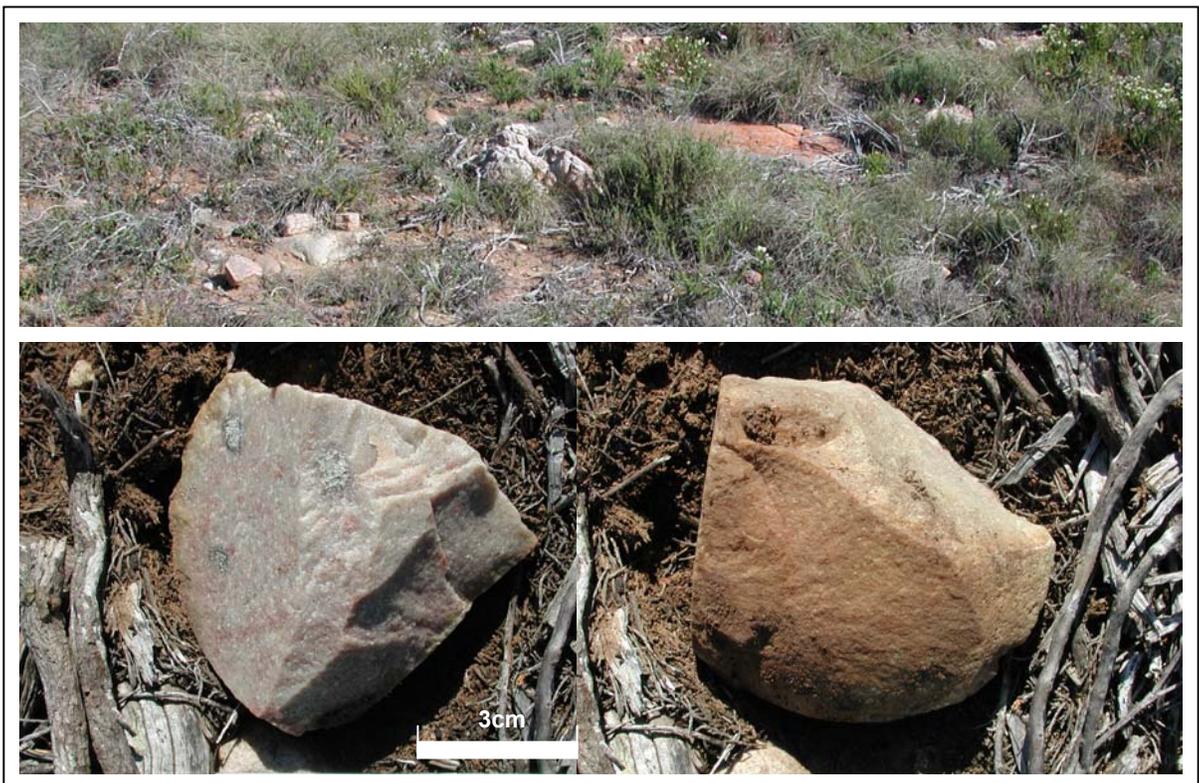
Plate 6. Top picture shows context of the MSA core (bottom) and its location is indicated in Figure 3 (1).

Site Number	Period/Age	Significance	Mitigation
1	MSA	Local	Archaeologist to provide guidelines for identification and action re Stone Age artefacts. <b>Obtain permit from HWC for damage/destruction</b>

- The National Heritage Resources Act, No. 25 of 1999, protects archaeological occurrences and therefore a permit for damage and/or destruction must be obtained from Heritage Western Cape prior to any vegetation clearing and earthmoving activities.
- In the event that vegetation clearing and earthmoving activities expose archaeological materials, such activities must be halted and Heritage Western Cape must be notified immediately.
- Unmarked human burials may occur anywhere in the landscape and are often exposed during earthmoving activities. Human remains are protected by law and, if older than 60 years, are dealt with by the State Archaeologist at the South African Heritage Resources Agency (Mrs. Mary Leslie who can be reached at 021 462 4502).
