**PROPOSED REZONING AND SUBDIVISION OF A PORTION OF VAALEVALLEY  
219, MOSSEL BAY, WESTERN CAPE PROVINCE**

**ARCHAEOLOGICAL HERITAGE IMPACT ASSESSMENT**

**FINAL REPORT**

28 September 2005

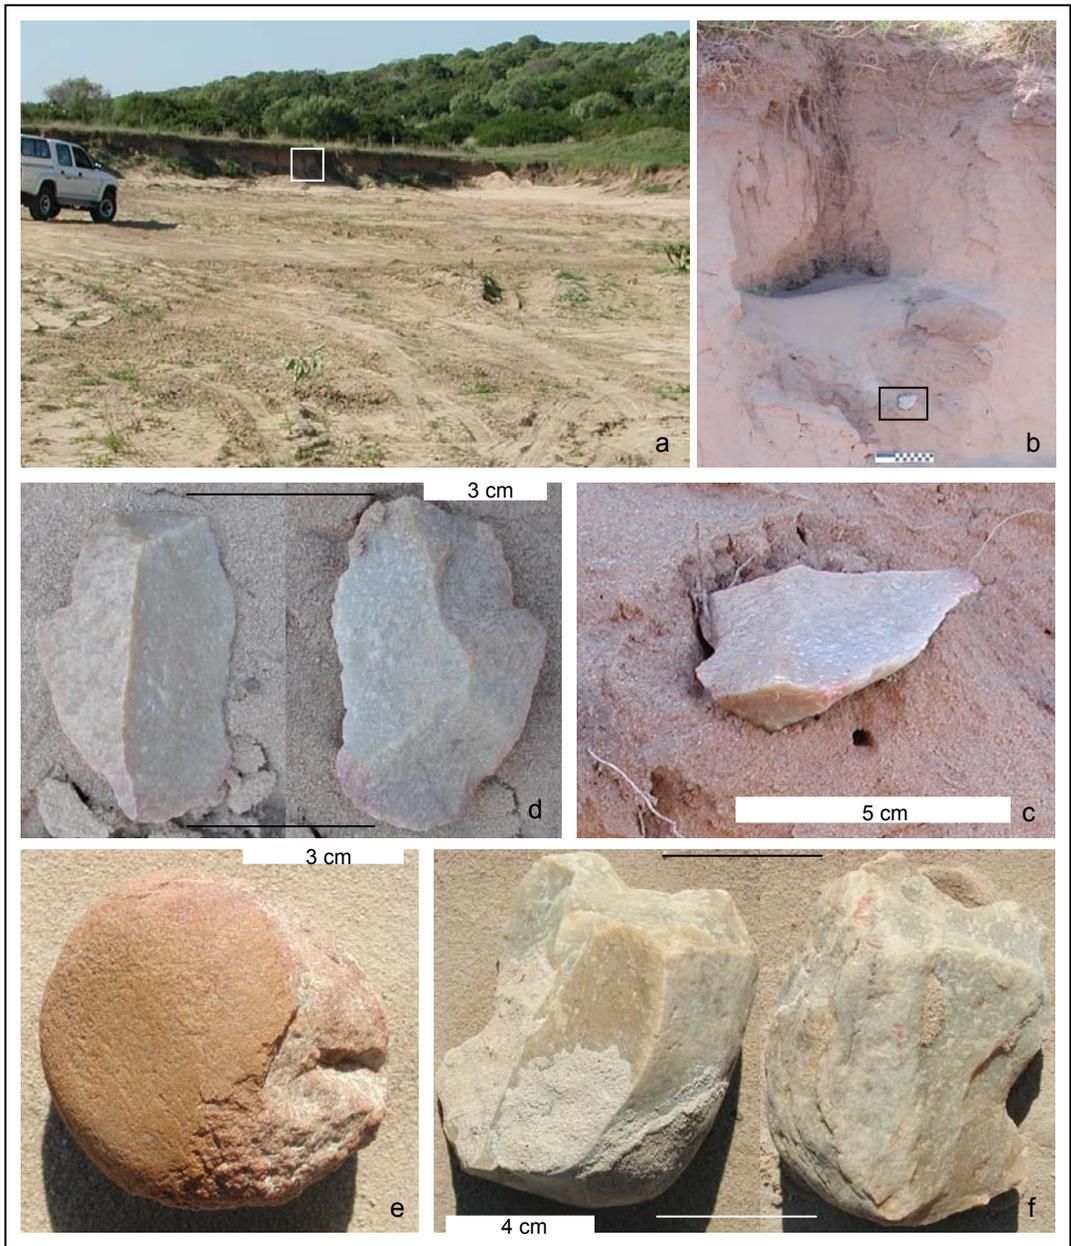
Plate 8. Stone artefacts at occurrence 1 are shown. Image c is the enlarged frame in b and b is the enlarged frame in a. All except the hammer stone/grind stone in e appear to be MSA in origin. The artefact in e may be of ESA origin.

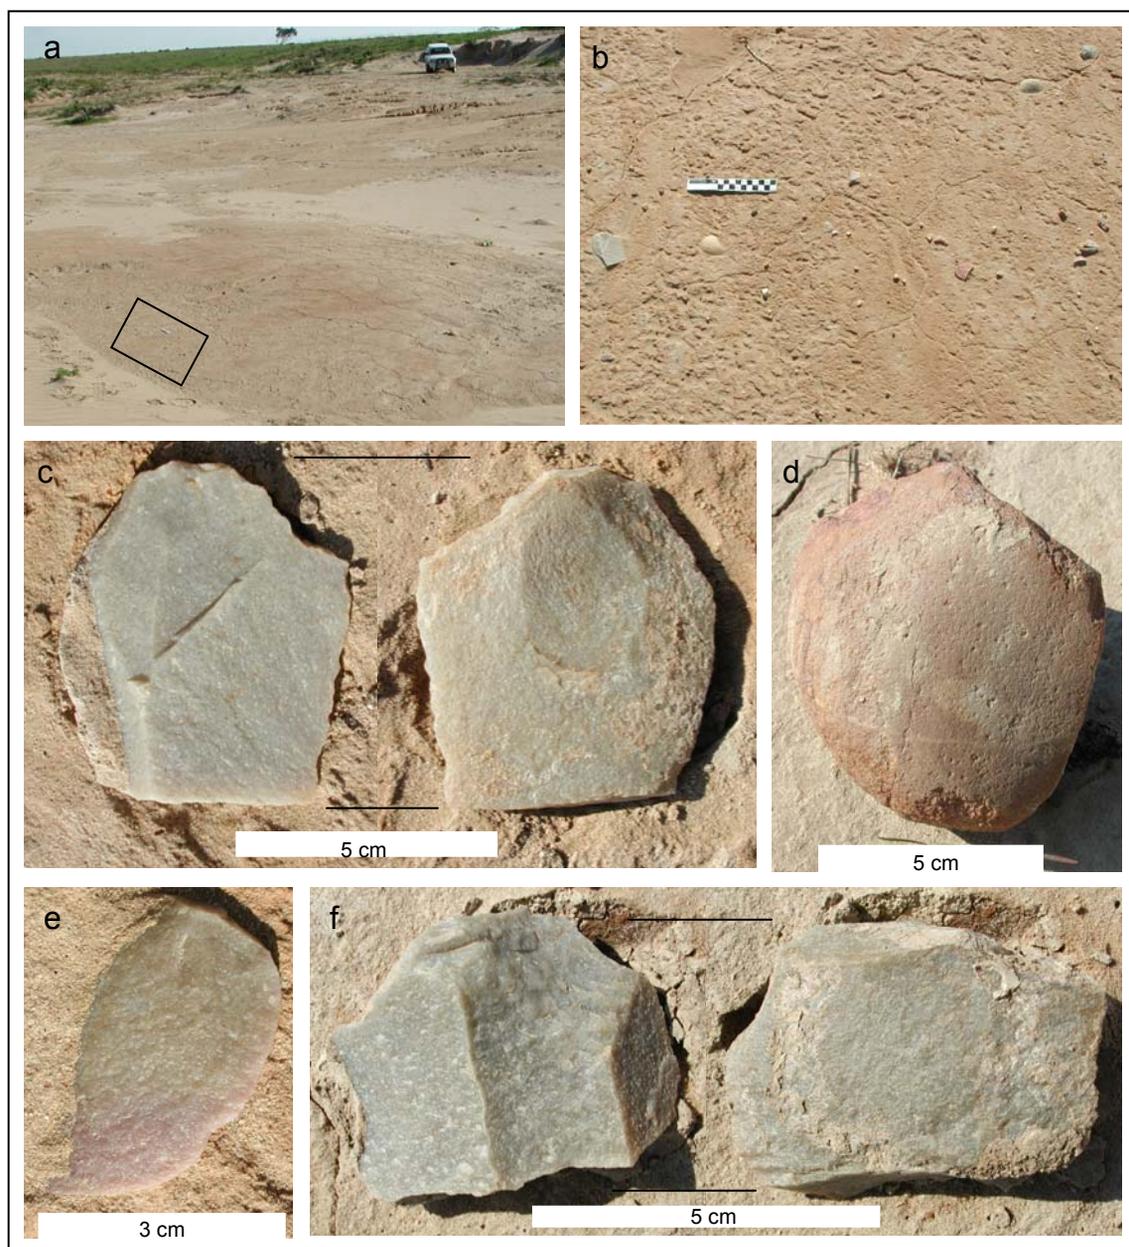
Plate 9. The context and a selection of stone artefacts at occurrence 2 are shown. Image b is the enlarged frame in a. Scale intervals in b are in centimeters. Dorsal and ventral surfaces of flakes with prepared platforms are shown in c and f. The artefact in d is a combination hammer stone and upper grind stone while the flake with prepared platform in e appears to be *in situ*. All appear to be of MSA origin.

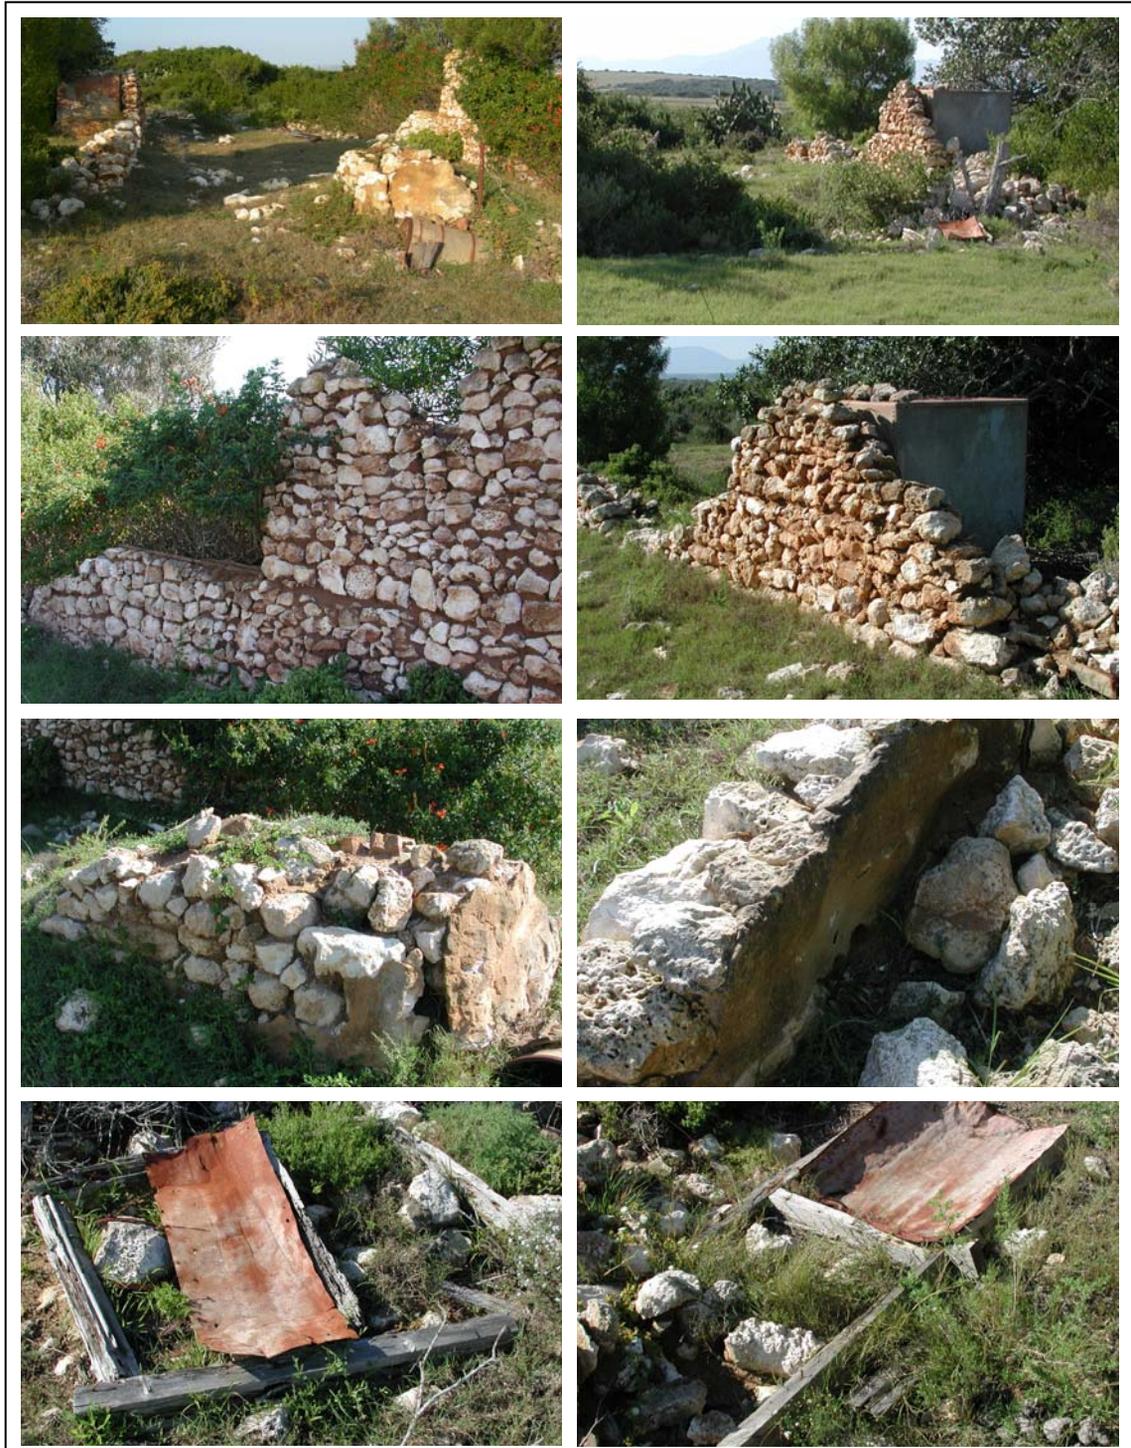
Overgrown ruins most likely of 19<sup>th</sup> century origin, but they are potentially older. Some building blocks are of cemented beach and what appears to be aeolianite material. Blocks of Enon conglomerate and calcrete were also used in the structure as well as relatively crudely made bricks of orange to red clay. Parts of the plaster and mortar consist of lime with marine shell temper while mortar of clay was also noted. A great deal of shell in the plaster and mortar is burnt and calcined. Some of the existing walls are around 50cm thick. The structure has undergone some recent, illegal damage, almost certainly by earthmoving machinery. Some artefacts seemingly of the 19<sup>th</sup> and possibly 18<sup>th</sup> century were noted in the vicinity of the ruins to the south, but no dump or midden was identified. Materials actually included a mixture of modern and older materials.

Plate 10. Cottage constructed predominantly of calcrete blocks and clay mortar recorded at occurrence 3. The top left image was taken from the northeast while the right image at the top was taken from the southwest. Remaining images are examples of walling, features, plaster and window frames.

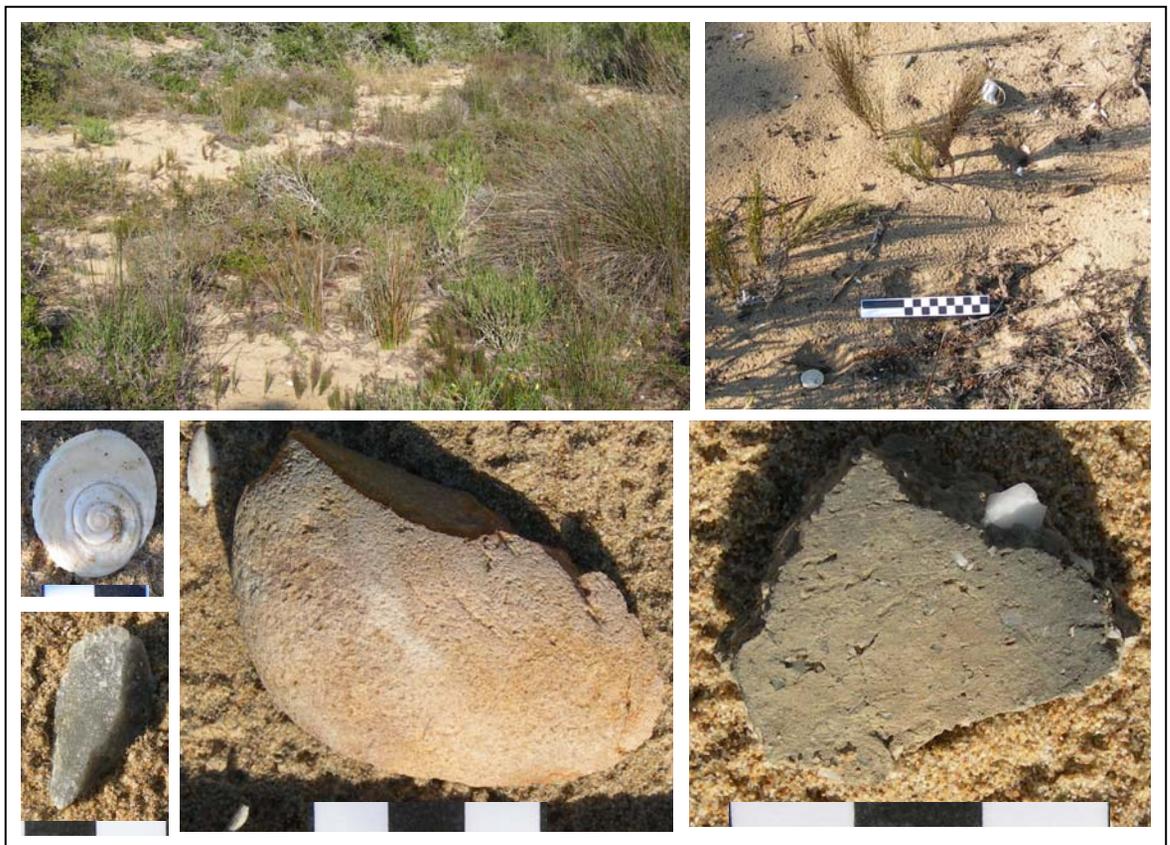
Medium to low density scatter of marine shell including brown mussel, alikreukel, limpets, white mussel, periwinkle and also saw a few milky quartz and quartzite stone artefacts. This scatter was exposed and damaged illegally by vegetation clearing and/or earthmoving activities. The densest part of the scatter is only some 5 x 3 m in area, but its subsurface nature and extent is currently unknown and requires investigation via shovel testing.

Plate 12. Low density scatter of marine shell, stone artefacts and pottery at occurrence 5. Intervals on all scale bars are in centimeters.

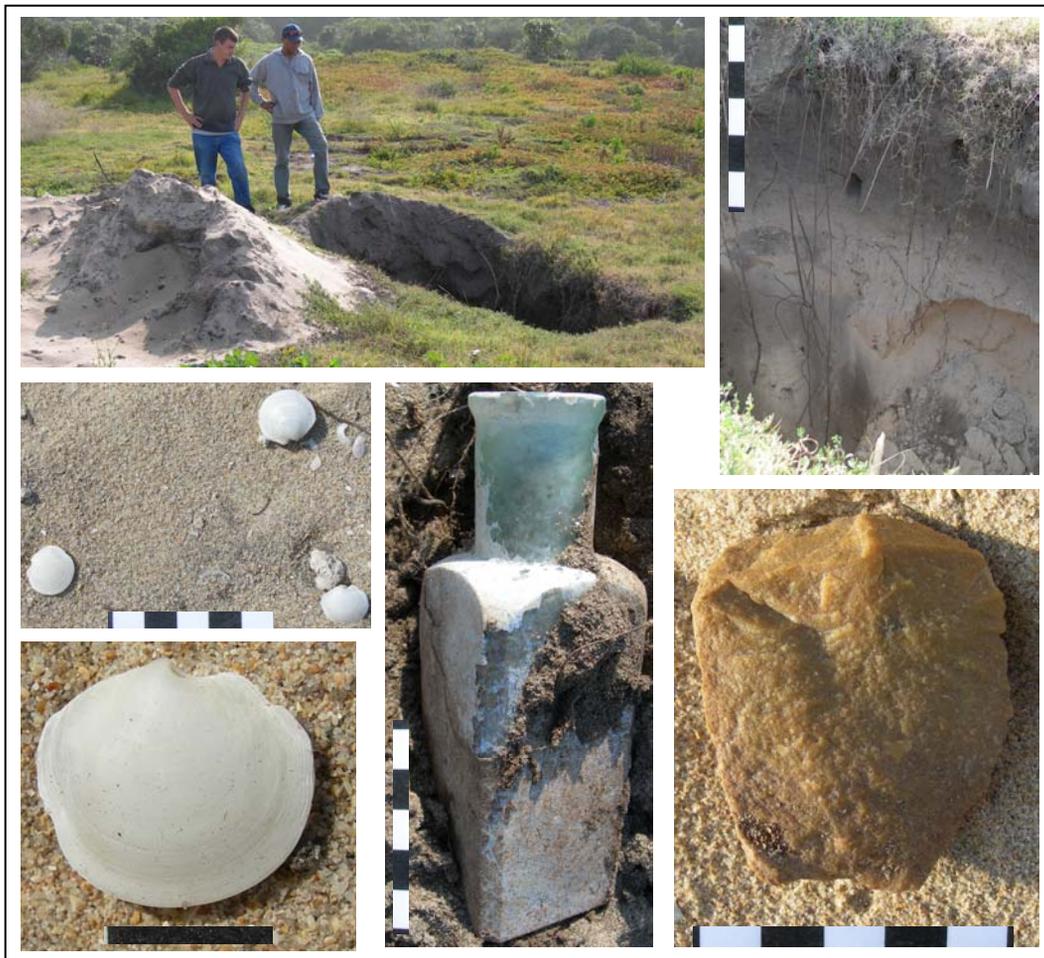
Plate 13. Developer's test pit at occurrence 6 yielding marine or estuarine shellfish, a MSA flake and 19<sup>th</sup> century materials. Intervals on scale in top right image are 20cm while the remainder are in cm.

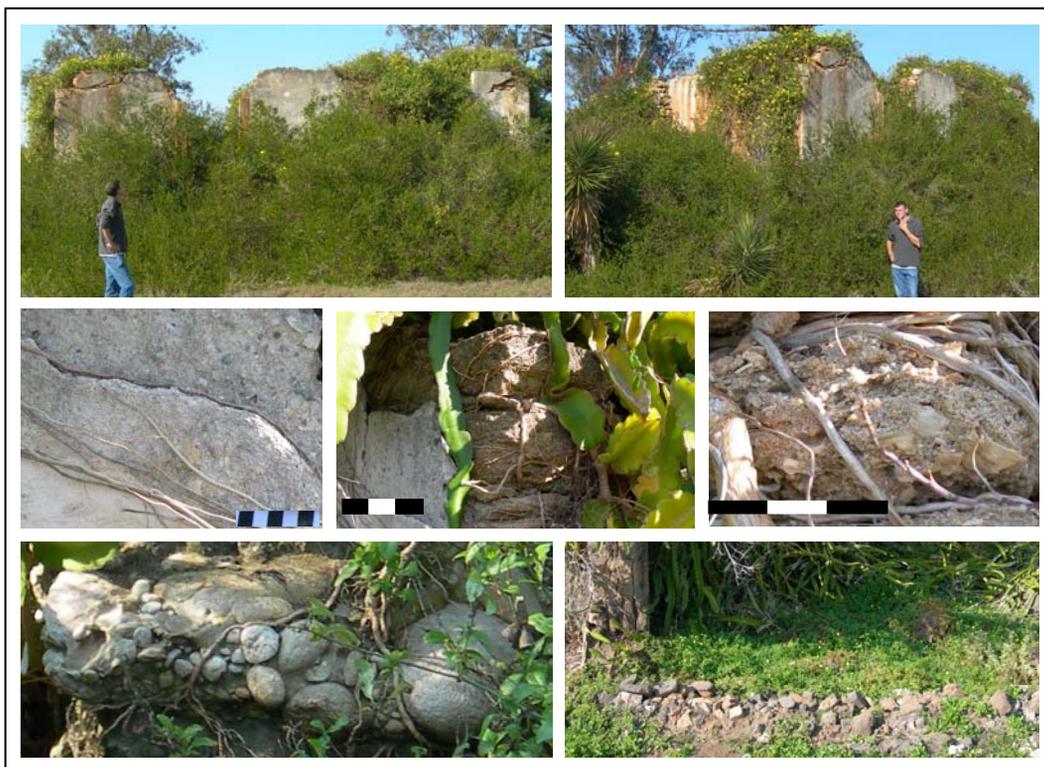
Plate 14. Ruins at occurrence 7, showing plaster and construction blocks in middle row and bottom left, and bulldozer damage at bottom right. Scale intervals in cm except 10 cm intervals in central image.

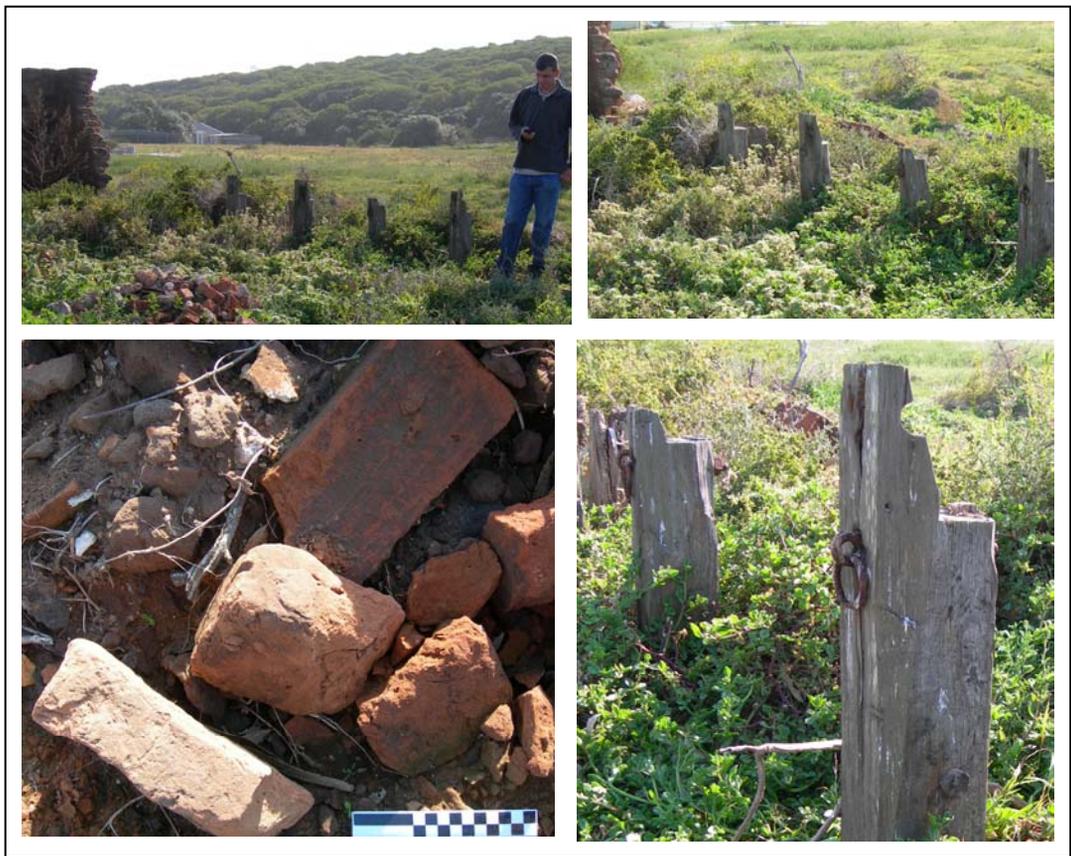
Plate 15. Ruins at occurrence 8 showing vertically planted wooden beams with metal tethering features and bricks of reddish clay. The scale intervals are in cm.

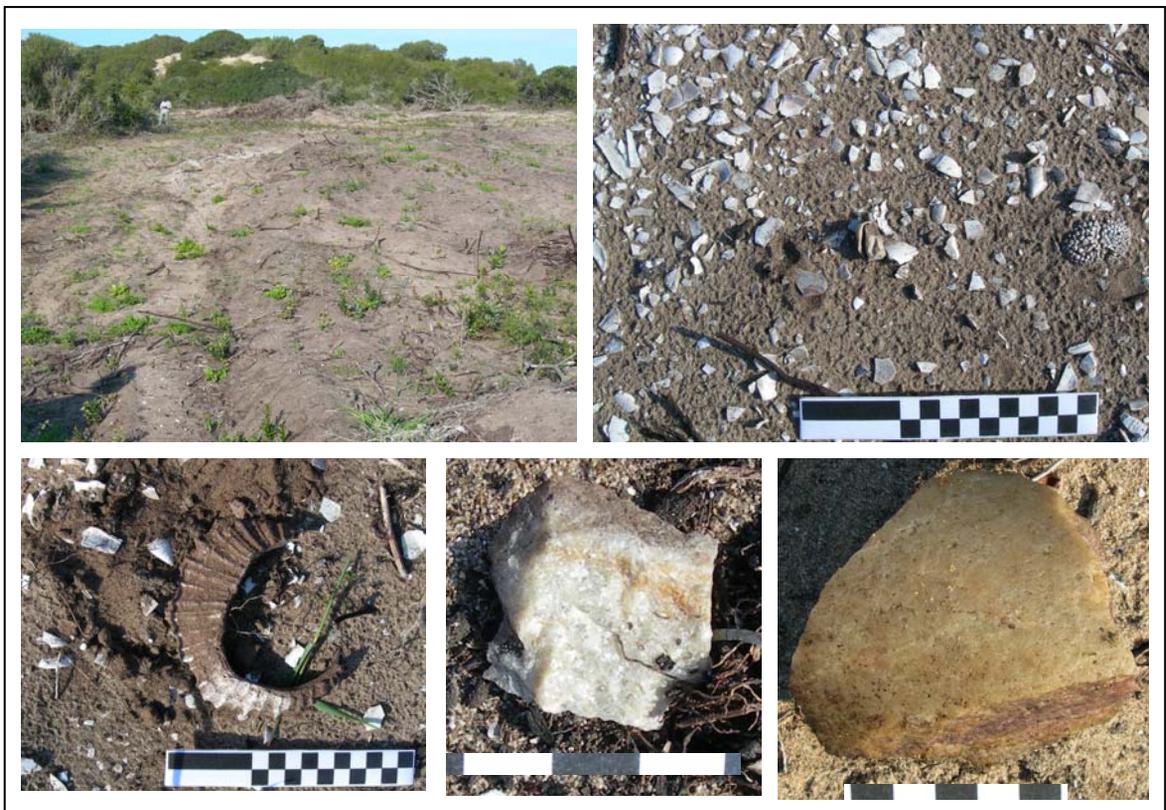
Plate 16. Low to medium density scatter of marine shell and occasional stone artefacts at occurrence 9. Earthmoving damage visible in top left image and examples of shell, milky quartz and quartzite artefacts. The scale intervals are in cm.

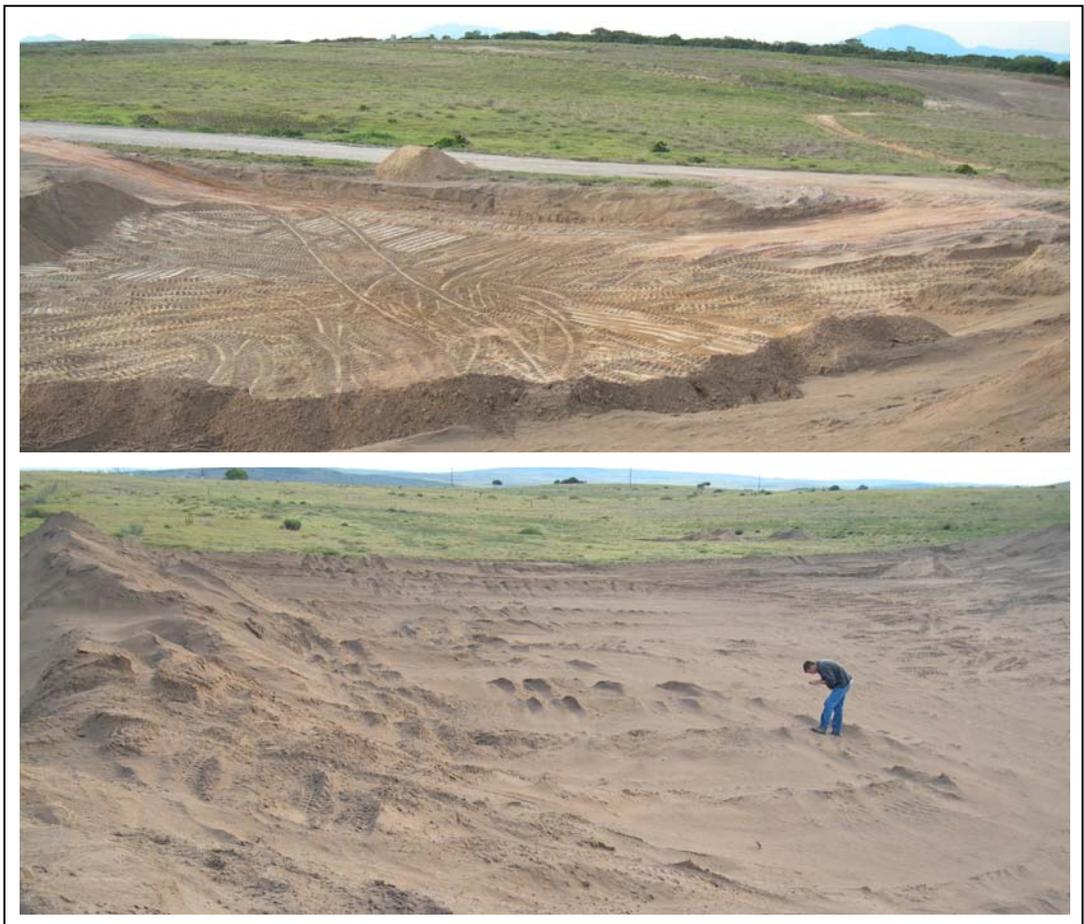
This more recent sand quarry did not exist at the first inspection of the study area early in April 2005. It is an extensive earthmoving exercise most likely to quarry the dune sands for construction purposes. No good profiles were exposed and no *in situ* materials were seen. At various places in the quarried area was a mixture of MSA and possibly LSA artefacts, ochre, Cape coastal pottery and so on. No marine shell or bone was seen. Stone artefacts are mostly in quartzite, though a few pieces of quartz and silcrete were also observed. Disturbance of subsurface archaeological materials through quarrying is performed illegally.

Plate 18. Newer sand quarry at occurrence 11. Perspectives toward the northwest (top) and southeast (bottom).

- Quarrying of sand at occurrences 1, 2, 3 and 11 has (and continues to) disturbed and damaged archaeological materials illegally and such operations must cease until a permit for such activities is obtained from Heritage Western Cape.

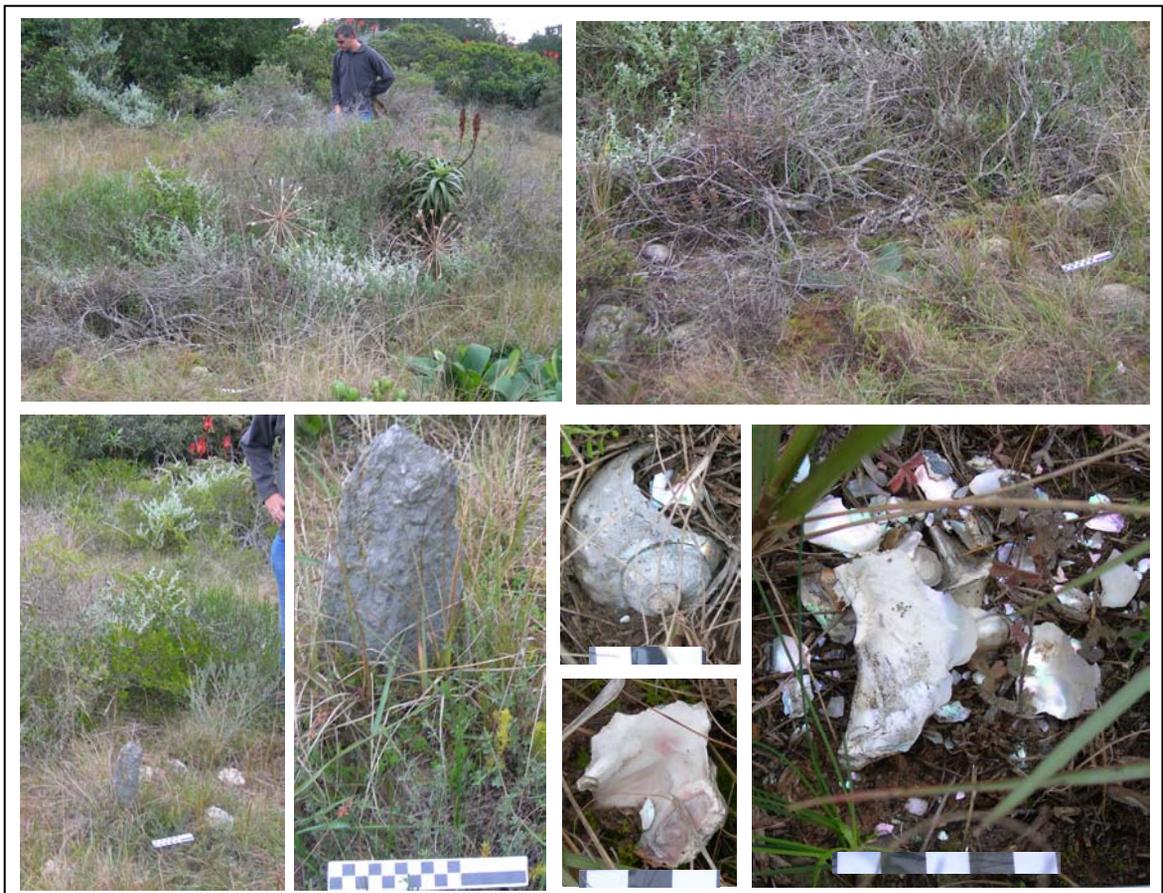
About 15 to 20 m north of the above-mentioned manuports is another collection or cache of manuports in quartzite and calcrete, which cover an area of approximately 12m<sup>2</sup>. This cluster of stone is not in a pile as those associated with clearing a field of stone before plow and neither is it in the vicinity of a cultivated field. The collection of stone is also too small to be the ruins of a structure and lacks any materials that may indicate the use of the area for habitation. A few pieces of marine shell were noted among and near the cluster of manuports and these include turbo and oyster. At the northern edge of the cluster is a vertically planted block of calcrete like those seen at occurrence 14. While these occurrences require further investigation, it is possible that they are associated with burial(s).

Plate 22. Large collection/cache of manuports – possibly a cairn - at occurrence 15 including a vertically planted calcrete block (2 images at bottom left) like those seen at occurrence 14. Scale intervals are in cm.

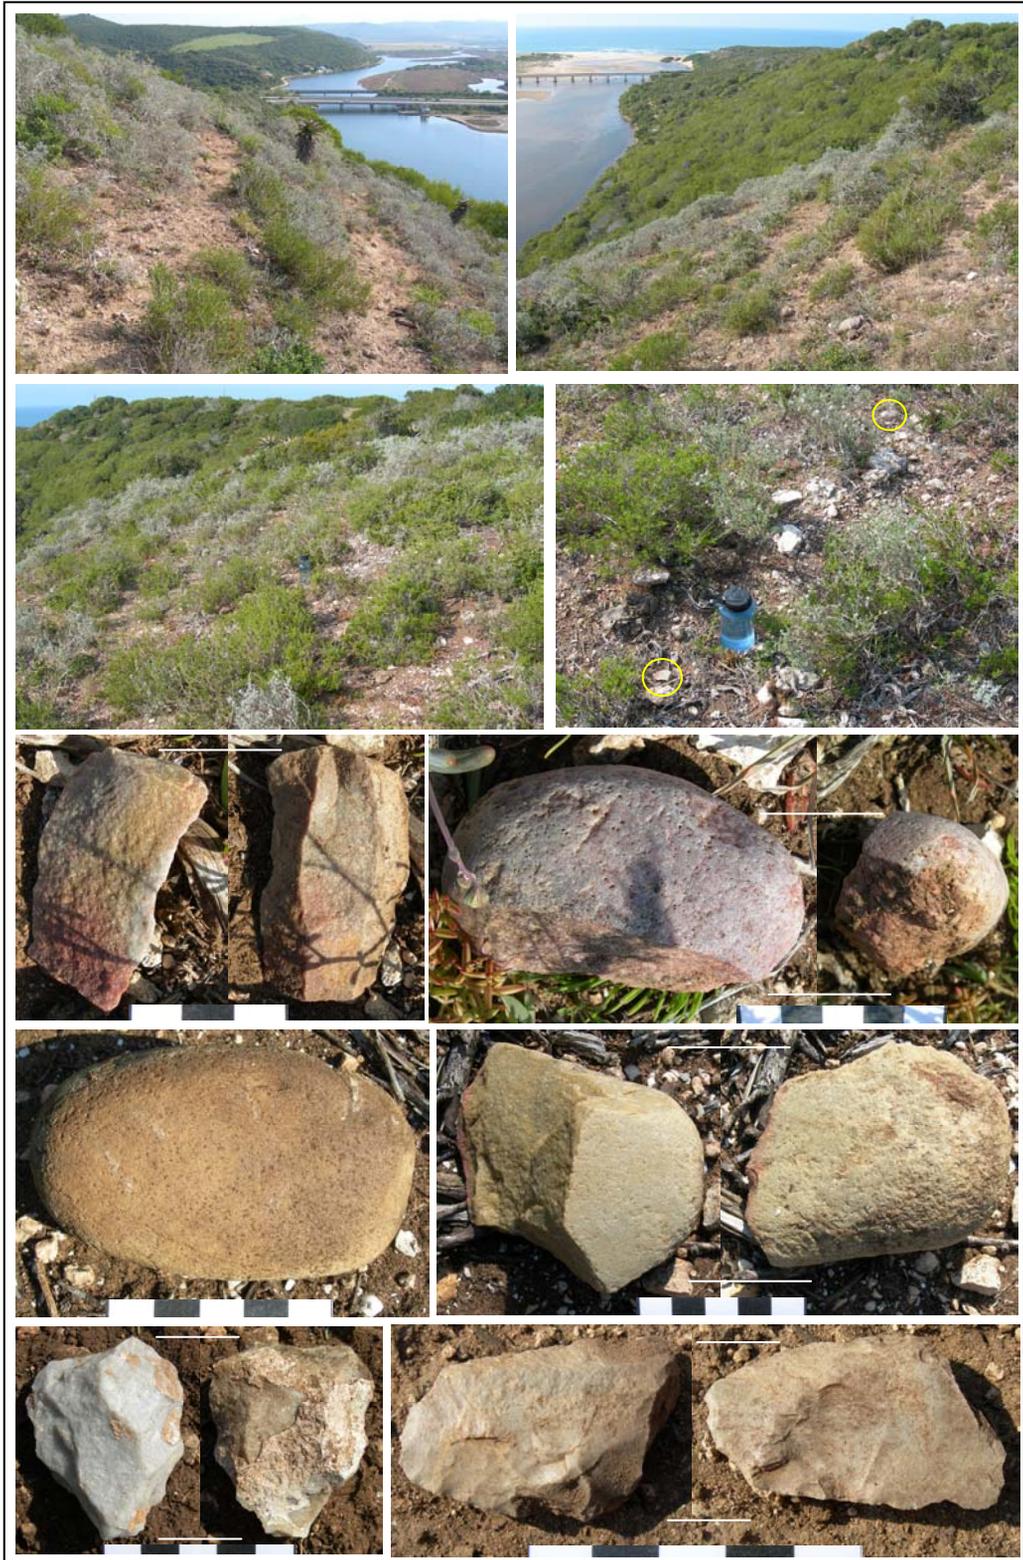
Occurrence 18 is situated near the top of a steep, sparsely vegetated slope among medium to high densities of calcrete blocks and nodules. Numerous artefacts were observed over a large area of some 120 m<sup>2</sup>, but densities are medium to low for the most part though some zones contained higher frequencies of artefacts. The artefact scatter continues some 30 m down slope where calcrete blocks and nodules are numerous and ubiquitous. Densities of artefacts drop off notably down the slope and peters out at the third GPS reading given above. The artefact scatter continues to the north to around the last GPS reading given above. Stone artefacts are mostly of MSA origin though at least one was seen that might be of ESA origin. Among the stone artefacts seen are; flakes, broken hammer stone, upper grind stone, combination hammer stone and broken upper grind stone, small, crude bifacial point, retouched silcrete and so on. Most artefacts are in quartzite, but milky quartz and silcrete were also seen. This site worth collecting and plotting as it may be very difficult to conserve. Also probably necessary to excavate a few shovel tests to investigate whether there are any *in situ* materials sub surface.

Plate 25. Low to medium density scatter of predominantly MSA stone artefacts at occurrence 18. Top four images show surroundings and ground surface with two artefacts circled in yellow. Bottom six images are examples of artefacts described in text including quartzite, milky quartz (bottom left) and silcrete (bottom right). All scale bar intervals are in cm.

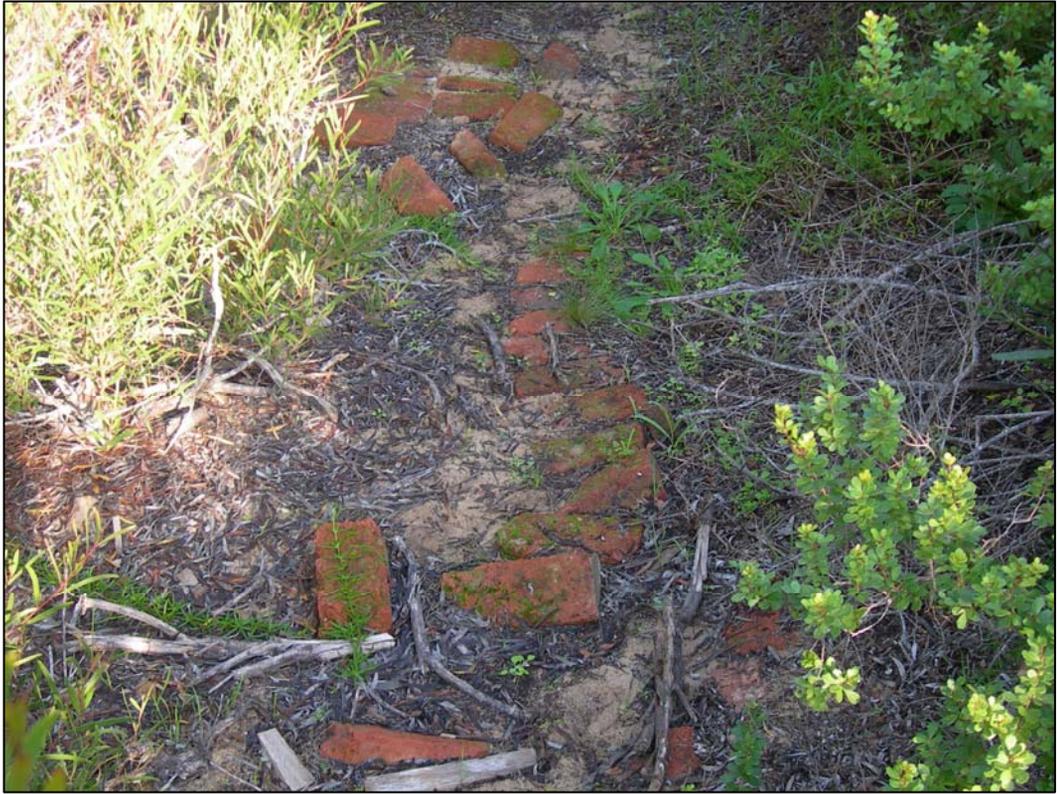
Between the two points indicated for this occurrence in Plate 5 is a disused single vehicle track in sand that is strewn with modern building rubble including corrugated and flat metal sheeting, brick, paving bricks, plaster/mortar and wood. Also noted was a small patch where the bricks appeared to be laid in the fashion of paving.

Plate 28. Stewn building rubble including bricks that appeared laid in the fashion of paving at occurrence 27.

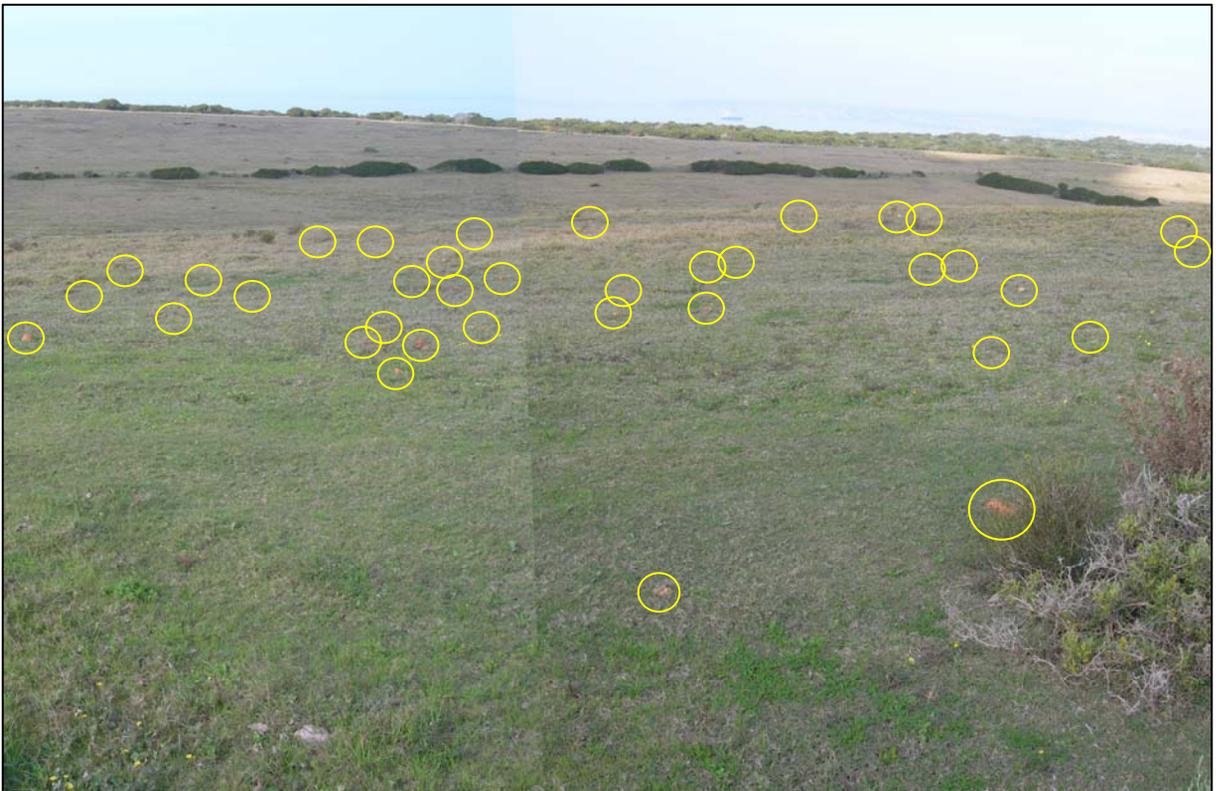
The scatter varies in artefact density with the densest areas containing up to 10 artefacts per 4 m<sup>2</sup>. It is estimated that, as far as ESA sites are concerned, this is a medium to high-density scatter. Since the ground is covered with grass for the most part, it is highly likely that many more artefacts lie beneath grass and possibly subsurface. This would certainly increase the artefact density. Some artefacts display fresher fracture surfaces and these may be the result of damage during plowing or the artefacts may be more recent in origin (MSA or LSA). Nevertheless, the majority of artefacts are of ESA age. It is surprising that the stones were not cleared for plowing and cultivation. No piles of stones resulting from clearing were seen in the vicinity of this field or occurrence.

Plate 29. Medium to high-density scatter of overwhelmingly ESA stone artefacts at occurrence 28. Yellow ovals encircle larger stone artefact that can be seen on an enlarged version of these stitched images. Numerous additional artefacts, including smaller ones, are visible on site and more lie beneath the grass cover.

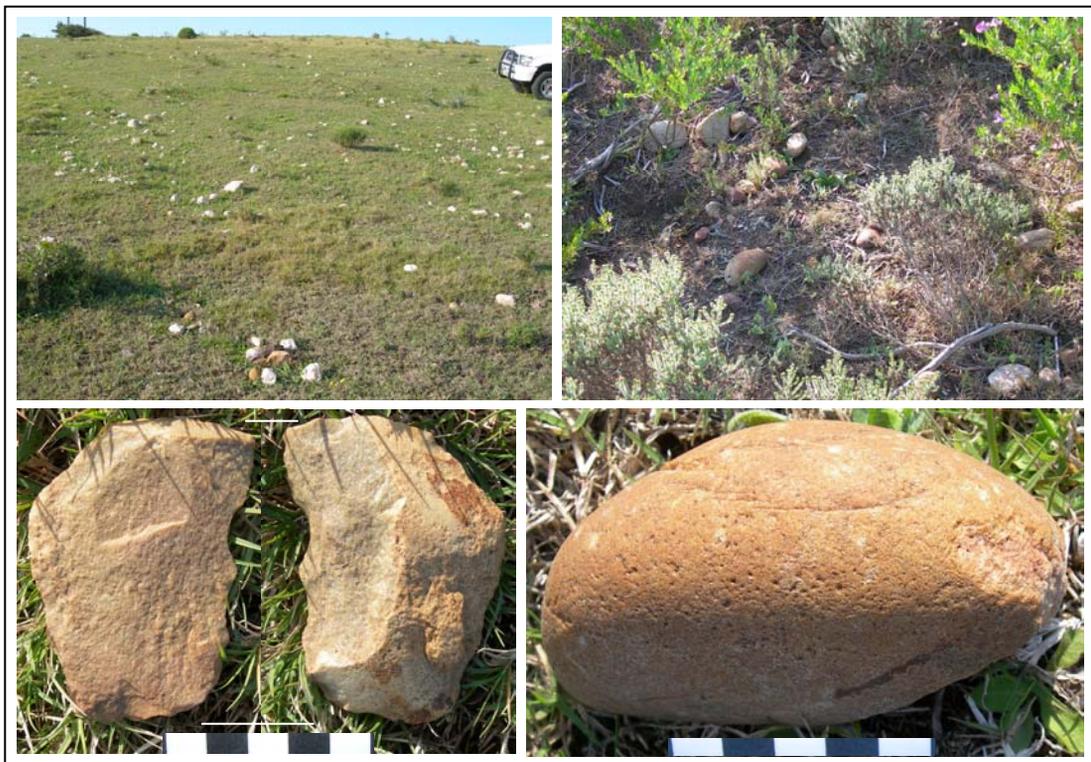
These are large, low to medium-density scatters (each about 3500 m<sup>2</sup>) of mostly Enon derived cobbles that also include cores, flakes and hammer stones that are probably ESA/MSA in origin. These scatters are possibly the result of clearing fields for plowing and cultivation, but similar materials were noted in vegetated areas adjacent to these fields (Plate 31).

Plate 31. Low to medium-density scatter of Enon derived cobbles including some stone artefacts at occurrences 29 and 30. Scatter in field and adjacent to field (top left and right respectively). Example of flake (bottom left) and hammer stone (bottom right). Scale intervals are in cm.

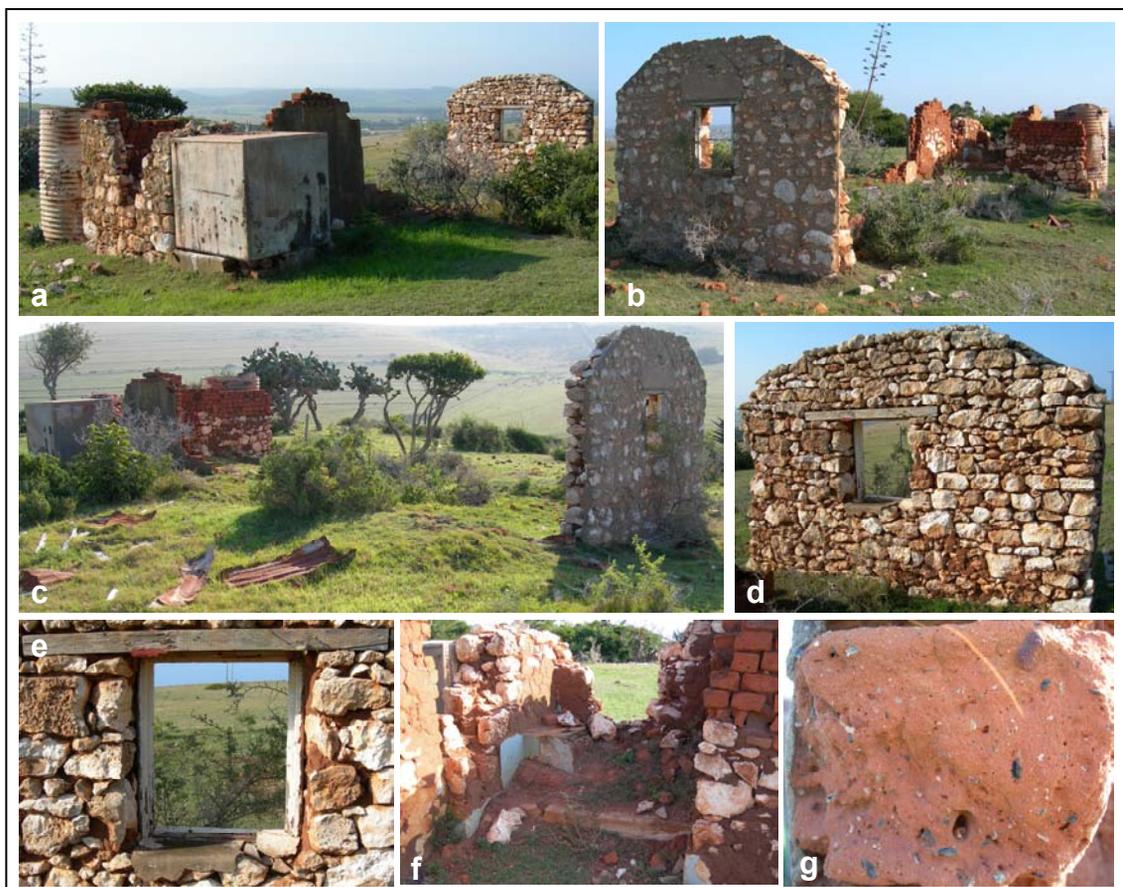
Ruins of a north-facing cottage built partially of both brick and calcrete blocks. The ruins are reminiscent of those observed at occurrence 3. Remains of window frames appear to be of Oregon pine. Original clay mortar is still visible between clay bricks - with temper of fragments of burnt bone and marine shell - and calcrete blocks as is clay plaster beneath whitewash and/or paint. Certain areas of the structure include plaster and mortar that appear more modern. No midden was located in the vicinity of the ruins. Old fence poles and wire are still in place in certain areas around the house and garden. While older building rubble and metal sheeting is strewn around the ruins, very little modern rubbish such as plastics was seen.

Plate 32. Ruins of an old cottage at occurrence 31 viewed from southwest, northeast and southeast (a, b & c respectively). Presented are examples of walling (d & f), window frame (e), mixed building materials (f) and brick (g).

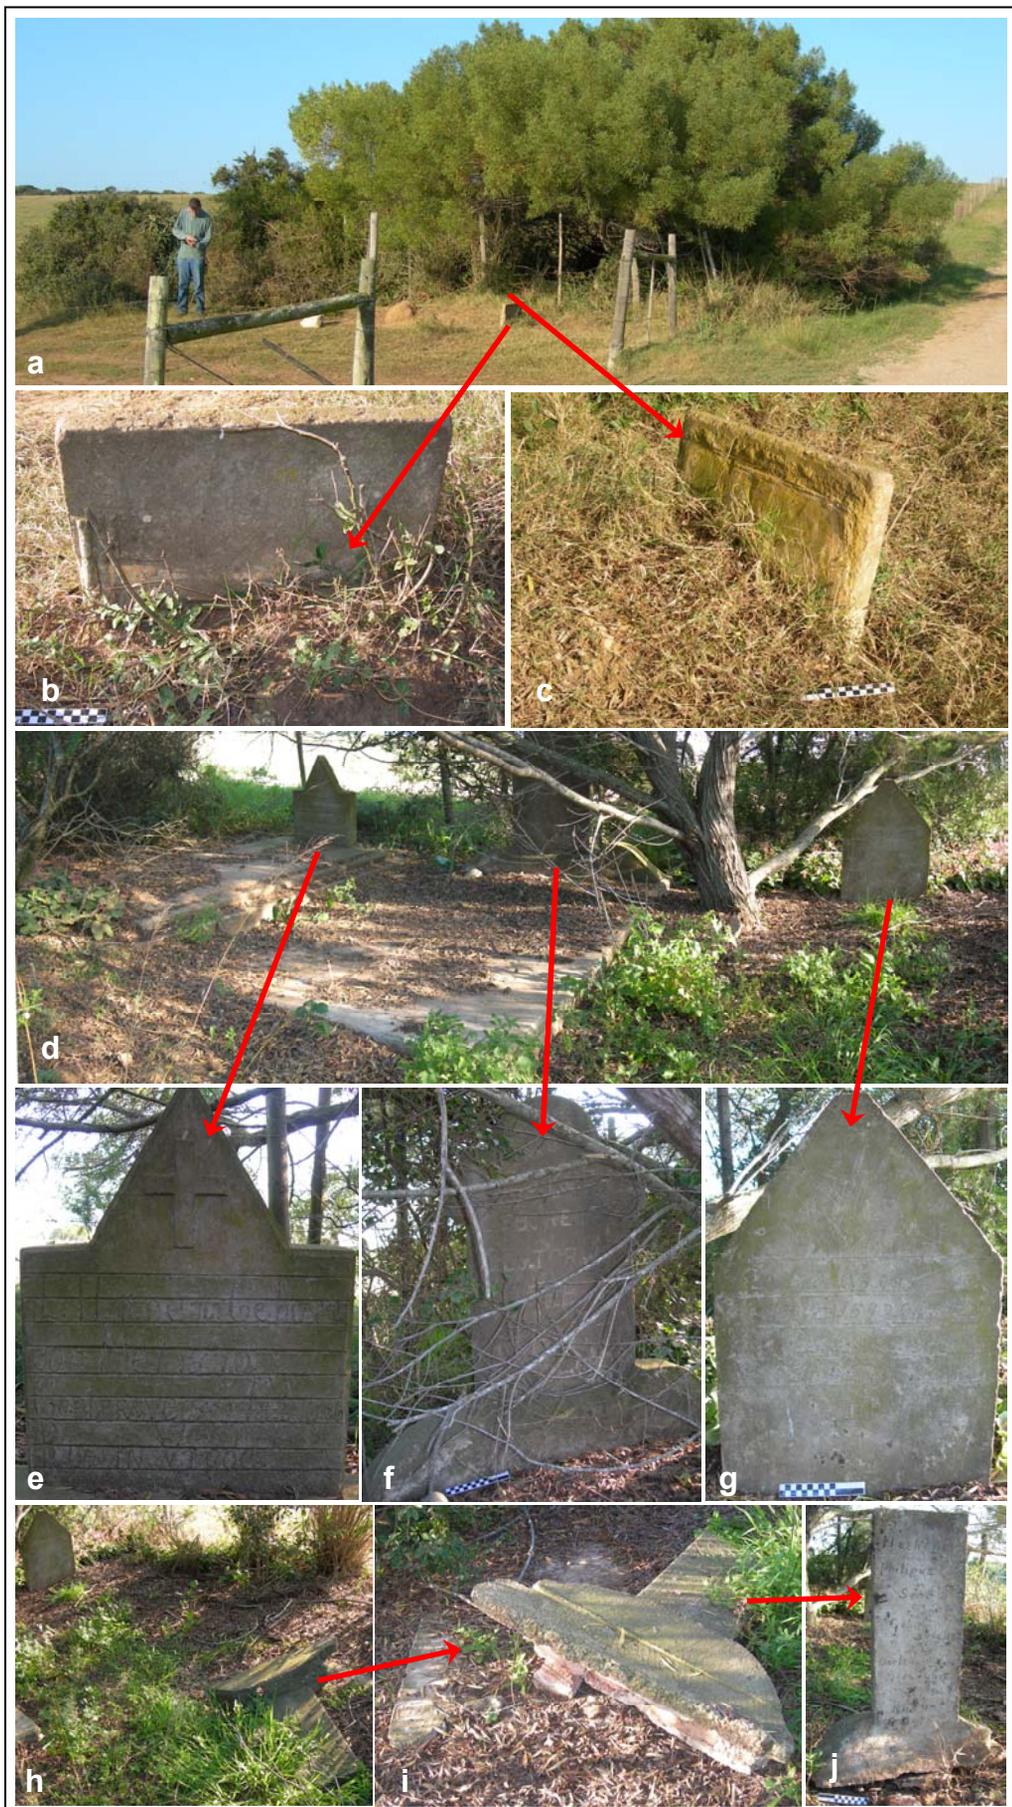
Some 200 meters east of the subway under the N2, along the main gravel road into the property are five graves situated under and next to a large Rooikranz bush on the north side of the road (see Plate 5). All graves have old concrete headstones that face in a north to northeasterly direction. Three graves are capped with concrete "beds" (Plate 33 e, f & i). The only materials associated with these graves are a modern wine bottle and a broken glass container.

Plate 33. Graves in and adjacent to large Rooikranz bush at occurrence 32 (a). The gravestone to the west is not inscribed (a, b & c) while the remaining four bear inscriptions (e, f, g & j). Scale intervals are in cm.

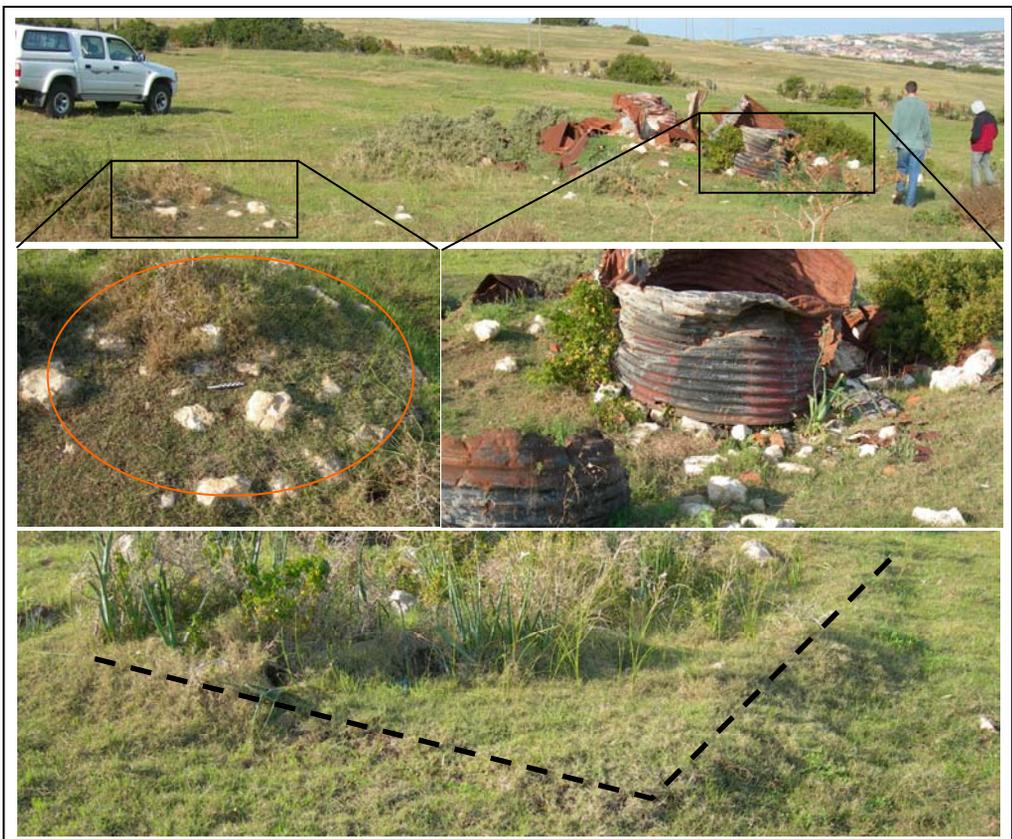
Several old, rusted water tanks and building rubble including calcrete blocks are clustered in a formerly cultivated field. Associated with these are what appear to be remnants of a former structure including a circular calcrete feature (Plate 39, indicated with orange oval) as well as a linear ridge of grass that may cover ruins of walling. The circular feature is likely the platform for a water tank. Also noted was a large, old metal pot. The nature of this occurrence cannot be determined without clearing vegetation and archaeological excavation. No modern looking debris was seen and it is possible, therefore, that this occurrence is 19<sup>th</sup> century or earlier in origin.

Plate 39. Water tanks and rubble at occurrence 38. Dashed line indicates raised grass.
