**PROPOSED REZONING AND SUBDIVISION OF A PORTION OF VAALEVALLEY  
219, MOSSEL BAY, WESTERN CAPE PROVINCE**

**ARCHAEOLOGICAL HERITAGE IMPACT ASSESSMENT**

**FINAL REPORT**

28 September 2005

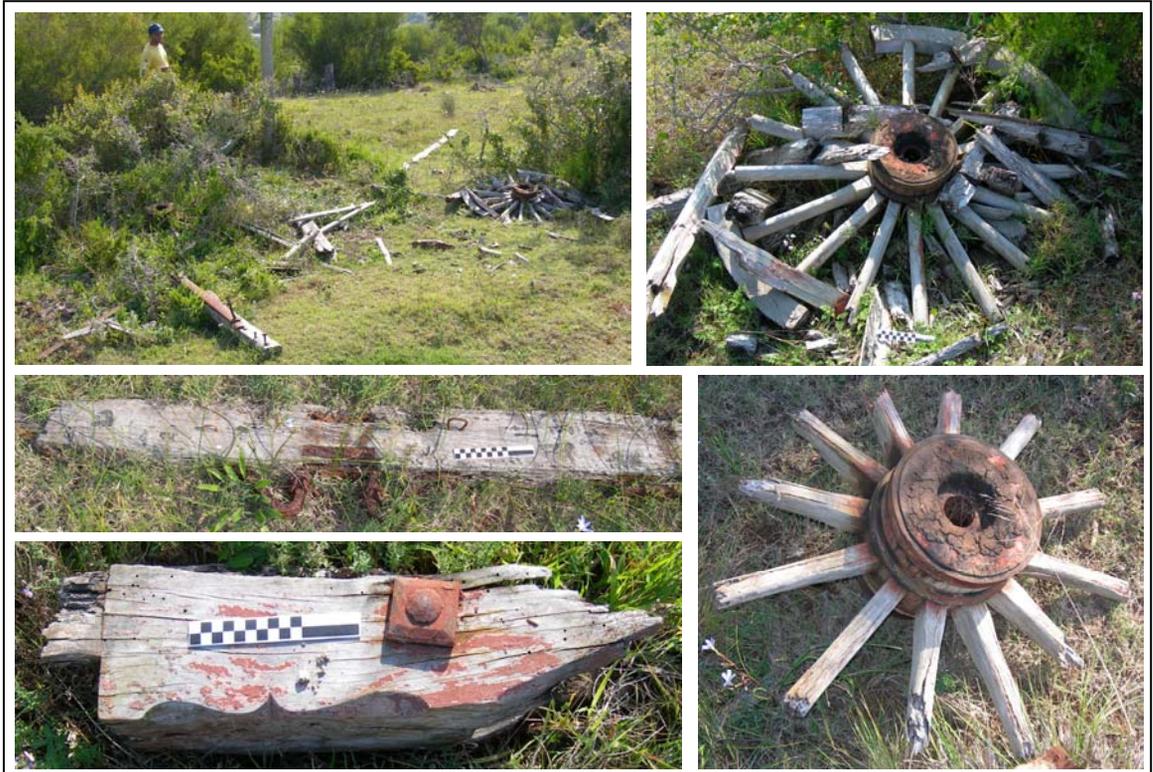
Several parts of a broken up ox wagon are strewn about on the western edge of a formerly cultivated field. Some parts may be rescued for restoration.

Plate 45. Parts of an old ox wagon strewn about at occurrence 44. Scale intervals are in cm.

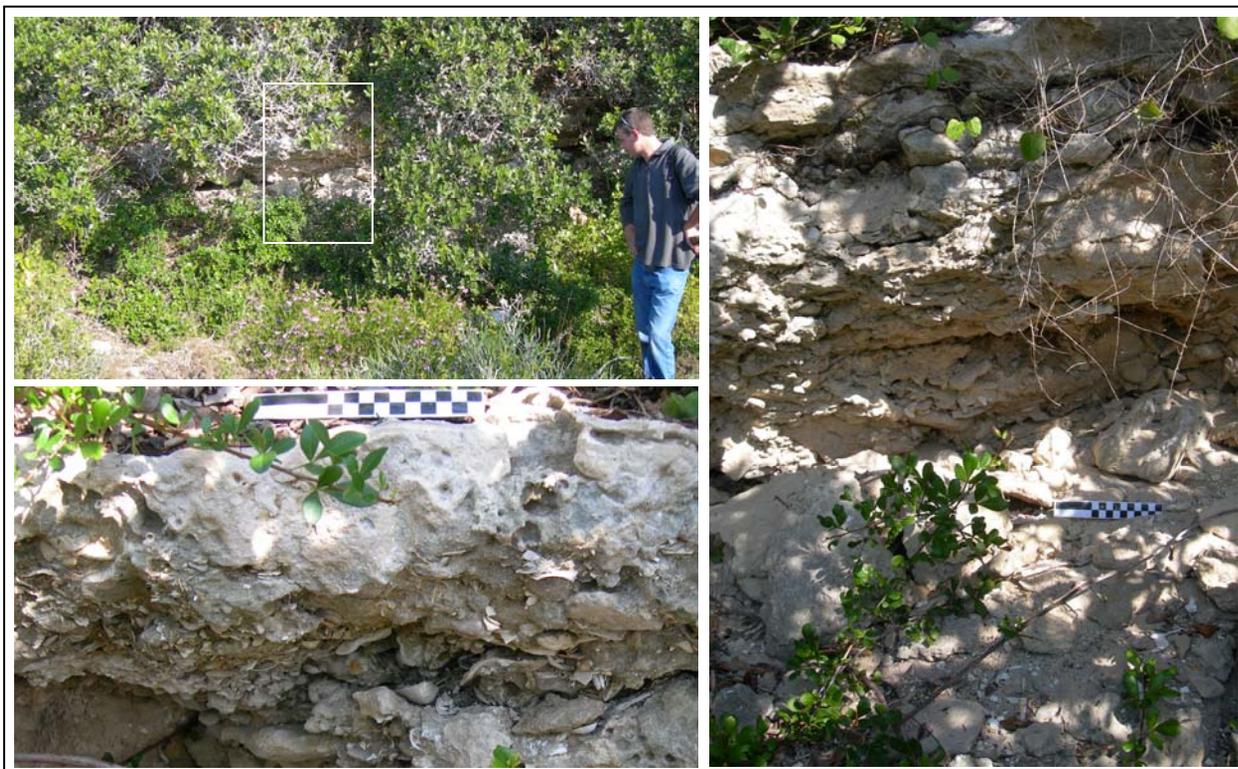
This palaeontological/geological feature is a raised beach nearby the above two occurrences that is at least 10 meters above the high water mark of the tidal Klein-Brak Rivier. Large numbers of complete specimens and large fragments are cemented into the sands of the raised beach. This occurrence requires investigation by a paleontologist. It is likely that this occurrence will require mitigation and conservation measures to be recommended and reviewed by a specialist and the heritage authorities respectively.

Plate 48. Geological/palaeontological feature at occurrence 25 is a raised beach. White frame in top image is enlarged at right and the bottom image is a close-up showing *in situ* marine shell in raised beach. Scale intervals are in cm.
