ARCHAEOLOGICAL MONITORING OF EARTHWORKS AT THE ARABELLA HOTEL SITE, CAPE TOWN FORESHORE

March 2002

Archaeology Contracts Office

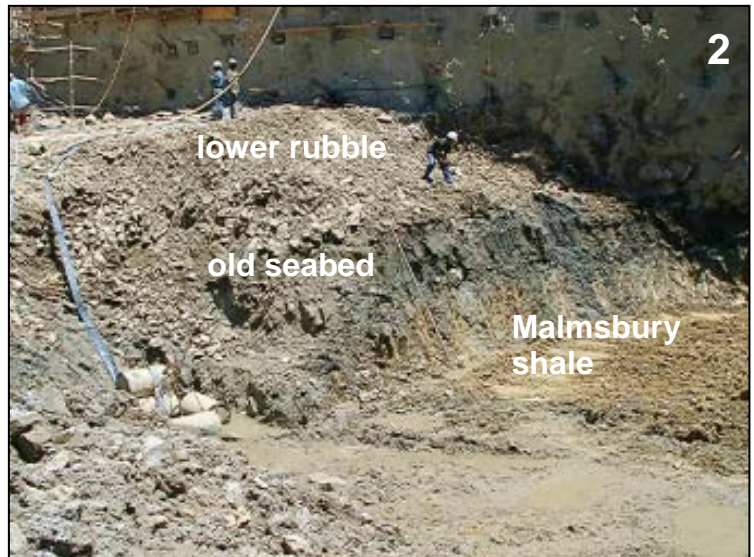
- upper rubble: this is a landfill made up largely of building debris and from the smell in places, also industrial waste;
- dredged sand: landfill consisting of dredged seabed material, white in colour and rich in water rounded marine shell – this is not believed to be the sand brought from near the airport (see Cox 2000 and Sharfman & Mavradinov 2000);
- lower rubble: earlier landfill containing much rocky material and other debris. This appears to have been submerged or waterlogged and had a strong sulfurous aroma;
- old seabed: this was marked by a relatively thin deposit (on average 80cm thick) of black/grey clay also having a strong sulfurous aroma;
- bedrock: Malmsbury shale.

Very small quantities of 19th century refined earthenwares were found in both rubble deposits while not a single piece of any 18th century material was recognised. Dark green bottle glass was found occasionally in the seabed material but the impression was that these were chance finds from an occasional discard. Lumps of coal were also found in the seabed material.

The lack of any 18th century artefacts in the seabed unit and other factors, particularly the absence of an *in situ* marine stratigraphy (we would have expected the white sand to lie on top of the basal seabed clays), suggests that dredging has occurred in the past. This may have occurred during the 19th century prior to the establishment of the harbour when ships were still loaded and unloaded via the numerous jetties jutting out into the bay in the vicinity, or may relate to the more recent landfilling event. Whatever the case, the lack of any shipwreck material may be the result of this earlier intervention.

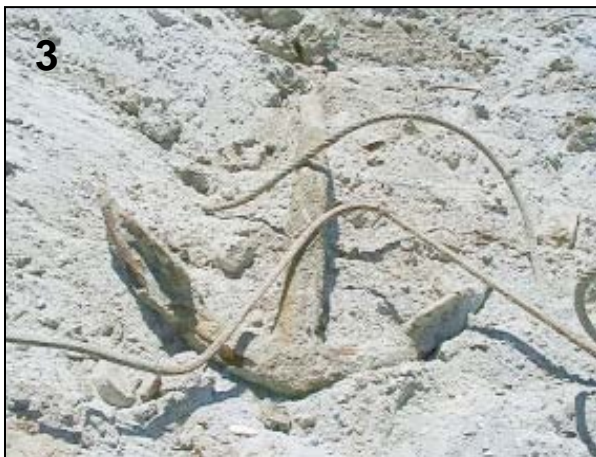
Two anchors were recovered from the lower rubble fill. The admiralty pattern anchor

shown in Plate 3 is made from wrought iron and has curved arms tipped with flukes. These were used throughout the 19th century. This specimen was sent to the Maritime Museum at the waterfront for curation. The anchor in Plate 4 had lost its arms although the mechanism at the top of the shank was well preserved (see plate 5). Neither anchor had a stock (an "L" shaped iron bar that passed through the shank just below the chain ring at

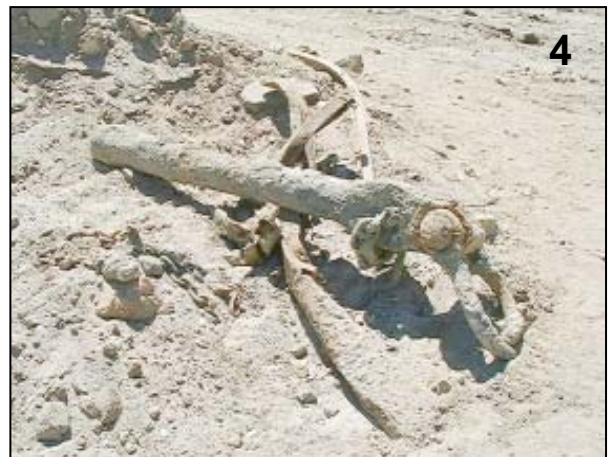
right angles to the arms, that prevented the anchor from lying flat on the seabed causing the arms and flukes to dig in).

As this specimen was found over the festive period it could not immediately be collected by the Maritime Museum. Despite requests to the earthmoving contractor to keep it to one side, it disappeared from site and was presumably dumped along with the fill.
