# **AN INITIAL SCOPING STUDY OF THE SANBONA WILDLIFE RESERVE, BARRYDALE**

**Earthworks**

September 2002

**Archaeology Contracts Office**

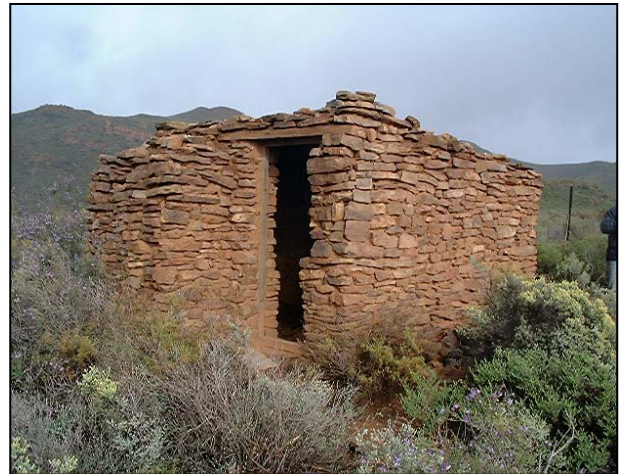
**Site name:** KALKOENSHOEK 1 (KH 1)

**Description:** Small, largely intact, stone building with corrugated iron roof. Single room with chimney breast to rhs of door. Single small window in back wall. Wooden beams, lintels and frames. Earth floor. Mud mortar.

**Sensitivity:** Vernacular building style representing an aspect of traditional farming practices. Almost certainly older than 60 years. Vulnerable to being plundered for building materials.

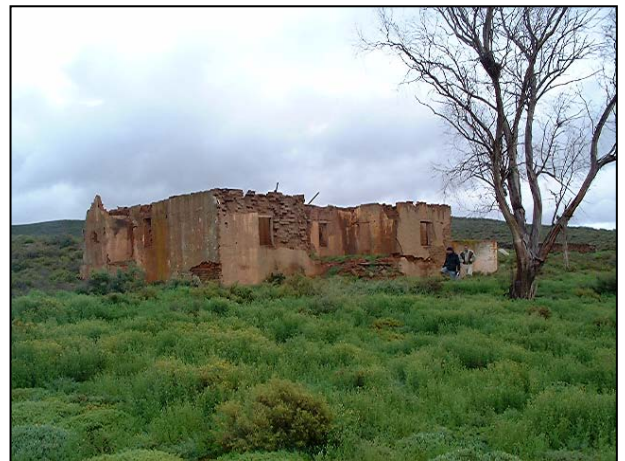
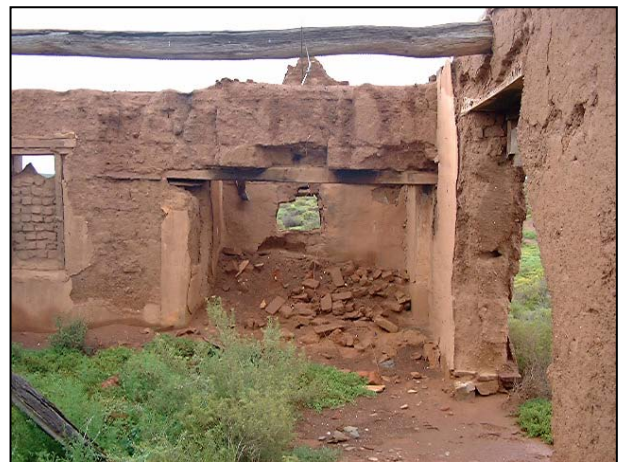
**Site name:** KALKOENSHOEK 2 (KH 2)

**Description:** Remains of a large farmhouse in ruinous state with extensive stone walled "double" kraal at rear. Originally a 3 roomed dwelling, 2 were added later on either side of the stoep. Chimney breast on south side. Use of sun-dried mud brick throughout with thin cement plaster skim in places. Wooden lintels, rafters, frames. Roof collapsed – probably originally thatched. Traditional features include a "muurkas". Floor surface not visible but probably compacted earth.

**Sensitivity:** Vernacular building style. Certainly older than 60 years (19<sup>th</sup> century).

**Related features:** Large stone walled kraal divided into two parts. Milking? shed attached to south wall. Additional stone walling to the south of the farmhouse (old boundary wall?).

Traces of a household dump are located to the rear of the house containing 19<sup>th</sup> century ceramics, glass, ostrich eggshell fragments and bone and hearth debris. 2 smaller ruins (one brick and one stone) are also found to the rear. Remains of ox wagon are in the field in front of the ruin.

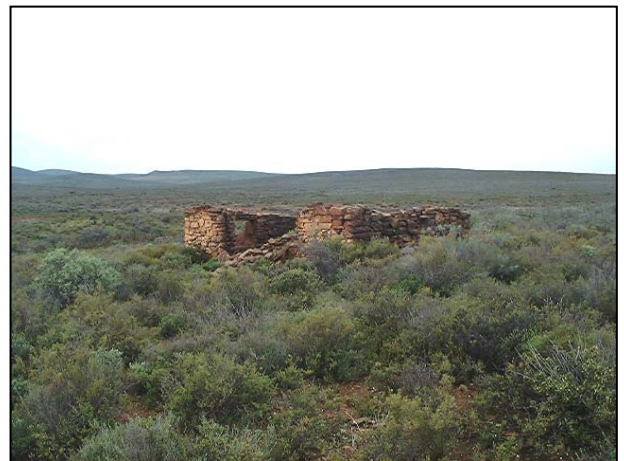
**Site name:** KALKOENSHOEK 4 (KH 4)

**Description:** Remains of a small, 2 roomed stone labourer's cottage. Roof missing. Chimney breast on east wall.

**Sensitivity:** Vernacular building style representing an aspect of traditional farming practices. Almost certainly older than 60 years. Vulnerable to being plundered for building materials.

**Related features:** Stone boundary wall to the east continues towards KH2. A household dump is found between the wall and the cottage containing a small amount of refined earthenware and bone. To the front (north) is a small stone feature which may have been a "lammerkraal" or chicken coop, the remains of a "longdrop" toilet, and a mound of stone which may be the base of a clay oven or even possibly a grave.

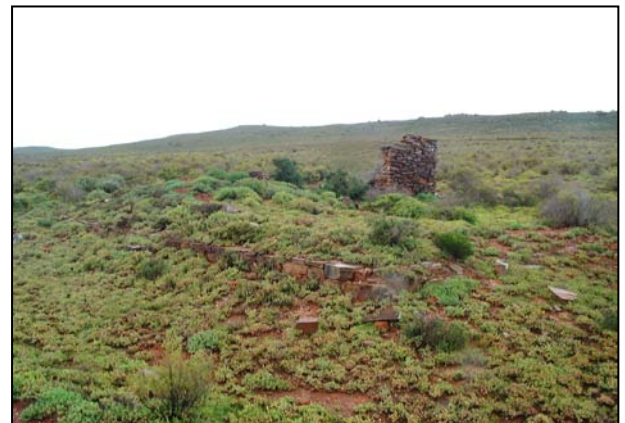
**Site name:** KALKOENSHOEK 5 (KH 5)

**Description:** Remains of a small stone cottage(?) of which only a corner is left standing. A pile of stone nearby suggests salvage for re-use.

**Sensitivity:** Stone building platform and a corner of the cottage are all that remain. The building is probably older than 60 years. The building marks an aspect of traditional farming practices.

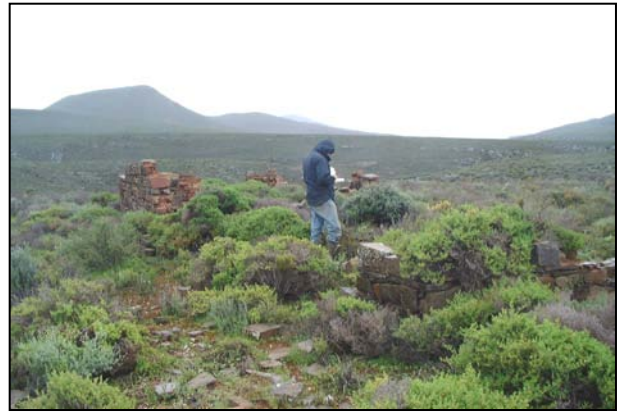
**Site name:** KALKOENSHOEK 6 (KH 6)

**Description:** Remains of a small single roomed stone cottage.

**Sensitivity:** The building is probably older than 60 years. The building marks an aspect of traditional farming practices.

**Related features:** Another square feature exists at the rear, the purpose of which is unknown. A very extensive, though not very dense, Middle Stone Age artefact scatter is found in the area between the cottage and the road. Some European ceramics dating to the late 19<sup>th</sup> century are also present near the cottage.

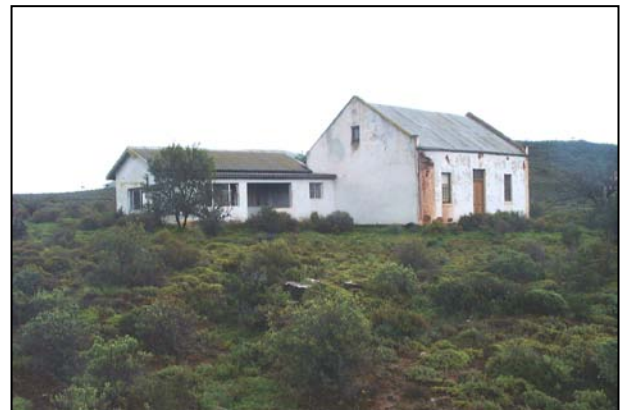
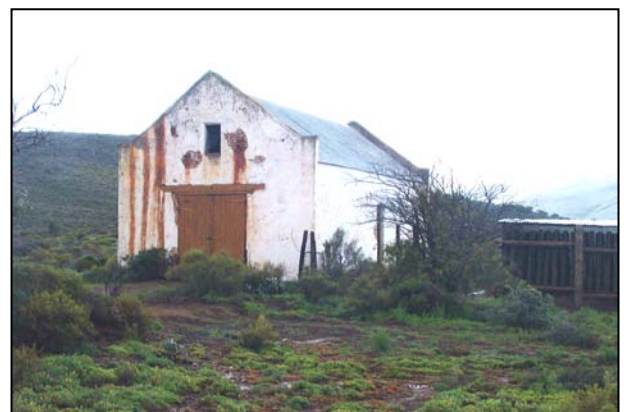
**Site name:** HOOGFONTEIN 1 (HF1)

**Description:** A well preserved dwelling, barn and various small outbuildings including 2 labourer's cottages. Two outbuildings are of more recent construction, as are two additions to the main house (sitting room and kitchen). Both the main house and barn retain many of their original architectural features, such as wooden floors windows, doors, frames etc. A well preserved feeding crib is found in the barn, also joinery and *rietdak*. The interior colour scheme of the house appears original. The present corrugated iron roof has probably replaced a thatched one. Both barn and dwelling have attics. No fireplace was evident.

**Sensitivity:** Very fine examples of the vernacular building style incorporating Georgian elements. Certainly older than 60 years, likely mid 19<sup>th</sup> century. Vulnerable to illegal and/or uninformed alteration, plundering for joinery and other building materials.

**Comment:** A boma used in the introduction of black rhino to the reserve has recently been insensitively constructed in front of the barn.

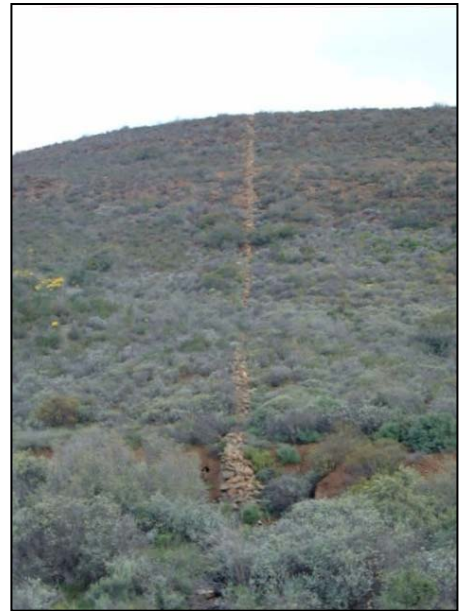
**Site name:** RIETHUIS 1 (RH1)  
**Position:** 33°50'29.7"S 20°35'07.2"  
**Type of site:** Structure

**Description:** Dry packed stone "ostrich" wall (T. Hart, pers comm.).

**Sensitivity:** This is an example of a common feature of the area associated with early farming. Certainly older than 60 years (late 19thC). Vulnerable to plundering for building stone and joinery.

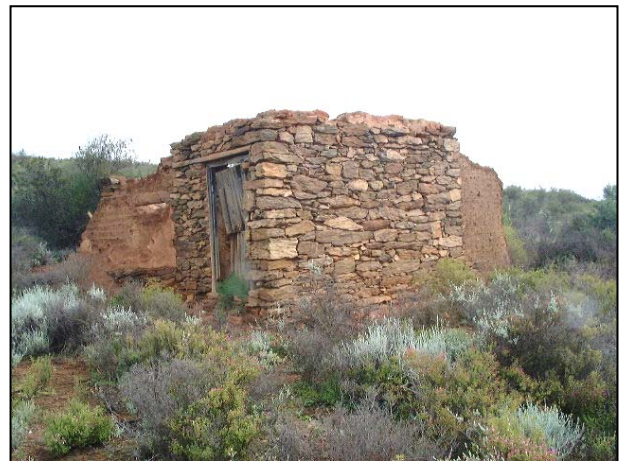
**Site name:** RIETHUIS 2 (RH2)  
**Position:** 33°50'21.7"S 20°35'31.1"E  
**Type of site:** Structure (partial ruin)  
**Period of use:** Historical

**Description:** Small 3 roomed stone and mud brick cottage. Chimney breast to rhs of entrance door. Appears that mud brick has been used for the central room whereas the two ends are composed of stone. Wooden frames and lintels are still present. The use of brick in the center suggests that this may have originally been 2 stone buildings joined through construction of a central room.

**Sensitivity:** Vernacular building style representing an aspect of traditional farming practices. Almost certainly older than 60 years. Vulnerable to plundering for building materials.

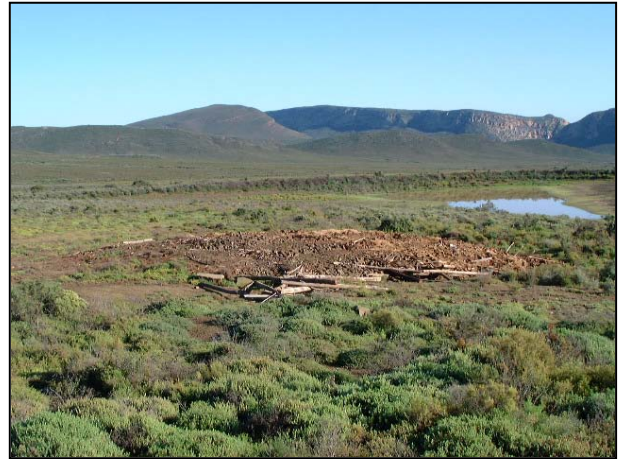
**Site name:** KLEINVLEI 1 (KV1)  
**Position:** 33°48'4.4"S 20°37'33.3"E  
**Type of site:** Historical site with remains of recently demolished structures.

**Period of use:** 19<sup>th</sup> century or earlier.  
**Description:** Remains of a farmstead located close to dam. There were at least two buildings on the site that have been recently demolished. The remaining rubble indicates that these were built with vernacular materials including mud bricks and reeds. It is likely that one of the buildings may have been a dwelling, the other a barn.

**Use:** Small farmstead and outbuildings.  
**Sensitivity:** Despite un-authorised demolition of structures, the site remains sensitive as elements of the historic landscape are preserved, as are foundations of the demolished structures.

**Protected by legislation:** Yes  
**Related features:** A fairly well preserved *trapvloer* (threshing floor) is evident, there is also a household midden/dump containing 19<sup>th</sup> century ceramics.

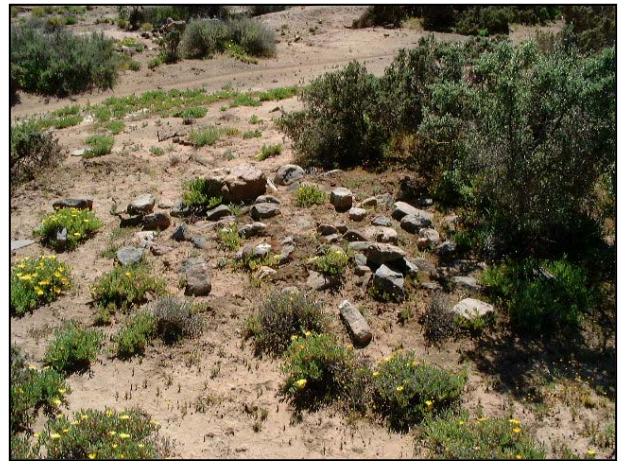
**Site name:** TILNEY 3 (T3)

**Description:** 18 or more low burials mounds situated on an outwash pan. Some of these have crude head and foot stones, some have been disturbed.

**Sensitivity:** Sensitive to disturbance by flooding or development activities.

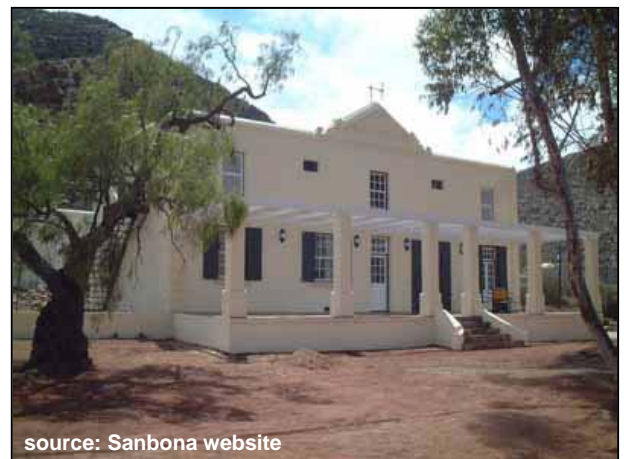
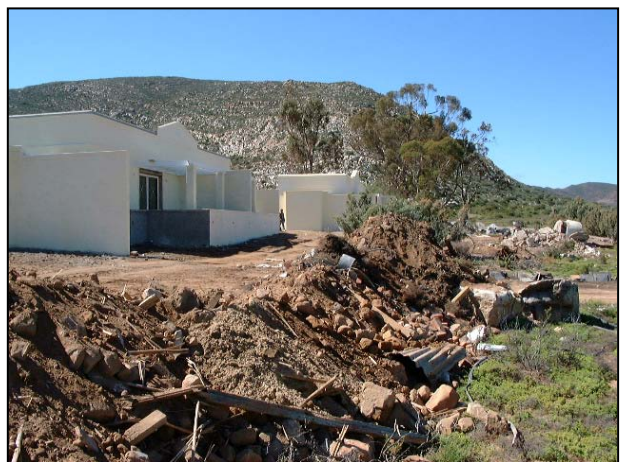
**Site name:** TILNEY 4 (T4)

**Description:** Historical Georgian period vernacular farmstead with some outbuildings. Previously one of the larger farming complexes in the area with a very well preserved flat roof Georgian farmhouse with a soldier and gable. The structure has been very recently rehabilitated to accommodate a tourist lodge, additions have been built onto the rear. A number of outbuildings have been demolished and replaced with contemporary structures (Luxury accommodation). Surrounding area has been extensively re-landscaped. It is unclear whether the structure was professionally recorded before modification, or whether any formal liaison was carried forward with SAHRA.

**Related features:** This aspect is unclear due to recent modifications of the surrounding landscape. A number of small labourers cottages still remain along with remnants of fields and graveyards.

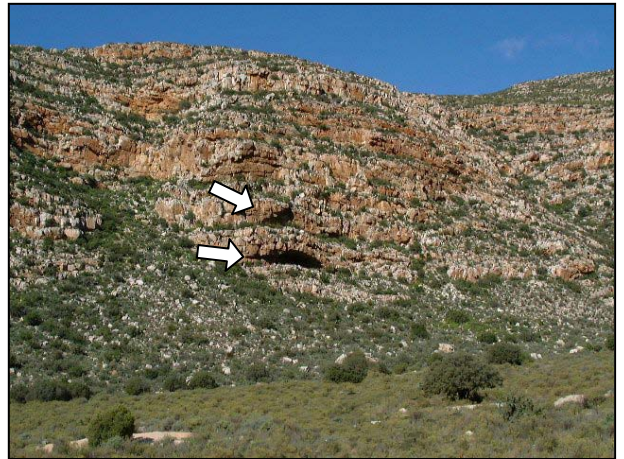
**Site name:** TILNEY 5 (T5)

**Description:** A rock shelter with a shallow deposit and artifacts (the upper shelter on the photograph). Rock art is very faded and difficult to discern. Two chert thumbnail scrapers, flakes and potsherds were noted on the surface. There are two lower grinding stones, one of which is stained with ochre.
