**CULTURAL HERITAGE RESOURCES  
IMPACT ASSESSMENT OF THE FARM  
VLAKLAAGTE 161 TSAKANE BENONI  
GAUTENG**

**AFRICAN HERITAGE CONSULTANTS CC**

**APRIL 2007**

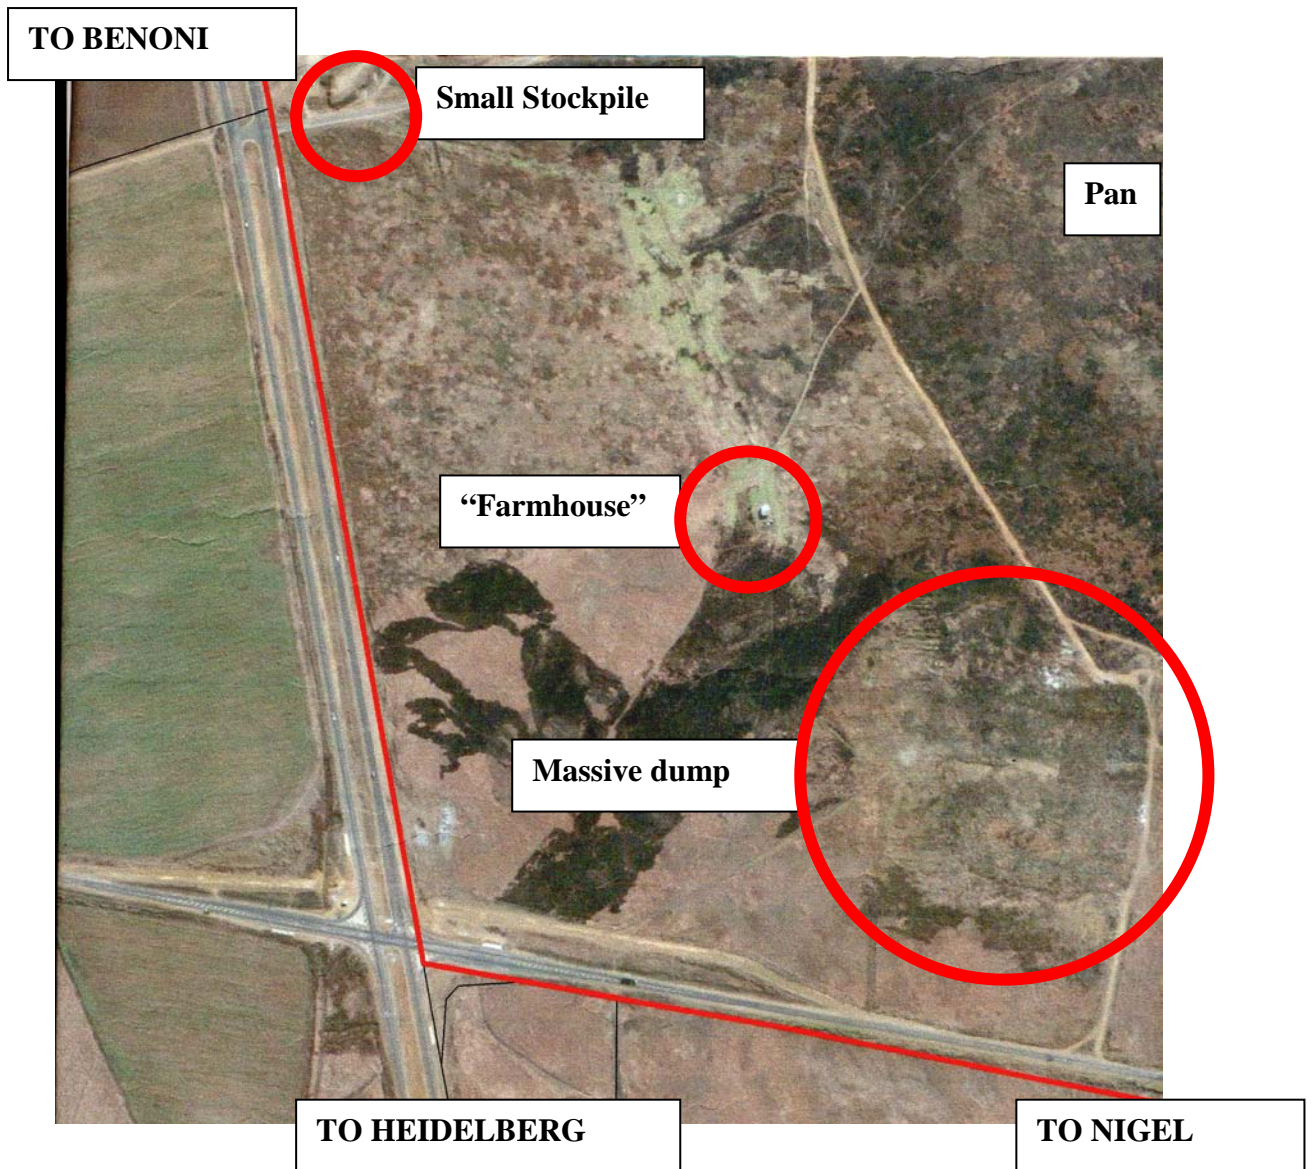
*Figure 1. Aerial view of the western portion of the property investigated.*

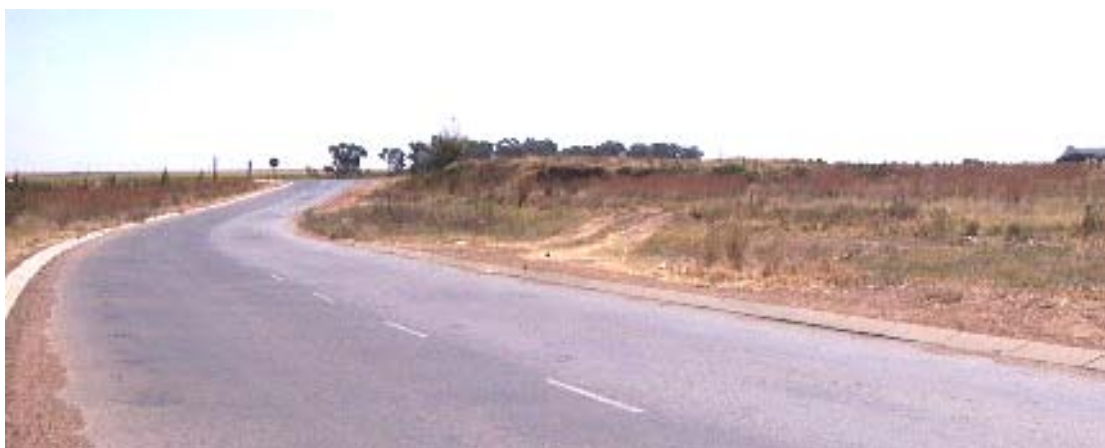
*Figure 2. Small stockpile of soil, possibly a leftover from the building of the Tsakane–Nigel link road.*

On the aerial photograph above a “massive dump” is indicated. The structure is approximately 200 x 200 meters in extent and averages about two to three meters thick. As the original material is overgrown and also covered with typical small loads of rubbish it is not clear what the original purpose of this dump was.

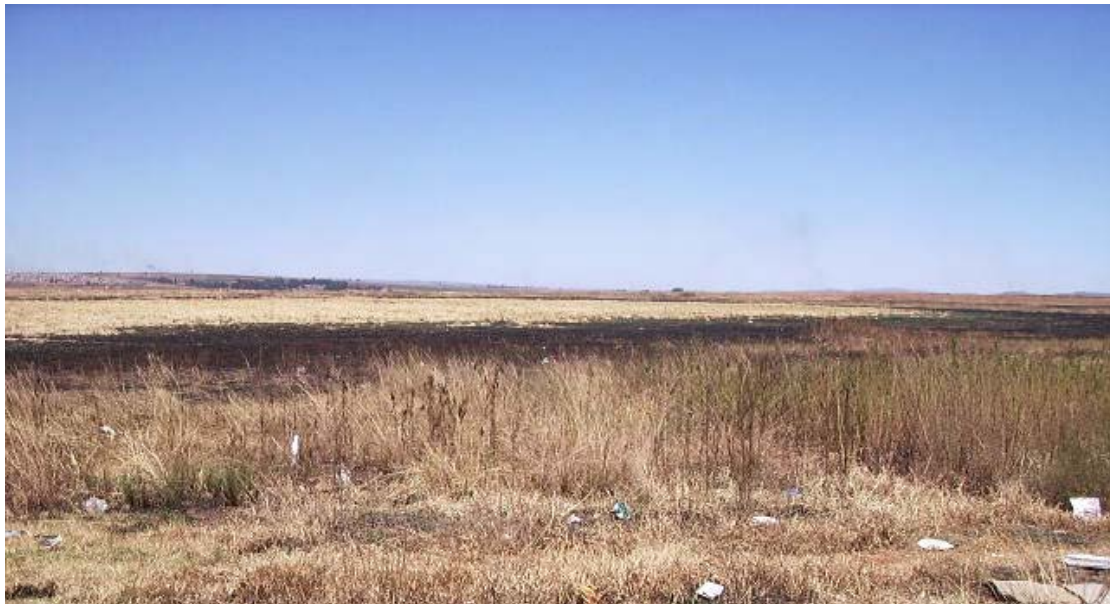
*Figure 3. The geological structure in the northwest of the property is, what is generally known in South Africa, a pan. In the pre-historical past these were often the focal points of hunter-gatherer activities. Owing to the dumping of rubble all around the pan, it is impossible to see if any stone tools are present. On the other hand, the much larger pan just to the east of Benoni , would have relegated this much smaller pan to a secondary role.*

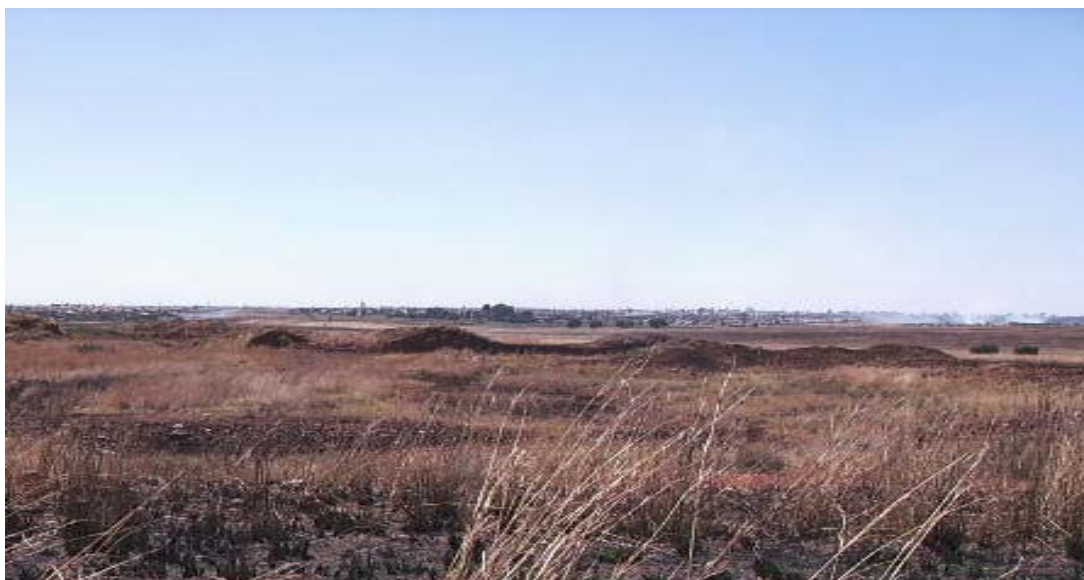
*Figure 4. These large excavations in the central section of the property next to the Nigel road appear to be a quarry for good quality road building material. It is possible that this material was used in the building of the infrastructure of Tsakane.*

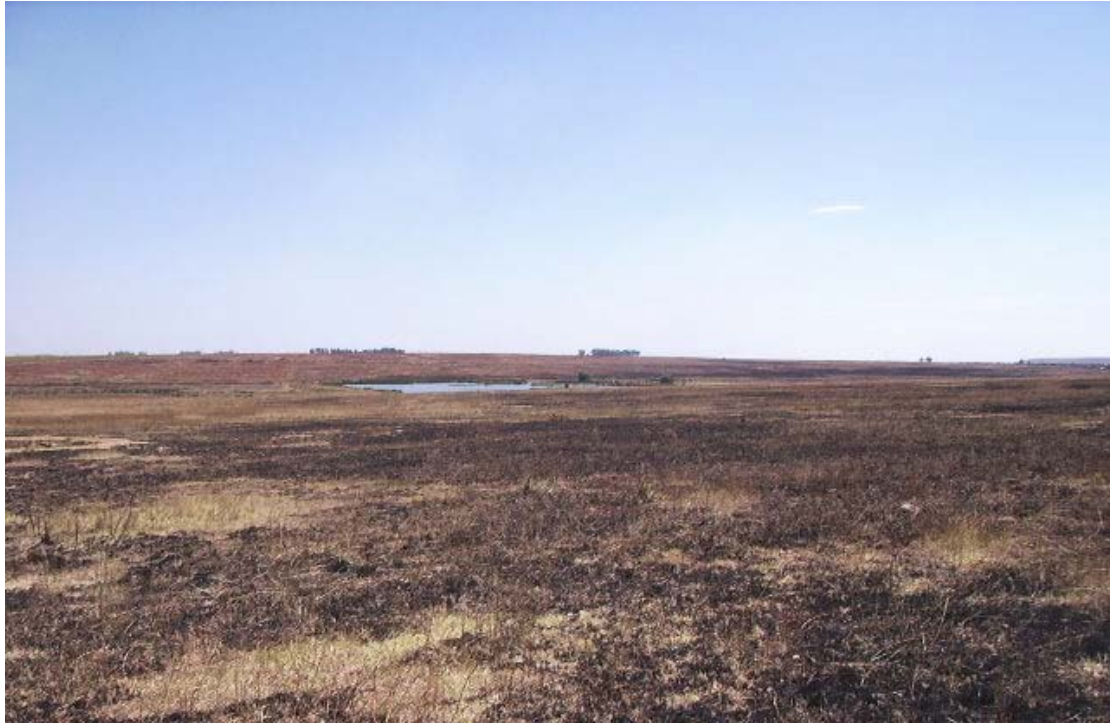
*Figure 5. In the central portion of the property there exist quite a large reservoir. Its original purpose was possibly to have sufficient water for farming purposes. The proximity of a very large cattle kraal is indicative of the above comment. At present though it serves as a buffer for the rather large sewerage treatment works that is situated directly north of the property under investigation.*

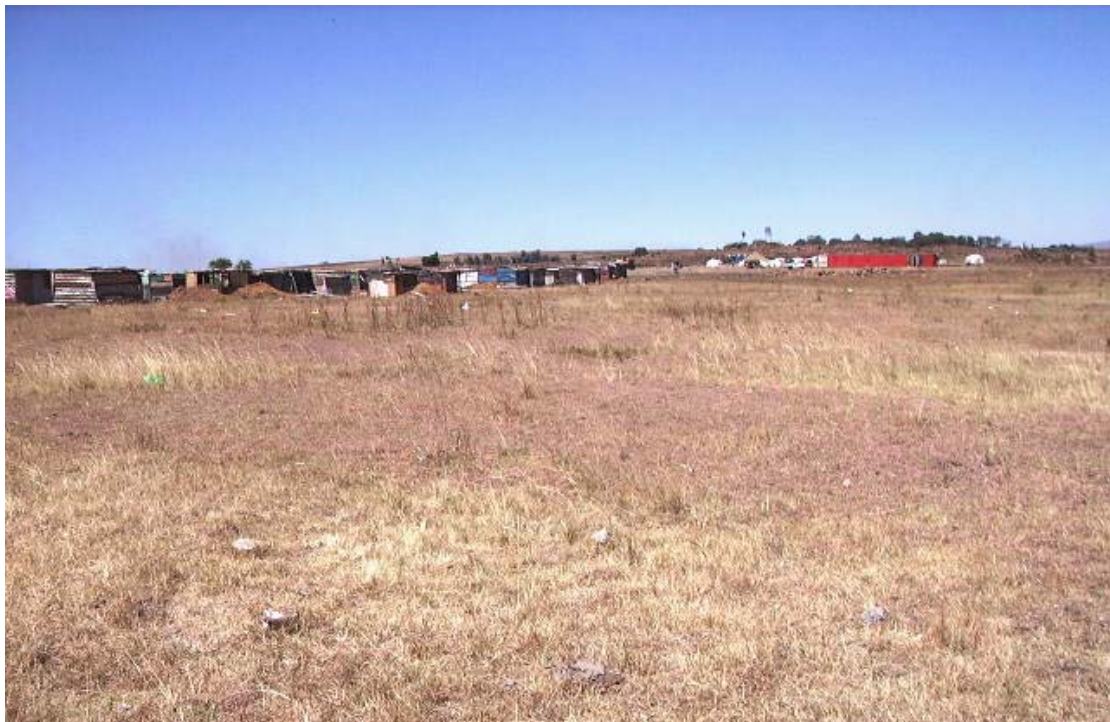
*Figure 6 Directly east of the property there exist a large informal settlement that appears to be on the verge of encroaching onto the property.*

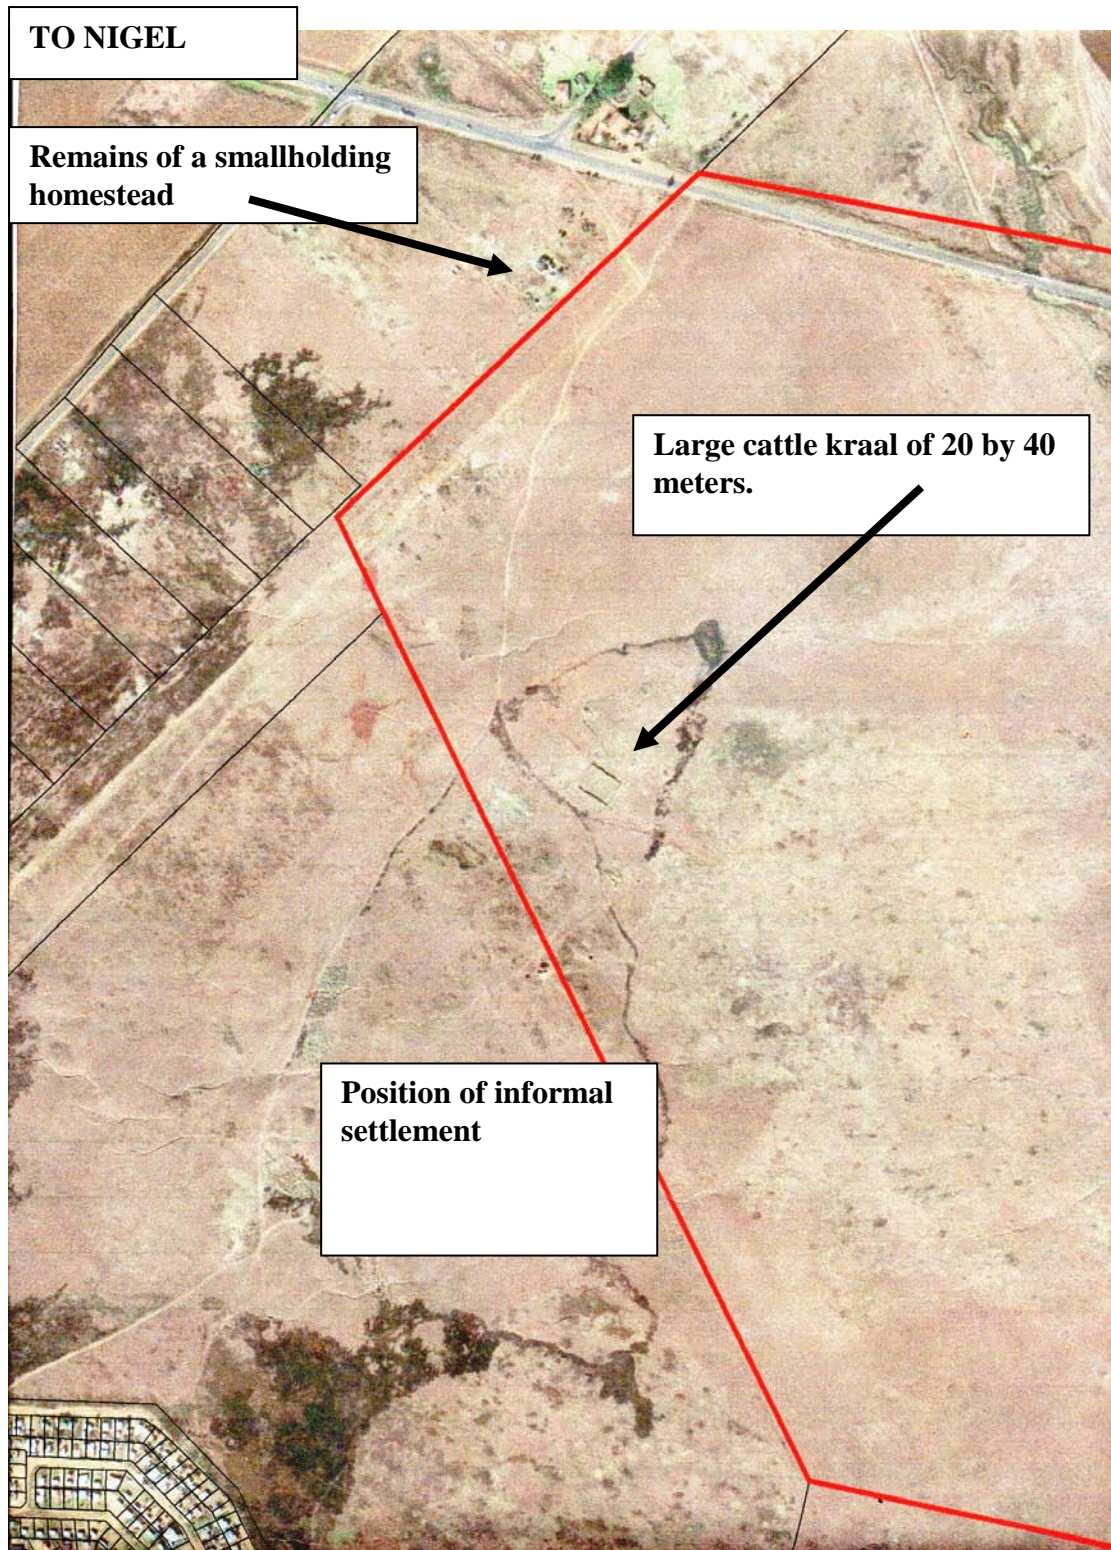
Figure 7. Aerial view of the eastern end of the property.

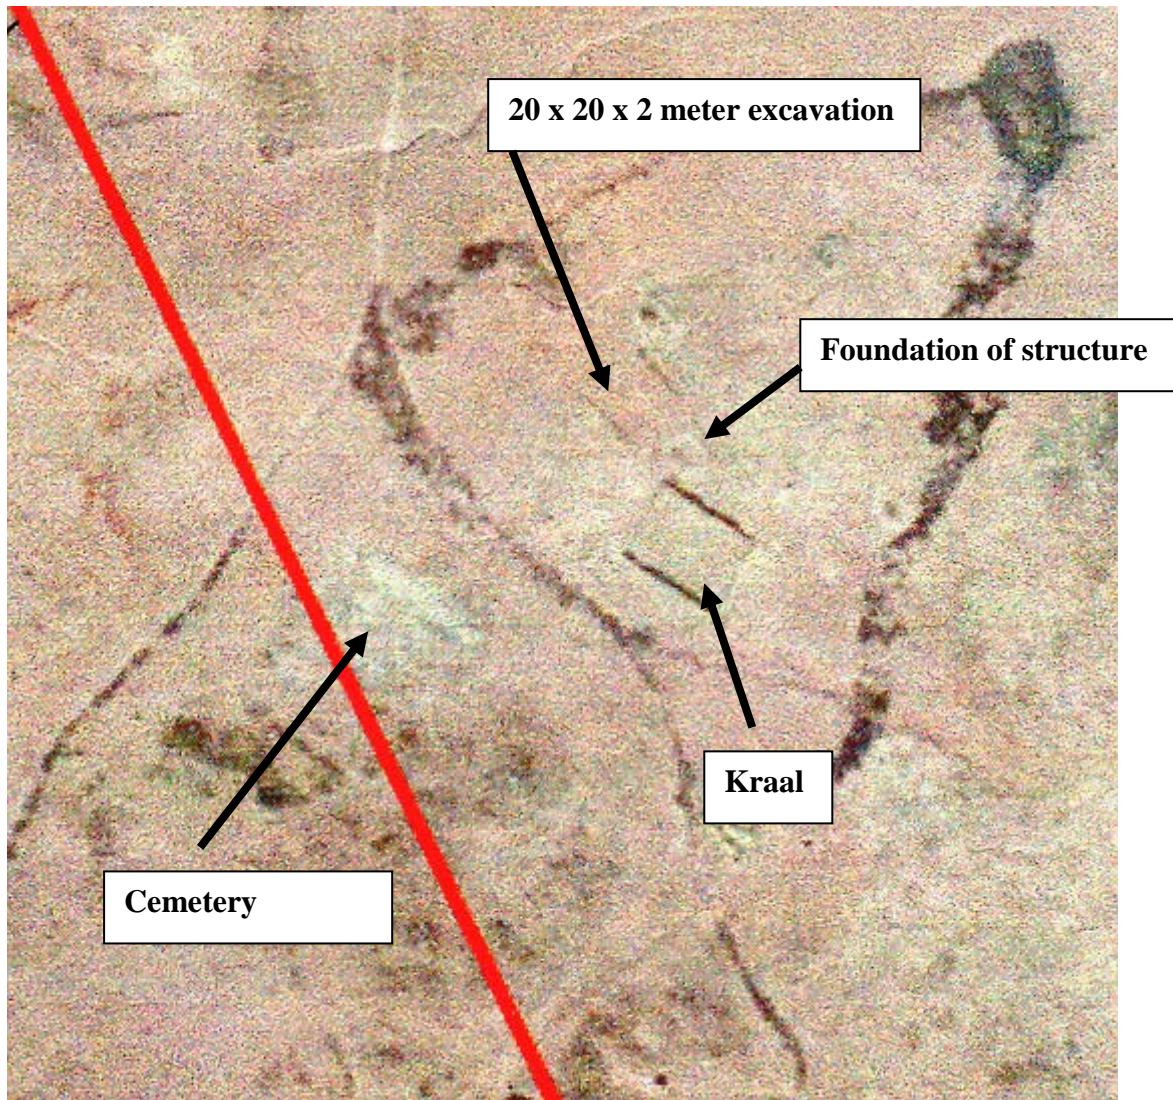
*Figure 8. Close-up of the area surrounding the large kraal.*

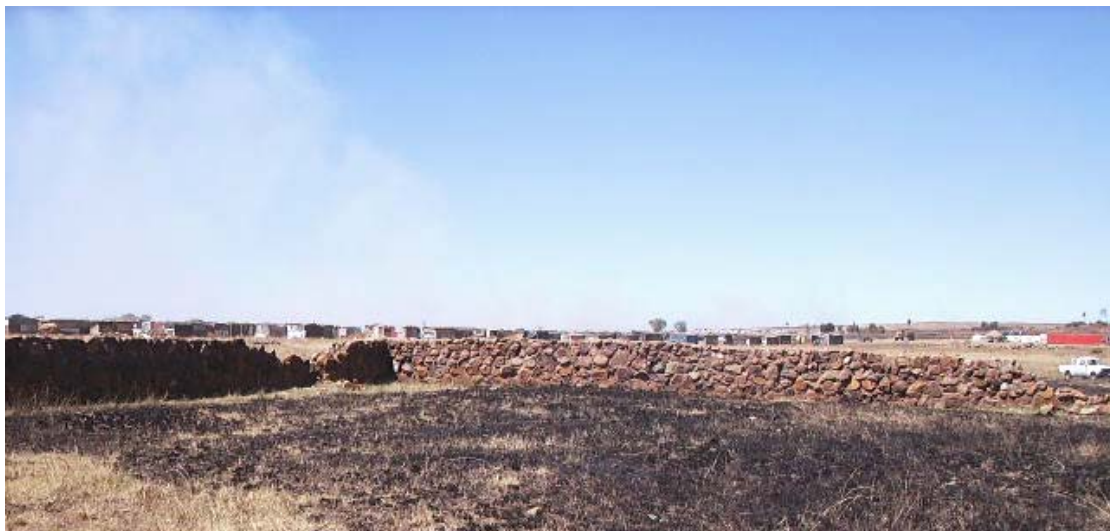
*Figure 9. Inside the large kraal. Note the informal settlement directly north of the kraal.*

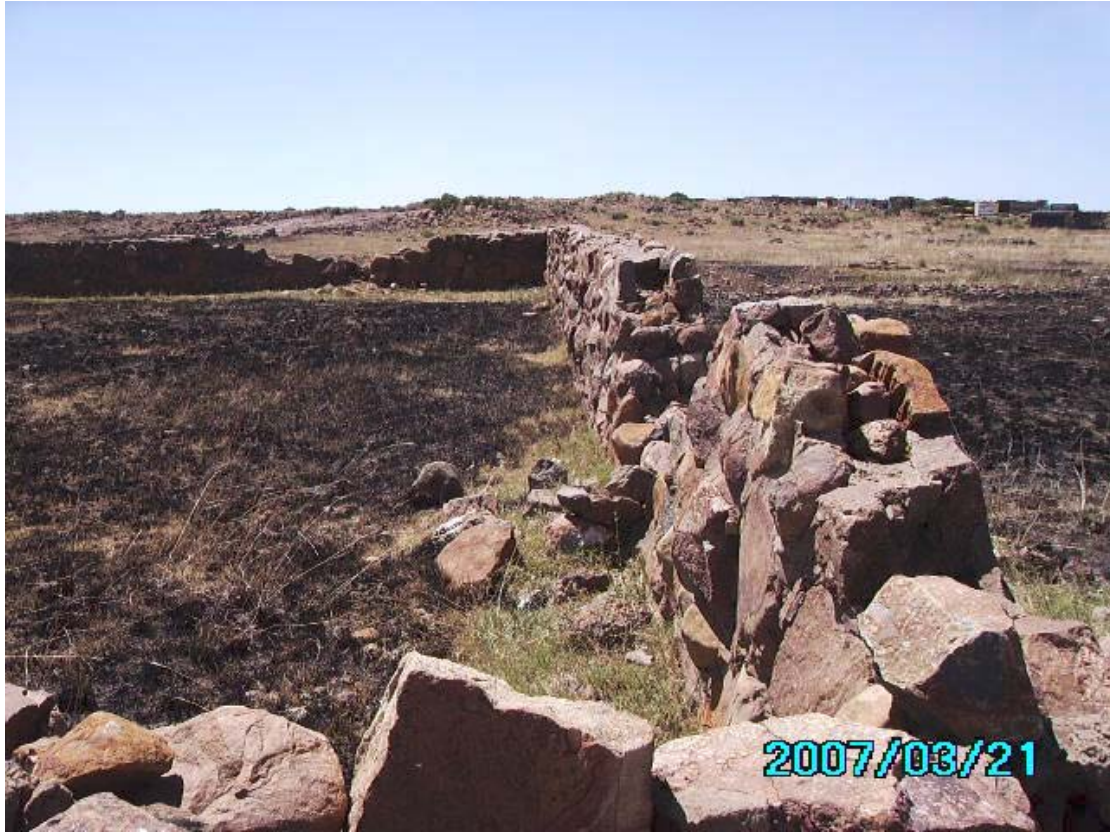
*Figure 10. The wall of the kraal is built of stone but cement mortar was used as binding material.. There is no apparent reason why this should be preserved.*

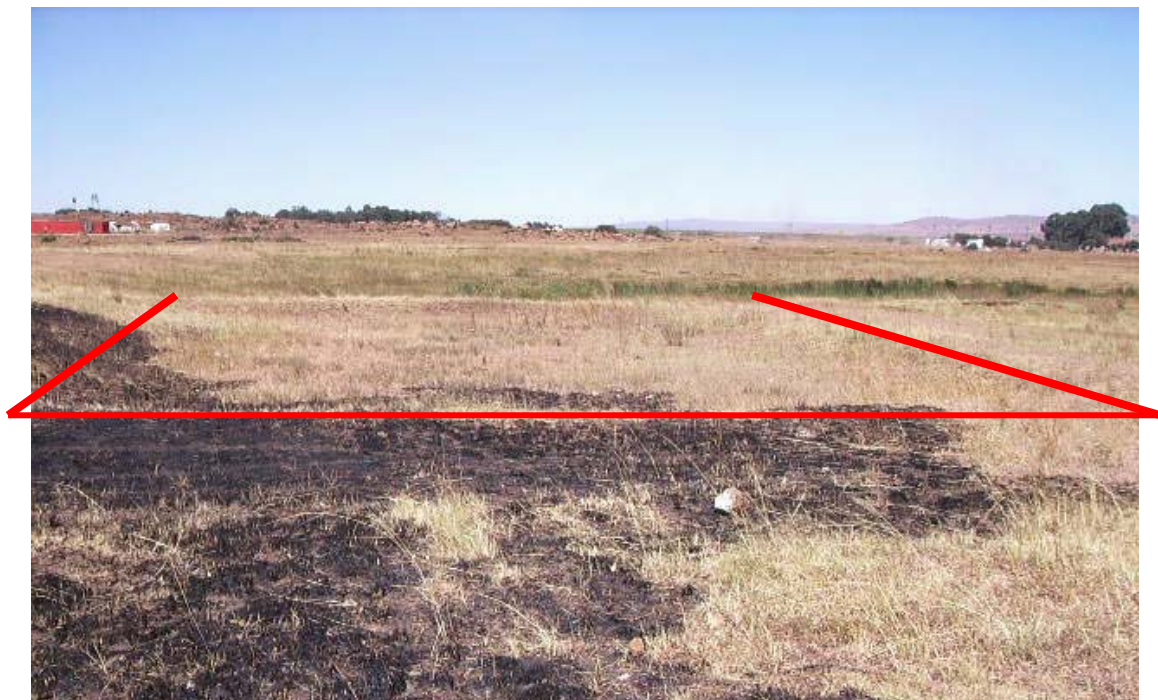
*Figure 11. The excavation east of the kraal. Its purpose is unknown.*

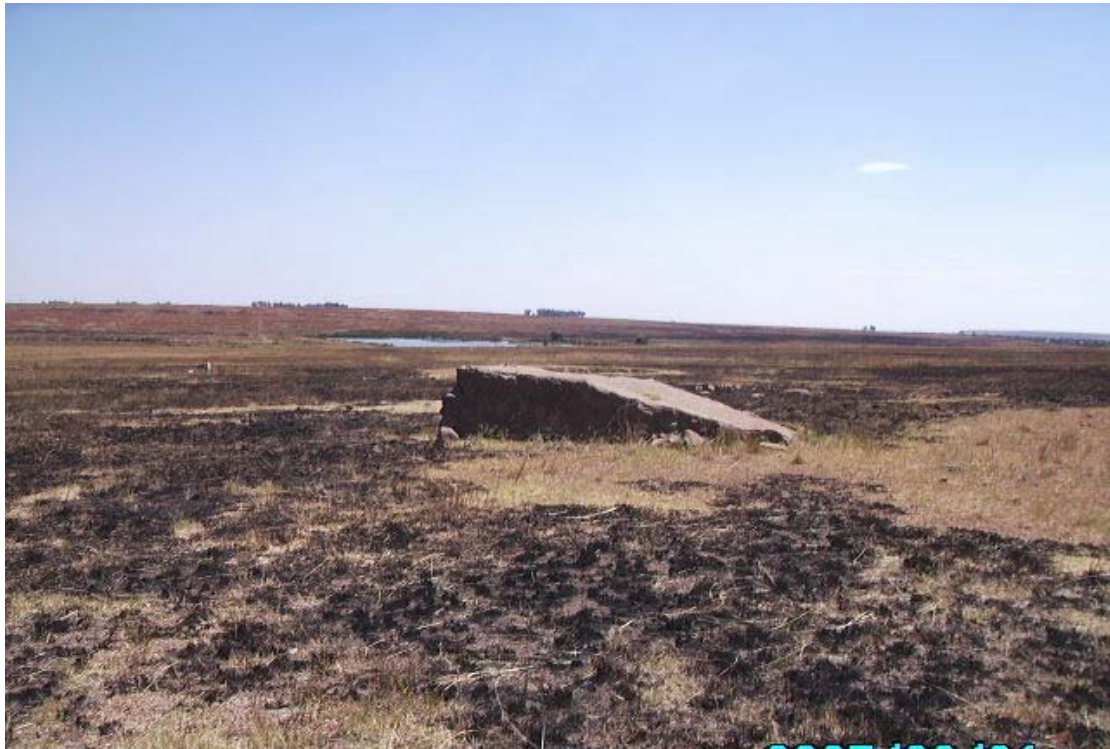
*Figure 12. The loading ramp to the south of the kraal.*

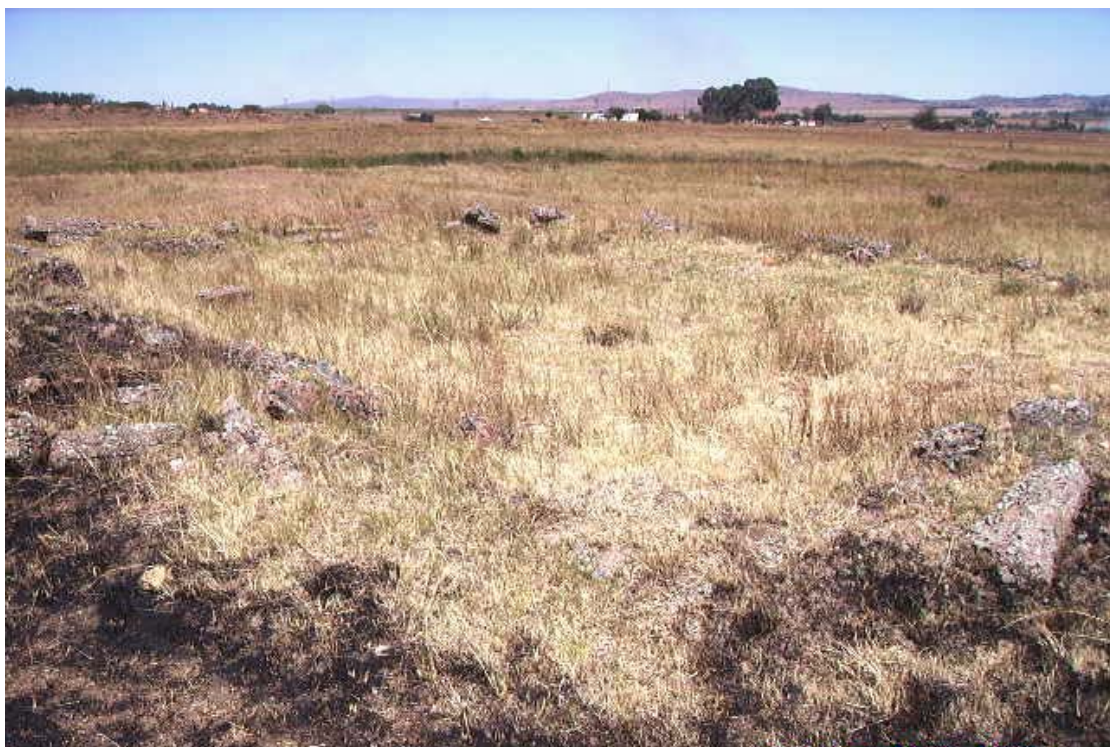
*Figure 13. The foundation of a structure adjacent to the kraal. The size and material suggests that this was a store for materials and equipment associated with the kraal.*

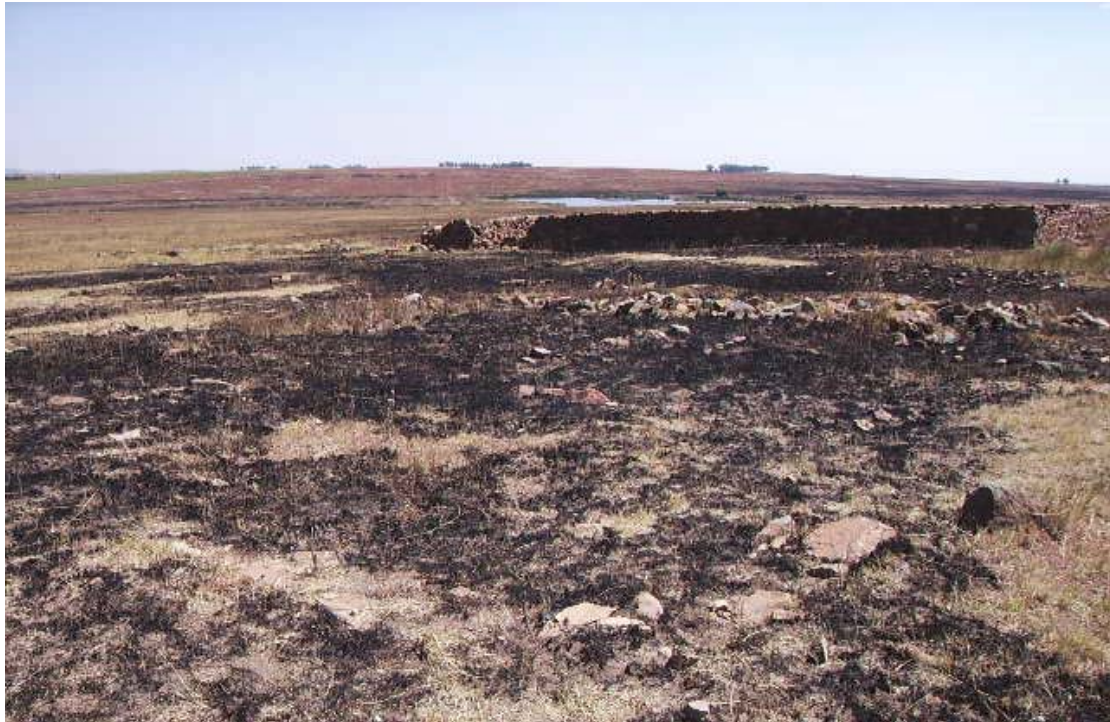
*Figure 14. To the east of the kraal there are two more foundations. These appear to have been dwellings for personnel associated with the kraal.*

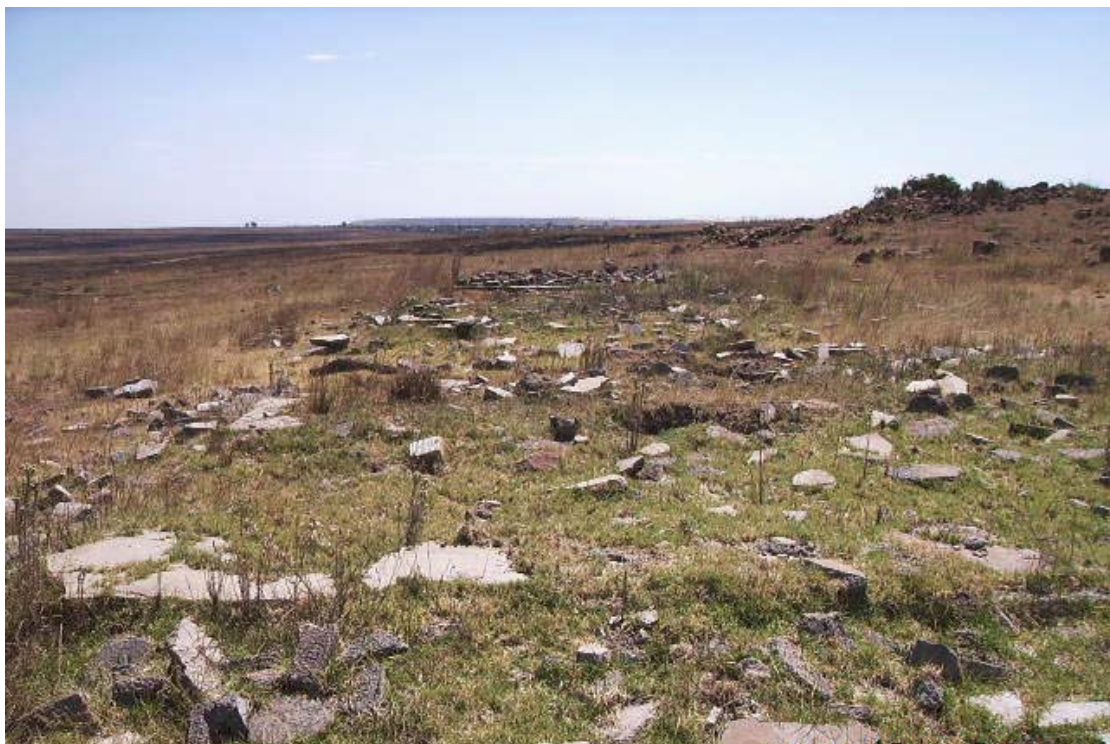
*Figure 15. These foundations appear to be associated with a “contractor camp”. It is also marginal whether they do in fact occur on the land under investigation.*

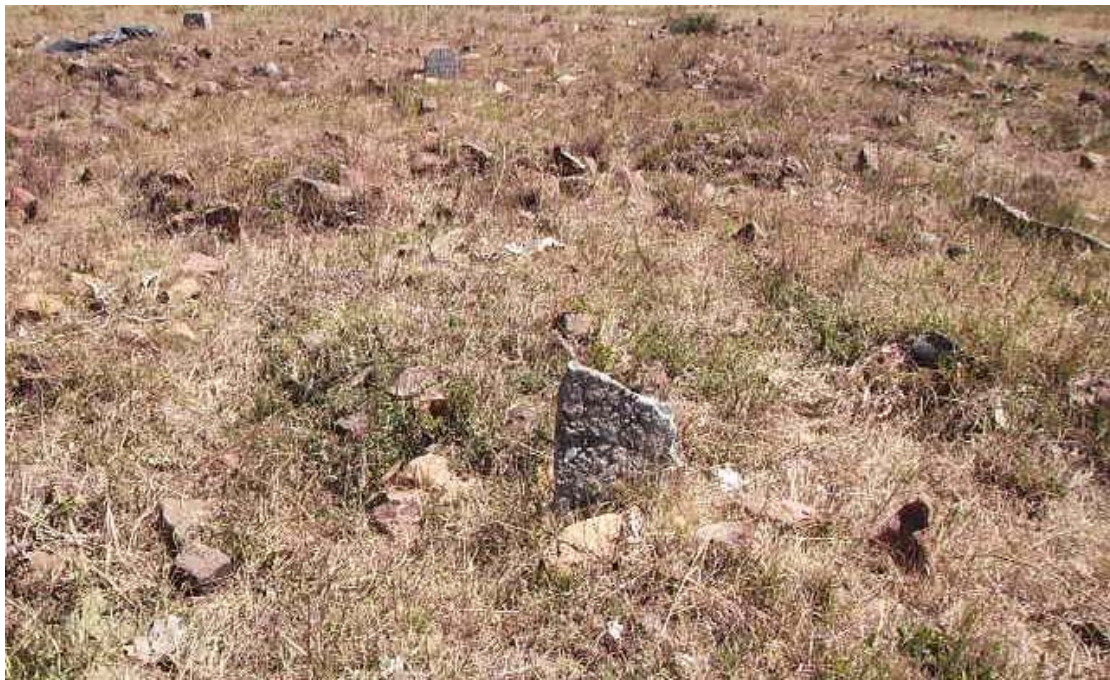
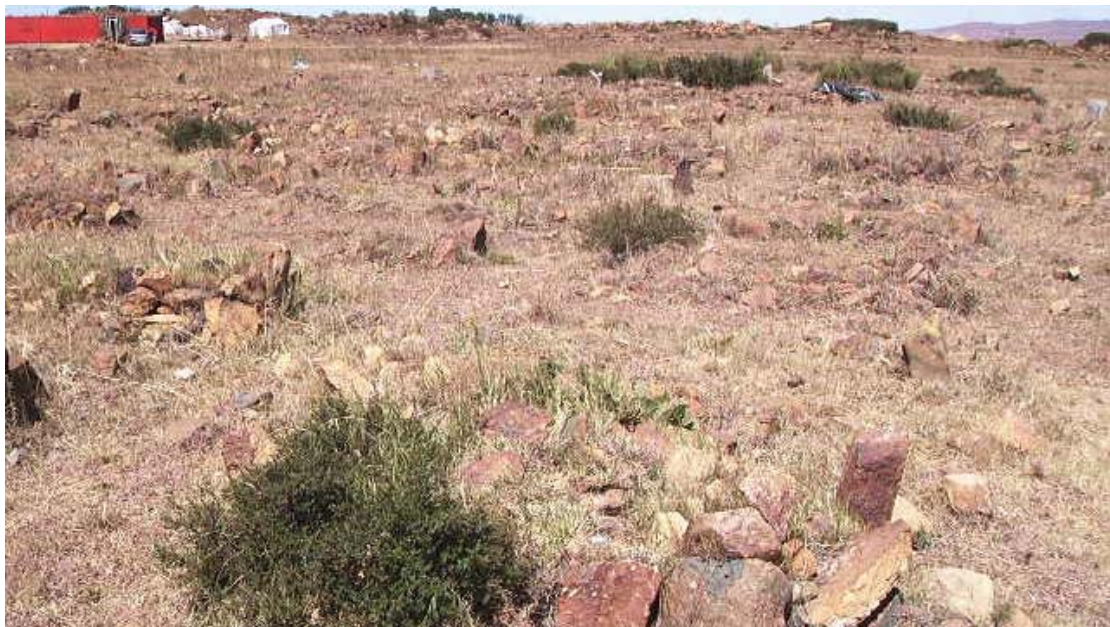
There are a number of structures and graves present on the land investigated. The structures are remains of farming that can be dated to the last fifty years, and are therefore not of concern. The graves though are an issue of greater concern. There are at least one hundred of these on the northeastern border of the property. These will either have to be relocated or negotiations with relatives will have to be undertaken.

The cemetery is situated at S26° 23' 15.1" and E28° 22' 14.2"

*Figure 16. Two views of the large graveyard on the eastern border of the property. These will have to be relocated or arrangements will have to be made to protect them in-situ. Some hundred graves were discovered in the neglected cemetery.*

None of the structures found on the proposed development site are older than sixty years. There are also no archaeological sites present. What is important is the cemetery, which should either be properly fenced in or maintained or an application for mitigation should be made.

It is recommended that the area of the cemetery be properly fenced of and maintained as a feature in the township or

- The graves be mitigated and moved to an existing cemetery in compliance with the relevant legislation controlling graves.
