HERITAGE IMPACT ASSESSMENT
FOR THE
REZONING OF TWO SECTIONS OF
PORTION 5 OF THE FARM BRAKFONTein
399 JR AND TOWN DEVELOPMENT

IN THE VICINITY OF
ROOIHUISKRAAL

Report: MPM-2002-09-27 / HIA
Compiled by: P. Birkholtz
Date: 27th of September 2002

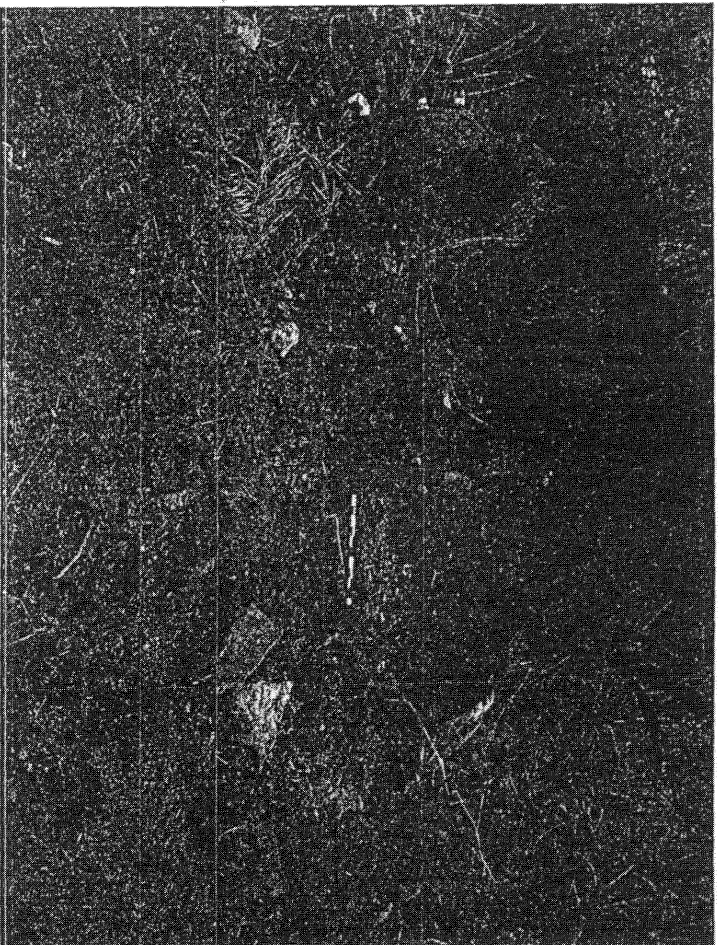
The third structure consists of a semi-circular shaped stonewall located on the northern side of a natural boulder. This structure is made up of a single line of stones (refer **Annexure C Figure 1**).

Figure 1. Semi-circular stone structure from Site 9

Nevertheless, it is recommended that the site be recorded photographically, described and documented by way of surveying and measured drawings.

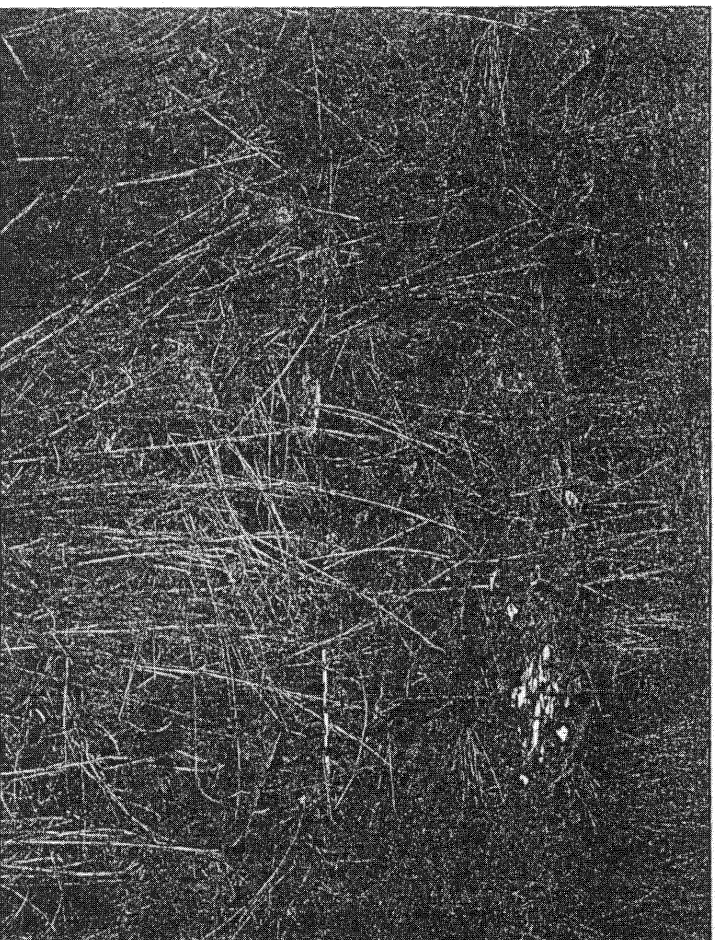
characteristics as well as their closeness to one another. These two associated structures (refer **Annexure C Figures 2 and 3**) are located on a natural terrace approximately twenty meters north of a small stream. The structures are both circular, and are approximately the same size, namely three meters in diameter. The distance between the two structures is approximately one-and-half meters. The walling on both these structures appear to be quite rough. This may be due to the fact that the walling is deteriorated, but may also indicate an unrefined building technique.

Figure 2. One of the two circular stone structures from Site 9. This structure is the easternmost of the two.

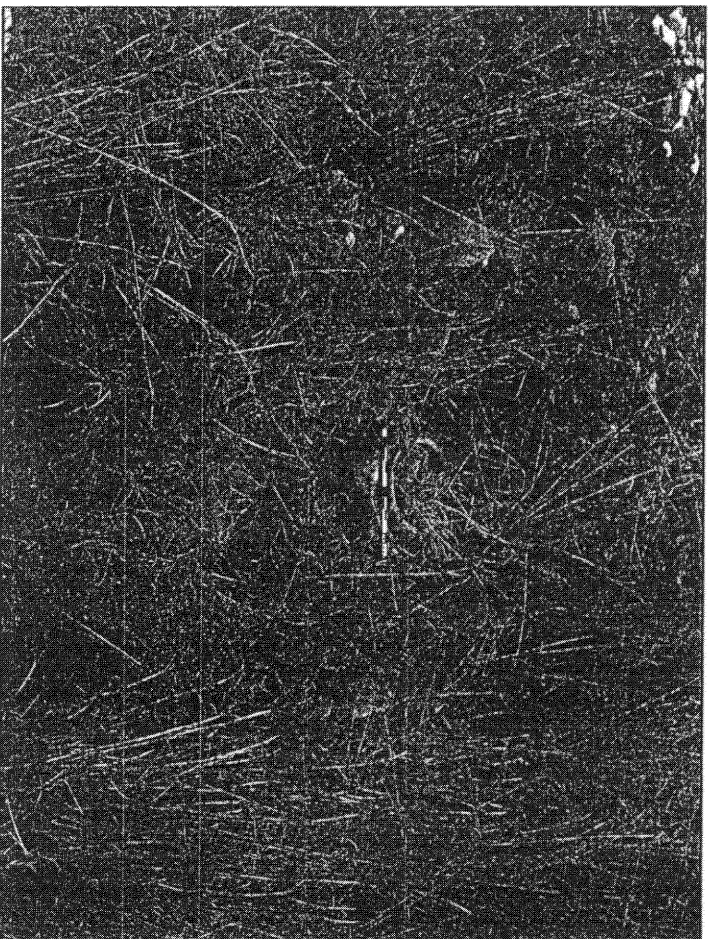
Figure 3. The second circular stone structure from Site 9

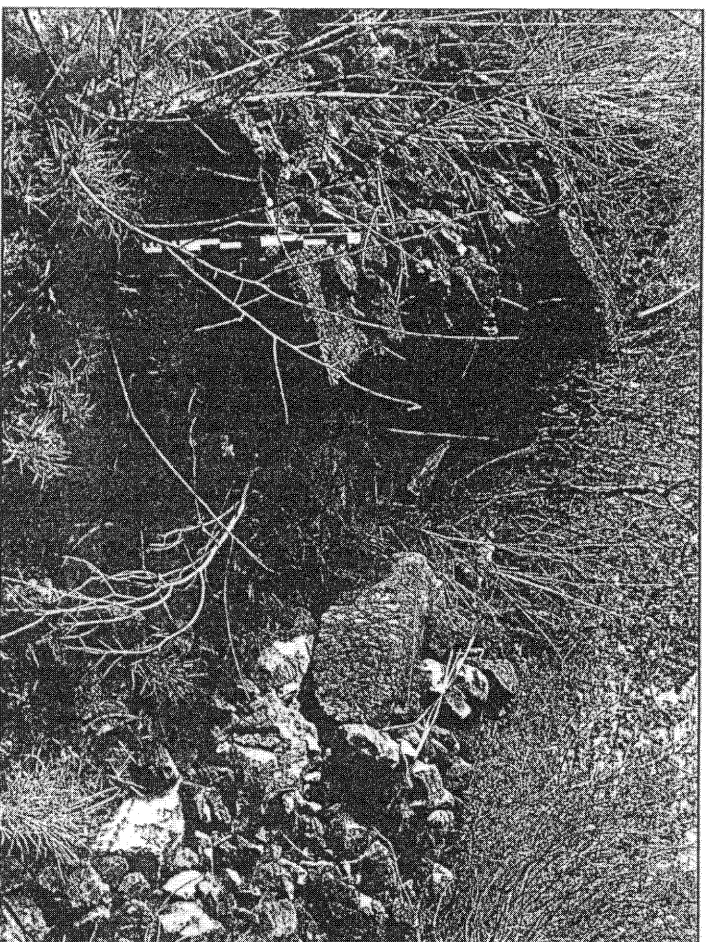
The structure is rectangular shaped, and is approximately ten meters in length and nine meters wide, with an entrance located on its southern side (**Annexure C Figure 4**). The entrance is made up of the two walls ending parallel to each other. The entrance width is approximately half-a-meter.

Some portions of the walling of the structure in general appear to be still in a very good condition. Other portions are quite deteriorated. Observations made from the more intact sections seems to indicate that the walling was constructed using larger stones on the outside and bottom, with smaller stones in the middle and on top.

The average width of the stone walling in the intact sections is around 60 cm, whereas the deteriorated or fallen down walling can be more than one meter wide. Although the structure is located on a slope, the soil surface on the inside of the structure is quite level. This terracing effect is also indicated if one looks at the outer and inner heights of the walling. On the western wall (the upslope section) the outside of the wall is approximately 10 cm high, whereas the insides are on average between 30 and 40 cm in height. Terracing is also indicated on the downslope side of the site (the eastern wall), in that the inside of the wall here is approximately 10 cm in height whereas the outside is approximately 40 cm high.

Figure 4. Site 10 / Rectangular Structure 1 (10.1). The entrance is clearly visible.

✓ It is proposed that the two structures be fully documented and photographed, and that recording in terms of surveying and measured drawings be undertaken to allow for approval for destruction.

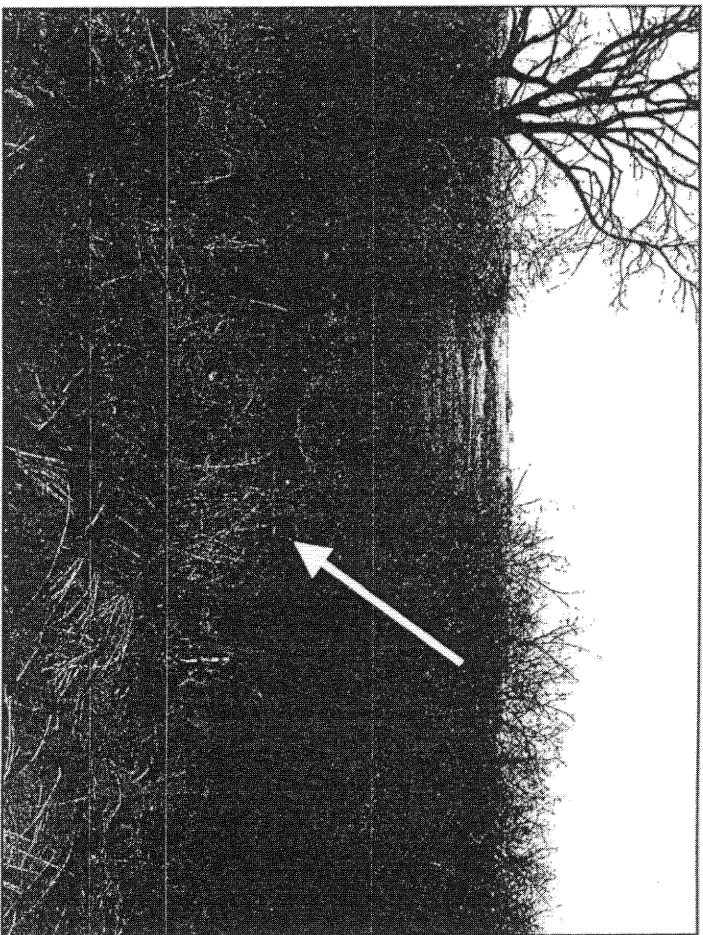
The second structure is located some forty meters north of the first structure. It appears to be located on a slight slope in-between naturally occurring rocky outcrops (refer **Annexure C Figure 5**). The shape of this second structure is less formally rectangular, but possesses definite angled corners on most sides. The structure is approximately eight meters by eight meters in extent, and has an entrance (refer **Annexure C Figure 6**) on its western side.

In terms of condition this structure appears to be more deteriorated than the other structure. The intact sections of the wall are again approximately 60 cm in width, whereas the deteriorated or collapsed sections may be much wider.

Figure 5. View of Rectangular Structure 2 from Site 10 (10.2).

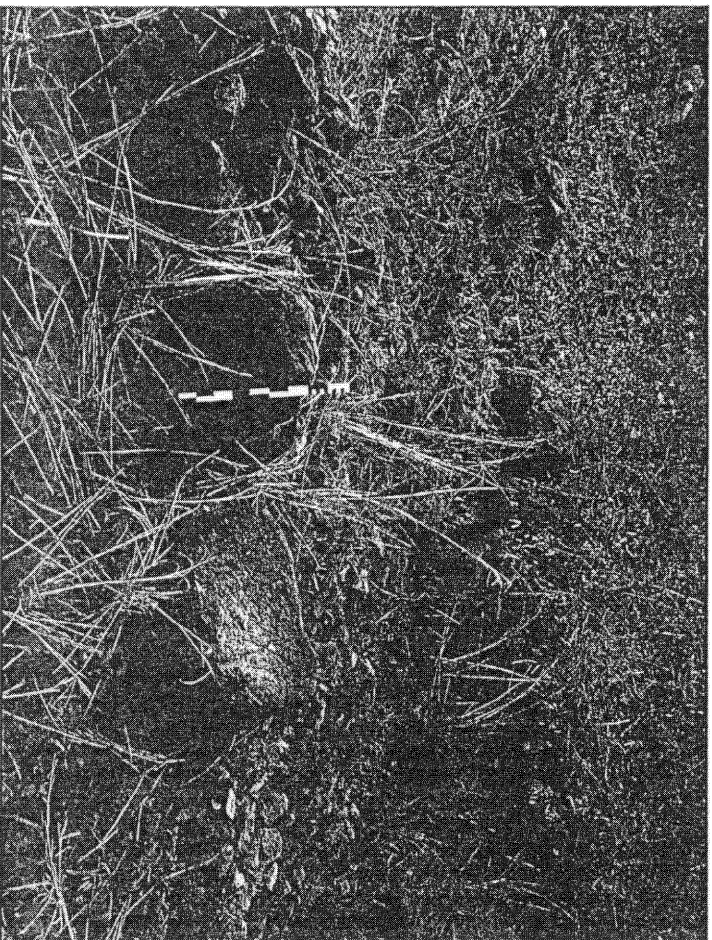
Figure 6. Entrance at Rectangular Structure 2 / Site 10.

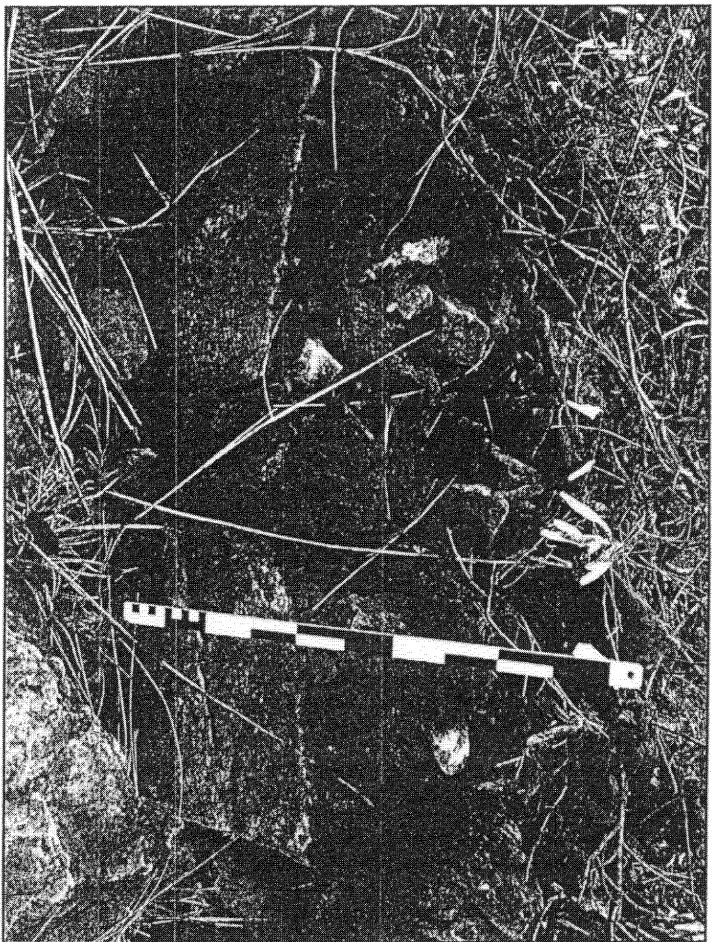
The building technique used in this structure makes use of naturally occurring rocky outcrops and boulders. Apart from this the general building technique of larger stones at the base and outsides and smaller stones on the insides and on top (observed at the first structure) was also found here (refer **Annexure C Figure 7**).

Figure 7. Close-up view of walling from Rectangular Structure 2 / Site 10.
