COBUS DREYER

24 April 2006

ARCHAEOLOGICAL AND CULTURAL HERITAGE ASSESSMENT OF THE PROPOSED WATER RESERVOIR AND PIPELINE INSTALLATION AT VAN STADENSUS, FREE STATE

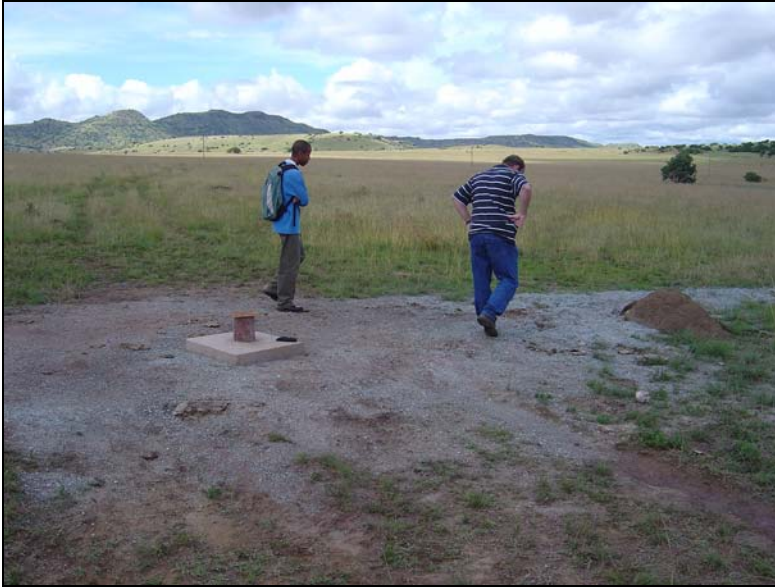
Fig.1 Borehole 2.

Bore hole 2 29°59'42"S 027°01'30"E Altitude 1485m (Fig.1)

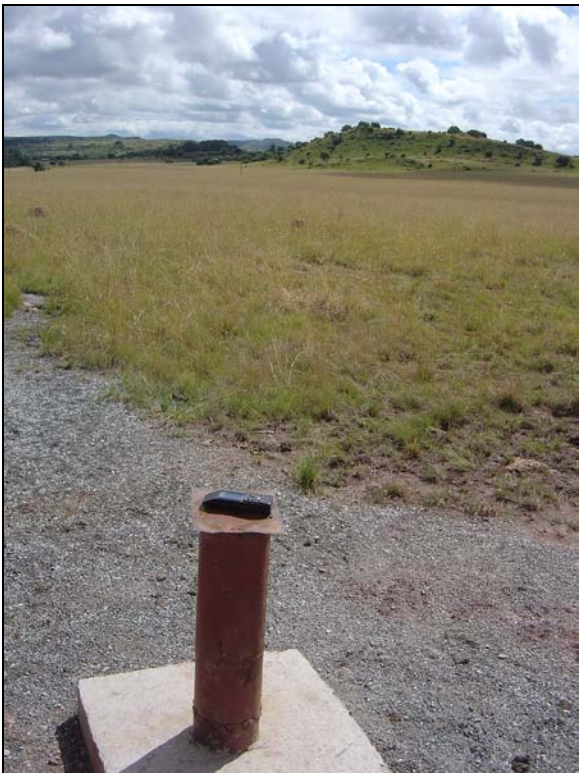
Fig.2 View from borehole 3 facing east towards the water reservoir.

Bore hole 3 29°59'24"S 027°01'22"E Altitude 1480m (Fig.2)

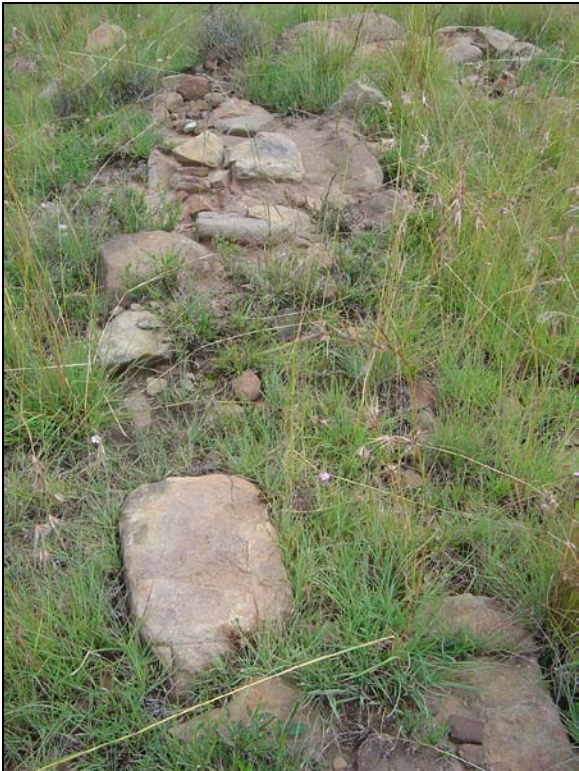
A cluster of foundations of rectangular and circular stone-walled structures were found in the area near borehole 3 (Figs.3&4). The origin and purpose of these features could not be ascertained. They do not seem to be of any cultural or historical significance.

Fig.3 Foundation of a rectangular structure near borehole 3.

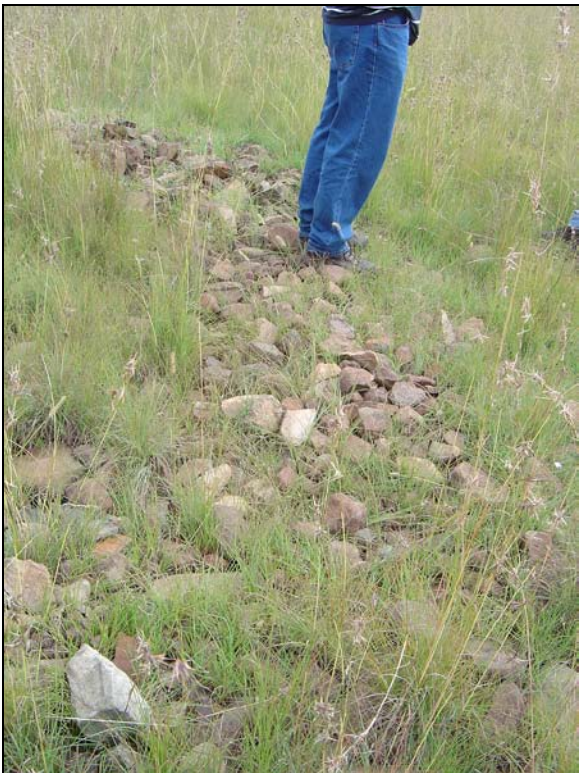
Fig.4 Base of a circular stone wall near borehole 3.

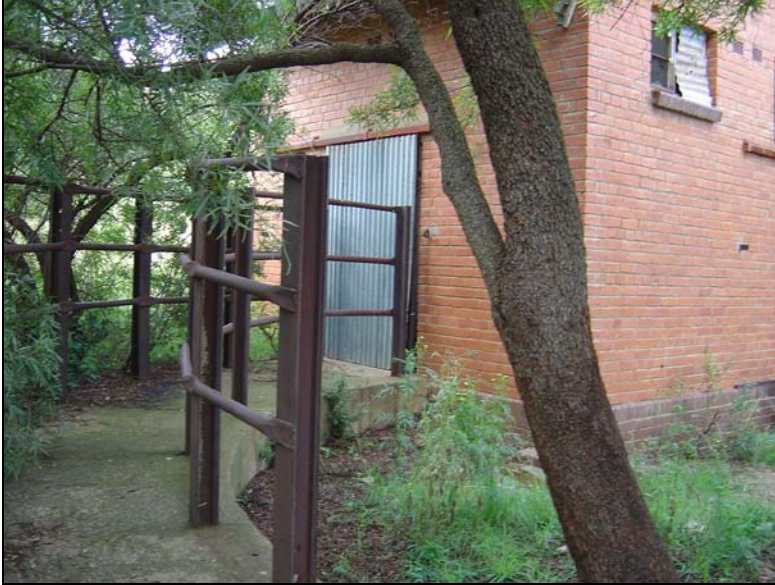
Old abattoir 29°59'19"S 027°01'21"E Altitude 1487m (Fig.5).

The land lies adjacent to the residential area and were used as common grazing area for many years. The abandoned buildings date from the recent past and have no obvious historical value.

Fig.5 An old abattoir View along the proposed route of the pipeline.

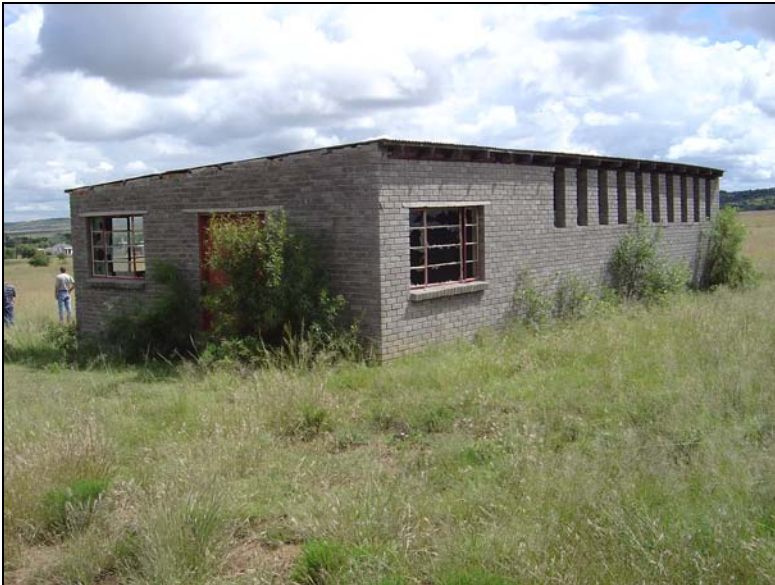
Chicken penn 29°59'17"S 027°01'18"E Altitude 1483m (Fig.6).

Fig.6 An unused chicken run dating from about 2002.
