Prepared for the attention of the
SOUTH AFRICAN HERITAGE RESOURCES AUTHORITY

requested by
UMSIMBITHI MINING PTY LTD

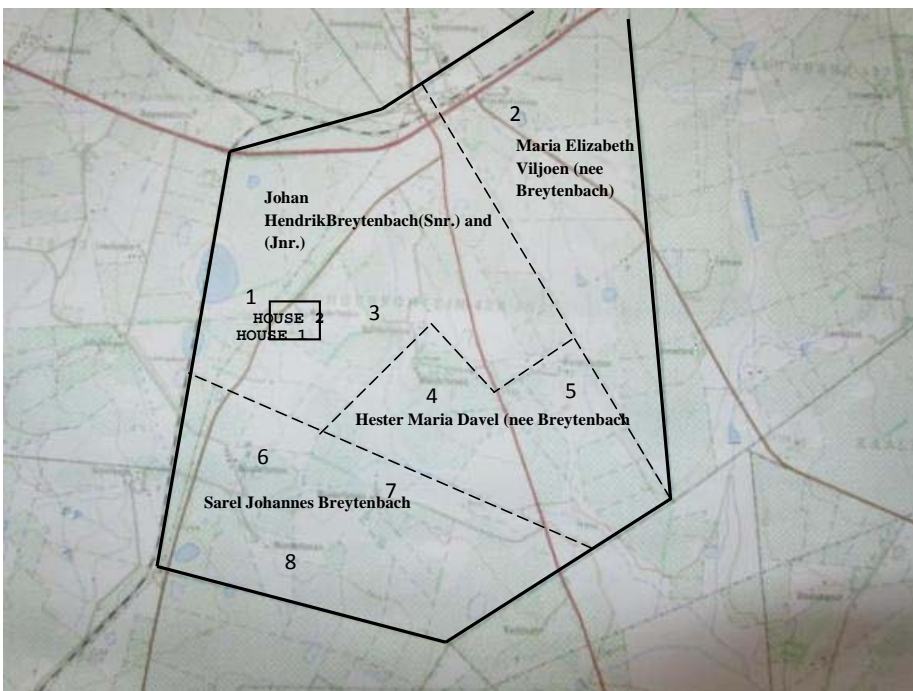
Figure 002: Location of the farm Wonderfontein 428 JS on the surveyor general's 1:50000 MAP 2529 ARNOT between Middelburg and Belfast in 1925. This shows the farmyards to be documented delineated in a black square, (site 1) as well as the locations of the other historical Wonderfontein farmyards numbered from 2 to 8. The broken lines indicate the boundaries of the original subdivision in 1925 according to the last will and testament of Johan and Elsie Breytenbach.

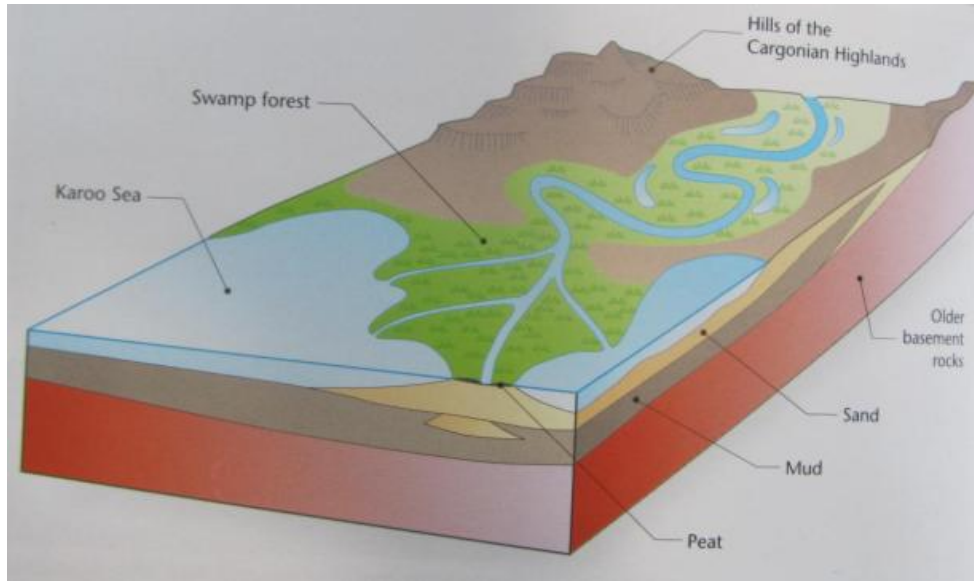
Figure 003: Schematic explanation of the formation of peat deposits on the shores of the Karoo Sea according to McCarthy and Rubidge, page 200.

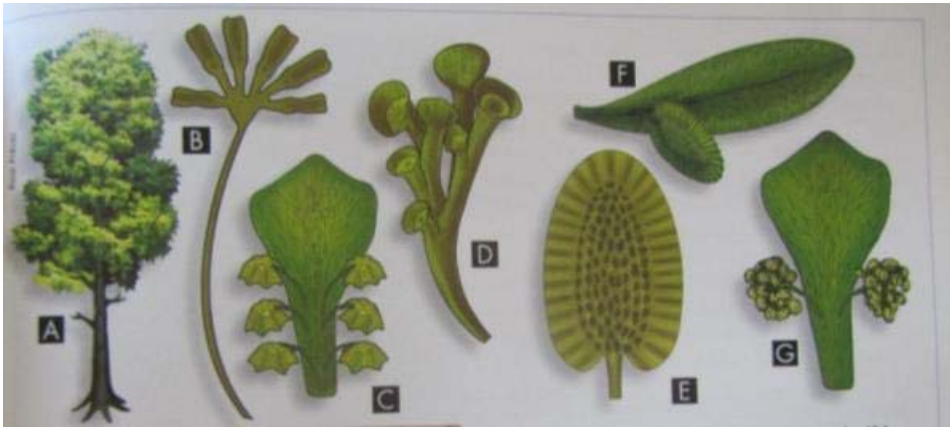
Figure 004. Reconstruction of *Glossopteris* (A) and its diversity of seed-bearing organs (B to F) and pollen producing organs comprising clusters of sacs attached to scale leaves. (G) (McCarthy and Rubidge, 2019)

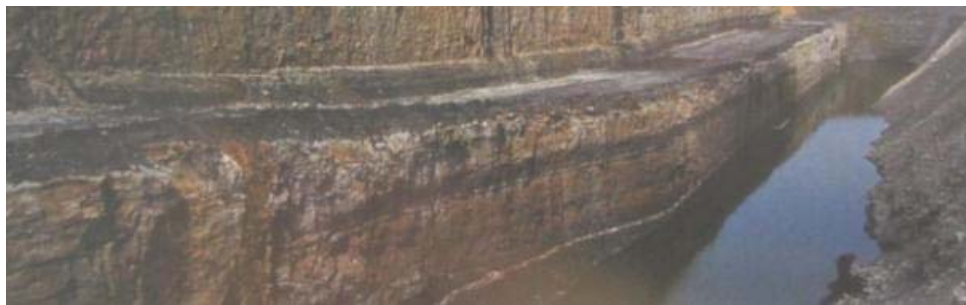
Figure 005. This mining pit illustrates the separation of coal seams by pale-coloured sedimentary rock as described in the text. (McCarthy and Rubidge, 2019)

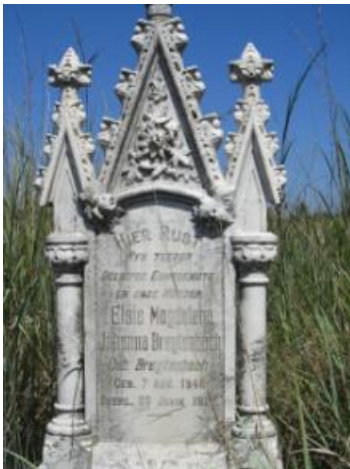
The graves of the ancestors of **Andries** and **Johan**, mentioned above, are then to be found some 400 meters to the south east of house no. 1 on the Wonderfontein site 1. Engraved on an elaborate marble gravestone one finds the following inscription. '*Hierrust my tedergeliefde vader Johan Hendrik Breytenbach Geb 13 Feb 1847 Oorl 29 April 1933. Psalm 130 Vers 3*'. In the same cemetery are also found two more engraved headstones with the following inscriptions. '*Hier rust my tedergeliefde echtgenote en onzemoeder Elsie Magdalena Johanna Breytenbach Geb 7 Aug 1849 Overl 30 Junie 1925*' and '*Hierrust my geliefde echtgenote Elizabeth Maria Grobler Geb Breytenbach Geb 17-11-1884 Oorl 17-11-1920*'

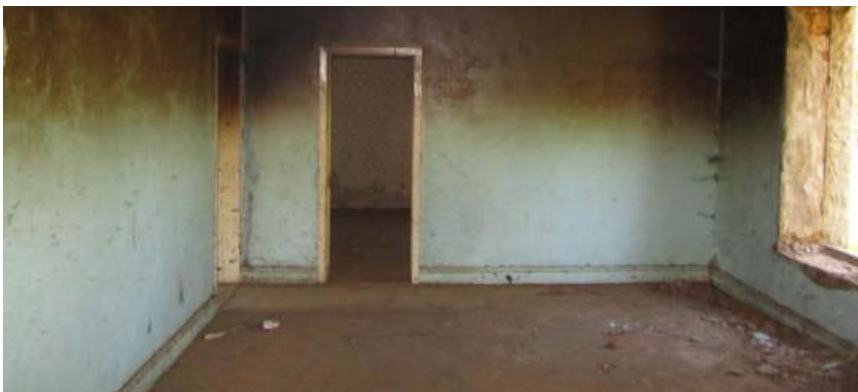
Figure 022. Although some vandalism has occurred, the dwelling is still in a good state of repair.

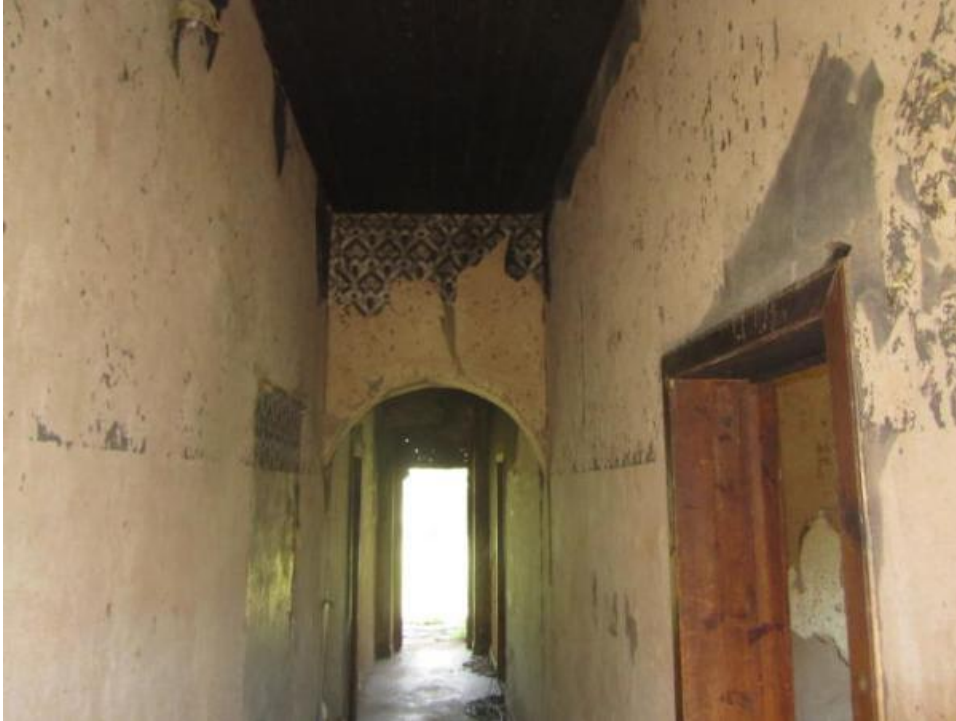
*Figure 023.*The central passage of the *Davel* homestead showing many Edwardian elements such as the arched hallway partition wall, the dado line and the papering of the top section of the walls. All of this will be lost if not recorded and monitored in a heritage maintenance plan.

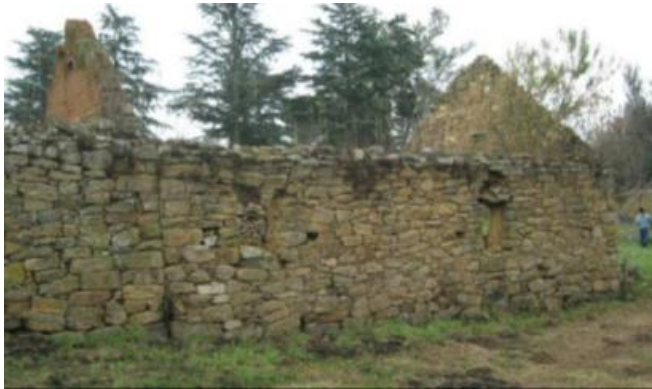
Figure 032. The main wagon shed on the farm 'Lakenvlei' situated to the northeast of Belfast. Although not 'dressed stone' it is similar to the building in figure 134. This building was extended over the years to double its original length with milking and stock sheltering facilities. The amount of effort invested in these structures is immense, but it was necessitated by the adverse winter conditions on the Highveld. (Author's photo 2000)

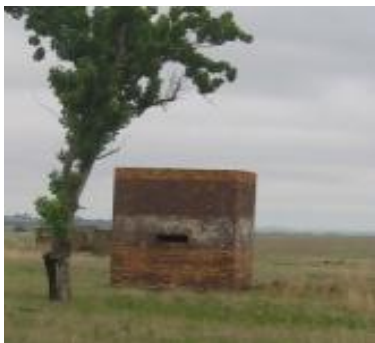
The impact of the mineral extraction, political unrest and martial law in the Transvaal played a large role during the 1870 to 1910 period. The rural lifestyle of whites, as well as towns being no more than church gatherings and places of bartering and small shops, and black South African still mainly living 'traditional' lives were shaken from its century old foundations. Diamonds and gold, trains and motor cars, bullets bombs and death, corrugated iron, glass the telegraph, press and radio exploded into a new 'world view' into the minds of South Africans, and those located near the mines were most influenced. Ancient Roman philosophies of order and building practices, refined over a thousand of years by the Britons were

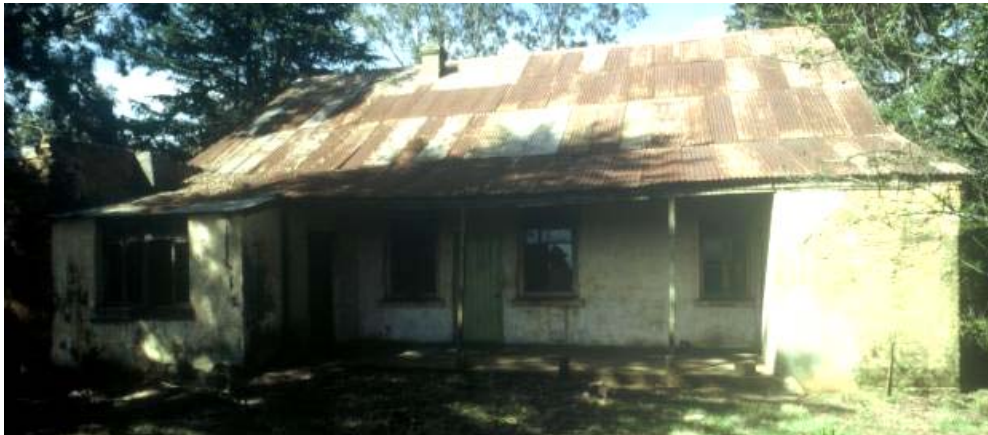
Figure 034. Western elevation (back door) of the nineteen twenties dwelling on the farm 'Lakenvlei' as documented by the Cultural History Museum in 1980. These dwellings were seldom 'pretty' but were functional and reflected the materials available at the time of its construction. Over time though additions such as the kitchen to the left and the bathroom to the right became standard facilities, seldom designed to improve the architectural beauty of the building in general, but rather the functionality of the dwelling. Often similar additions were added to the 'front' of the house, eventually destroying all aesthetical character of the building. (Cultural History Museum photo 1980)

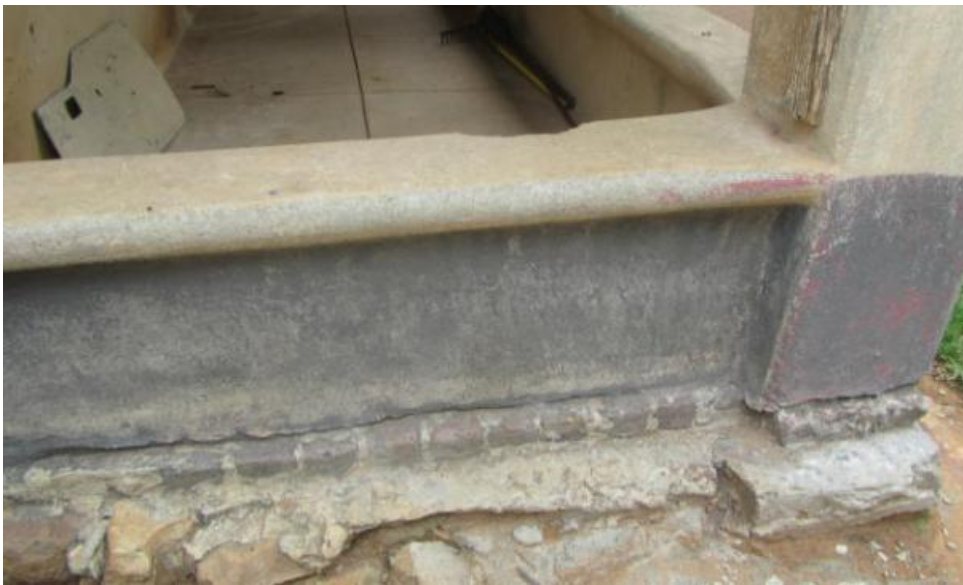
Figure 059. Detail of veranda wall and stone foundations of house no. 1. (P16)

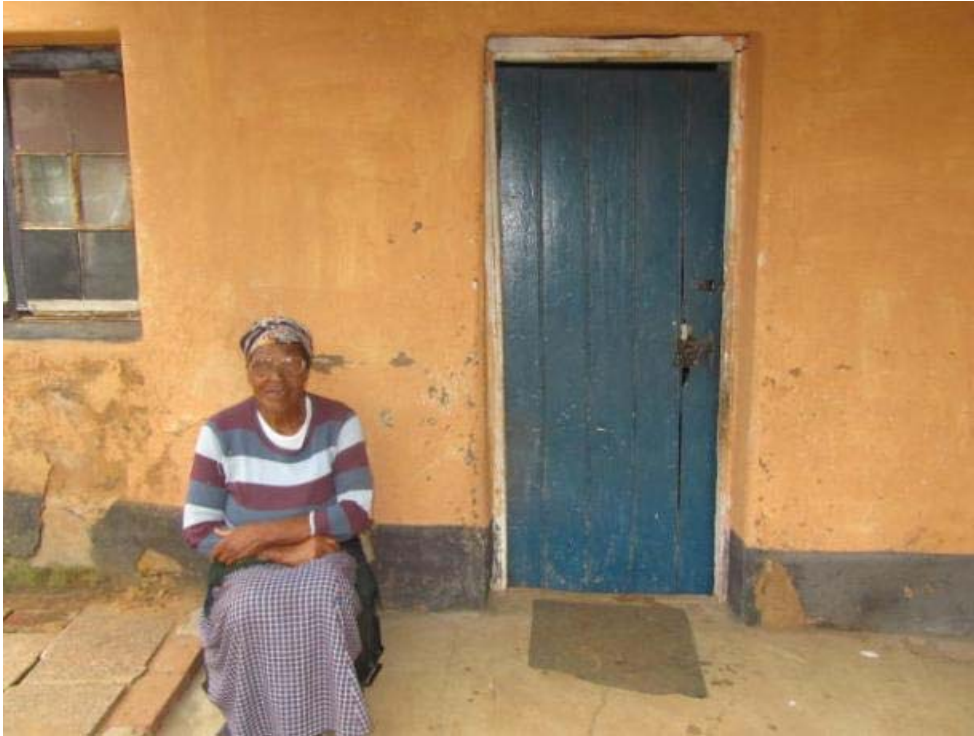
Figure 060. Emma Mavhele Skosana, inhabitant of house no. 1 and detail of kitchen door. (P17)

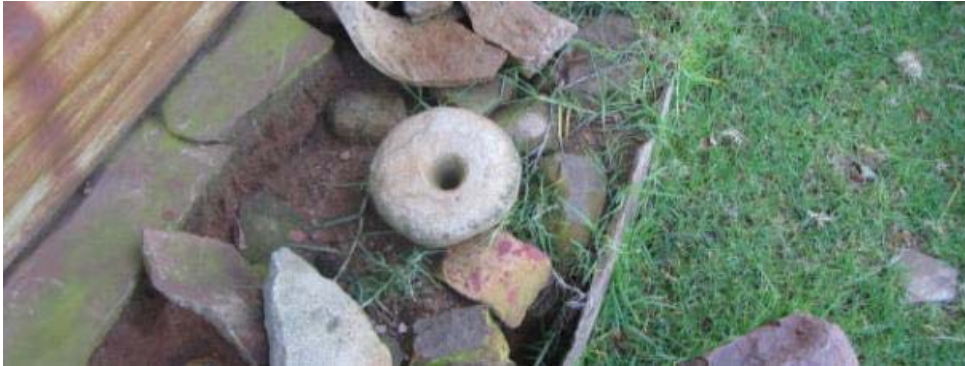
Figures 147.A 'bored stone' of classic proportions resting on the foundation of lean-to. None of the present inhabitants have any knowledge regarding the origin of this stone. (P40)

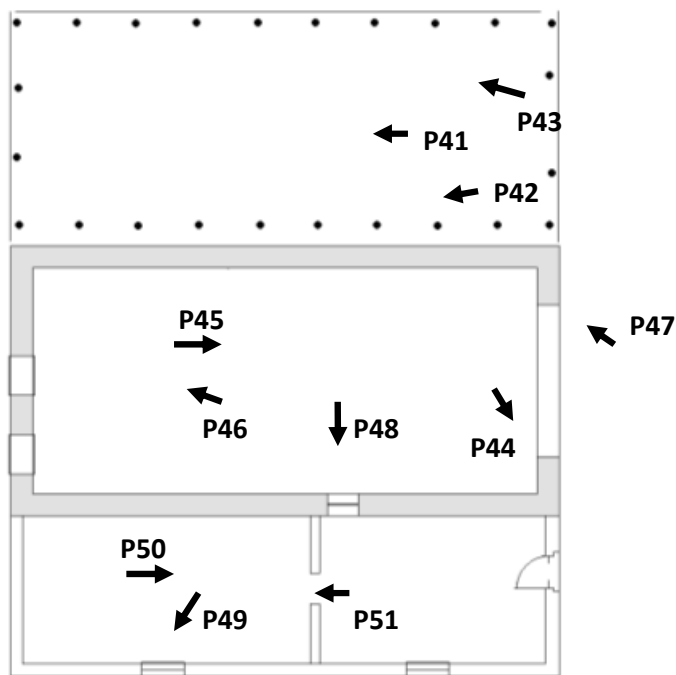
Figure 148. Schematic representation of wagon shed and additions for internal photo documentation

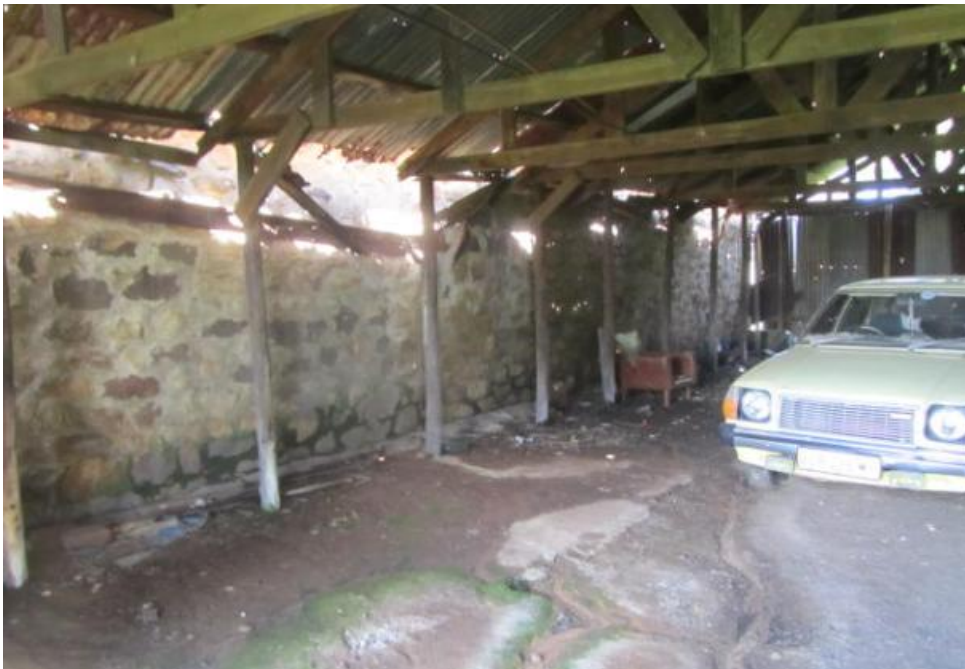
Figure 150. Interior of additional shed. Structure consist of modern 150 mm treated poles supporting individual trusses Note floor finish that consist of compacted soil and cement (Not concrete as illustrated by erosion caused by rainwater The purpose of this structure is unknown. (P42)

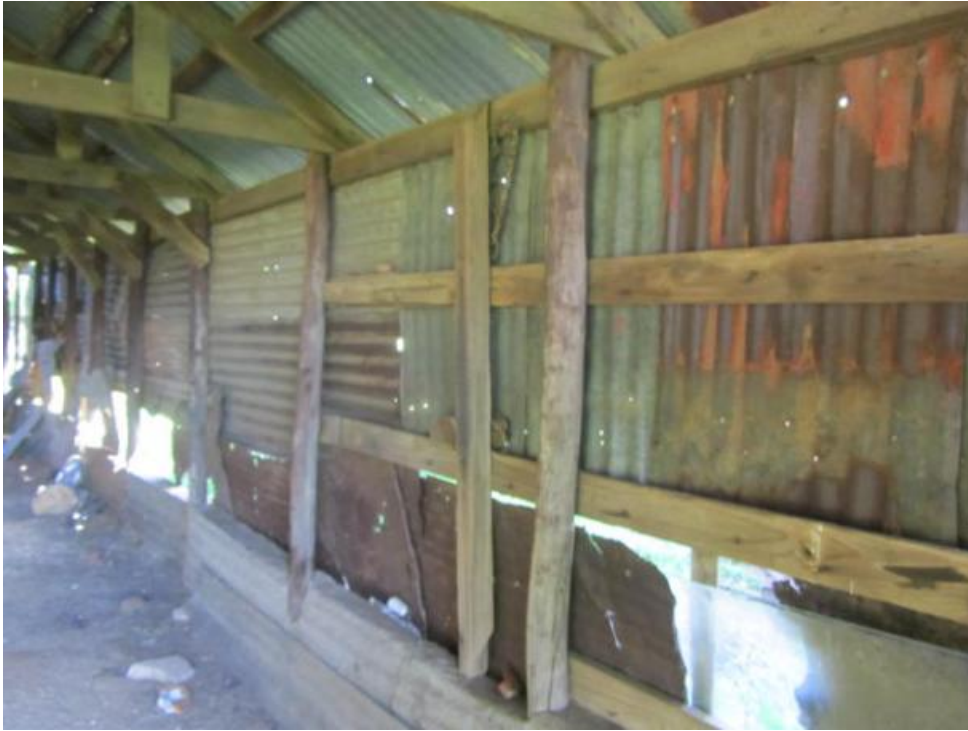
Figure 151. Interior of additional shed. Note unconventional carpentry and material application. For full discussion see text. (P43)

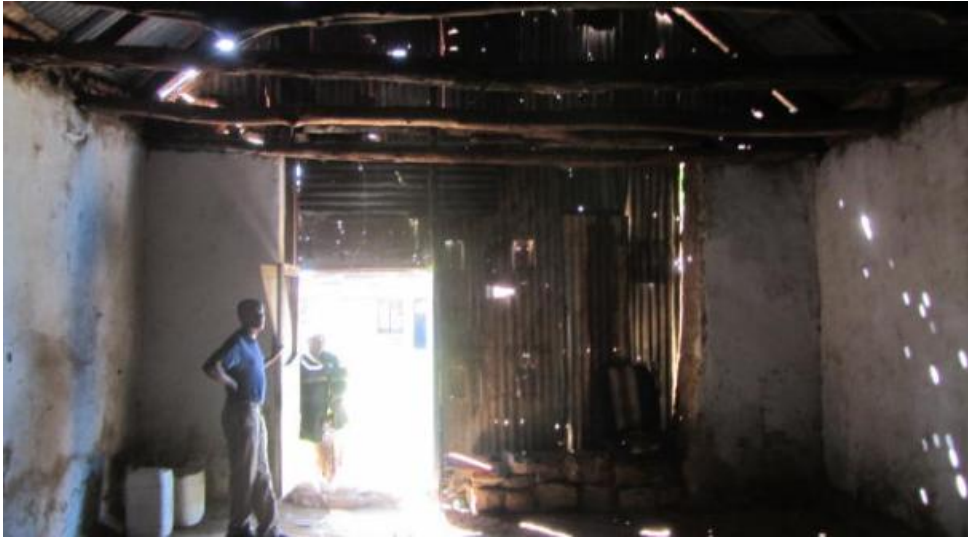
Figure 153. Eastern wall of wagon shed. Original gable replaced by recycled corrugated iron. Original door and frame has been replaced by modern materials and recycled corrugated iron. John W. Maredi inhabitant of 33 years of house no 2 is holding the door. (P45)

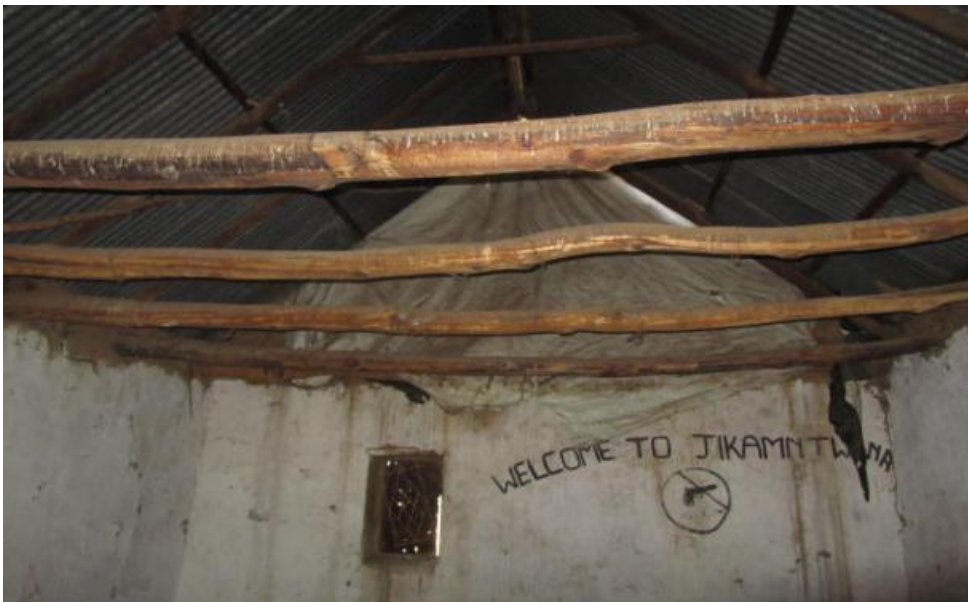
Figure 154. At present the wagon shed is used over week-ends as a community facility. Note the inefficiency of the trusses. (P46)

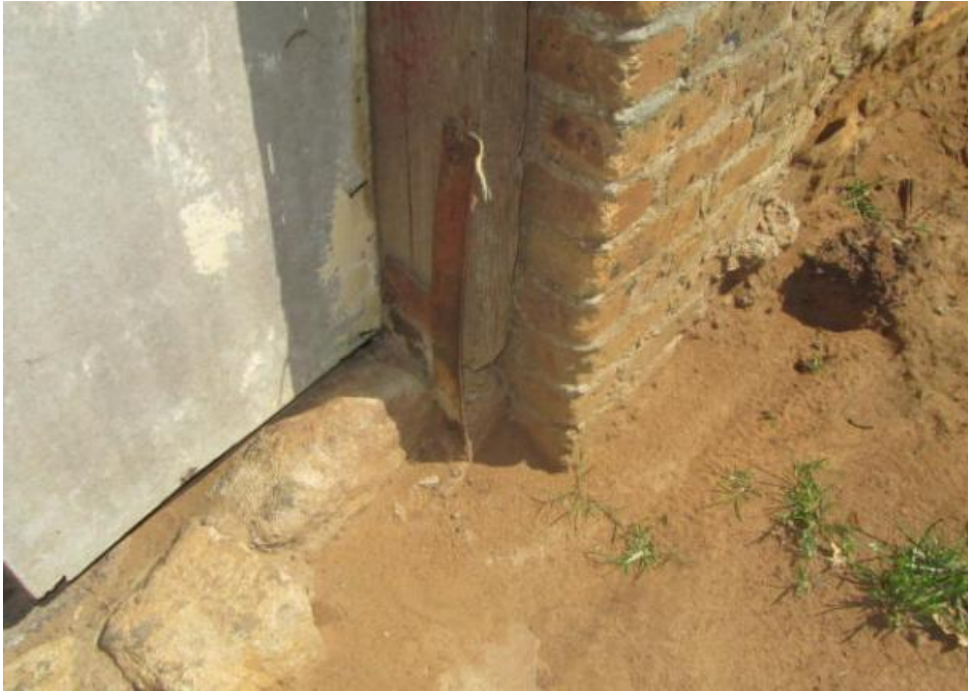
Figure 155. Detail of alteration to doorjamb and threshold. Bricks were utilized to repair stonework and to fix new frame. Threshold was built-up to avoid flooding of shed. (P47)

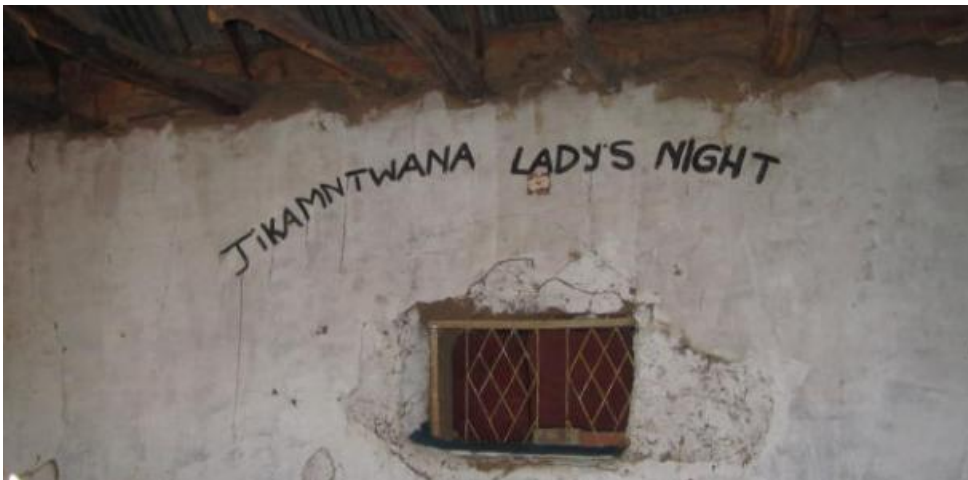
Figure 156. Adaptation of wall for serving hatch for refreshments. (P48)

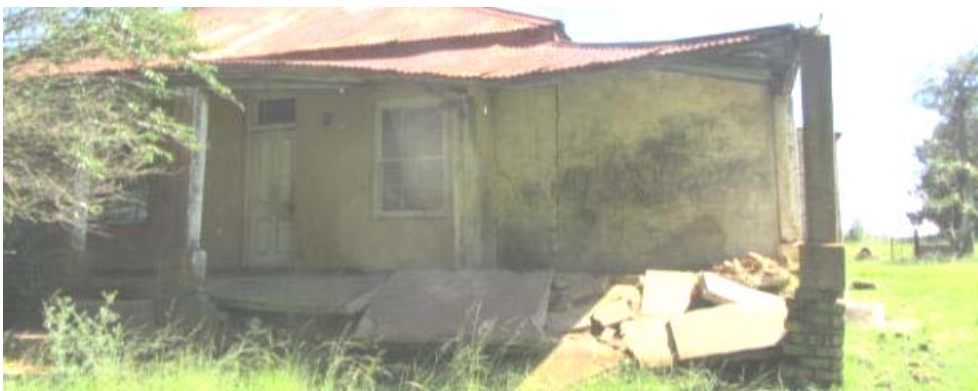
Figure 175. South elevation of the eastern part of the veranda showing conditions of imminent collapse. The reason for this is not clear as the veranda is not exposed to rainwater that may have contributed to the situation. (P121)

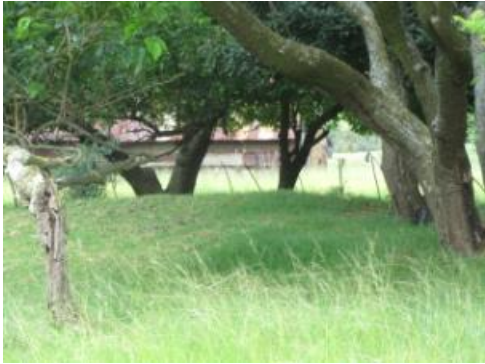
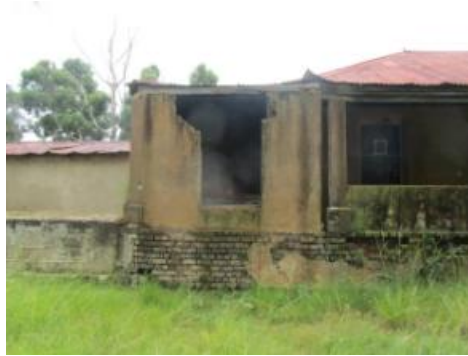
Figures 176 and 177. Midden to the south of house no.2 and south elevation of the western portion of the veranda. (P122 and P123)

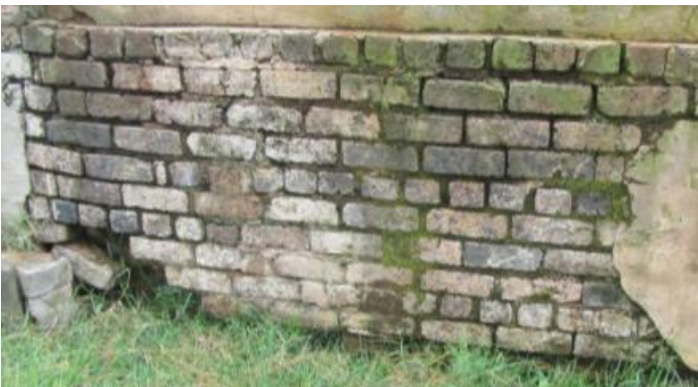
Figure 180. Detail of south veranda foundation wall showing typical English Garden wall Bond. Although normally applied for decorative work in face brick walls its application may add strength where mortar is expected to be weaker than what is needed. Here the foundation was plastered. (P126)

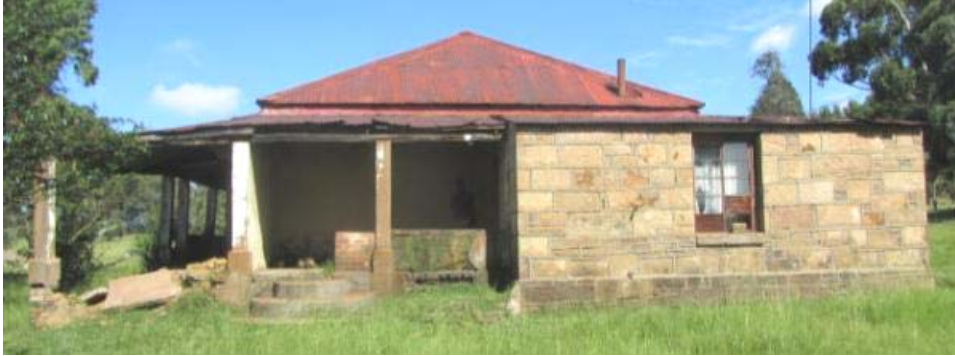
Figure 181. Eastern elevation showing sandstone addition.(P127)

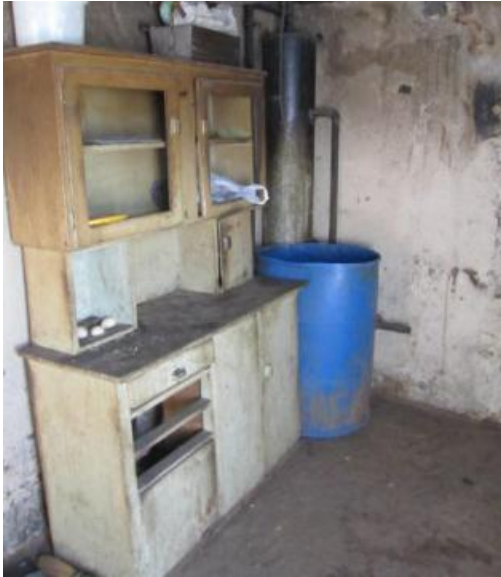
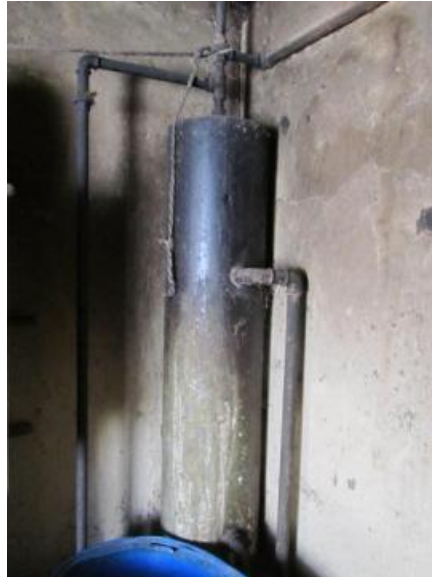
Figures 203 and 204. Remains of a loose standing cupboard and shelves, as well as the boiler that would have been accompanied by a coal stove. (P165 and P166)

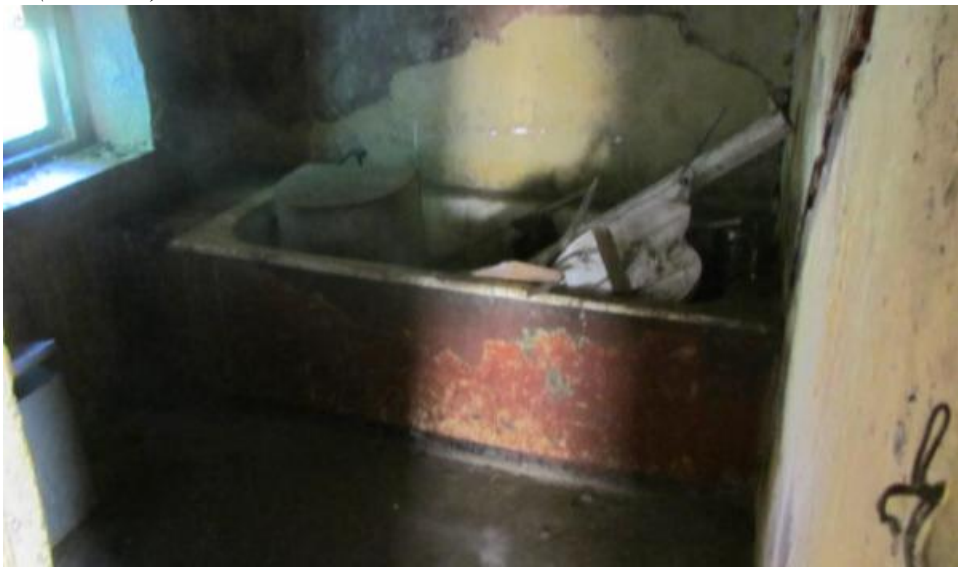
Figure 205. Detail of built-in bathtub. (P167)

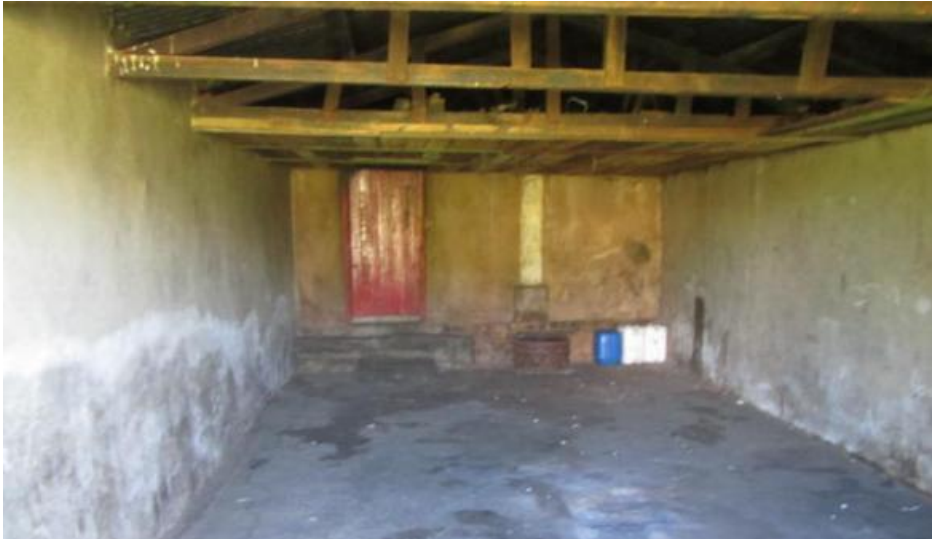
Figure240. Interior of garage showing signs of flooding and rising damp damage. Note the remaining veranda column and the unconventional carpentry in the trusses. (P131)

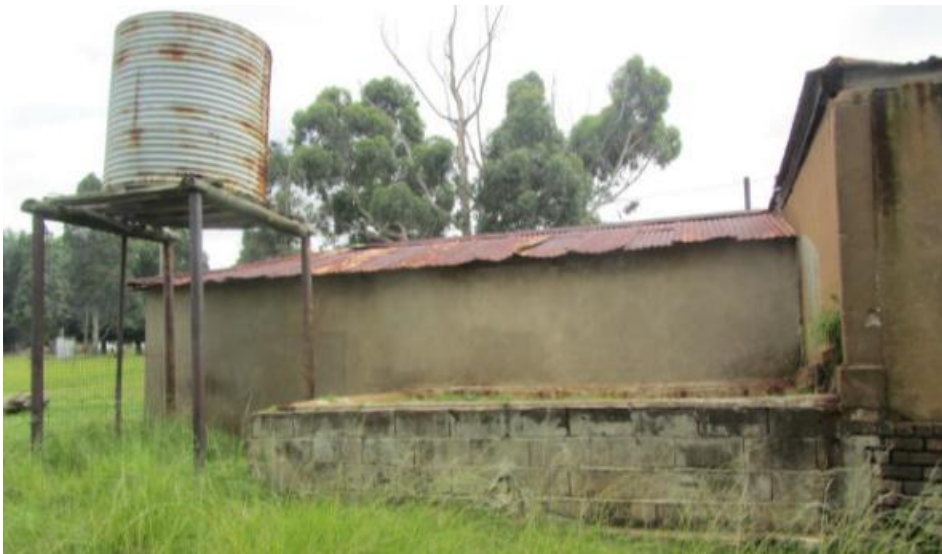
Figure241. Water overflow reservoir (swimming pool for children?) to the south side of the garage. This structure appears to predate the garage and may have been built at the time that the north eastern sandstone addition was made. (P132)

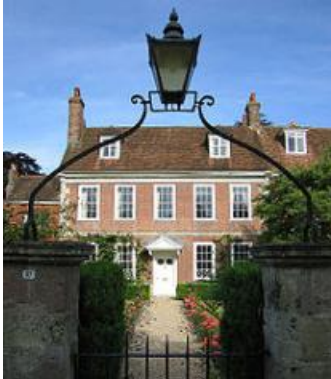
A **sash window** or **hung sash window** is made of one or more movable panels or "sashes" that form a frame to hold panes of glass, which are often separated from other panes (or "lights") by narrow **muntins**. Although any window with this style of **glazing** is technically "a sash", the term is used almost exclusively to refer to windows where the glazed panels are opened by sliding vertically, or horizontally in a style known as a "**Yorkshire light**", sliding sash or sash and case (so called because the weights are concealed in a box case). The oldest surviving examples of sash windows were installed in England in the 1670s, for example at **Ham House**.

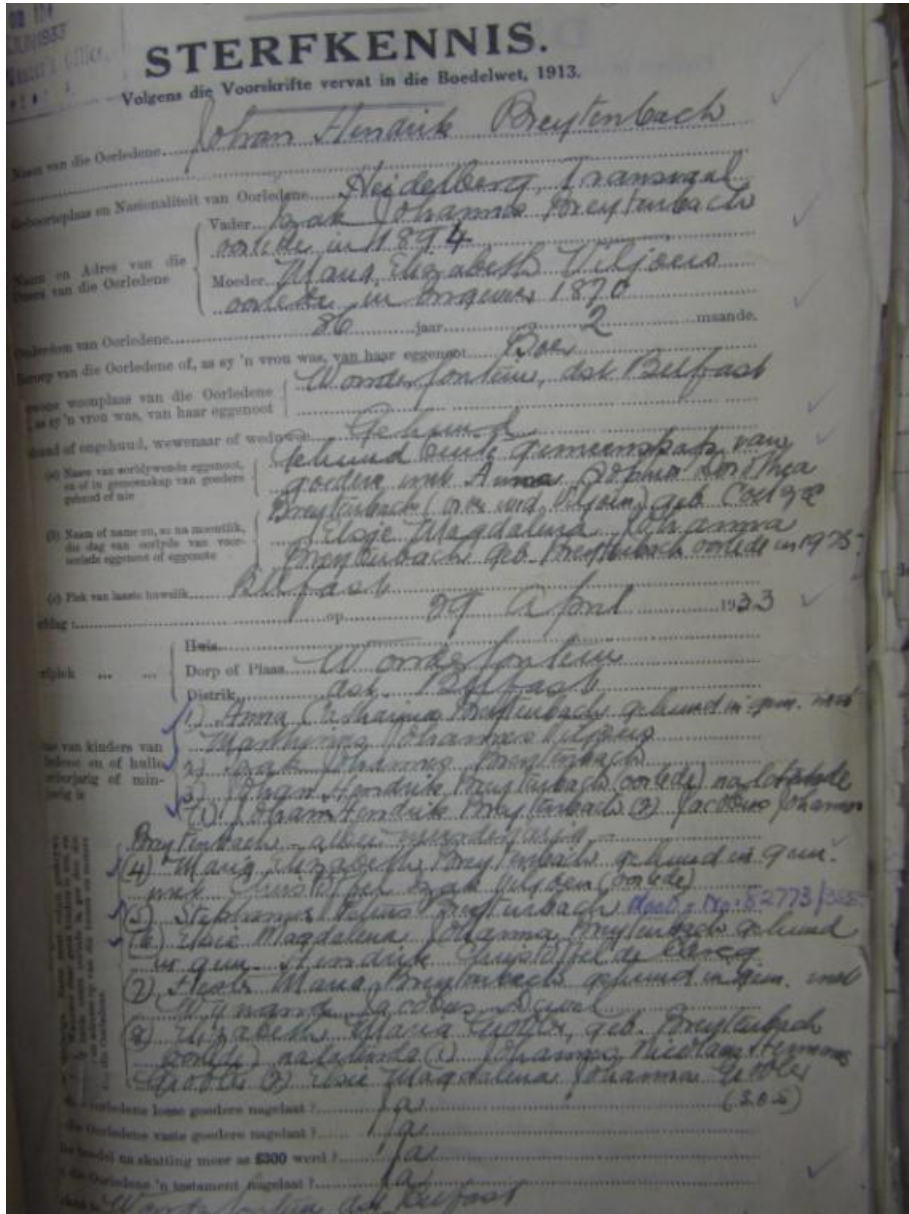
Death notice of Johan Hendrik Breytenbach where evidence of his second marriage was found
