# ARCHAEOLOGICAL IMPACT ASSESSMENT OF FOURTEEN BORROW PITS IN THE AURORA AND REDELINGHUYS AREAS, PIKETBERG AND CLANWILLIAM MAGISTERIAL DISTRICTS, WESTERN CAPE

(AIA conducted under Section 38 (1) of the National Heritage Resources Act  
as a freestanding AIA.)

**Jeffares & Green (Pty) Ltd**

17 January 2007

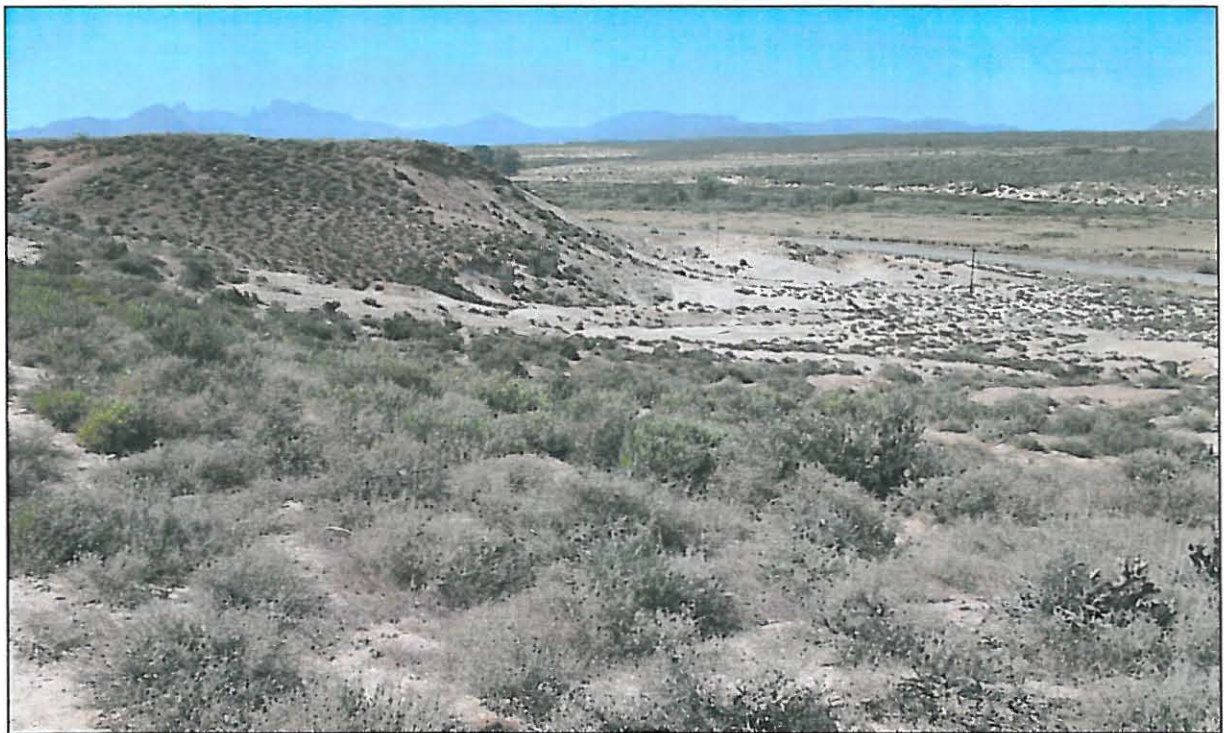
**Plate 3:** View towards the southeast showing the existing borrow pit and the hill on which Site 1 is located.

- **Archaeology:** Occasional quartz artefacts were noted in the flat area above the borrow pit and a moderate density artefact scatter (Site 1) was found stretching around the lip of the existing borrow pit.

- **Site 1:** This site lies between 32° 31' 19.9" S 18° 38' 00.2" E and 32° 31' 16.4" S 18° 37' 59.3" E. The artefacts are most dense at the first co-ordinate but a reasonable scatter is also present at the second. The scatter is of quite low density between the points and extremely low elsewhere. It is clear that the borrow pit was excavated into a small hill and that the people who occupied the area took advantage of the good visibility over the valley afforded by the high ground (Plate 3). The majority of artefacts were Later Stone Age (LSA) and made of quartz (Plates 4 & 5). Some silcrete LSA artefacts were also found. A few flakes and chunks of silcrete were almost certainly Middle Stone Age (MSA). Among the LSA artefacts was a probable adze made from quartz (Plate 6).

It is recommended that quarrying at the fourteen borrow pits be allowed to proceed but that mitigation actions be carried out at MR531/55.1/R/50 (Site 1) and MR531/63.9/R/150 (Sites 2, 3, 4 & 5) as outlined above. The cottage at OP585/0/L/320 should be avoided during excavation and damage to the tree line at MR534/25.65/R/520 should be kept to a minimum. Rehabilitation of the OP585/0/L/320 site, which lies immediately adjacent to Aurora is important.

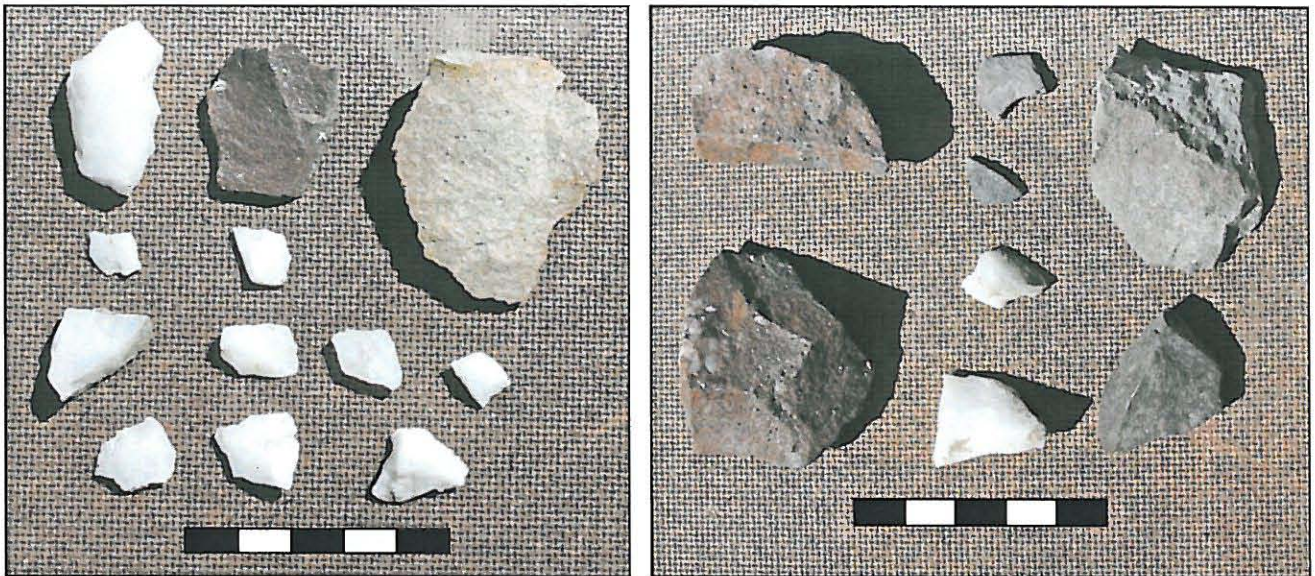
**Plates 4 and 5:** Stone artefacts from Site 1. The probable adze is at top left in Plate 4. Scale in cm.

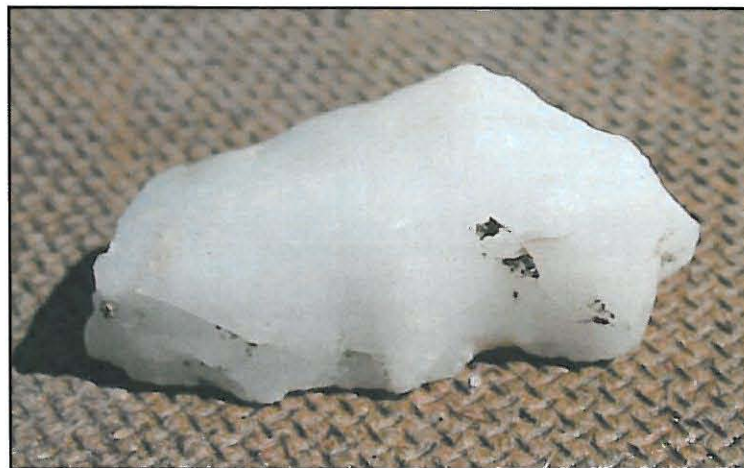
**Plate 6:** The probable adze from Site 1.

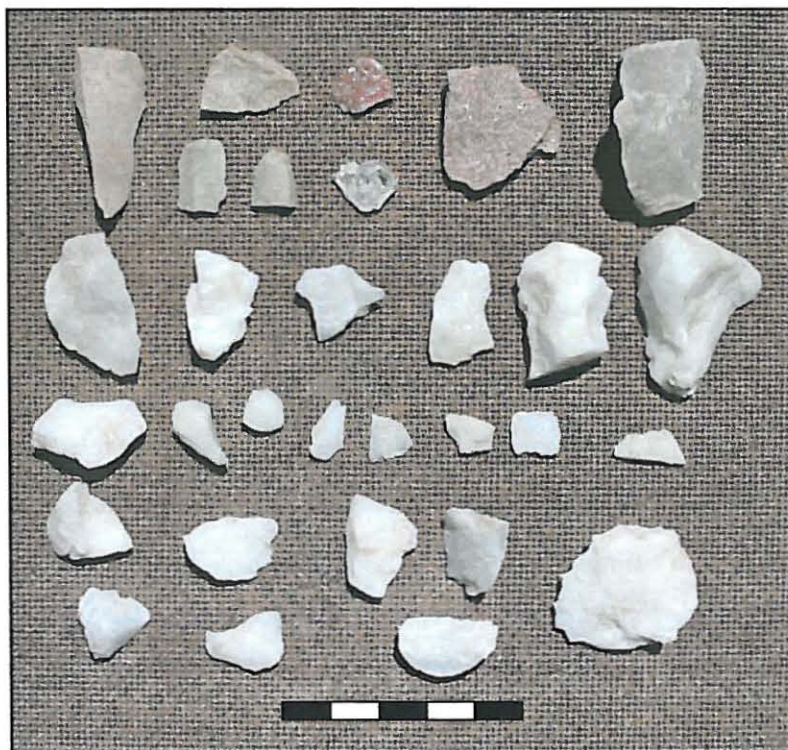
- Site 2: This scatter is located at 32° 29' 06.3" S 18° 33' 13.8" E and is just above the slope. It is a fairly extensive scatter of flaked artefacts with vein and crystal quartz, quartzite, sandstone and silcrete all present (Plate 9). No formal tools were seen but the site is clearly LSA. The densest scatter lies within a diameter of at least 30 m.

**Plate 9:** Photograph of stone artefacts from Site 2. Scale in cm.

Those at Borrow Pit MR531/63.9/L/200 (Sites 2, 3, 4 & 5) are in a very sandy area and, given the prevalence of archaeologically significant deflation hollows within the general area (Manhire 1987), it is likely that the artefacts seen there originated in a deflation hollow that was ploughed flat during cultivation. The possibility still exists that further non-lithic finds could be present in the area and, given the high density of artefacts noted, sampling of these sites would be of value. It will be possible to sieve the sand here to maximise the amount of material collected but detailed spatial information is unlikely to be present. A 1.5 mm sieve is likely to be feasible here. Collection within large grid squares of perhaps 3 m by 3 m could serve to isolate any gross spatial information that may still be preserved. A single grid should cover the whole area.

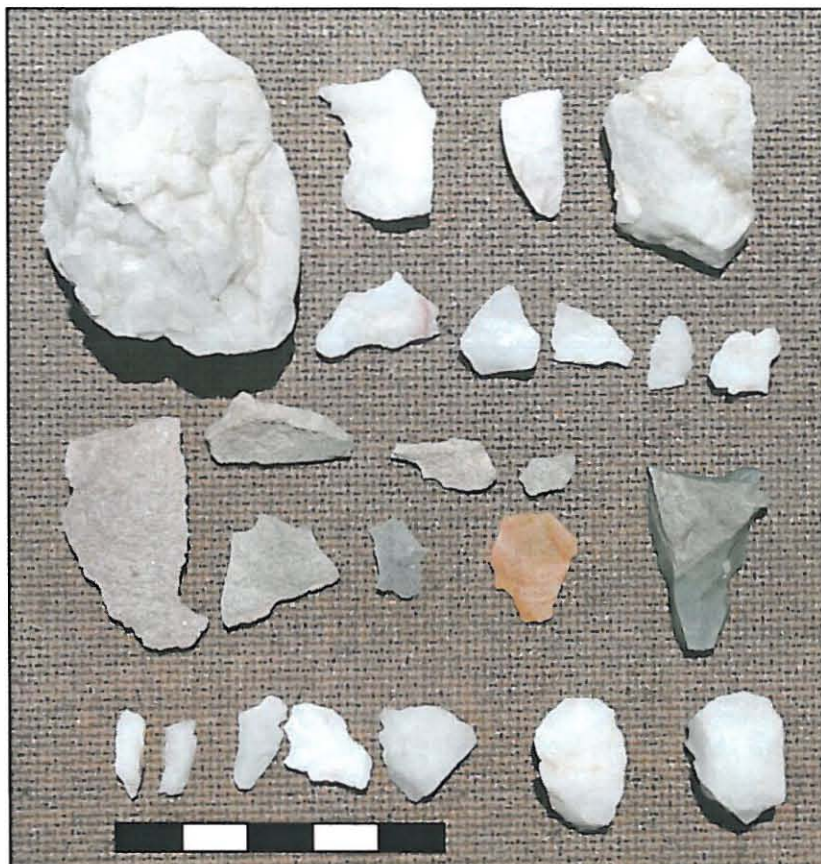
- Site 3: This scatter lies some 50 m closer to the road at 32° 29' 05.4" S 18° 33' 15.0" E. It may well be related to Site 2. Vein quartz was common and there was more silcrete here than at Site 2. One piece of hornfels was also seen (Plate 10). A single formal tool, a backed bladelet made on silcrete, was noted (Plate 11). This tool is typical of late-mid-Holocene LSA sites on the west coast. The densest scatter lies within a diameter of at least 30 m.

**Plate 10:** Photograph of stone artefacts from Site 3. The silcrete backed bladelet is second from left in the middle row. Scale in cm.

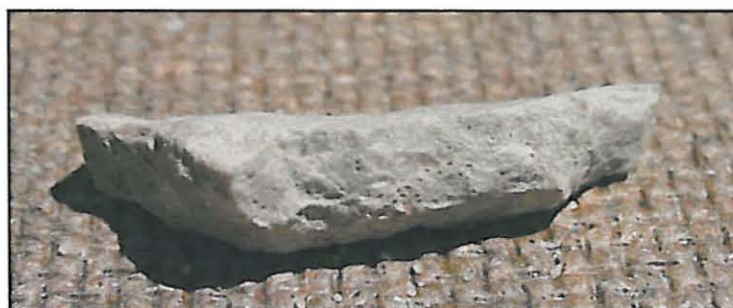
**Plate 11:** The silcrete backed bladelet. The backed edge is in picture with the unifacial retouch having been applied to the upper edge as we look at it.

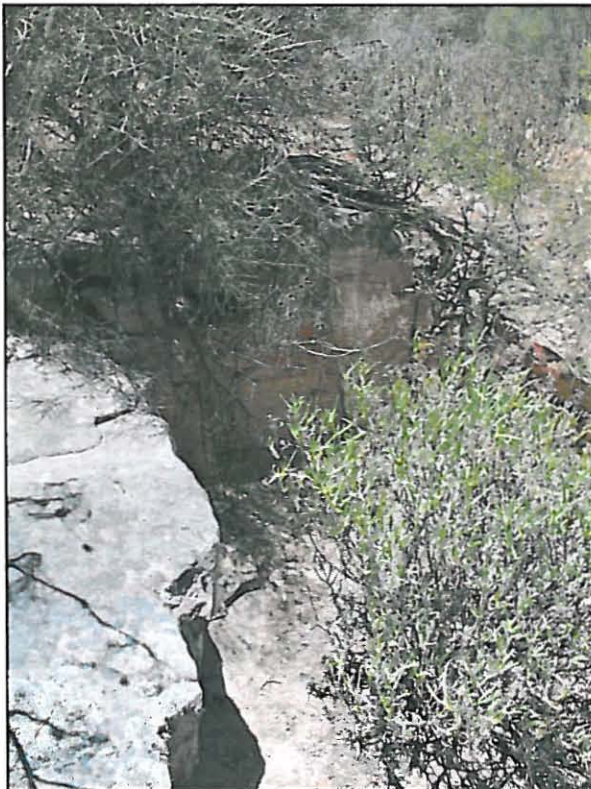
- **Site 6:** The site is a tiny sandstone quarry located at  $32^{\circ} 27' 57.6''$  S  $18^{\circ} 33' 00.1''$  E. (Plate 13). It is likely that during the early years of construction in the area people wandered around the hills looking for suitable sandstone outcrops, probably those displaying sedimentary stratification. No more than about  $3 \text{ m}^3$  of rock would have been removed from the site. A small scatter of stone dressing debris lies just below the excavated area (Plate 14).

**Plate 13:** (left) The small sandstone quarry. The face at the back of the excavation is only about 0.5 m high.

Only two historical sites were located within the surveyed areas. One, a small sandstone quarry (Site 6; DR2180/1/R/10), is of very low significance and requires no further consideration. The other comprises a small cottage of early-mid 20<sup>th</sup> century age (Site 10; OP585/0/L/320). It has been much modified and is not highly significant but should be avoided during quarrying operations. Care should also be taken not to damage it in any way. Should any need arise to remove this cottage then a permit would need to be applied for from Heritage Western Cape.

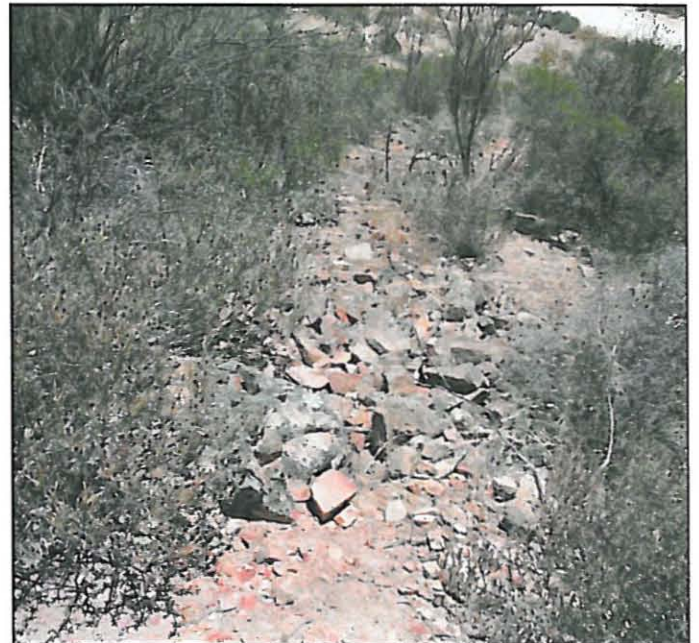
**Plate 14:** (right) The remains of stone dressing lying on the slope just below the quarried area.

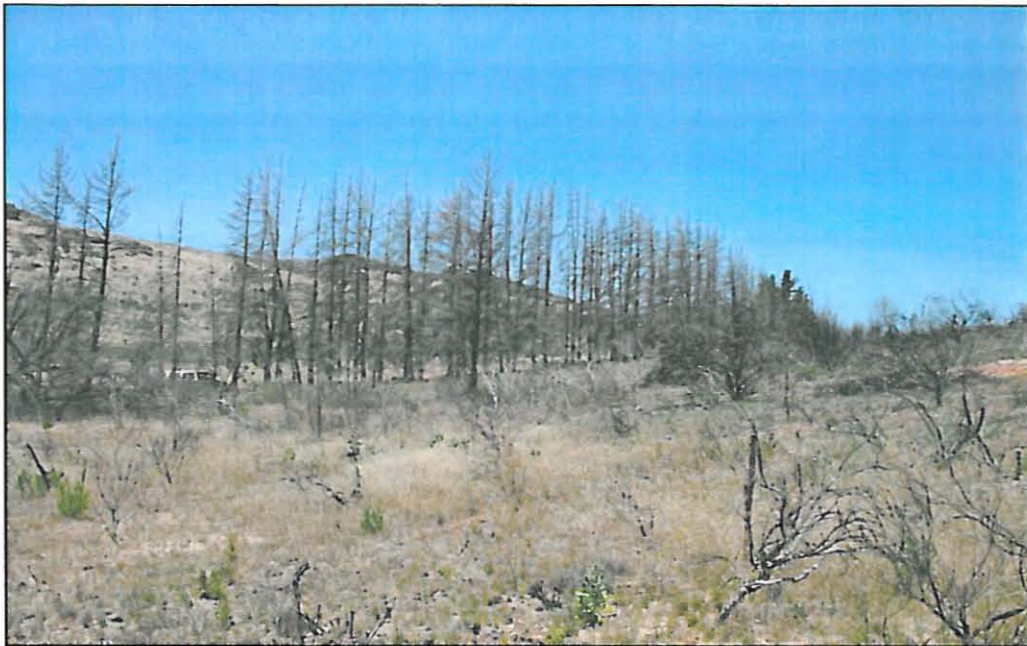
Archaeology: No prehistoric archaeology was seen at all. The only item of concern here is the line of pine trees along the road (Figure 13, Plate 20). These trees comprise an element of the cultural landscape although they may well only be some 40 to 50 years old. Unfortunately all the trees alongside the borrow pit location have been burned.

**Plate 20:** View towards the west showing the now burnt line of pine trees alongside the road.

One other cultural landscape feature was noted. This is the tree line at Borrow Pit MR534/25.65/R/5200. It is not very significant but it is suggested that it be avoided as far as possible during excavations. Unfortunately the tree line has already been damaged by the recent mountain fire that occurred in the vicinity.

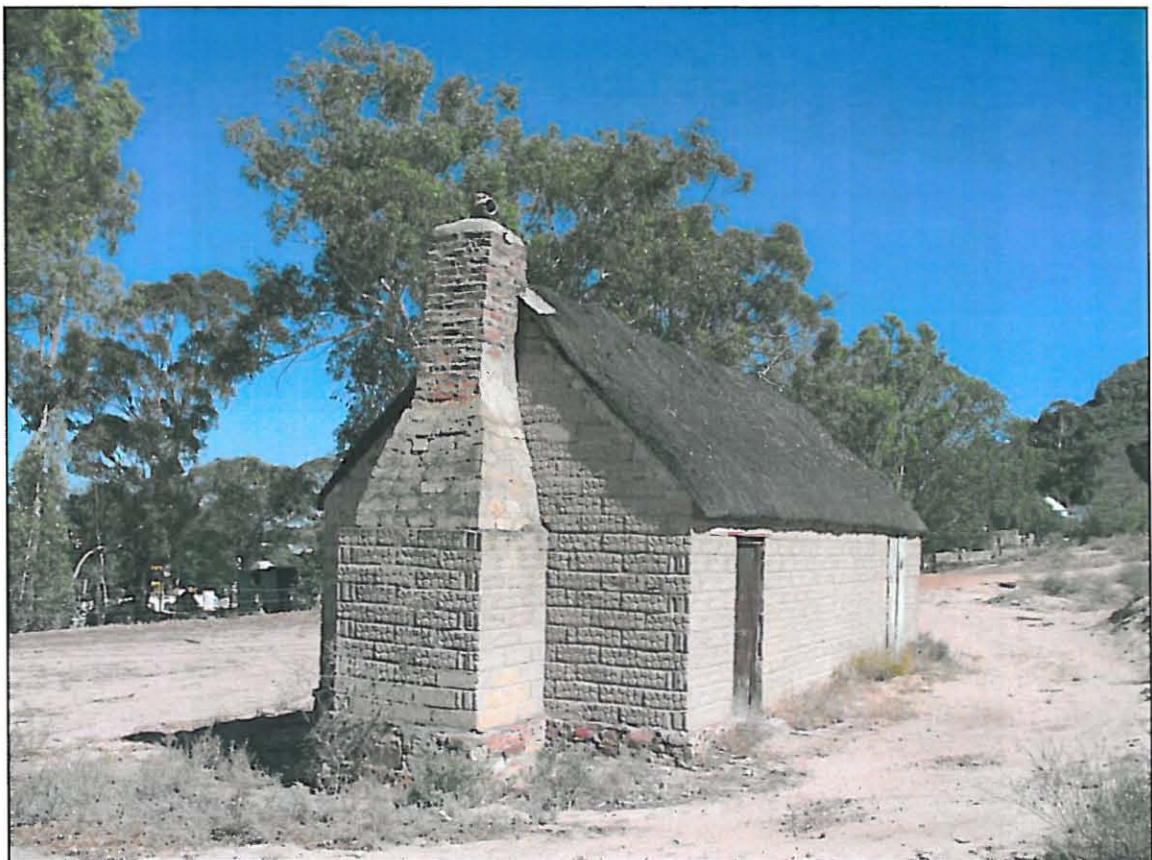
**Plate 26:** The small cottage on the northern edge of the polygon.

- **Site 10:** This site consists of a small vernacular style cottage probably dating to the 1930's or 1940's located at  $32^{\circ} 42' 24.4''$  S  $18^{\circ} 29' 22.8''$  E. It is built of decorative breeze blocks on a stone foundation. The chimney has had more recent modifications and the roof has been replaced very recently (Plate 26). The upper edges of the gables have been repaired with modern bricks and cement, probably when the roof was replaced. The building is not in use and the openings, with the exception of a single locked door, are securely boarded up. The surrounding area has fragments of modern glass, ceramics and other rubbish lying on the ground surface.

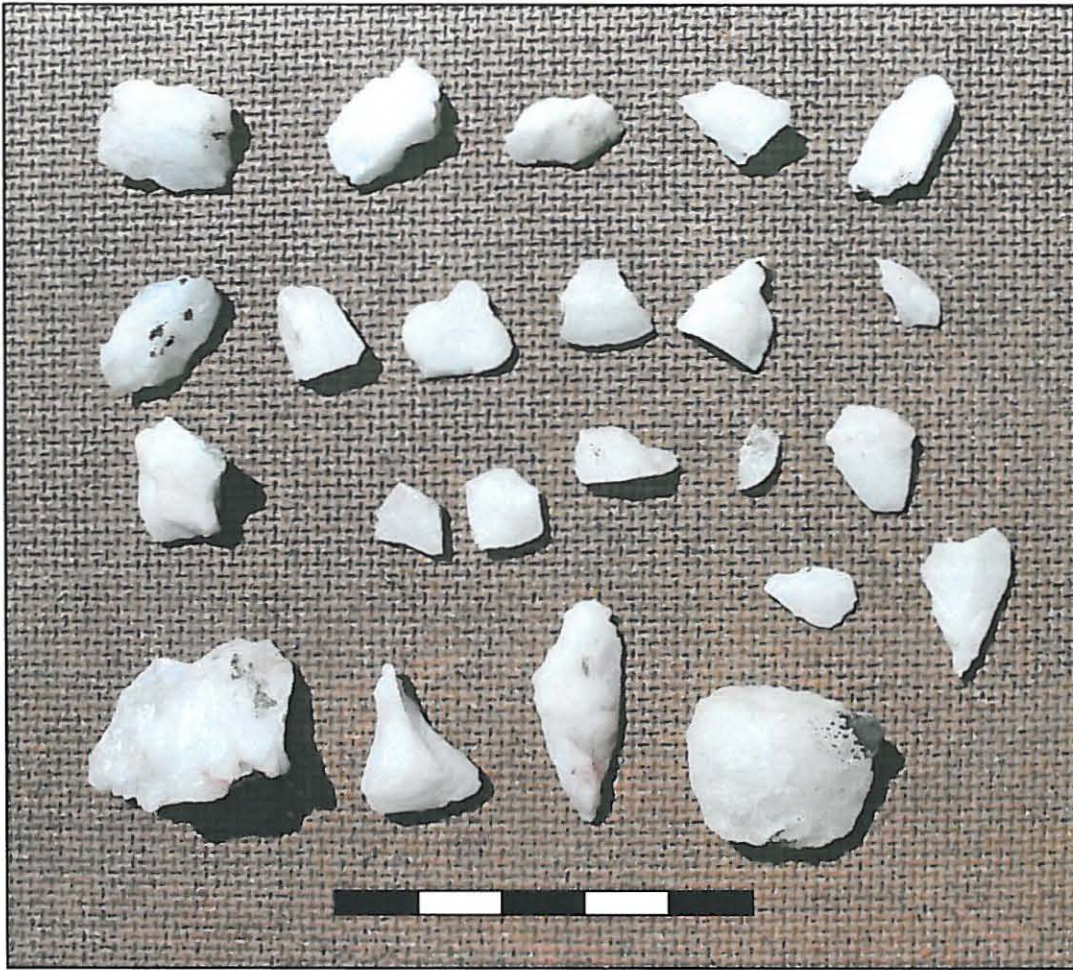
- Site 12: This site consists of an approximately 20 m diameter scatter of quartz flaked artefacts located at 32° 43' 12.7" S 18° 29' 57.5" E. The scatter lies some 100 m from the base of the rocky ridge. No formal tools or other finds were seen but the stone artefacts were quite numerous.

**Plate 31:** Photograph of artefacts from Site 12. Scale in cm.

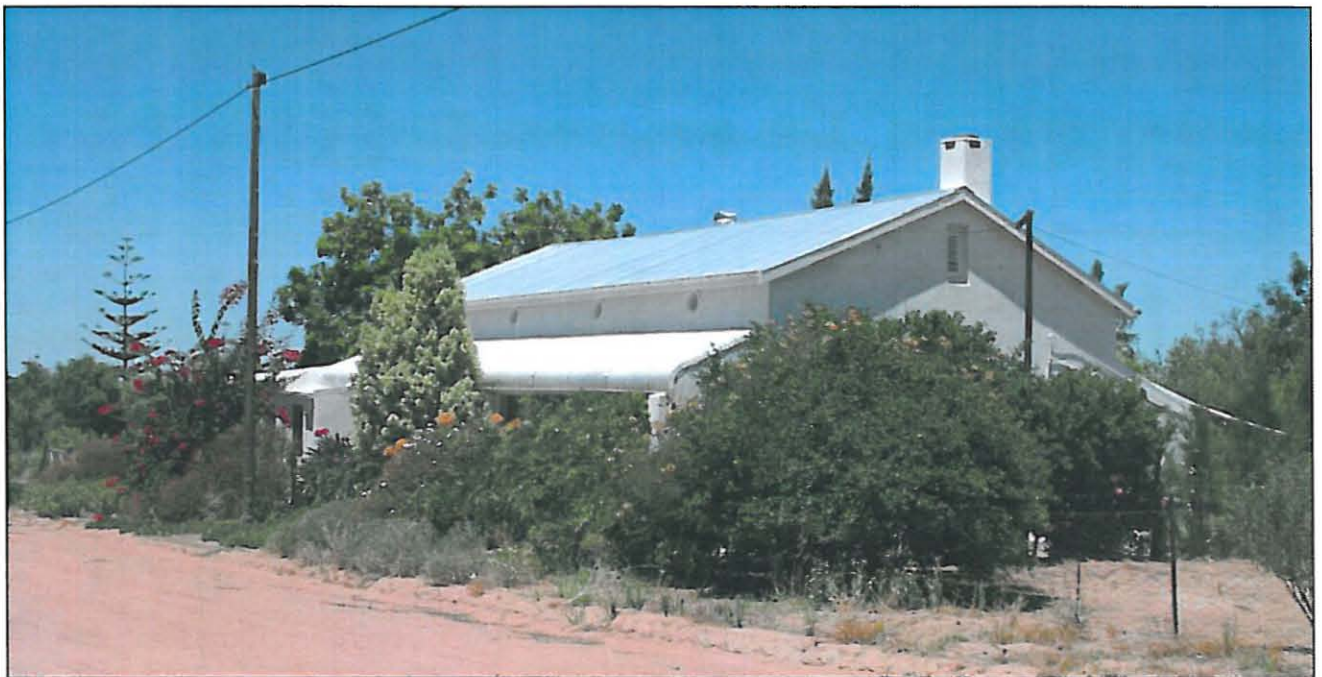
Only one cultural landscape of significance was noted during the survey. This is the rural village landscape of Aurora (recorded as Site 11). Although there are many late 20<sup>th</sup> century buildings in the village, several early 20<sup>th</sup> century and possibly late 19<sup>th</sup> century buildings are also present (Plates 34 & 35). Most of these have been very well maintained although some modification is occasionally evident. Overall, though, the village area has good scenic and aesthetic value. In mitigation of impacts to this landscape care should be taken to rehabilitate the borrow pit after completion of quarrying so as to maintain and even improve the scenic value of that part of the town.

**Plate 34:** This house in Aurora may originally date to the late 19<sup>th</sup> century.

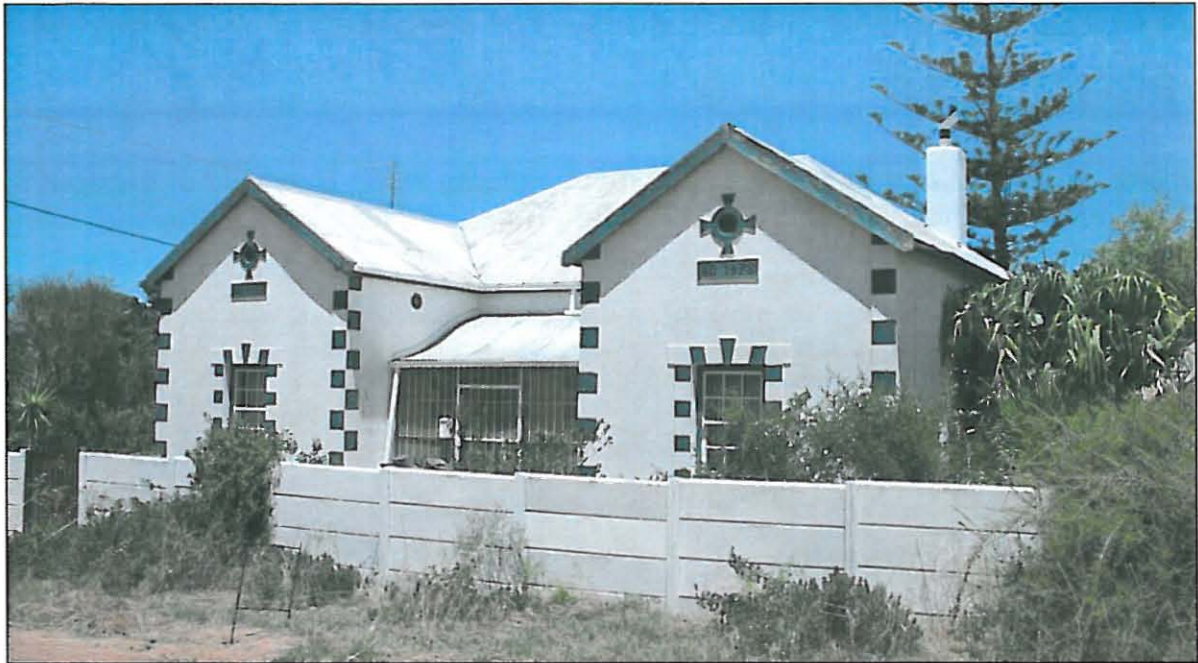
**Plate 35:** This house in Aurora has a gable date indicating construction in 1928.
