HERITAGE IMPACT ASSESSMENT THE PROPOSED RAISING OF THE CLANWILLIAM DAM WALL, OLIFANTS RIVER VALLEY, CLANWILLIAM DISTRICT

Ninham Shand Consulting (Pty) Ltd
As part of an EIA

October 2005

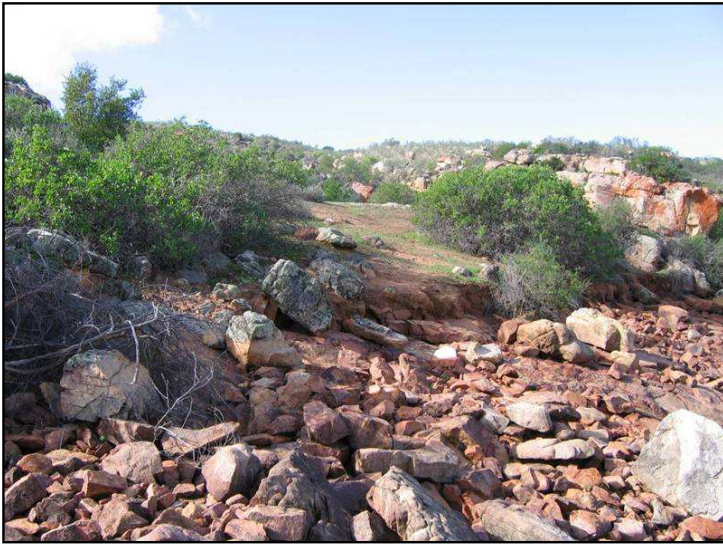
Plate 4: An example of bank erosion alongside the current full supply level near CDE5. Large artefacts on or in the sand may still be recovered from the gravel but small artefacts will be lost.

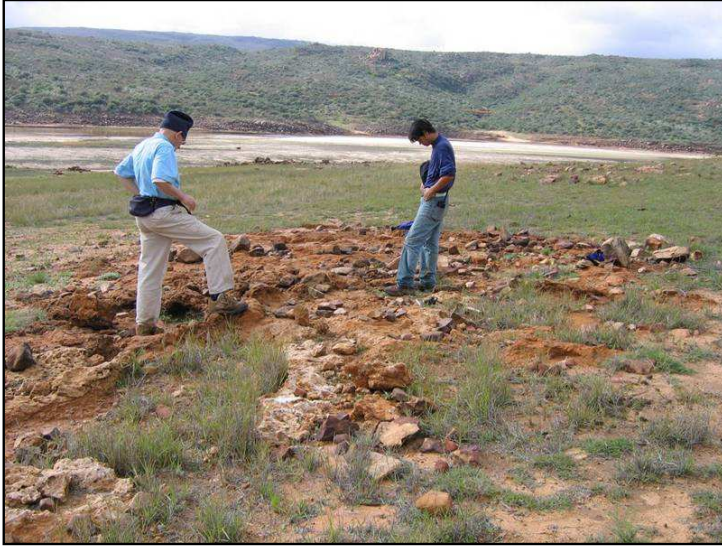
Within the current FSL ESA artefacts were frequently encountered lying on exposed gravels and bedrock, or naturally cemented into fossil *termite* which are more resistant to erosion than the surrounding sediments. Plate 7 shows an example of such an occurrence and Plate 8 illustrates some of the artefacts found. This site would not have been exposed if it were not for the action of the dam water. Many more such sites will become exposed as a result of the raised dam level. Since studies (in progress) have revealed that ESA scatters that are presently below the FSL appear to retain some degree of spatial patterning, it seems that flooding of the sites as a relatively small effect on lateral movement of artefacts.

Plate 7: CDW34. A fossil termitarium with ESA artefacts naturally cemented into it. This site is below the current full supply level.

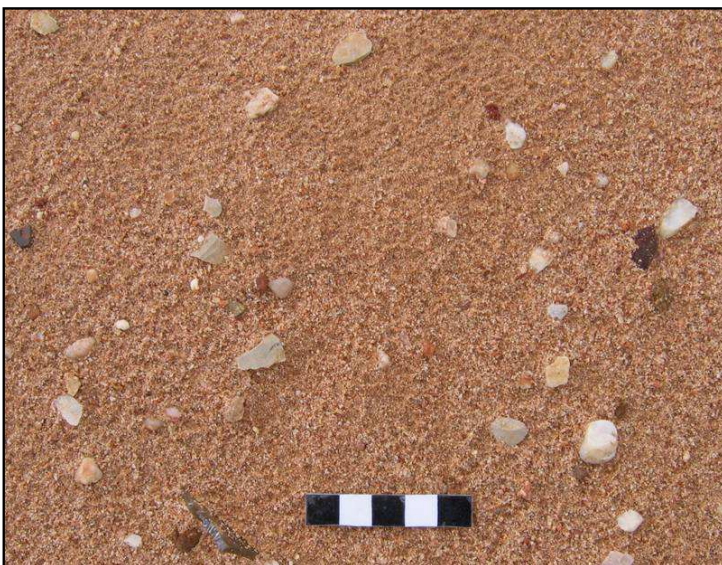
Plate 9: CDE07. An example of a stone artefact scatter that may be MSA or LSA (scale in cm). These artefacts and the underlying sands are below the current full supply level and are being actively eroded by the dam water.

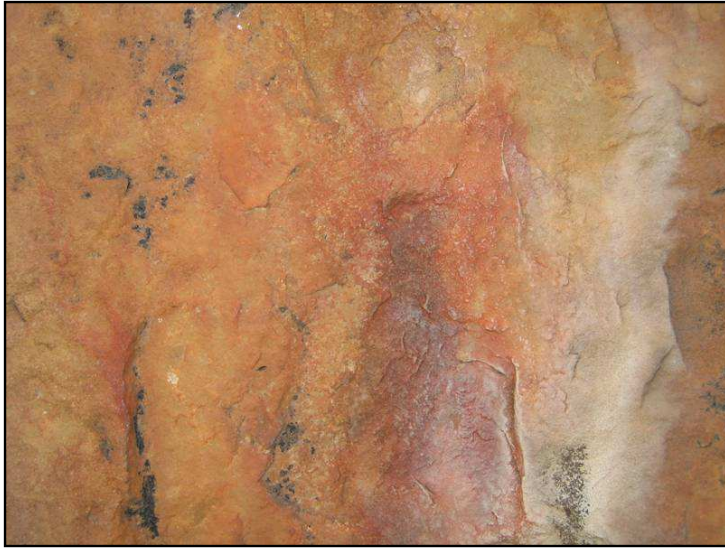
Plate 16: CDW24. An example of very poorly preserved rock art. It is not possible to determine what was painted here but it is likely that it was only one or two images.

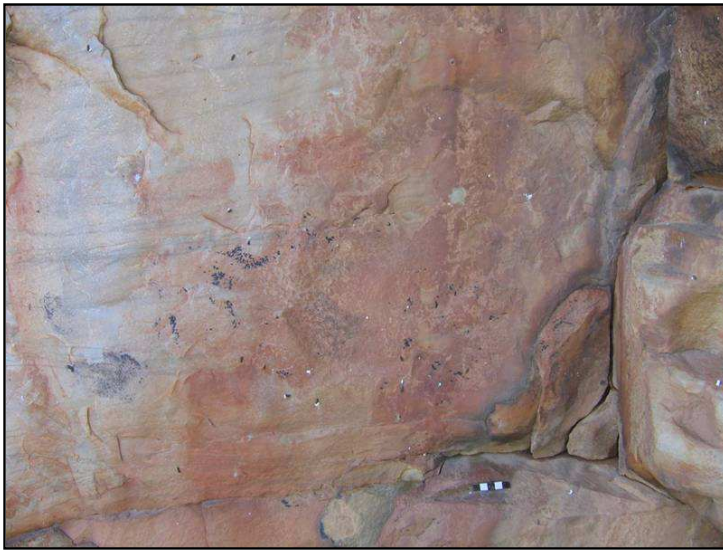
Plate 17: CDE15. An example of poorly preserved but more complicated rock painting. At least two eland, three elephants, one human and one other indeterminate image are painted on this panel. Some of the images are in black pigment, but as is typical of this colour, it has preserved less well than the red. The eland would have had white on them but this colour is gone completely (scale in cm).

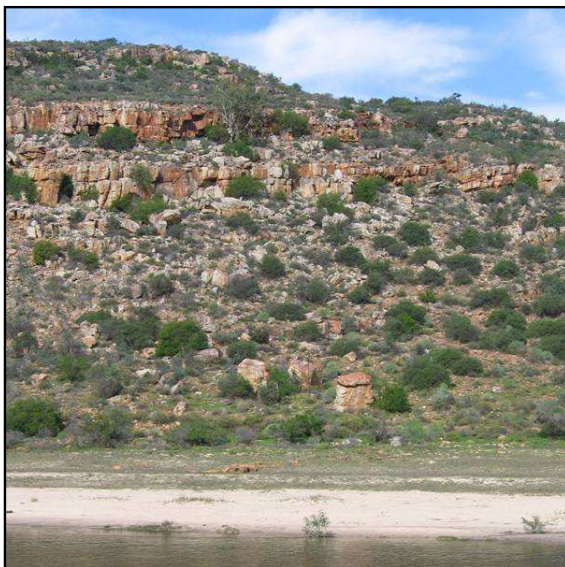
Plate 18: CDE15. The paintings shown in Plate 5 are located on the front of the big boulder nearest the river. Due to its location, this panel is exposed to wind, rain and sun and this has led to natural deterioration of the painted images.

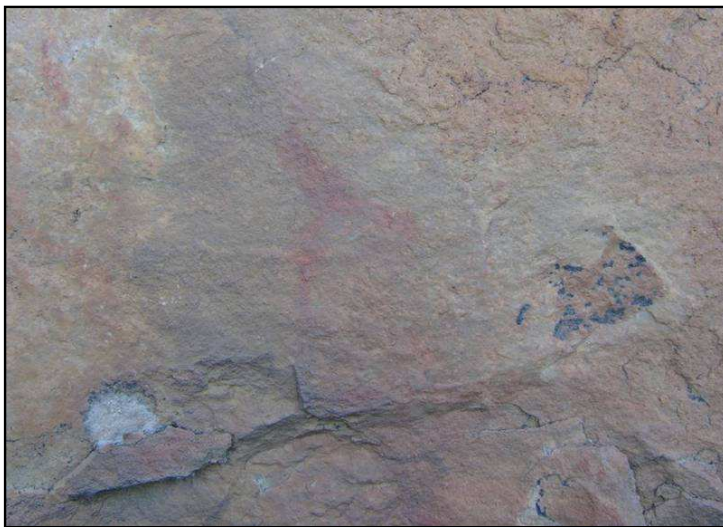
Plate 21: CDE13. An example of a rock painting with just a single image, that of a human figure. The site is exposed resulting in poor preservation of the art.

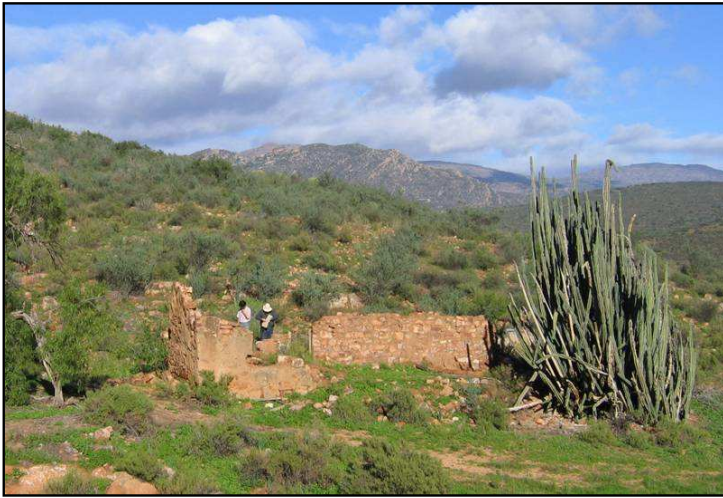
Historical buildings, most of them farmsteads and their related outbuildings, are present in the Olifants River Valley. In terms of overall occurrence, they range widely in both age and condition. Older ruined buildings are by far the most common structures in the study area. Many are in very poor condition due primarily to their roofs having been removed/collapsed since their abandonment. They are mainly built with mud bricks which are very poorly fired. As a result, any exposure to water causes them to dissolve and the structures then begin to fall apart. Those found within the proposed inundation zone are mostly ruined and likely to date to the 19th century or earlier (e.g. Plate 22).

Plate 22: CDE16. An example of a presumed late 19th century dwelling that is now in ruin. Several other features related to this little farmstead are to be found in the immediate area.

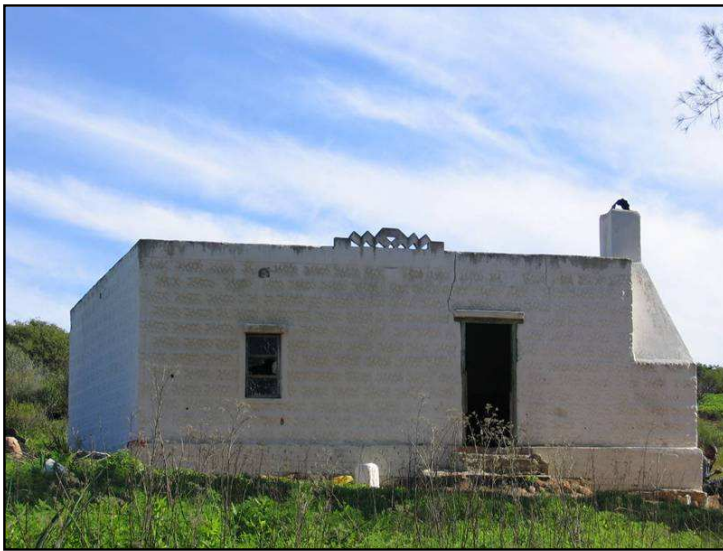
There are a few 20th century buildings in the study area, most of which are occupied and less than 60 years of age. One or two have been abandoned and are in a poor state of repair (e.g. Plate 23).

Plate 23: CDW27. An example of an historic structure that is still currently in use as a residence. This cottage probably dates to about the 1930's or 1940's.

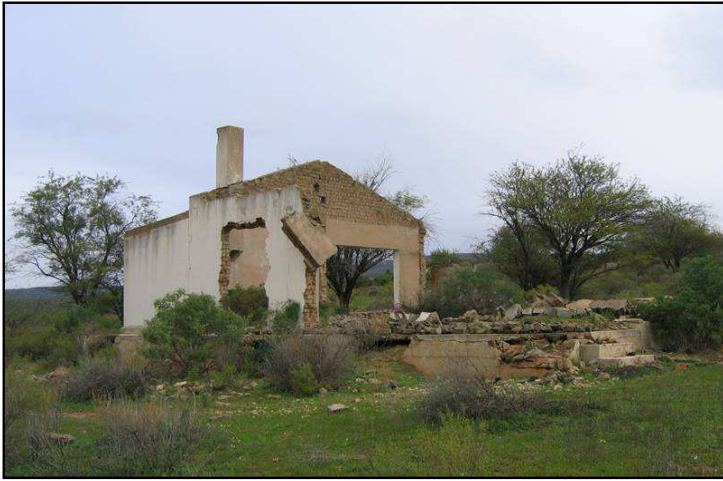
Plate 25: CDW44. An example of a modern house that is already in ruin. This house has an inscribed date of 1944 on a drain indicating that it is older than 60 years and hence is protected.

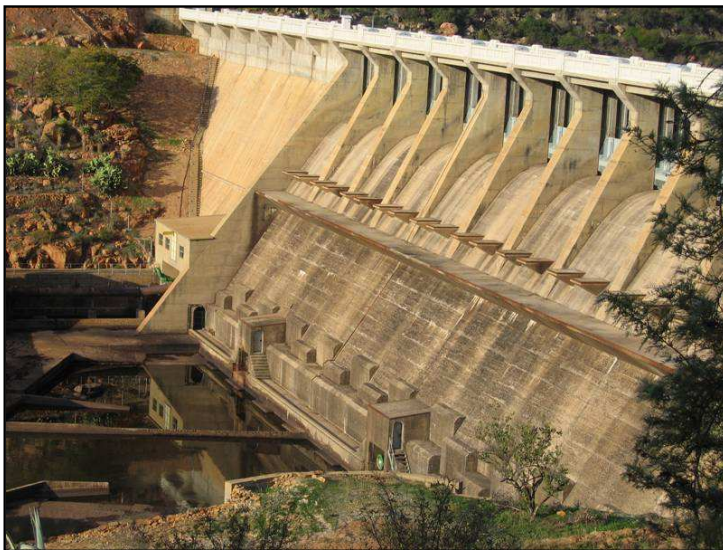
The proposal is to strengthen and raise the Clanwilliam Dam wall. The present wall which was initially built in 1935 and raised in 1966 is showing signs of failure necessitating a minimum of extensive engineering work to strengthen the wall. It is therefore logical for Department of Water Affairs and Forestry (DWAF) to investigate raising the wall height and increase the storage capacity which would help provide water for agricultural development in the Vredendal – Van Rhynsdorp area. Scenarios of raising the dam wall by 5, 10 and optimally 15 m have been considered. For the purposes of this study 15 m is considered to be the zone of full supply level (FSL) and is therefore the study area for the purposes of this Heritage Impact Assessment.

Plate 32: CDW62. The Clanwilliam Dam wall. The bulk of the wall was built in the 1930's but the upper portion with the sluice gates was added in 1966.

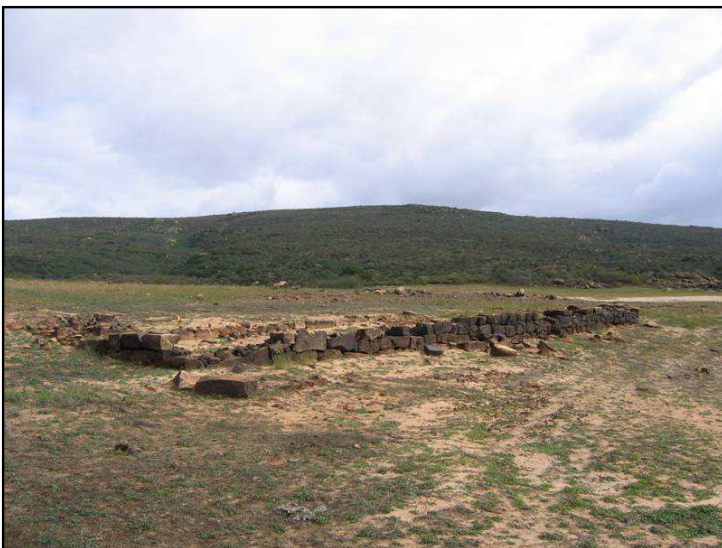
Plate 35: CDW33. An example of a cultural landscape that has been all but obliterated by the original flooding of the Clanwilliam Dam. This picture shows the remains of a house, while a threshing floor is located in the valley behind. The nearby fields, in the same valley, were probably cultivated by the inhabitants of this house.

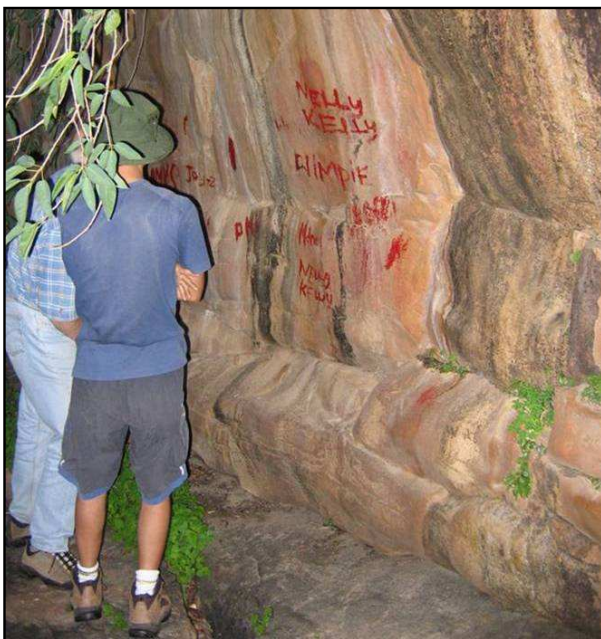
Plate 40: CDE20. An example of a site that has been deliberately vandalised. This degree of vandalism is rare; charcoal, koki pen and white correction fluid are far more commonly used for graffiti. This graffiti was added after July 2004.

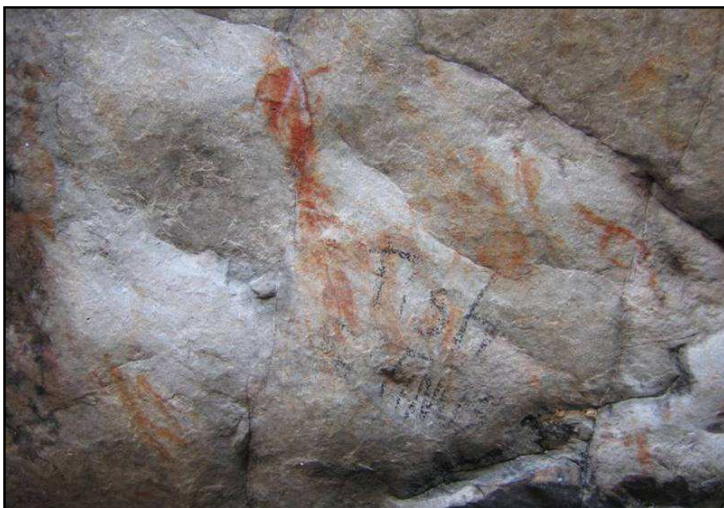
Plate 41: CDE23. Another deliberately vandalised site. Charcoal is relatively easy to remove, but nonetheless the removal process will also have an impact on the painting.

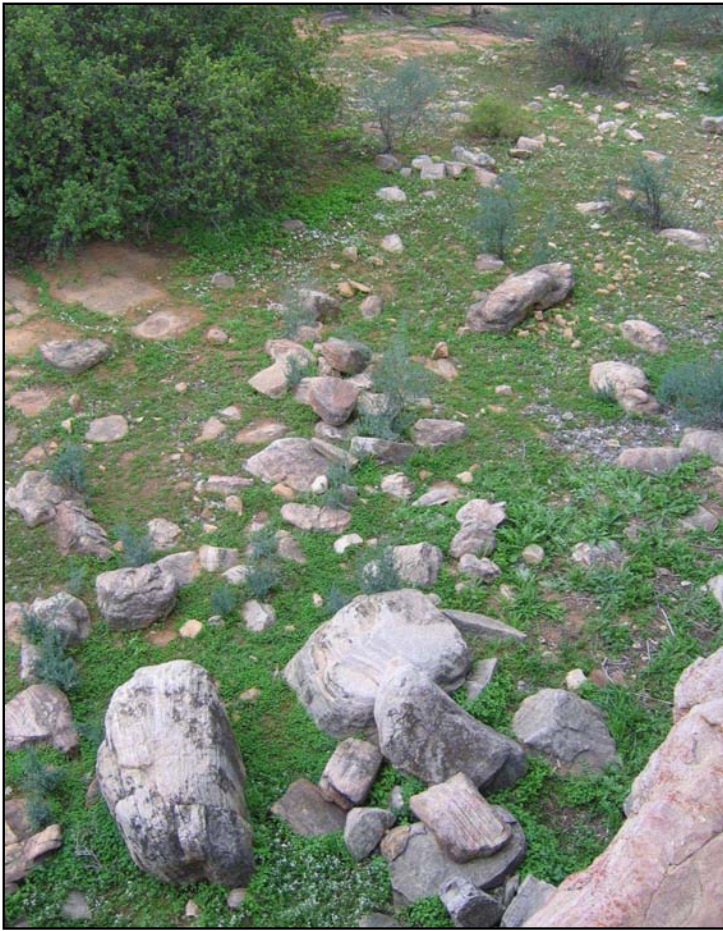
Plate 45: CDW11. The toppled remains of the stone kraal can be seen curving up and rightwards from the base of the photograph.
