**ARCHAEOLOGICAL IMPACT ASSESSMENT: PROPOSED
HELDERBERG INTERNATIONAL SCHOOL ON GUSTROUW 918/82,
STELLENBOSCH DISTRICT, WESTERN CAPE.**

(Assessment conducted under Section 38 (1) of the
National Heritage Resources Act, No 25 of 1999)

July 2009

Dr Lita Webley
Archaeology Contracts Office
Department of Archaeology
University of Cape Town
Private Bag
Rondebosch
7701

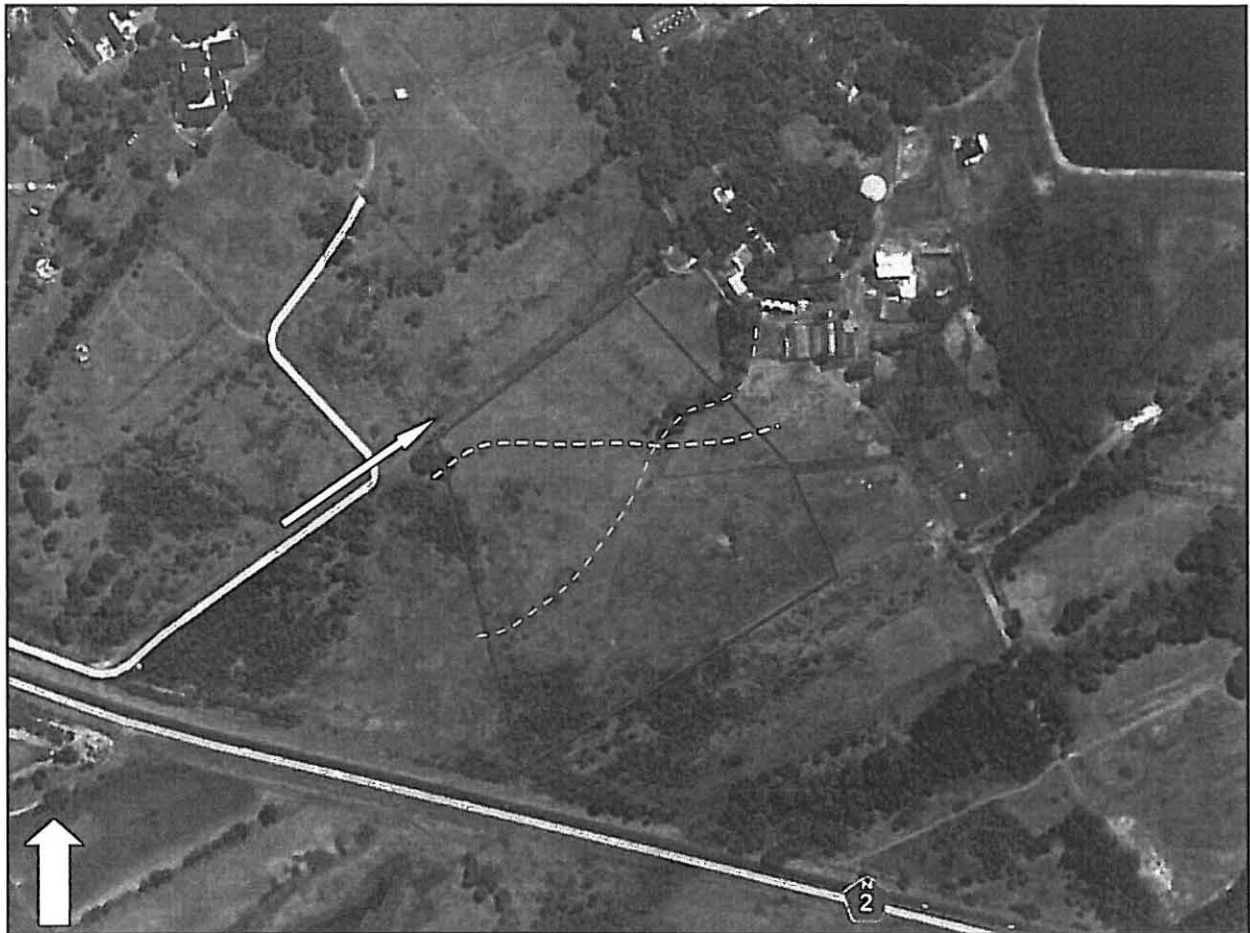
Figure 2: Aerial view of the development area (outlined in red) on 918/82. The diagonal white arrow indicates the direction of the present central access road to the farmstead. The yellow line indicates the pre-1944 entrance road to the farm. The blue line indicates the non-perennial watercourse. The stone bridge is at the intersection of the yellow and blue lines.

of the original approach. There is a second and earlier “entrance” to the manor house on the southern boundary of Gustrouw 918/81 is marked by two mature stone pine trees, it crosses the drainage ditch, then crosses the property in a north-easterly direction, to cross the non-perennial river course at the old double stone wall (former narrow bridge) and continuing to the Broadlands stables (Figure 2). This pathway to Broadlands is still visible on the 1944 aerial map.

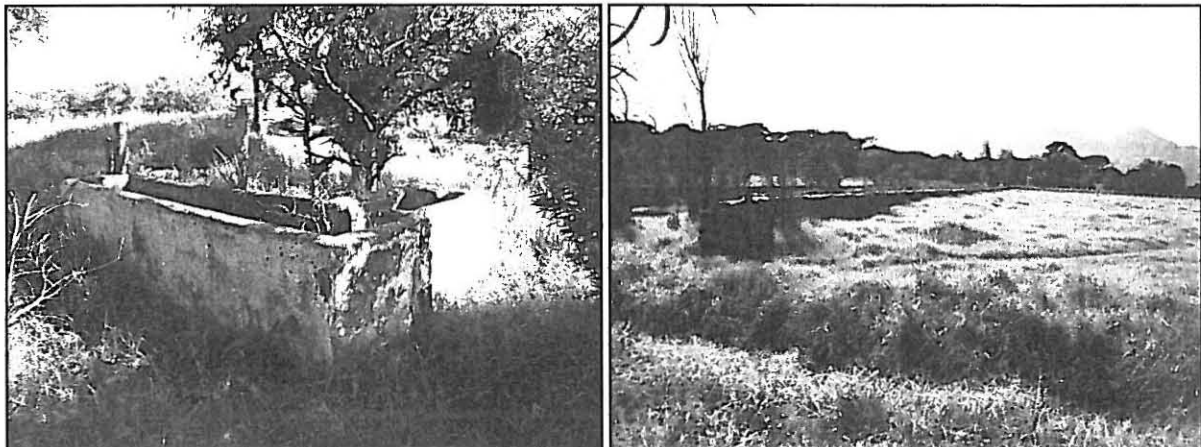
1) Right next to the road, there is a concrete water trough (Plate 1), but not clear if this is outside the perimeter of the property. Next to the trough is a small, rectangular raised area with 4 wooden poles on each of the corners.

Plate 1: Water trough. Plate 2: The ditch in the foreground, with the stonewalling of the entrance road visible on the left and the farmstead in the trees in the distance.

2) There is a drainage ditch which runs along the western perimeter of the property, commencing at the stone pines (Plate 2). It is about 50cm deep, but not stone-lined. The ground becomes progressively swampier toward the south-west corner, with standing water in several locations. I was informed by Mrs Austen that a farmer's dam higher up in the valley is leaking. The ditch continues into a dense stand of Port Jackson vegetation. At this stage there are standing pools of water in the ditch.

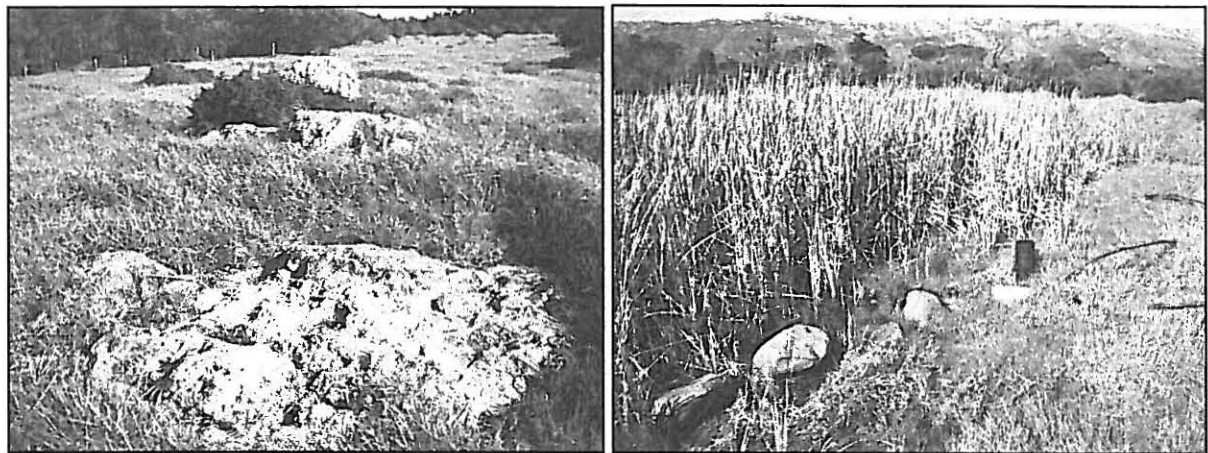
3) There is a ridge of in situ granite boulders running along the south-eastern edge of the property (Plate 3). Pistorius (2006) suggests that they may represent the edge of an old water course. There is a second line of granite boulders running parallel to the first.

Plate 3: The ridge of granite at the edge of the property. Plate 4: The dam which is filled with reeds, some rocks and pipes visible in the foreground.

4) In the middle of the land is a raised, circular earthen dam (Plate 4). Is it a dam or a natural spring with soil piled up around it? The water forms a small pool filled with reeds. On one side there is evidence that the water has been pumped out with water pipes. There are also some rocks (large round quartzite cobbles) on the edge of the dam, which may have come out from earth movement around the dam/spring?

It is recommended that the stone pines and the stone bridge are incorporated into future development plans. The pines indicate the possible start of an older track to the farmstead, while the stone bridge still serves a useful function across the non-perennial stream. It is not clear whether the small earthen dam/spring is natural or man-made. It can possibly be incorporate this into the design of the school as a water feature.

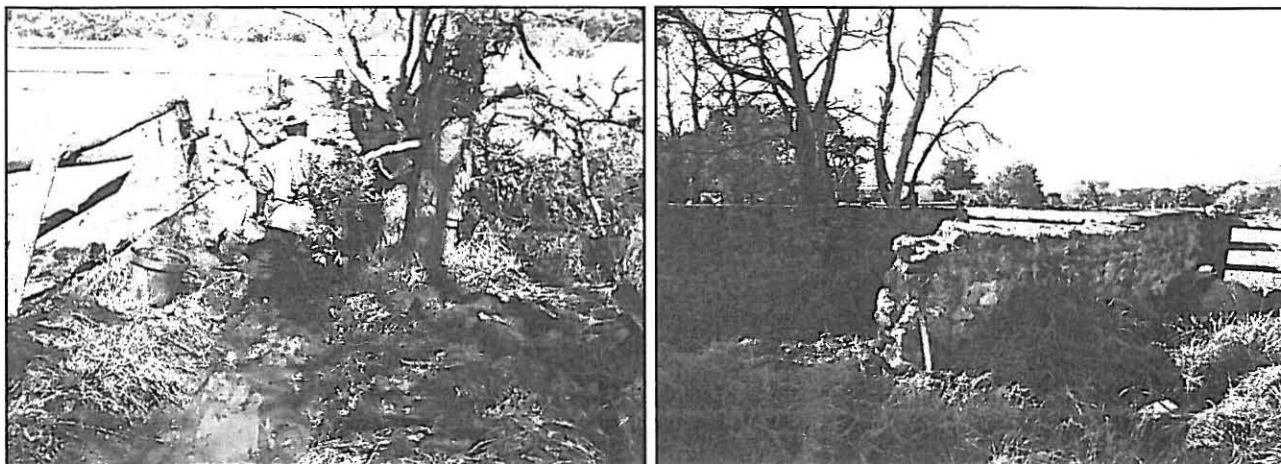
5) During the survey, it was observed that the farm workers were cleaning out the non-perennial watercourse running along the margins of a paddock. The soil is very dark and humic, but with no signs of river cobbles.

6) The workers were attempting to clear underneath the area of the little stone "bridge". It consists of two parallel stone walls, about 3-4 metres apart, built of river cobbles and cement. They are built to a height of 1.5 m and one has a wooden pole inserted in front of the wall. It does not seem that there has been a significant hole built under the bridge to accommodate the water from the stream? It appears to be a concrete pipe, which they are attempting to open with a long stick.

Plate 5: Farm workers cleaning out the stream which runs beneath the stone bridge. Plate 6: The stone bridge.

The stone bridge, with its location along the pre-1944 entrance to the farmstead and on the non-perennial stream crossing the property, is possibly related to an earlier (19th century) development of the Broadlands farm. However, without further information it is not possible to set a date on the bridge or to arrive at an index of its significance.

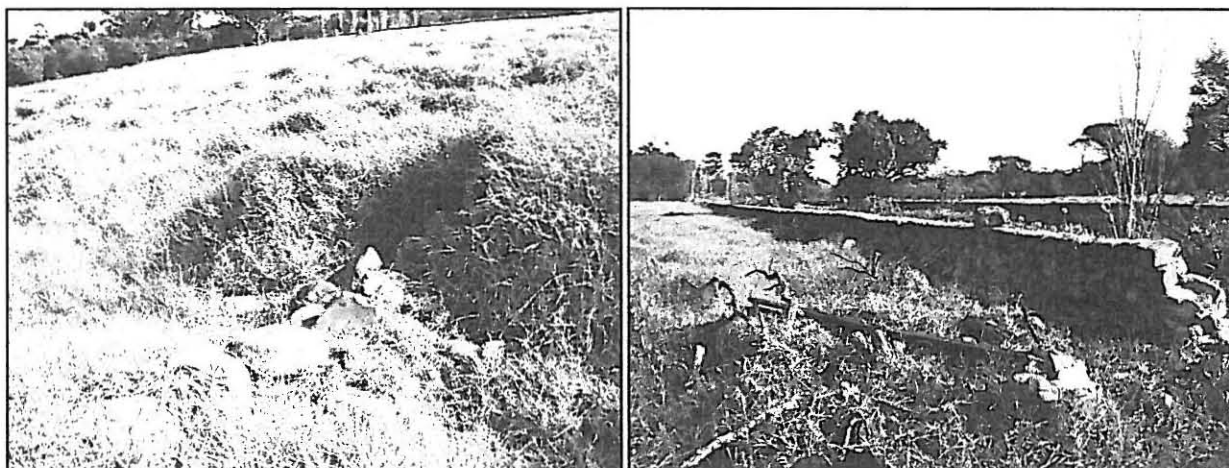
7) There is a short section of roughly packed stone walling half visible in the long kikuyu grass (Plate 7). It is about 6 m long, and appears to run at right angles to the non-perennial stream.

8) The stone walling which runs along the access road to the main house has had a section removed for a vehicle to pass through (Plate 8). The wall is made of river cobbles and concrete.

Plate 7: Short section of roughly packed stone visible in the long kikuyu grass. Plate 8: Section of stone walling leading to the farmstead showing method of construction.

The other features on the site (i.e. the ditch running along the western edge, the circular earthen dam and the rough stone walling) relate to farming practices and it is not possible to put a date on them. They are not of material significance.
