**ARCHAEOLOGICAL ASSESSMENT REPORT
FOR SUBDIVISION REMAINDER AND
PORTIONS 2/4 AND 3/4 RAYTON,
BLOEMFONTEIN DISTRICT, FREE STATE,
SOUTH AFRICA**

**REPORT FOR BOPA LESEDI MANAGEMENT
CONSULTANTS**

19 July 2007

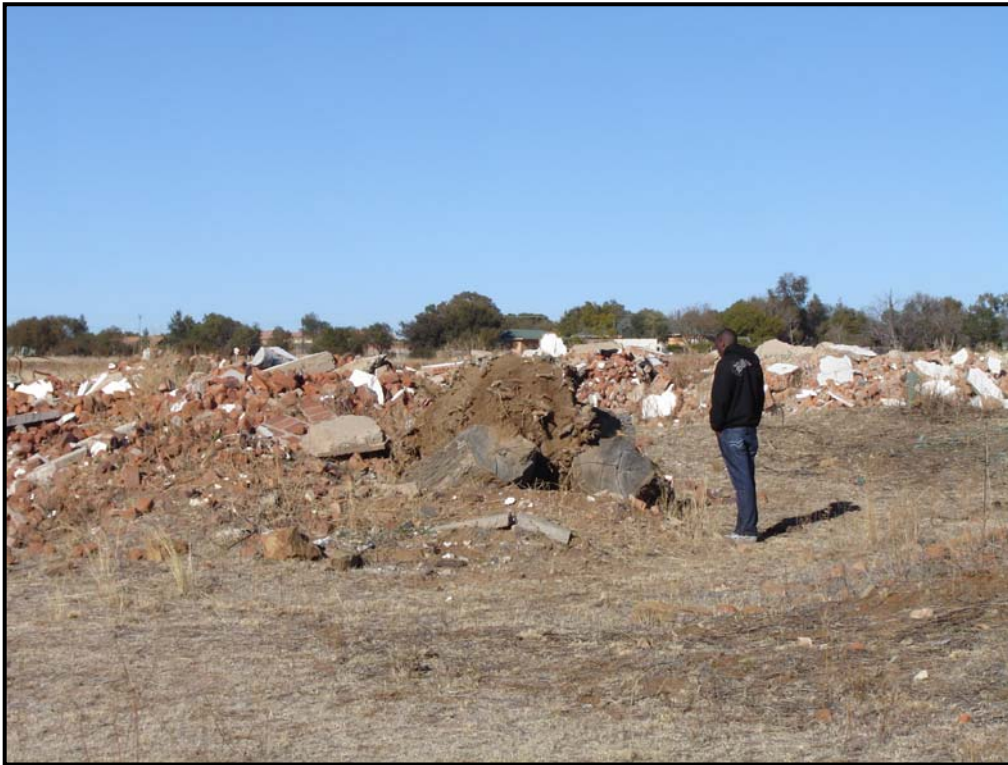
Visibility of the surface of the ground was reasonable for most of the surveyed area, apart from an area along the western section of the property, which had been used for dumping earth and building rubble.

Photo 3: View of dumped building material

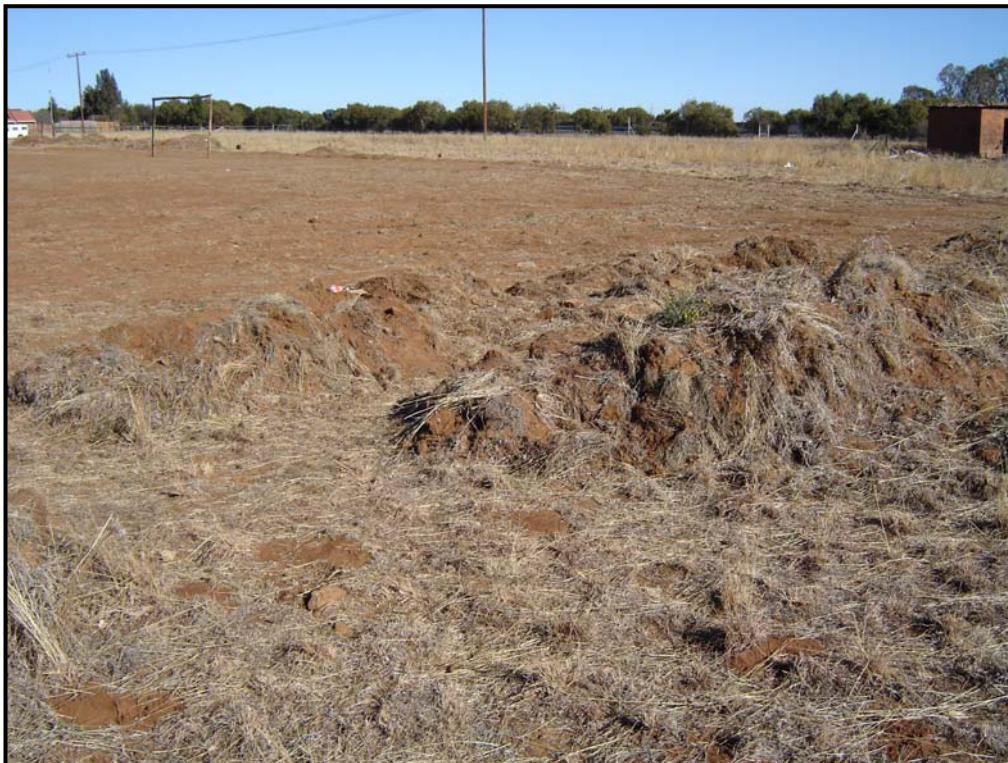
Disturbance of the surface of the property had occurred in several places. The most evident disturbance was the soccer field, which had been scraped, in the middle of the property (see map). The soccer field is apparently in regular use. It was constructed within the last year (information from local people consulted varied) with the use of a bulldozer.

Photo 4: View of scraped soccer field, looking west

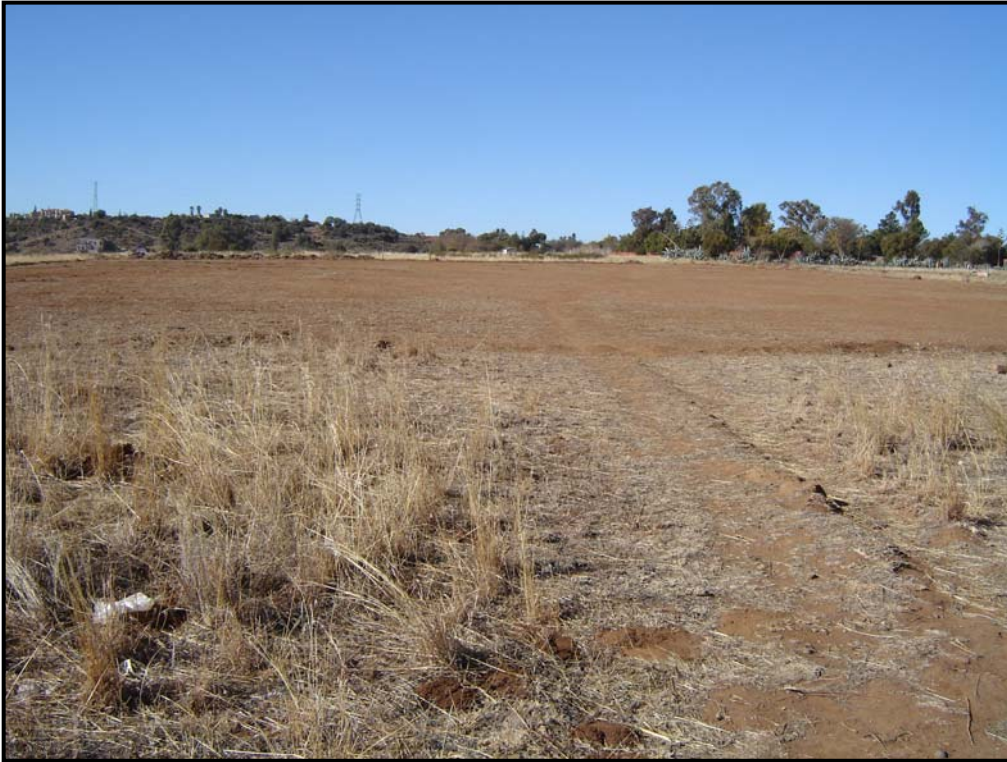
Photo 5: View of soccer field, looking south

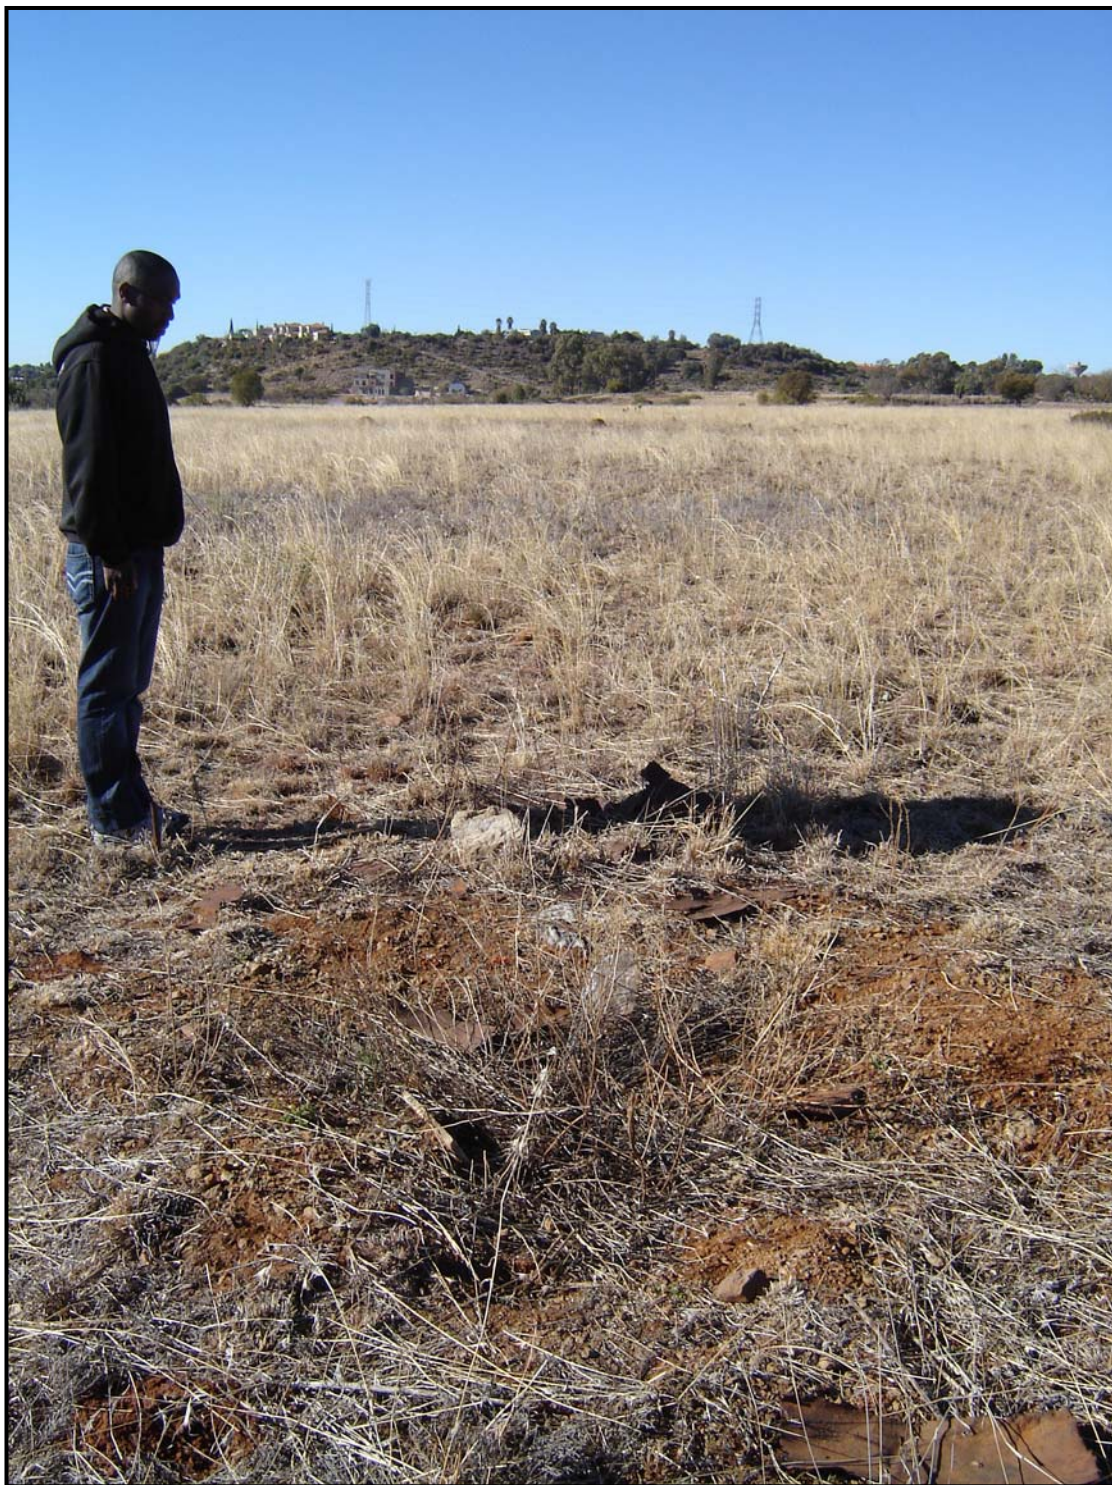
Photo 9: Hollow one

However, five hollows were observed clustered together (see map). These hollows are now filled with rubbish, and vary in depth. Three of the hollows have an associated iron pole or fence post. Almost all of them have associated broken asbestos roof sheeting or corrugated iron. The rubbish is all relatively recent. The hollows were probably associated with farm worker houses in the area. One of the hollows may have been an outside toilet. The hollows relate to human activity in the area during the recent past (less than 60 years), and are of no heritage significance.

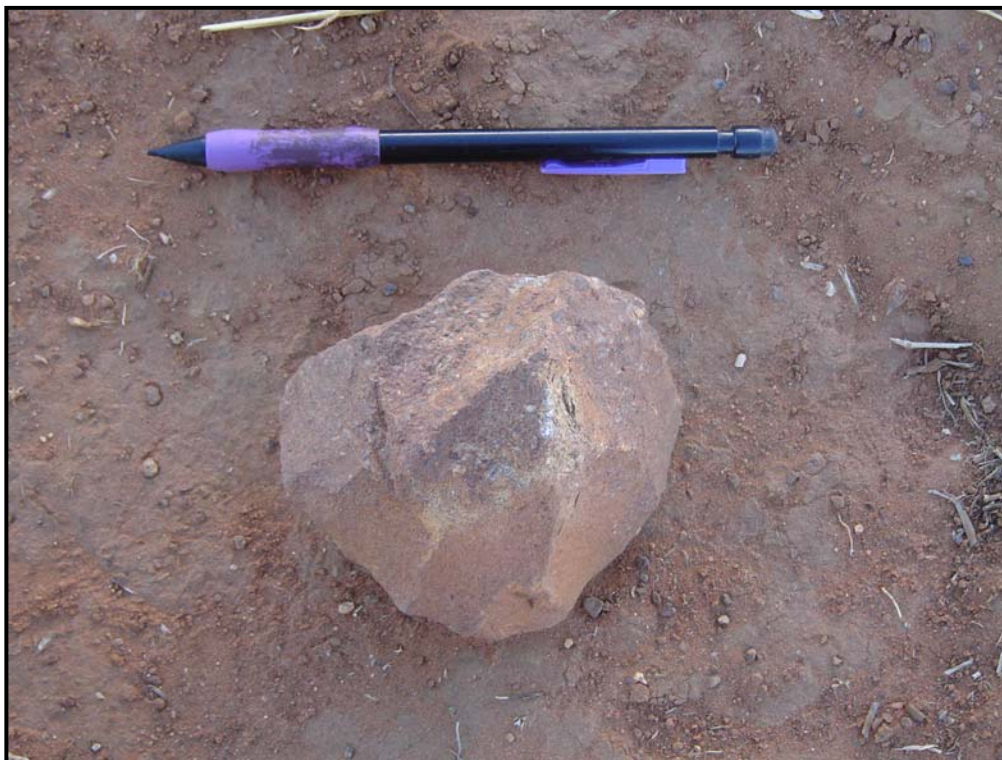
Three stone artefacts were found on the surface, all out of context. One was an irregular core found near to the entrance to the property, and two were flakes, one on the northern side, and one against the western fence of the property. All artefacts were of the same raw material. The core was probably of Middle Stone Age origin.

The significance of the artefacts described above is low, as the artefacts are not in situ, and are not diagnostic.

Photo 14: Stone tool - Core

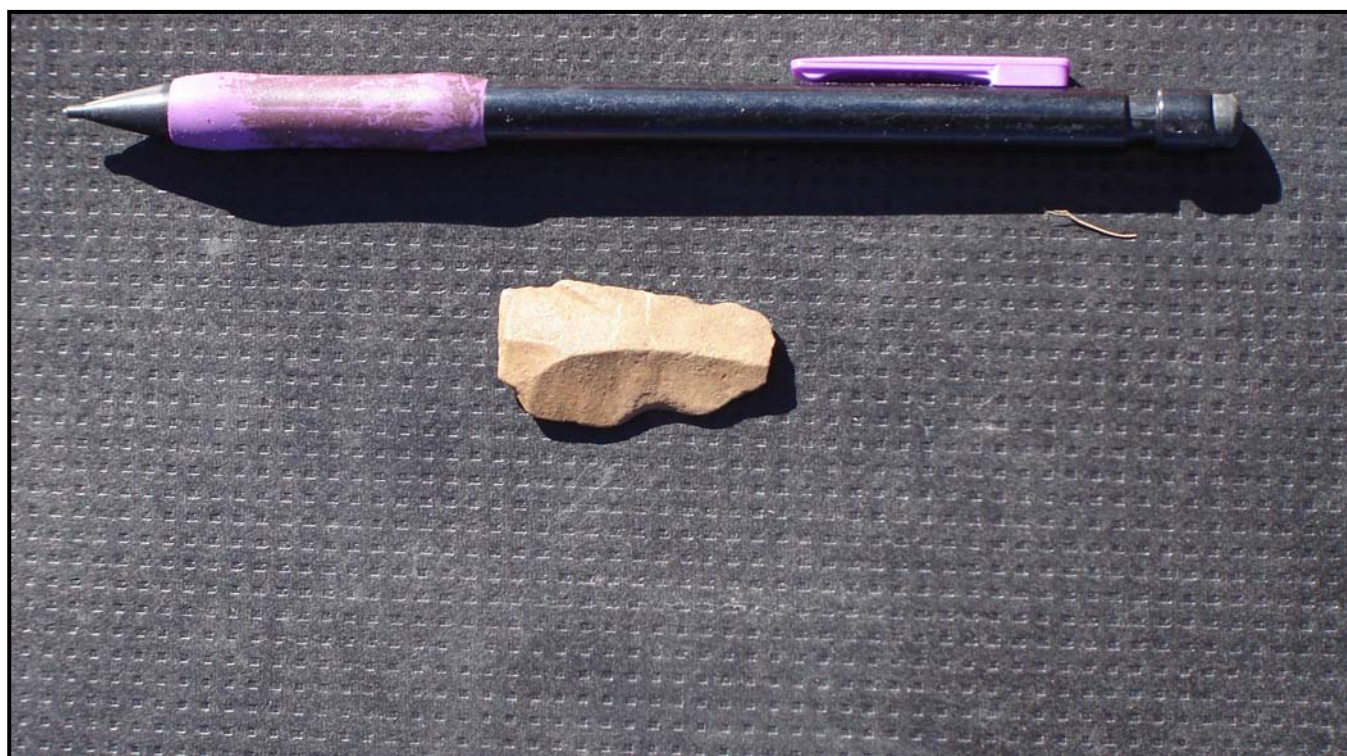
Photo 15: Stone tool, flake

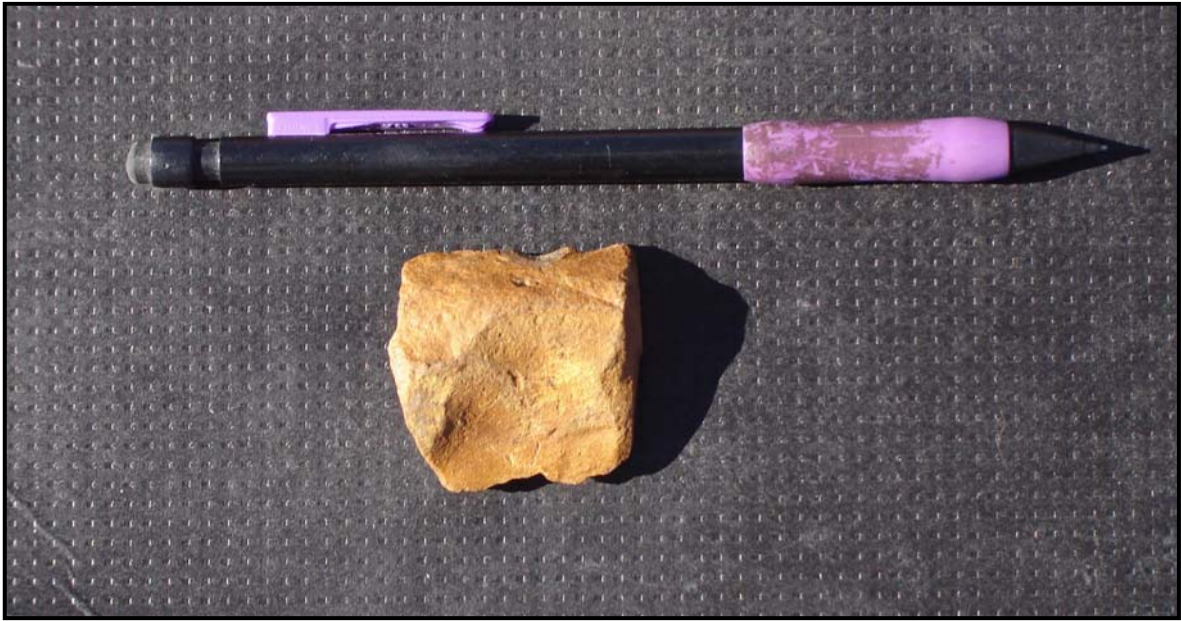
Photo 16: Stone tool, flake
