ARCHAEOLOGICAL IMPACT ASSESSMENT FOR THE CONSTRUCTION OF A DAM ON THE VERLORENVLEI FARM (“VERLORENVALLEY” 344) NEAR TOUWSRIVIER

February 2006

Jayson Orton

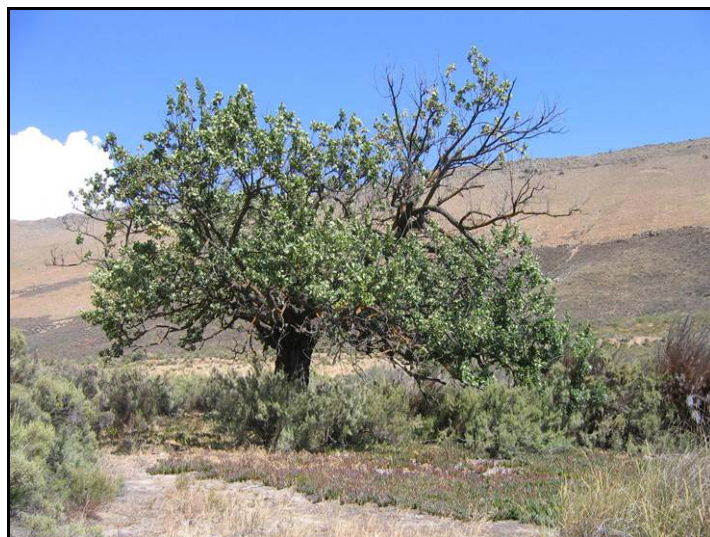
This find is indicated by point number 1 in Plate 3. Midway along the length of the flood area, on the northern side of the floodplain there is an old oak tree (Plate 4). Such trees usually indicate the position of some form of human settlement and this example appears to do just that. Some 20 meters south of the tree we found a stone alignment in sandy soil (Plate 5) that is almost certainly the remains of an old structure that was once located there. The stones are mostly undressed, although one showed evidence of having been shaped artificially (lower right rock in Plate 5b). Similar stones are plentiful on the hillside immediately to the south and the builders undoubtedly collected their materials locally. The total length of wall visible is about 9 meters (running north-south) and its width is 900 mm. There may be a corner at the southern end of the alignment but it is not possible to say this with confidence. Despite much searching, no artefacts could be found in the vicinity of the stone alignment.

Plate 4: The old oak tree found on the southern side of the floodplain.

It should be borne in mind, however, that with the existence of some form of settlement near the oak tree, there is a chance that one or more graves might be present nearby. While our search did not reveal any, it is possible that the bushy thickets in the vicinity could have obscured something. This is especially important in the light of the fact that the farmer would like to remove the topsoil from the flood area. During removal of the topsoil in the dam basin, a site supervisor should be instructed to watch for any human bones and should any be encountered, the find should immediately be reported to an archaeologist or to the South African Heritage Resources Agency (SAHRA). Mrs Mary Leslie or Ms Collette Scheermeyer of SAHRA can be contacted on (021) 462 4502 in this regard.

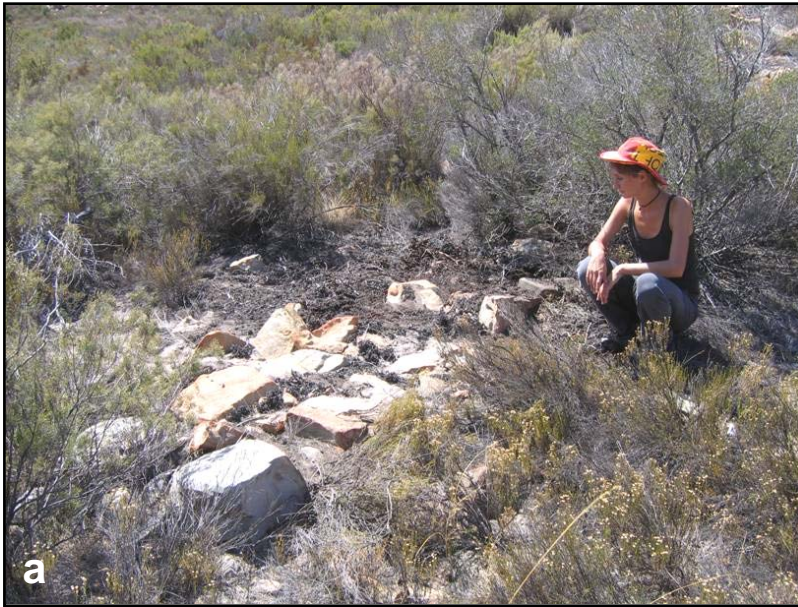
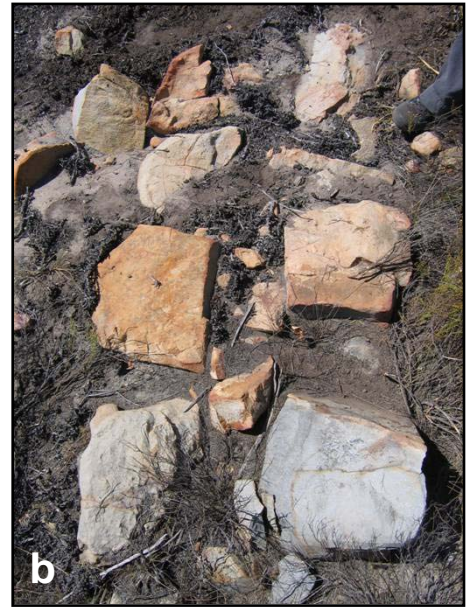
Plate 5: The stone alignment found in the bushes near the oak tree.

The oak tree and stone alignment are the only finds worthy of further consideration. Flooding of the proposed area and removal of the topsoil will result in the destruction of these items but given their context they are not seen as being very significant.

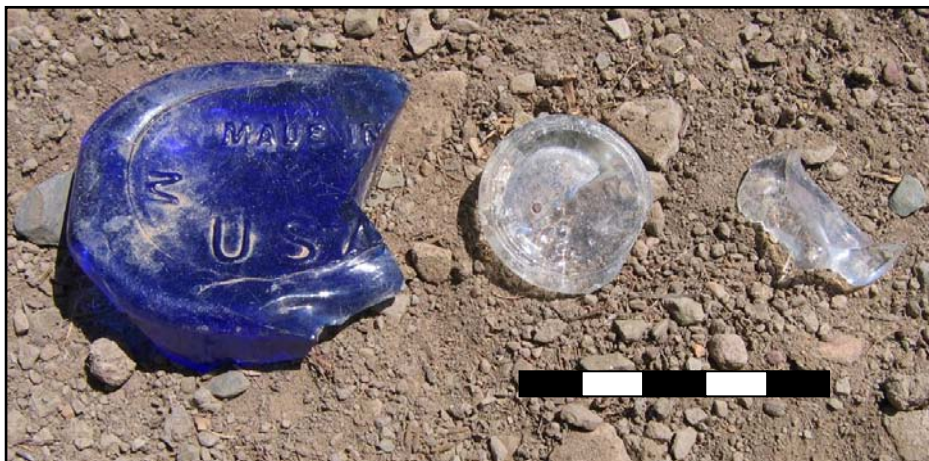
This find is indicated by point number 2 in Plate 3. Here, well above the floodplain, we found at least two sets of stones that appear to be artificially collected. It was not possible to say with confidence that there had been any structure built there but examination of the immediate surroundings clearly showed that some activity had occurred there in the past. A search of the surrounding area turned up three fragments of historical glass (Plate 6) as well as a modern broken bottle. The cobalt blue bottle base is likely to have been from a milk of magnesia bottle and a second small, clear base is from a medicine bottle. The third fragment is adiagnostic. The fragments may date to the turn of the 20th century with milk of magnesia having first been produced in the USA in 1880¹.

Plate 6: The three historical glass fragments found in the flood zone.
