Author : Amanda Lead of Lead Architects

Illegal work Description :

PHOTOGRAPHS – POST FIRE / PRE-RECONSTRUCTION 30.10.2017

PHOTOGRAPHS – POST-RECONSTRUCTION April 2023

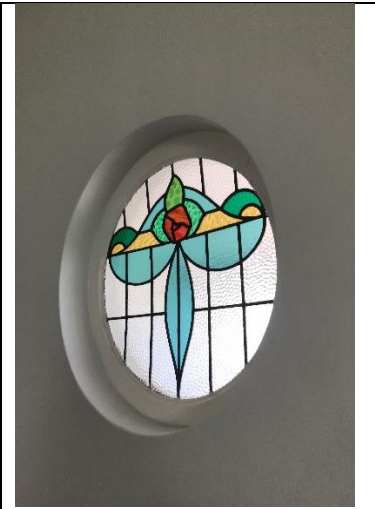
Window detail – survived !
