## APPENDIX B- Site photographs

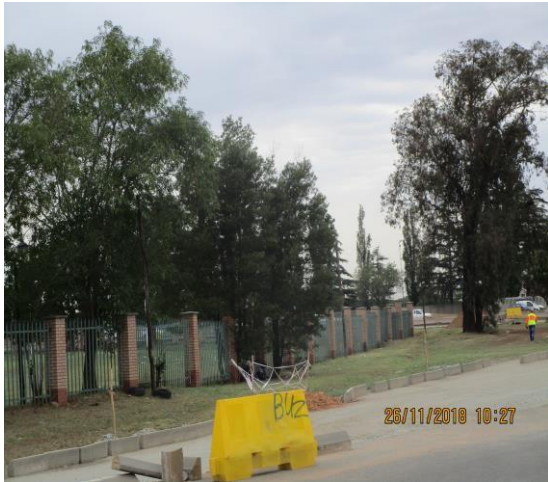
Photo1: View of the site along the Shoprite Hyper

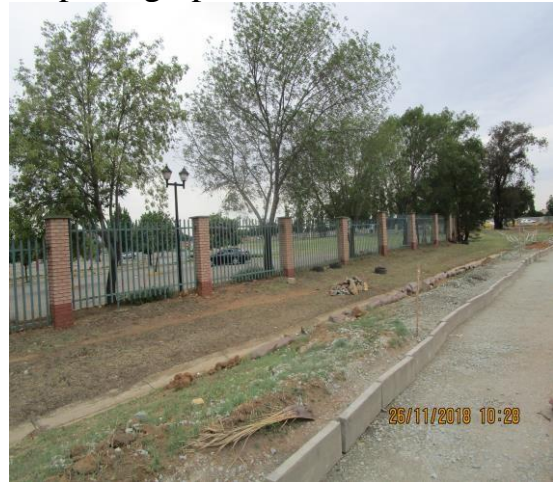
Photo 2: View of site along the Shoprite fence

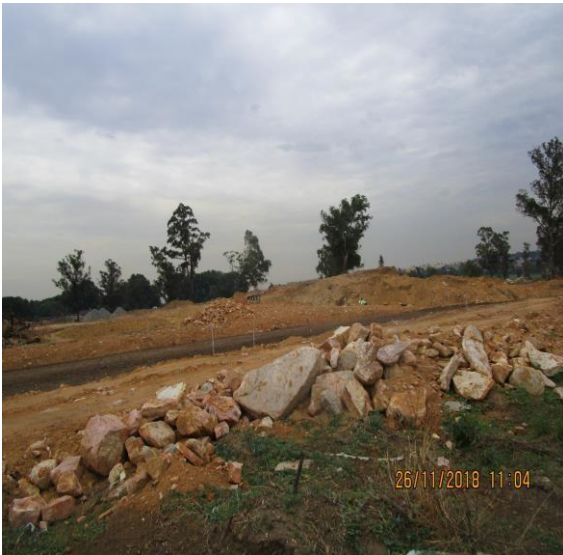
Photo 3: Existing Developments on site

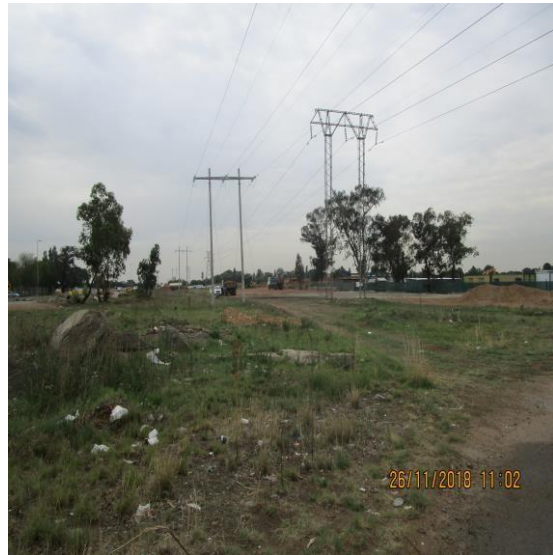
Photo 4: Existing overhead powerlines on site

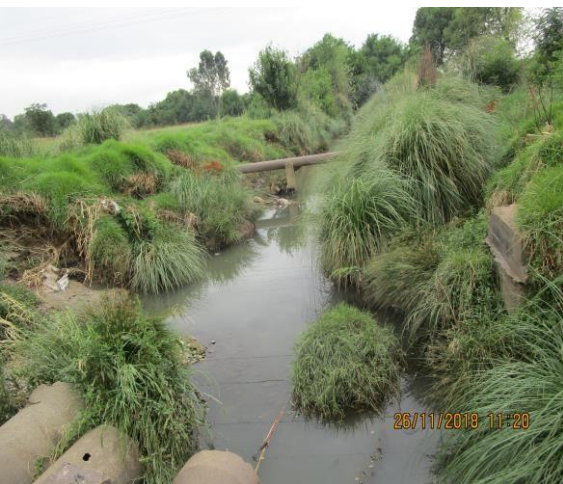
Photo 5: Existing 300mm Asbestos Pipeline

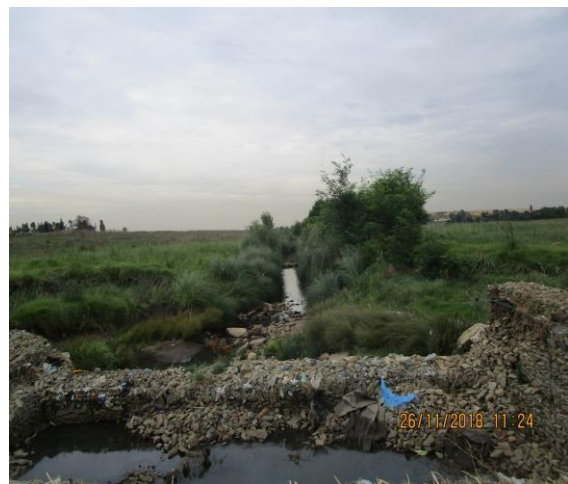
Photo 6: View of the crossing for Hyperama
