Addendum to the

1st phase H.I.A. of a proposed upgrading and extension of the proposed storm-water management project at Venetia Mine, Limpopo Province, South Africa

For De Beers Consolidated Mines (Pty) Ltd.

Project number DEB-VEN-21-02-03

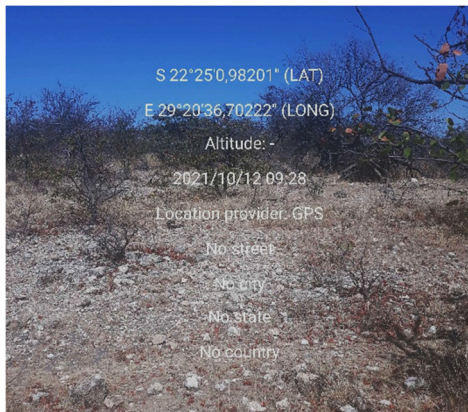
Fig. 01. The landscape in the areas of investigation consists of a calcite substructure inhibiting growth in vegetation, both trees and grass species. This substructure supports mainly two indigenous tree species of, namely *Colophospermum mopane* (Mopani tree) in the dry veld and *Lonchocarpus capassa* (Apple leaf tree) along drainage lines. On most portions of the site under investigation it is possible to do an on-foot survey owing to the scarcity of vegetation. This is then also a clear indication of the soils not being capable to support grain based societies. (Photo S.M. Miller 2021.)

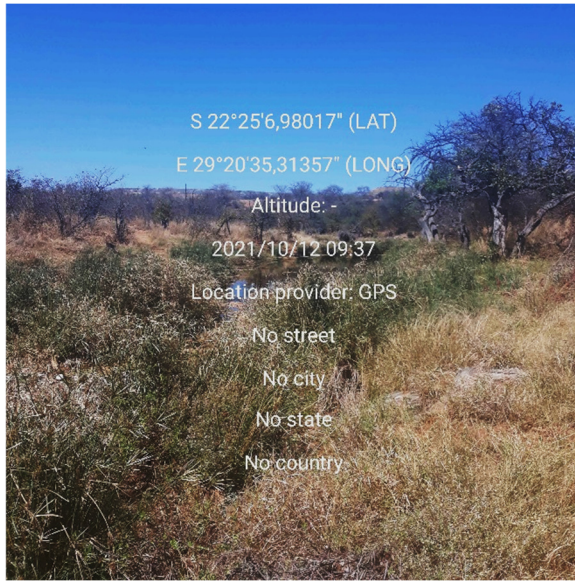
Fig. 02. Drainage lines such as the **Matotwane** in this image here on the eastern side and the **Kolope** on the western side of the mine may have had some suitable soils for limited cultivation. That is why these areas were more intensely investigated by on-foot survey. Note the stunted *Colophospermum mopane* (Mopani trees) growing right up to the drainage line, with the *Lonchocarpus capassa* (Apple leaf trees) surviving in the little soil available along its banks. . (Photo S.M. Miller 2021.)

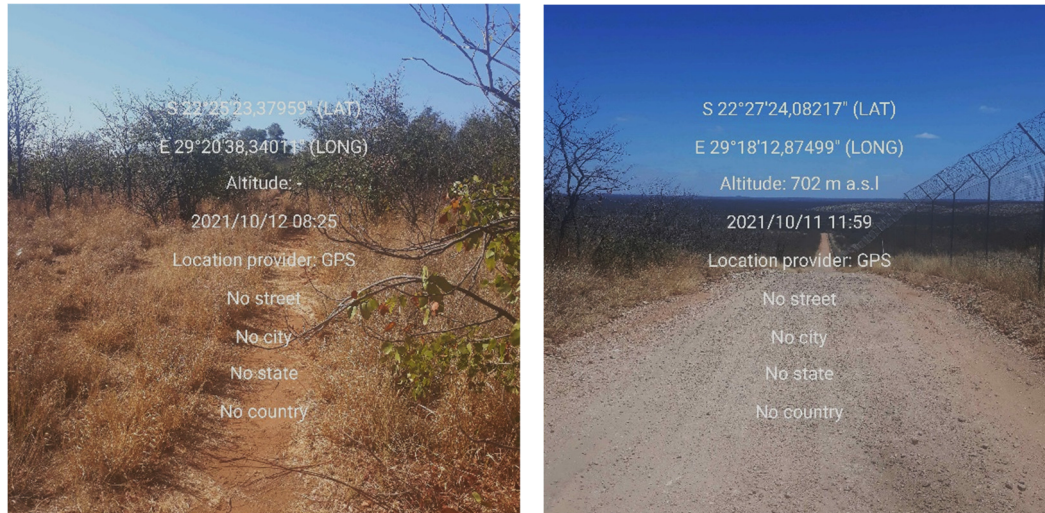
Figs. 04 and 05. Conditions that impact heritage assessment on Venetia mine. An elephant foot path in the eastern portion surveyed and the typical all-present security fencing regulating no-go zones. (Photo’s S. M. Miller 2021.)

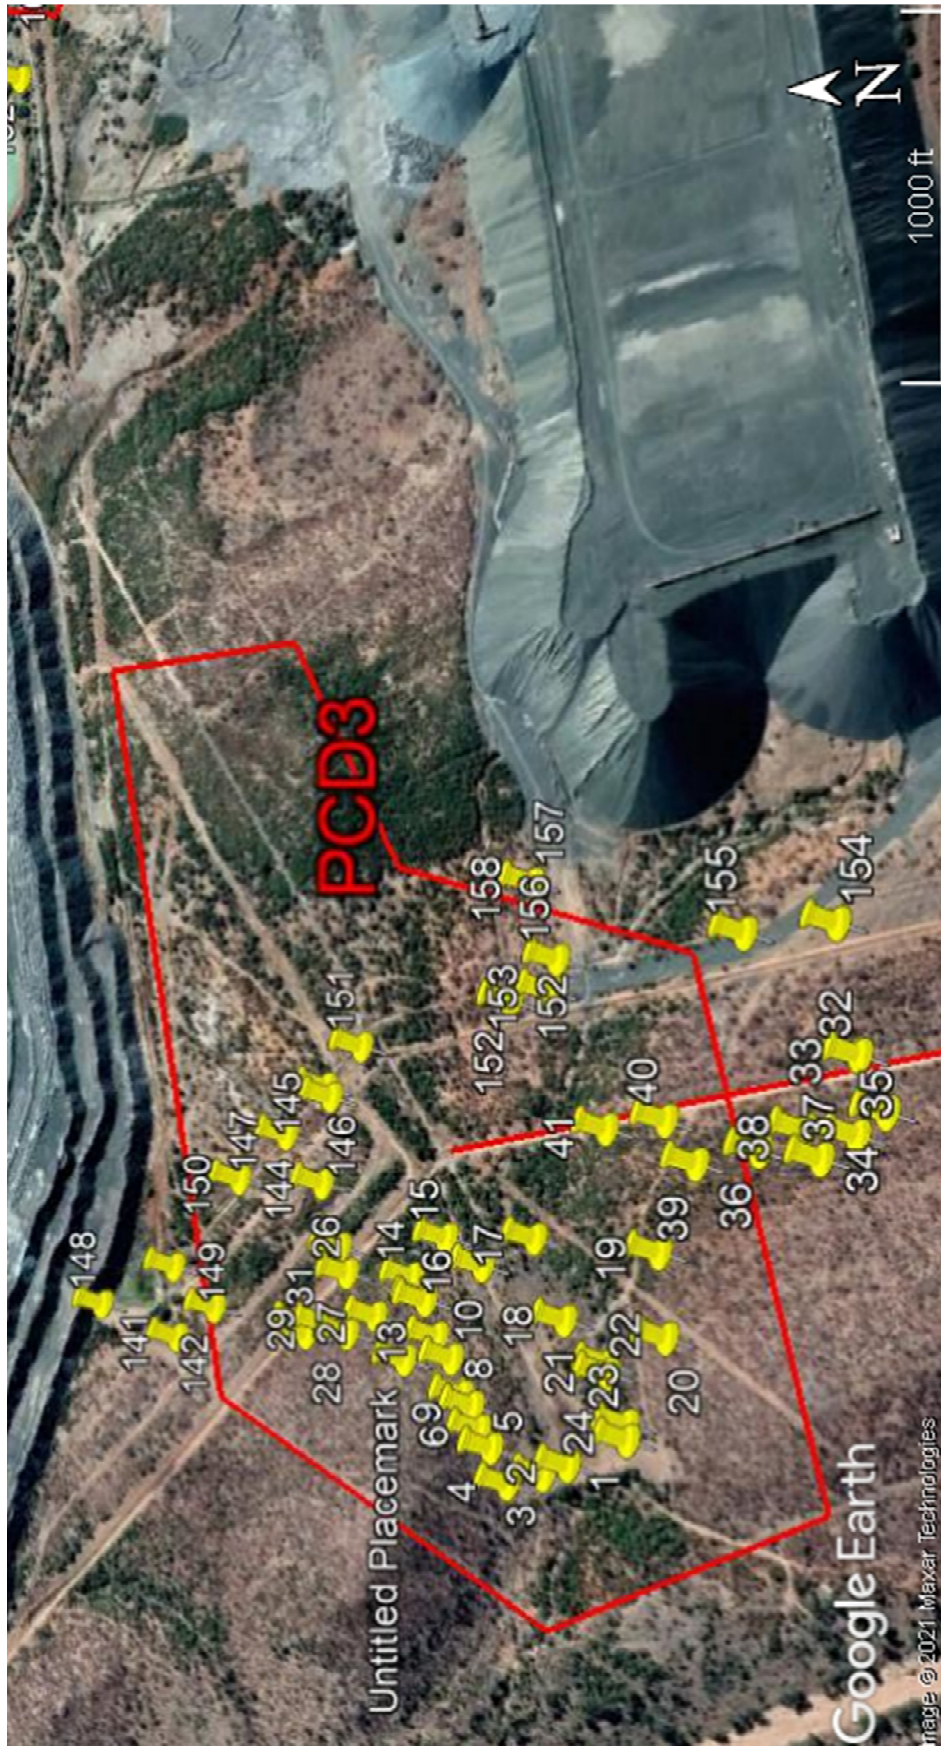
Fig. 09. All the points visited in PCD3 during the investigation. (Google Earth 2020.)

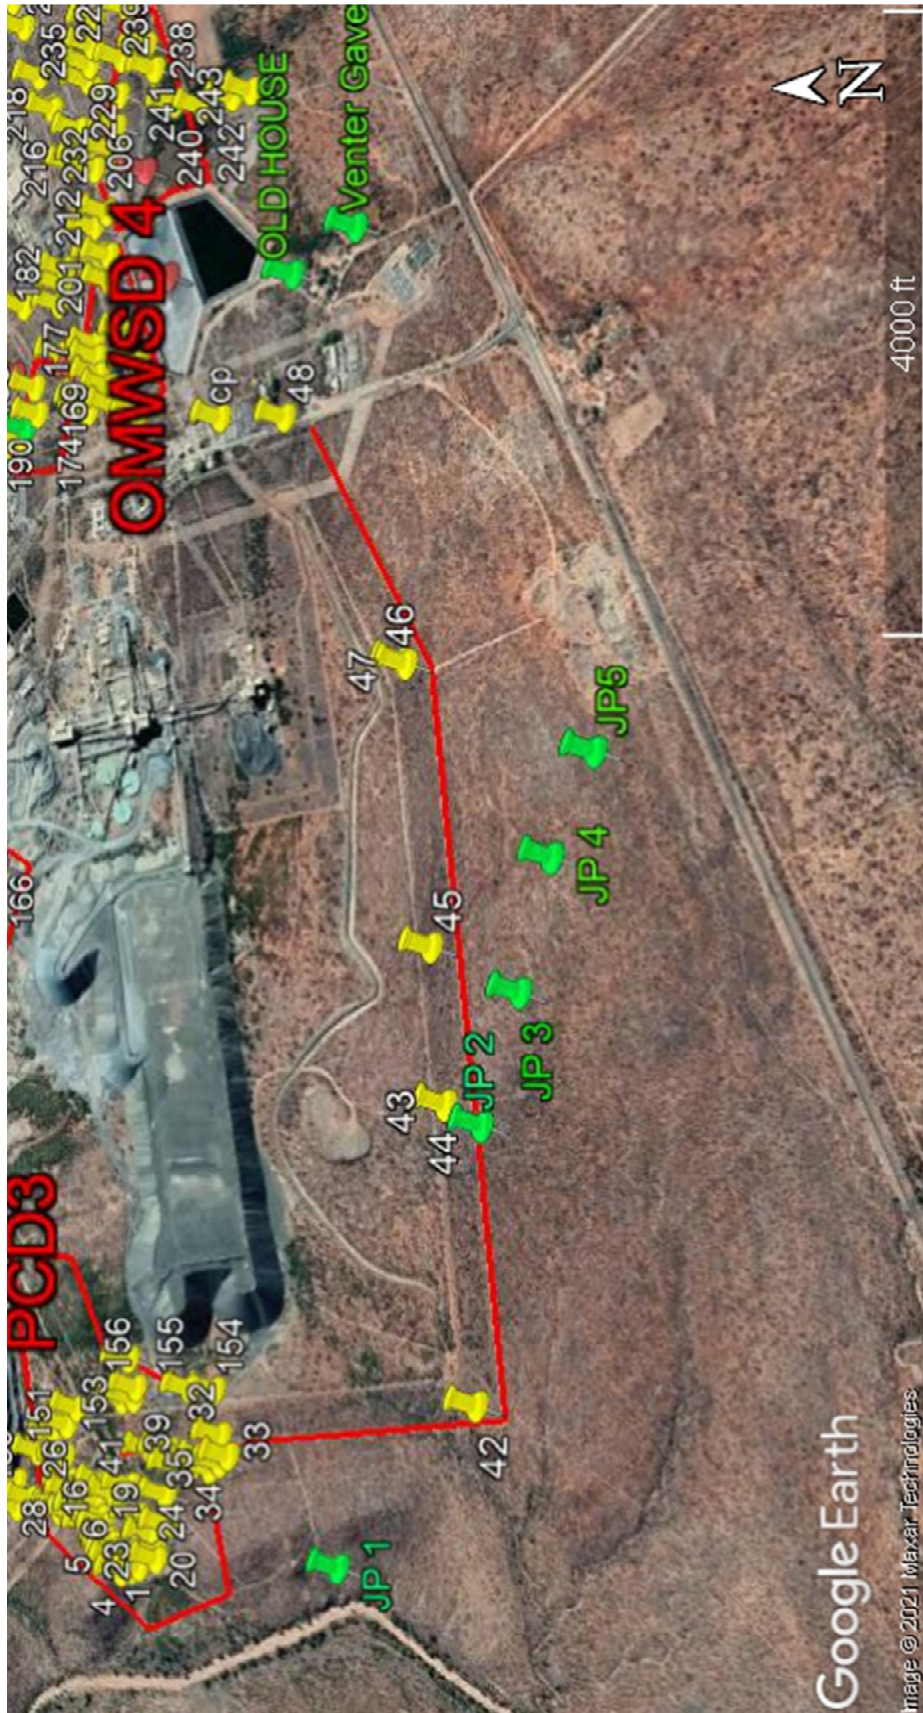
Fig. 10. All the points visited on the south road during the investigation. The green markers are approximation markers of the sites mentioned in Pistorius’s 2012 AIA. (Google Earth 2020.)

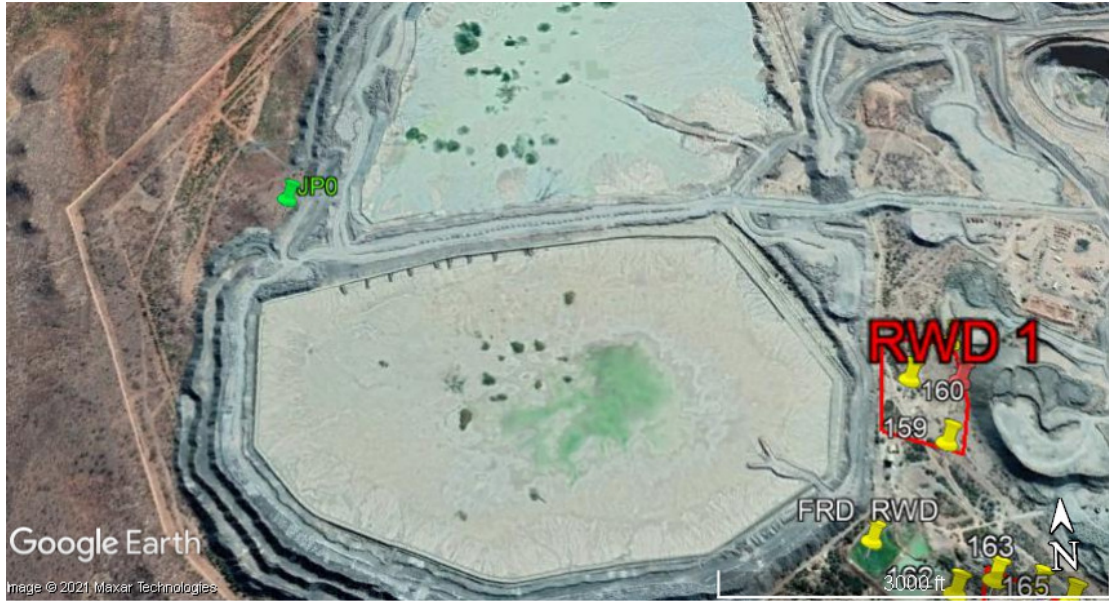
Fig. 13. The green marker is one of the points mentioned in the 2011 Pistorius AIA. (Google Earth 2020.)
