SUMMARISED HERITAGE IMPACT ASSESSMENT TABLE: PROPOSED HUDDLE PARK DEVELOPMENT

ANNEXURE 5: ALTERNATIVES, MITIGATION AND BROAD HERITAGE CONSERVATION GUIDELINES

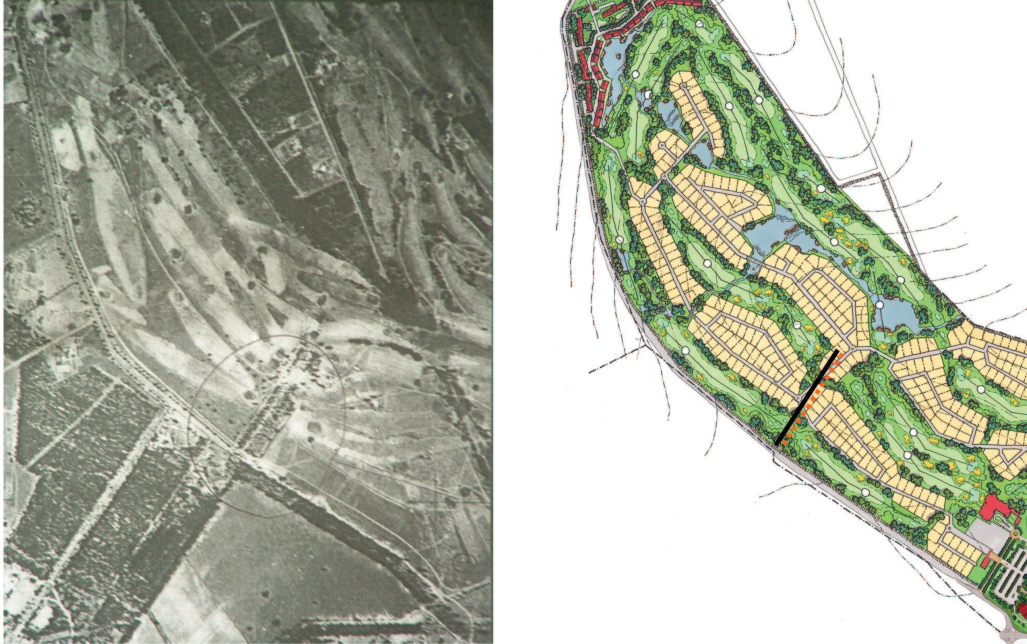
FIG D: Comparison between the 1938 aerial photo and the 2004 Master Plan (now abandoned) (Investec, 2004) – the historic treed avenue (position accentuated with black and dotted orange lines) and historic buildings are not conserved.

The comparison (See Fig. D) indicates that, while the eastern edge of the club is made partially green by means of golf links on the eastern border, the layout is otherwise devoid of any reaction to the historical cultural landscape. The historical access lane is not incorporated, and all historical structures are omitted in the design. The built form: open space ratio is dominated by built form, diminishing the memory of open green space. Positive aspects are the linear configuration of the stands along the idea of the linear pattern of the newly designed links, as well as the placement of the southern development outside of the area covered by the links. The shopping centre is positioned against the eastern boundary, presenting a large built component in an historically green, open area, without any mediation.

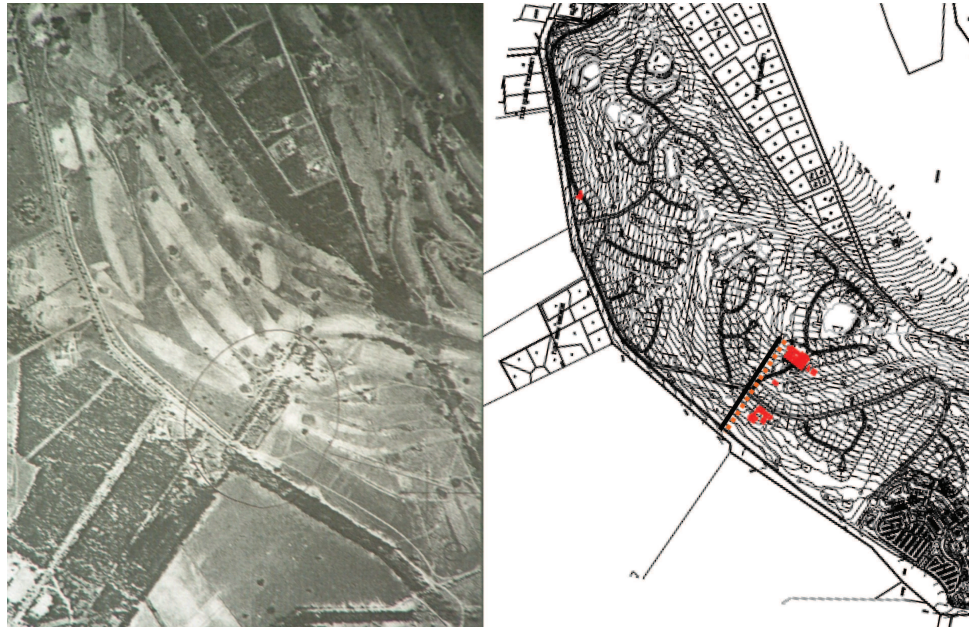
The comparison (See Fig. E) indicates that the built form: open space ratio is still dominated by built form, that the eastern edge of the club is completely built up and the lay-out is devoid of any reaction to the historical cultural landscape. The historical access lane is not incorporated, and all historical structures are not conserved. The stand organisation does not follow the historic north-south linear pattern of the historic links, and a large tract of car park is situated against the eastern boundary, presenting a large paved area in a historically green, open area.

FIG E: Comparison between the 1938 aerial photo and the 2005 Master Plan (now abandoned) (Investec, 2005) – the historic avenue (position accentuated with black and dotted orange lines) and buildings (position accentuated in red) are removed.

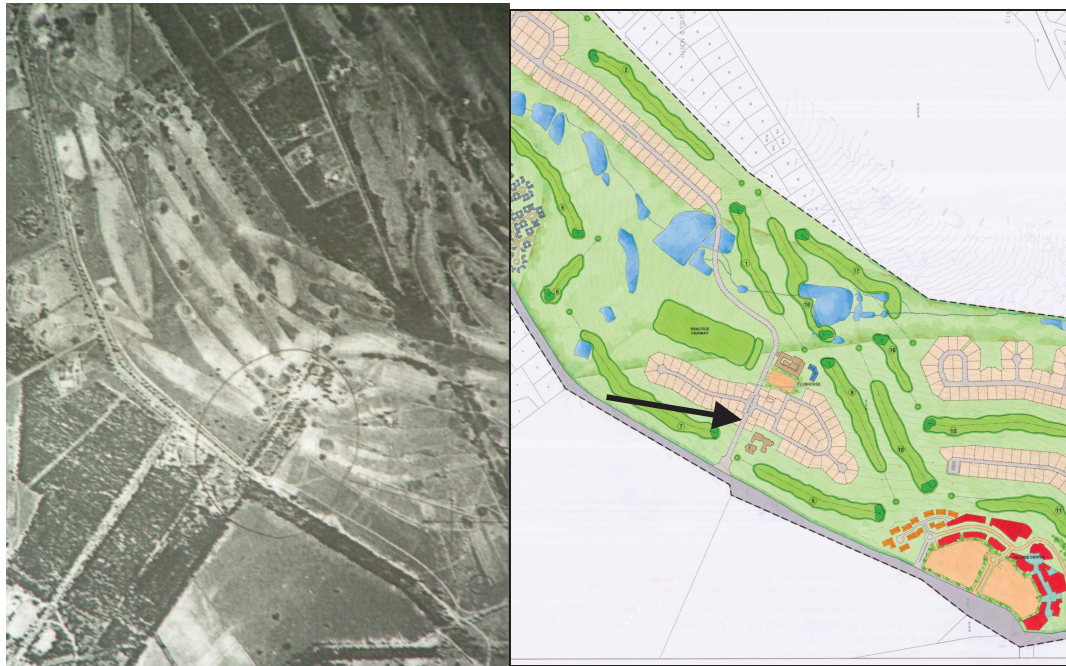
FIG F: Comparison between the 1938 aerial photo and the 2006 Master Plan currently under consideration (Investec, 2006) – the historic avenue (position indicated with arrow) is utilised and historic buildings are retained.

The comparison (See Fig. F) indicates that, due to the positive design reaction to the recently disclosed position of the historical natural landscape in the form of a wetland system, the built form: open space ratio is drastically in favour of open space. Similarly, due to a positive reaction to the Heritage scoping report, the layout is responsive to the historical cultural landscape. All historical structures that were indicated by Cultmatrix cc. as culturally significant are retained, and the historical treed access avenue and the large trees between the historical links are incorporated. It is positive

1.2.1 In order to achieve a relevant retention of cultural significance through conservation of significant site elements with site authenticity and integrity, the following alternatives, mitigation and guidelines are proposed:

Establish a positive relationship between the historical treed avenue and the historical clubhouse as well as the caddy compound.

As far as possible, retain portions of the existing historical tree lanes and groups between the existing golf links, in as far as their cultural significance and value as natural elements in the new development have been determined in more detail by the relevant consultant teams (Note: Although currently a contentious issue in our country, there are a few important precedents of the retention of indigenous species in historical cultural landscapes).

- Mitigate the intrusion of large built-up areas, namely the duplex development on the southern side of the eastern border, and the shopping centre on the northern side of the eastern border, with strong or thick green borders that will minimise their visibility from the road. This mitigation will also increase the experience of being in a green, tranquil environment for the inhabitants, shoppers and visitors once they are in the development parcels.

- Mitigate the negative intrusion of large parking surfaces at the shopping development by minimising the on-grade open vehicle parking, organising the smaller open parking areas in smaller parcels to minimise the scale and in order for green connections to Club Road to be established. These smaller parking parcels must ideally be less orthogonal, and be greened with trees.

- Establish a green strip on the western edge of the shopping development that is open to the public, that while commercial activity does edge it, is similarly suitable for free enjoyment of a public green space in various forms, and that allows for views over the new golf links and the existing landscape towards the west.

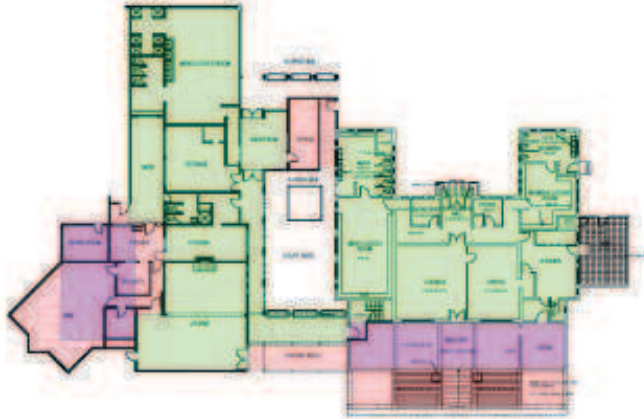
- The formal juxtaposition of the aesthetic of the 1940 clubhouse and that of the 1960 additions do not result in a meaningful architectural dialogue and presents the visitor with unresolved and negative architectural connections.

- The 1960 raised hall of the clubhouse affects the roof design and verandah space of the 1940 clubhouse negatively – the current veranda design is not resolved adequately and lacks proper detailing, and the large expanse of windows on the western aspect of the upper hall detracts from its functional efficiency. The diagonally placed double volume corner of the clubhouse bar presents large windows to the western aspect – the top area of this space has been provided with a ceiling to prevent the resultant excessive heat gain. The junction between the clubhouse and the 1960 entrance office is poorly executed, and negatively affects the movement towards the entrance of the 1940 clubhouse. The additions to the south or kitchen side of the 1940 clubhouse, towards the central treed avenue, diminish the quality

of the area as a whole and prevents a positive relationship with the avenue. The lean-to attached to the connecting passage just north of the main veranda detracts from the quality of connection between old and new. The ramp for the golf carts at the main veranda is poorly executed.

Fig. K: Positive and negative elements clubhouse building – position of possible demolitions, additions/alterations.

In terms of rehabilitating the existing clubhouse, the principle of allowing alterations and additions to support compatible re-use is accepted – all alterations and additions are to be according to the heritage legislation as well as currently accepted heritage theory conservation theory and practice.

From the analysis it is argued that all positive components of the existing architecture (marked green) be retained for rehabilitation, but that the developer be allowed to demolish (marked red) negative components of the architecture, including the raised hall above the old veranda, the diagonal section of the bar, the 1960 admin/entrance office connection as well as the lean-to added to the 1960 connecting passage at the north side of the veranda. It is further argued that the developer be allowed to add (marked purple) a new verandah structure better suited to the context and design of the original 1940 clubhouse, as well as a new bar on the north-west corner.

It is argued that, because it has been ascertained that the hall serves some purpose in the surrounding community (e.g. for weddings, music performances and parties), the developer must be supported in being allowed to build a new hall near the clubhouse, preferably to the south of the clubhouse along the central treed avenue. The existing screen walls and lean-to on the south side at the kitchen should ideally be removed and redesigned to facilitate either a more positive connection with the treed lane, or more positively, to allow the forming of a well screened delivery space by means of placement of another building to the south.

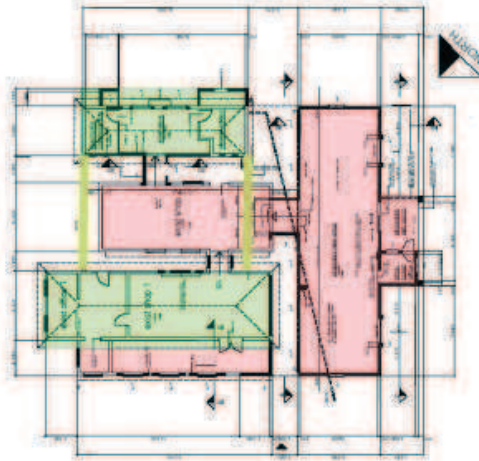
- The additions to the 1939 pro golf shop have little architectural merit, diminish the qualities of the original simple design concept and clutter the original courtyard. The closure of the outside verandas affects the original structure negatively. The lean-to addition to the west side of the pro-shop affects the courtyard between the pro golf shop and the clubhouse negatively.

Fig. L: Positive and negative elements pro golf shop building – position of possible demolitions, additions/alterations.

In terms of rehabilitating the existing pro golf shop, the principle of allowing alterations and additions to support compatible re-use is accepted – all alterations and additions are to be according to the heritage legislation as well as currently accepted heritage theory conservation theory and practice.

From the analysis it is argued that all positive components of the existing architecture (marked green) be retained for rehabilitation, but that the developer be allowed to demolish (marked red) negative components of the architecture, including the shop built in the original courtyard, the new shop to the south as well as the lean-to addition to the west. The courtyard walls should be reconstructed.

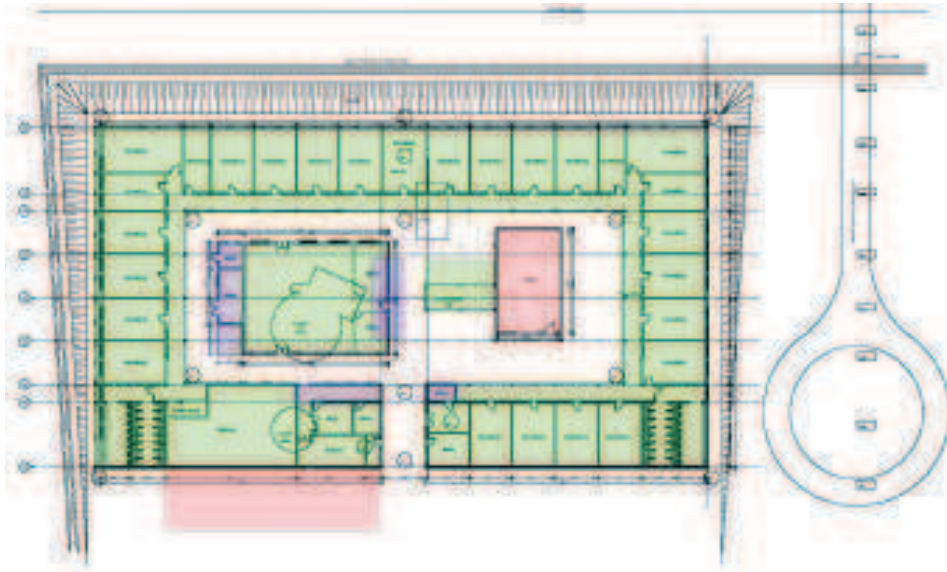
- The compound has been subject to some badly executed alterations, e.g. the closure of verandas, insensitive alterations to the hall and the addition of a badly placed and badly designed, storage building in the southern part of the courtyard behind the wash-up pavilion. Lean-to garages on the west side detract from the design and diminishes contact with the landscape to the west.

Fig. M: Positive and negative elements compound building – position of possible demolitions, additions/alterations.

In terms of rehabilitating the existing compound, the principle of allowing alterations and additions to support compatible re-use is accepted – all alterations and additions are to be according to the heritage legislation as well as currently accepted heritage theory conservation theory and practice.

From the analysis it is argued that all positive components of the existing architecture (marked green) be retained for rehabilitation, but that the developer be allowed to demolish (marked red) negative components of the architecture, including the store built in the southern part of the courtyard, as well as the lean-to garages to the west. The developer should be allowed to remove negative alterations to the south façade of the hall, as well as removing the northern small rooms attached to the hall if more courtyard space is required.
