AN ARCHAEOLOGICAL WALKTHROUGH SURVEY OF THE PROPOSED TURBINE FOOTPRINT AND INFASTRUCTURE FOR THE MSENGE EMOYENI WIND ENERGY FACILITY, BEDFORD DISTRICT, BLUE CRANE ROUTE MUNICIPALITY, EASTERN CAPE PROVINCE.

Prepared for: Savannah Environmental (Pty) Ltd

Prepared by: Dr Johan Binneman

Date: March 2014

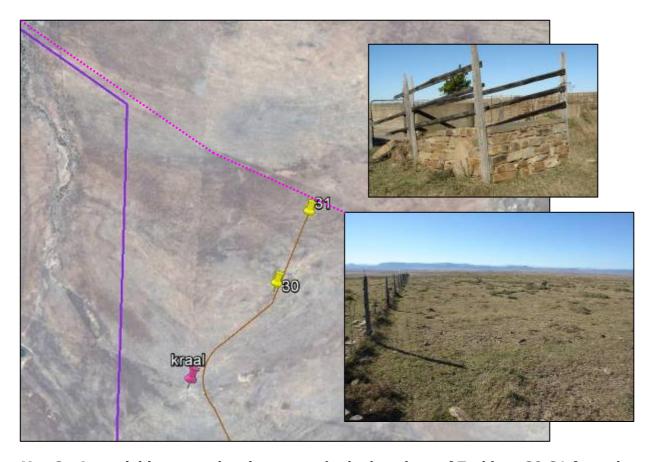
Map 3. An aerial image and a view towards the locations of Turbines 30-31 from the kraal (top insert). It is a relatively modern kraal and stone structure without historic dry packed stone walls and has little heritage value. The road/underground cables are well removed from the feature and should not have an impact. The existing power line is marked by the pink dotted line and the proposed new power line by the solid purple line.

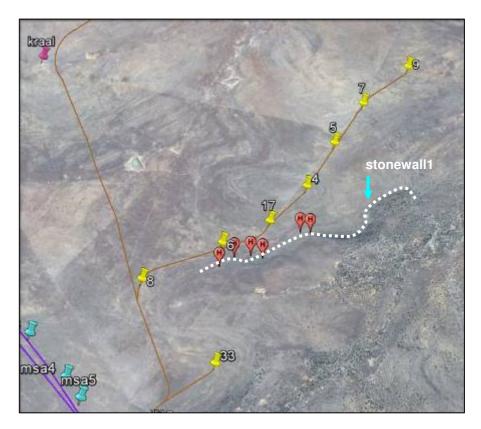
A number of dry packed stone walls, gates and a kraal were observed on the high ground. Among these structures were three stone walls of which two were extensive. Stonewall1 is some 1,2 kilometres long and near turbine positions 6 and 17 and the connecting service road (Figure 2) (Map 4). The development is about 50 metres from the wall, but care must be taken that no damage will come to the wall by fencing-off the section closest to the development. The other extensive wall structure (stonewall) is some 200 metres long and north of the service road between turbine positions 51-15 (Figure 7) (Map 9). For the most part the proposed service road is a fair distance from the wall, but at the far western end it is only 30 metres away. It is recommended that the road be constructed at least 50 metres from the wall. Furthermore precautions must be taken that the structure will not be damaged during the construction phase by fencing-off that section. The third stone wall is a short boundary marker towards the western end of the development near turbine position 26 and the service road between turbines 23 and 38 (Figure 8) (Map 10). The structure is 50 metres from the service road, but care should still be taken that the wall will not be damaged.

Map 4. An aerial image of the turbine positions 8-33 and the extensive dry packed stone wall. The development should not impact on the wall but must be protected against possible damage before construction starts.

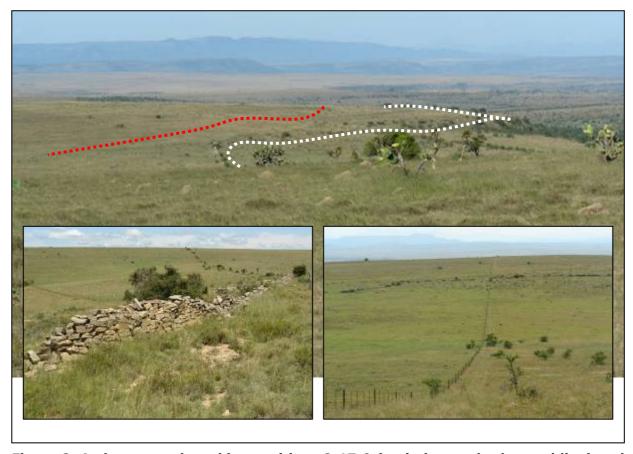
Figure 2. A view towards turbine positions 8-17-9 (main image, broken red line) and the nearby dry packed stone wall (inserts, white broken line).

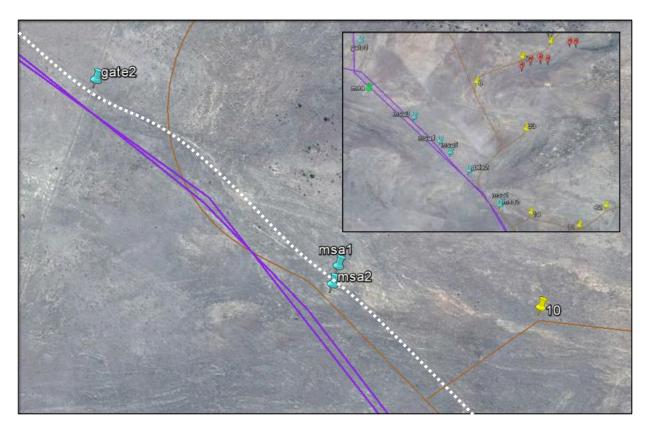
Map 5. An aerial image of gate2, msa1-2 stone tool occurrences and the turbine position 10. The possible ox wagon road is marked by the broken white line.

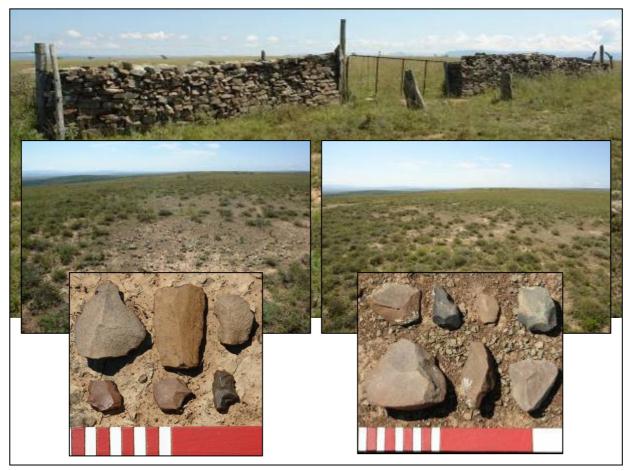
Two dry packed stone wall gates were also observed, one (gate) at the entrance to Alstonfield (Figure 5) (Map 7) and the other one (gate2) higher up the slope (Figure 3) (Map 5). No mitigation is necessary for both of the structures because they are more than 50 metres from the nearest developments, but precautions must be taken that the structures will not be damaged during the construction phase. Only one dry packed stone kraal (Figure 6) (Map 8) was observed near the service road between turbine positions 52 and 41. No mitigation is necessary for this structure because it is more than 50 metres from the service road, but precaution must also be taken that the structures will not be damaged.

Figure 3. Views of gate2 (main image), turbine positions 10,11,42 & 49 and samples of the Middle Stone Age stone tools from msa1-2 (inserts).

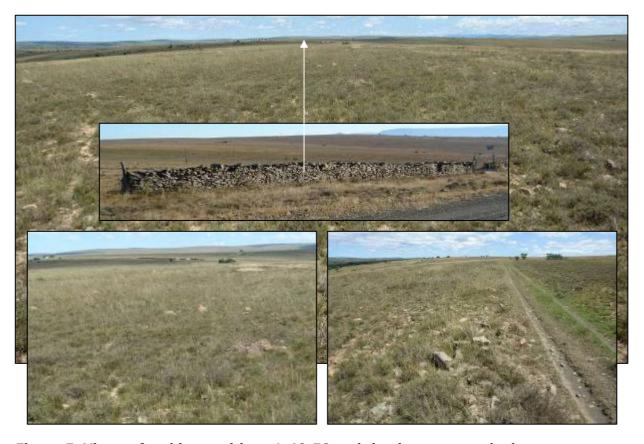
Figure 5. Views of turbine positions 1-40-50 and the dry stone packed entrance gate.

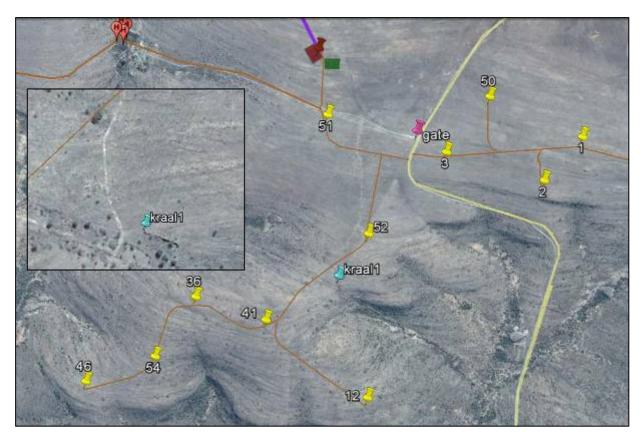
Map 8. An aerial image of the turbine positions 51-56 and the stone wall kraal1.

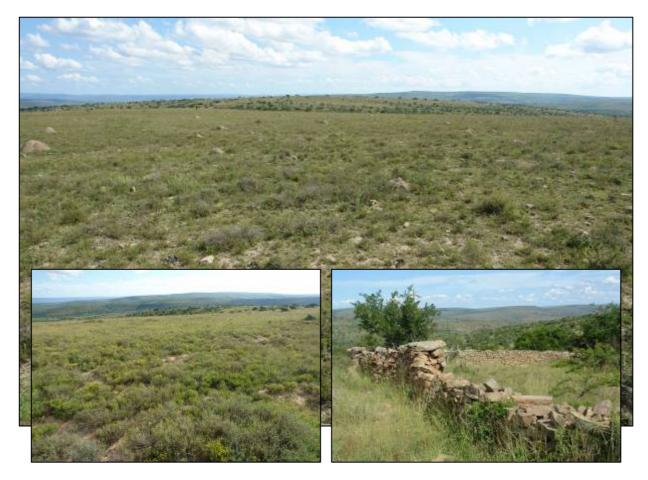
Figure 6. Views towards the turbine positions 51-56 (main image and left insert)and the stone wall kraal1 (right insert).

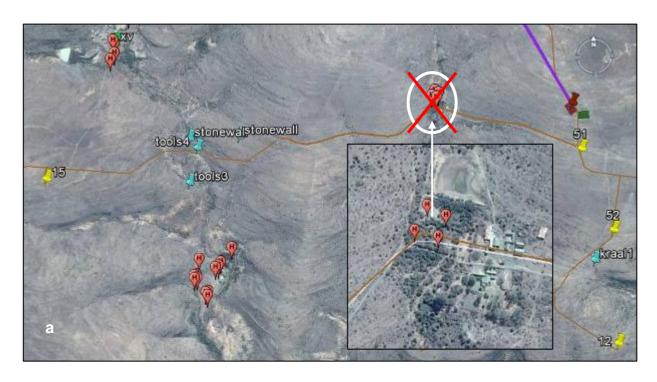
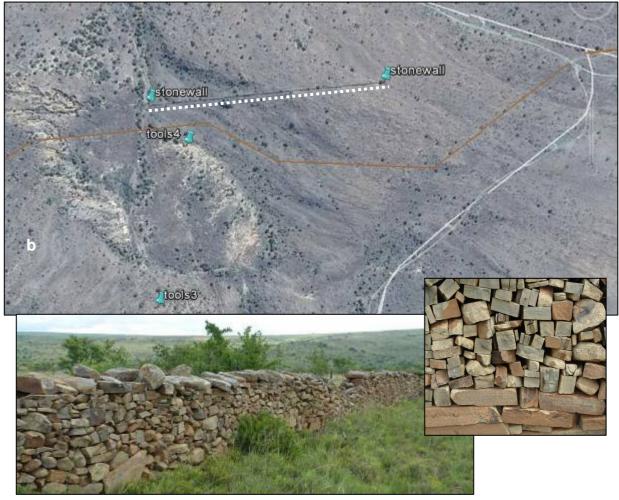
A major problem with the design/layout of the service road between turbine positions 51-15 is that it runs through a farm complex with historical features and graves (Halket *et al.* 2010) (Map 9a). All farm complexes must be no-go areas and it is recommended that the service road be re-routed to avoid damage/destruction of graves, graveyards and historical structures.

Map 9a & b. Aerial images of the service road from turbine 51 to 15 and the nearby lengthy dry packed stone wall (digital images). The white circle marks an area with graves and is a no-go area for any development.

The service road between turbine positions 51-15 (Map 9) must be moved to a distance of 50 metres from the wall at the far western end (Map 9).

The same road also runs through a farm complex with historic buildings and graves, and must be re-routed (Map 9).

It is recommended that the construction of the service road between turbine positions 51-15 be re-routed from the historic farm complex to avoid graves being damaged/destroyed.

Along the same route the road will be approximately 30 metres from a dry packed stone wall and it is recommended that the road be moved to 50 metres from the wall.

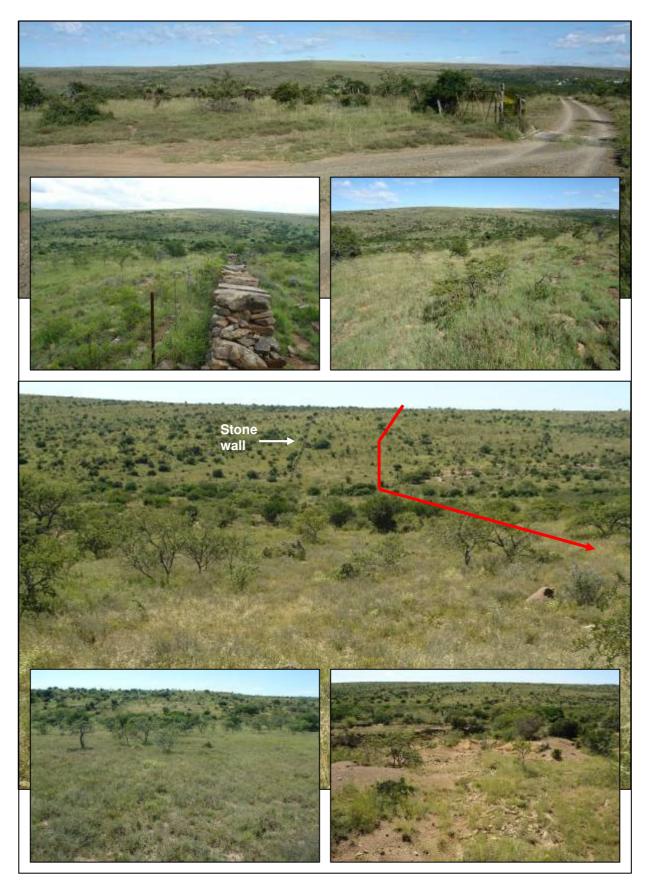
Figure 7. Views of the service road from turbine position 51 to15 - from the existing gravel farm road (top image) down the valley (top inserts), across the drainage line (bottom image) and up the other side across erosion channels (bottom inserts). The red arrow marks the approximate location of the service road.

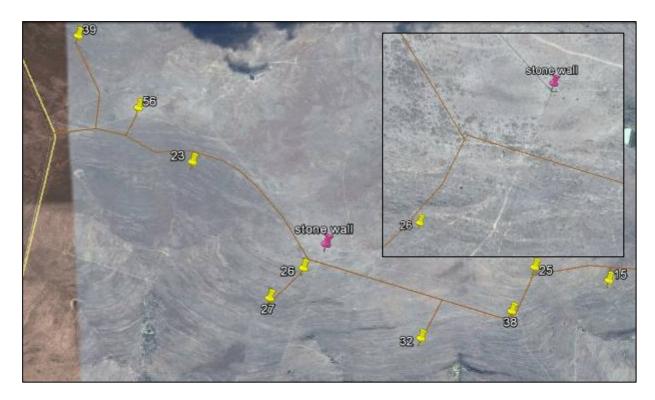
Map. 10. An aerial image of the turbine positions 15-56 and the nearby stone wall.

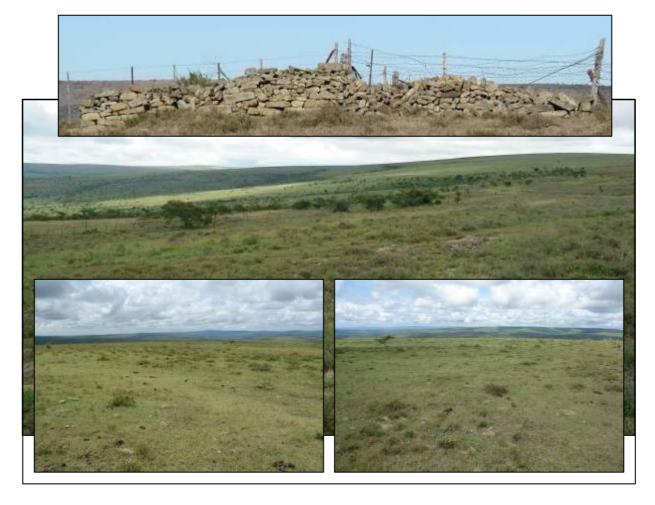
Figure 8. Views towards the turbine positions 15-56 and the nearby stone wall.

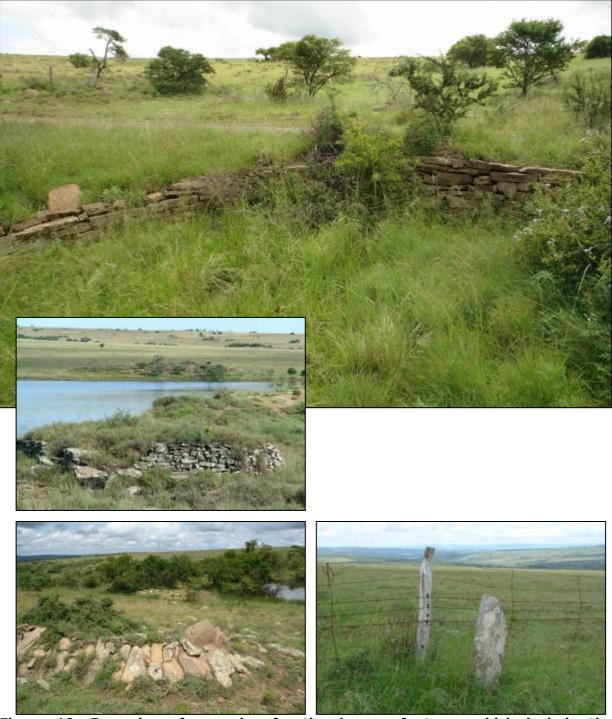
Numerous other stone features were also observed throughout the study area, such as stone fence posts, erosion prevention wall, furrows and low walls (Figure 10). Although these features have everyday functional value, they have little heritage significance.

Figure 10. Examples of everyday functional use of stone, which include the

construction of water furrows, dams, fence posts and erosion prevention walls. These features are often changed/re-built and have little heritage value. Note the dense grass throughout the region.

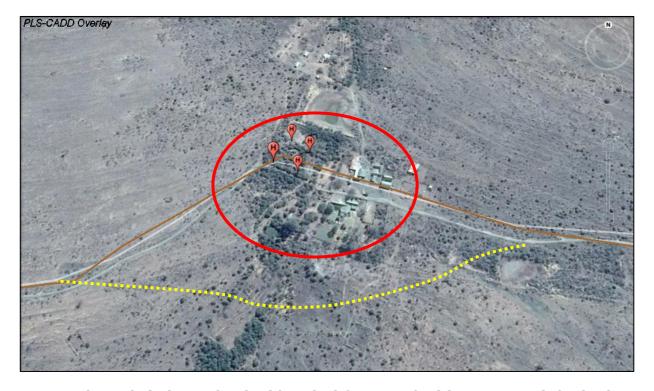
The area marked by the circle on the map below is a historical farm yard with graves (high cultural significance value) – a historical cultural landscape and any development near it must be avoided. It has been recommended by the original Heritage Impact Assessment for the proposed Amakhala Emoyeni Wind Farm Facility; *Keep infrastructure at least 500 m away from farm complexes, all of which have heritage elements* (Halkett & Webley, 2010:25, 5.2 Built environment). I have supported that recommendation in my report because the graves and farm yard represent a historical complex/unit/landscape and must be avoided by development (no go area) because all these features are protected by the Heritage Act.

Map 1. The red circle marks the historical farm yard with graves and the broken yellow line suggests a 'possible' route around this feature.

Against this background a 'possible alternative' route is suggested (see below). However, the route will cross a drainage line and therefore the final decision for the route lies with the specialists in the various fields of road construction/design, environmental assessment and ECPHRA.
