**APPLICATION FOR PERMIT: DEMOLITION
OF EXISTING HISTORIC BUILDING AT OLD
VOORSPOED DIAMOND MINE, FREE
STATE**

**ANNEXURE TO PERMIT APPLICATION
FORM
SUBMITTED TO
FREE STATE HERITAGE**

2. ASSESSMENT OF HISTORIC BUILDING FOR WHICH DEMOLITION PERMIT IS REQUIRED

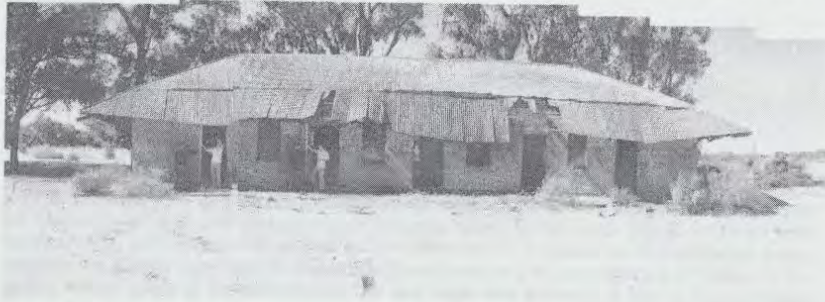
Fig 1a Composite view of west elevation (Aug 2005, Bakker).

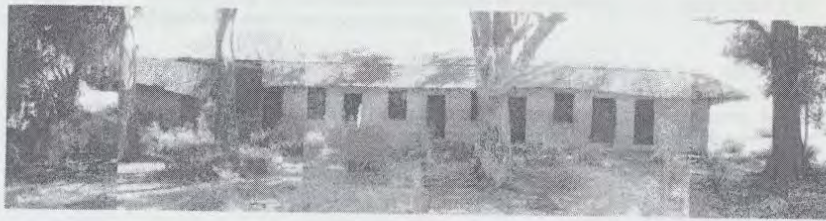
Fig 1b Composite view of east elevation (Aug 2005, Bakker).
