PROPOSED BLACK MAMBAZO MUSIC ACADEMY, LADYSMITH, KWAZULU-NATAL

Phase 1 Heritage Impact Assessment

November 2018 Updated March 2019

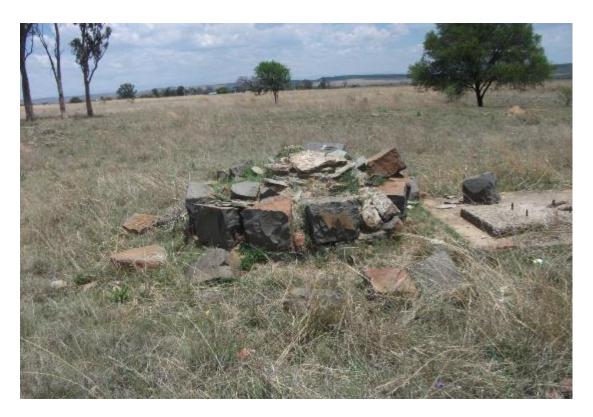
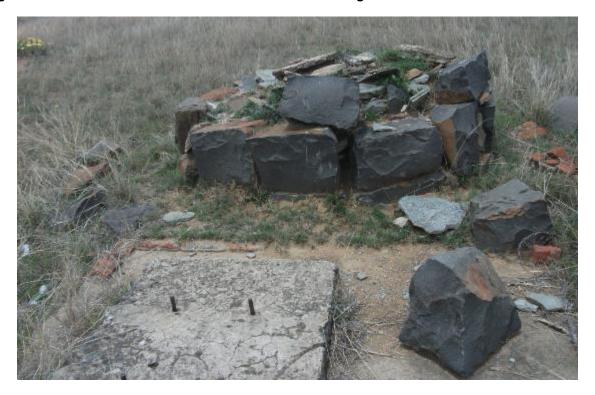
A round structure made from rough cut stone was found close to a concrete slab on which appears to be the remains of an old borehole. This structure is located at: 28°34'38.5"S 29°44'39.7"E.

In discussion with a resident who lives on the project area, Mrs Mlotshwa, told the specialist that there were graves amongst the remains of the structures mentioned above. According to her, due to the lack of stone, the graves were covered with sand/soil and flattened hence there is little evidence of the graves. She also believes that the round structure mentioned above and depicted in the figure below, is a grave.

Figure 7: Circular structure with cement structure on the right

Figure 8: Remains of circular structure

It is recommended that the area where the remains of the structures (as depicted in **Figure 5**) were found is to be secured by an 80 m buffer to avoid impacting on graves that could be amongst the ruins. No construction may take place within the buffer and the buffer should be made of a highly visible and durable material. The buffer would include the round structure (borehole or grave) and stone walling.

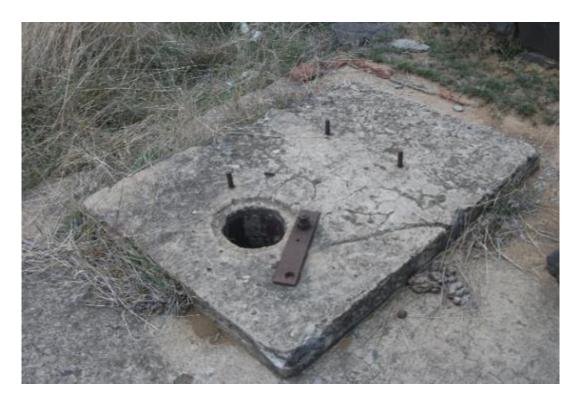
Figure 9: Concrete slab with remains of possible borehole

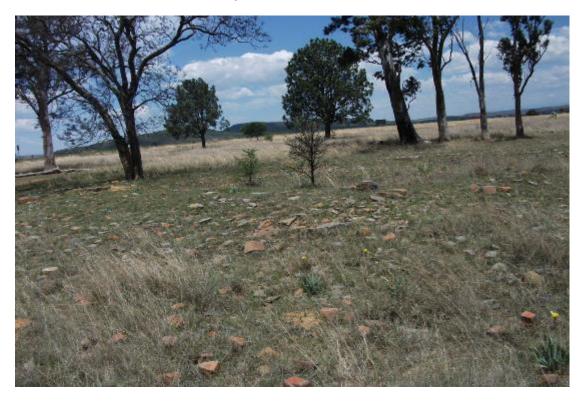
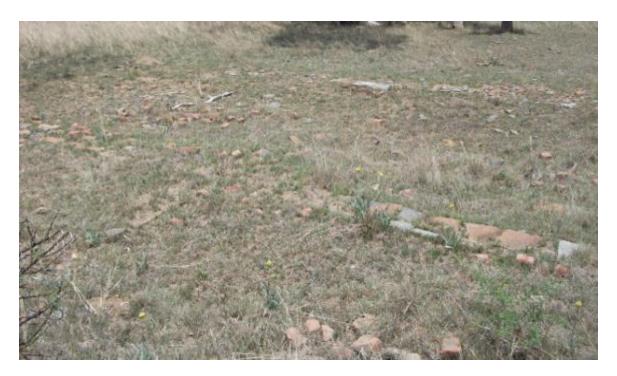
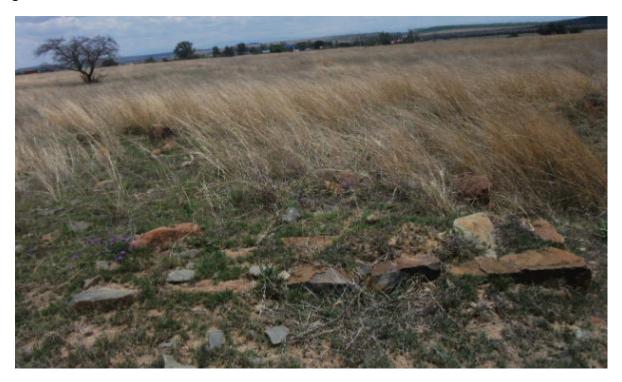
The remains of the structures mentioned above were found amongst gum trees and other exotic trees. These remains are located at 28°34'38.0"S 29°44'39.7"E, 28°34'37.41"S 29°44'39.18"E and 28°34'38.2"S 29°44'38.2"E (coordinates for centre of these remains). The area is strewn with rubble. The historical topographical map confirms that the remains of the structures are older than 60 years.

Figure 10: Scattered remains of structures

Figure 11: Remains of foundations of walls of structure

Figure 12: Remains of foundation of structure

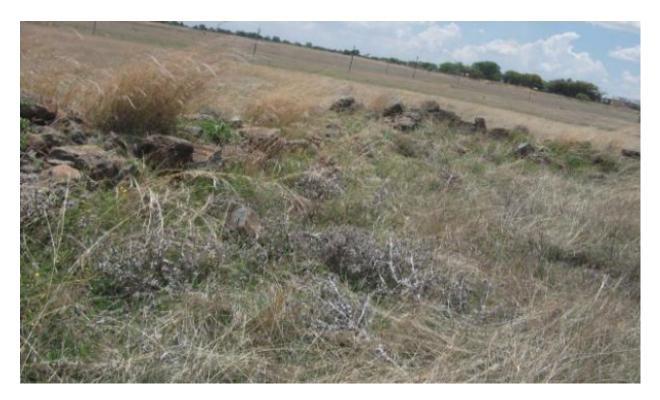
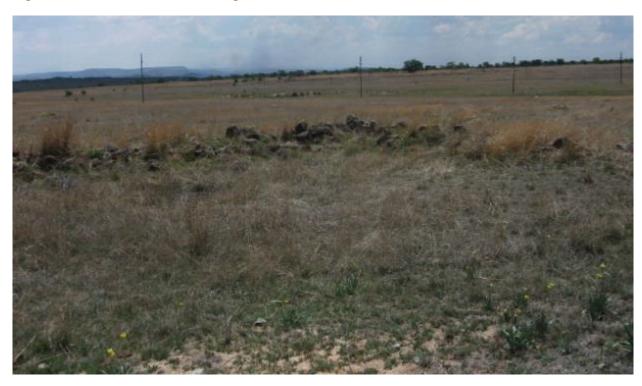
Close to the above remains, a section of rough stone walling was found which could be the remains of a cattle kraal or traditional hut (see **Figures 13** and **14** below). The coordinates of the stone walling are at: 28°34'37.9"S 29°44'38.0"E. The stone wall, which appears to be associated with the structures, appears to be over 60 years.

Figure 13: Remains of stone walling

Figure 14: Remains of stone walling

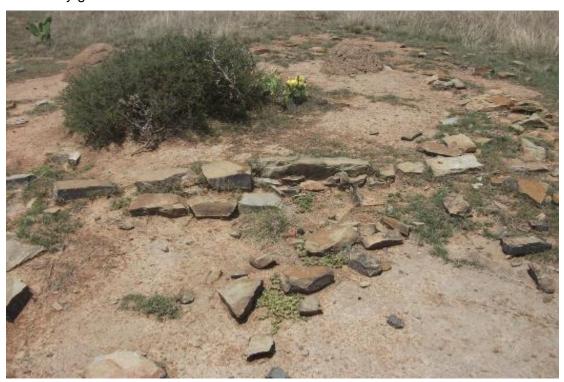
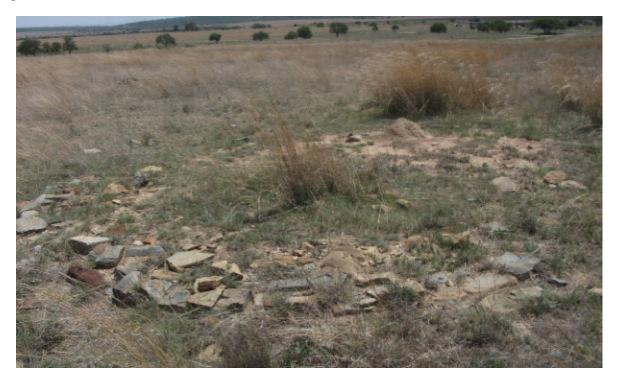
The remains of three circular structures were found at 28°34'31.9"S 29°44'18.0"E, at 28°34'32.6"S 29°44'14.4"E and at 28°34'34.3"S 29°44'15.7"E (see **Figures 15** and **16** below). An inspection of the surrounding area was undertaken, and no obvious grave sites were found. Mrs Mlotshwa did not know of any graves associated with the remains of these structures.

Figure 15: Remains of structure

Figure 16: Remains of circular structure

It is recommended that the area where the remains of three structures were found is secured by a 70 m buffer in case there are graves associated with the structures. No construction may take place within the buffer and the buffer should be made of a highly visible and durable material.

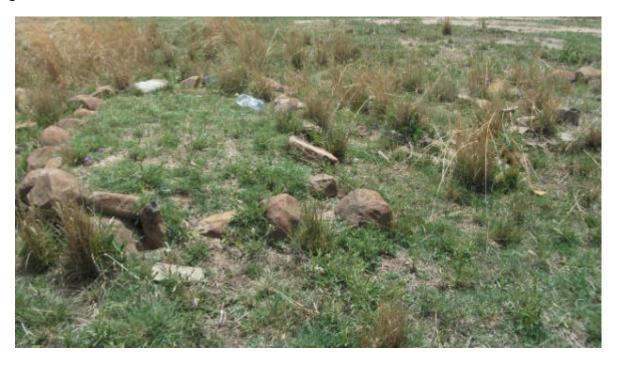
Several occupied houses and associated structures were located towards the western boundary of the project area and close to a large stream. The houses are recent structures. There are five graves situated to the west of the structures and one grave located in a cattle kraal. The five graves are delineated with rocks and are located at 28°34'29.2"S 29°44'01.2"E and the single grave is located at 28°34'29.5"S 29°44'01.2"E.

Figure 18: One of the five graves

Both grave sites situated near the occupied structures on the western boundary of the project area must be protected by a fenced buffer of 5 m to prevent any damage to them during the construction of the academy.

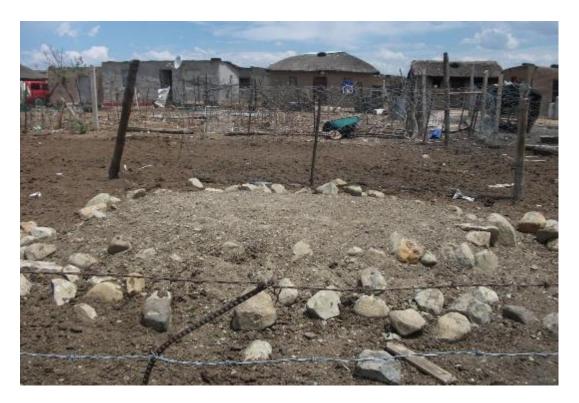
Figure 19: Single grave in cattle kraal

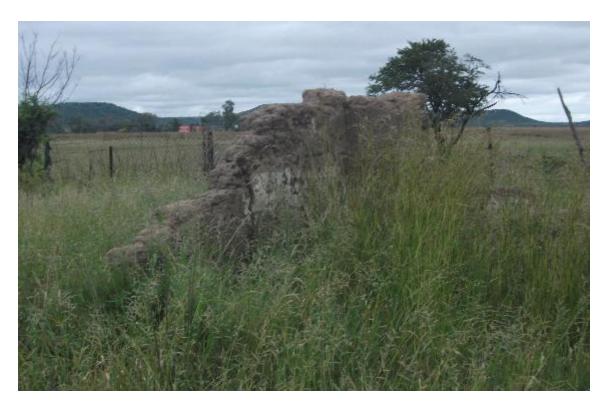
West of the stream that crosses the project site, the remains of several additional structures were found. The remains of a fenced mud structure were found at 28°34'39.52"S 29°43'55.1"E (**Figure 20** below). Only the partial remains of two adjoining walls are visible. A raised mound close to the remains was observed but the specialist could not determine if it is a grave. Outside of the fence on the western boundary of this site, the foundation stones of a circular structure were also found.

Figure 20: Remains of fenced structure

The ruins of the fenced mud structure should remain undisturbed because of the possible presence of a grave close to the remains of the structure. This also applies to the remains of the structures located to the east of the above site. It is therefore recommended that no development take place west of the river/stream that crosses the project area from north to south.

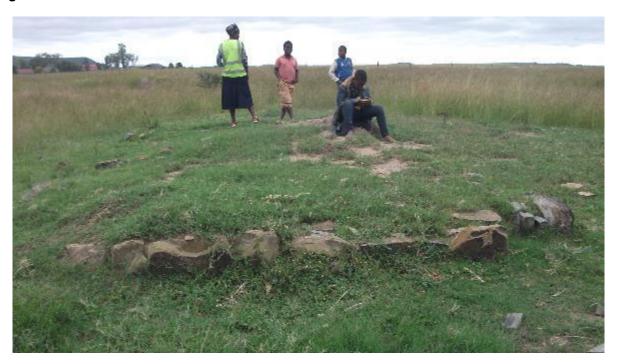
Some 260 m east of the above structure, the remains of foundations of two structures were pointed out to the specialist by the grandchildren of Mrs. Mlotshwa (see **Figure 21**). The two structures are located at 28°34'40.9"S 29°44'5.00"E and 28°34'40.40"S 29°44'5.50"E. An inspection of the surrounding area revealed no obvious grave sites.

Figure 21: Remains of structure

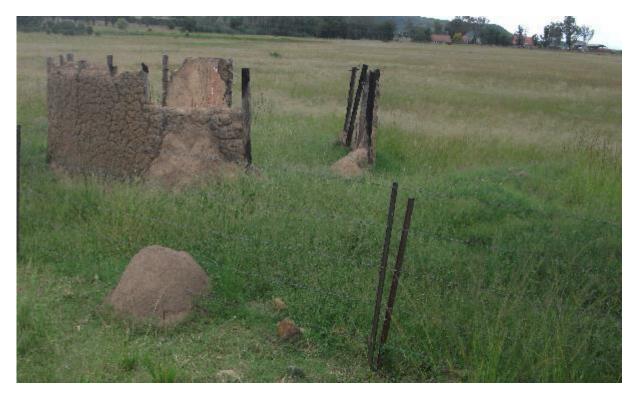
The remains of more structures were found situated just outside the project area on its southern boundary. The remains of a circular mud structure and the elevated ground of another structure were observed at 28°34'43.41"S 29°44'5.90"E (see **Figure 22** below).

Figure 22: Remains of circular mud structure just outside project boundary

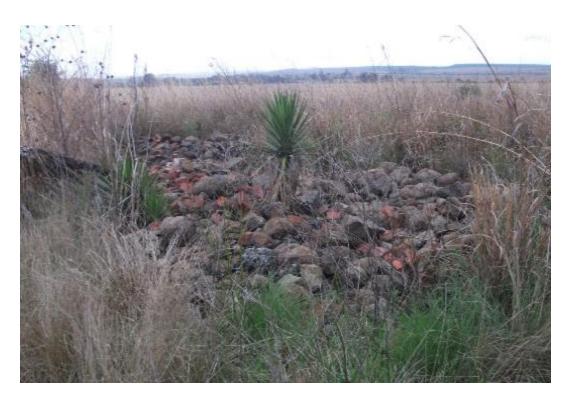
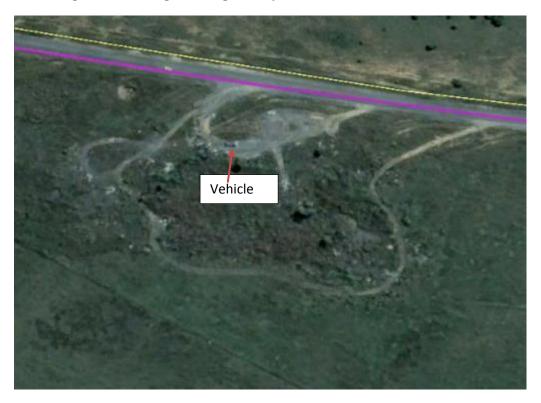
The area between the Bloubank road and barbed wire fencing was inspected on foot. The area has a very dense grass cover and is used extensively for the illegal dumping of building rubble and other waste (see **Figure 23**). The remains of what appears to be a tarred road was also found in this area. No heritage sites were observed in this area during both site inspections.

The early Google Earth images of this area indicate that dumping in this area has been ongoing probably before 2006. The images show the presence of informal roads that allowed easy access to the area and the 2008 image (**Figure 24**) shows a vehicle presumably dumping a load of rubble/waste. From a review of the historical topographical map, this area had telephone and telegraph lines running across it (see **Figure 5**).

Figure 23: Building rubble amongst thick grass layer

Figure 24: 2008 image of area where large-scale dumping is taking place

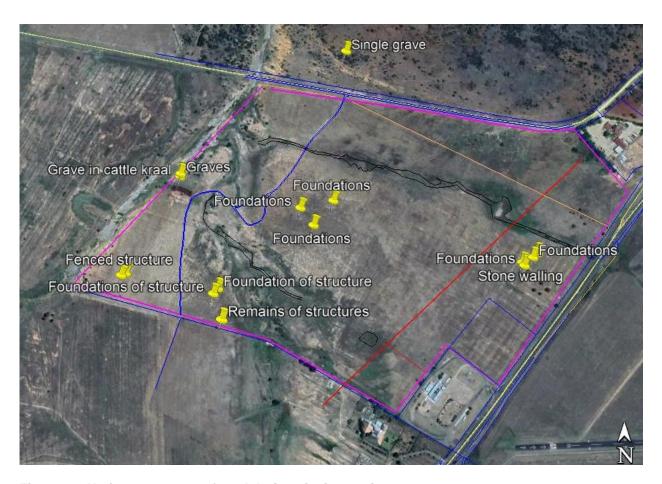
Figure 26: Heritage resources found during site inspection

The heritage resources found on the project area during the site inspection are listed in the table below and depicted on **Figure 26** below.
