HERITAGE STATEMENT FOR THE PROPOSED OUTENIQUAS DRIFT ON THE GOURITZ RIVER, RIVERSDALE AND MOSSEL BAY MAGISTERIAL DISTRICTS, WESTERN CAPE

(Assessment conducted under Section 38 (8) of the
National Heritage Resources Act (No. 25 of 1999) as part of an EIA)

12 March 2010

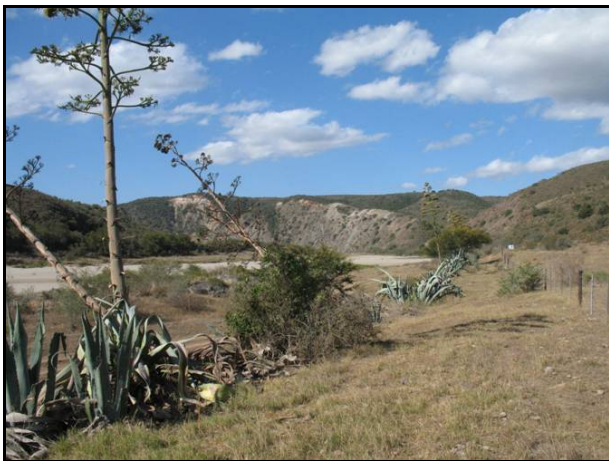
This is a 'tree' line of sisal aloes¹ (*Agave americana*) of unknown age but which can be considered an aspect of the cultural landscape. They run for some distance along the southeast bank of the river marking the edge of an agricultural field (Figure 26). The line extends to the southwest of the southern approach road but is far less prominent there.

Figure 26: The line of *Agave americana* at BD-01.

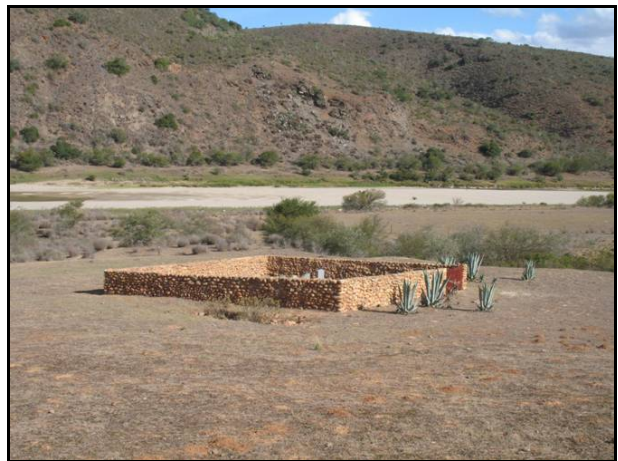
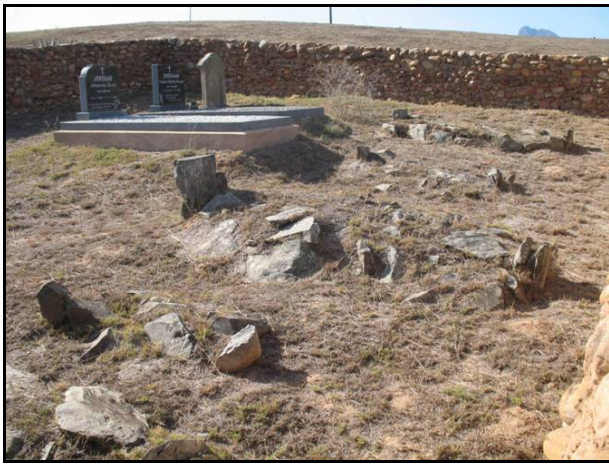
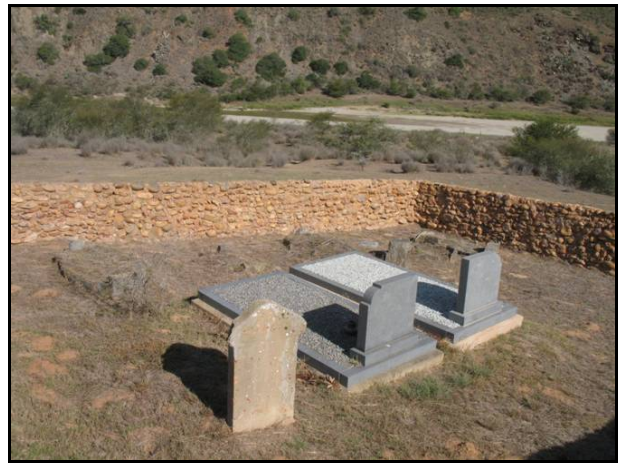
A farm graveyard was found to the north of the proposed crossing point (Figures 27 – 29). It is well away from the crossing. Although recently walled, the graveyard contains both older, less formal graves, as well as recent ones (up to 2006). Two informal stone-covered graves (2 adult, 3 children), one with a cement headstone and two with modern granite gravestones were present.

Figure 27: View of graveyard at BD-02.

Figure 28: Graves at BD-02.

Figure 29: Graves at BD-02.

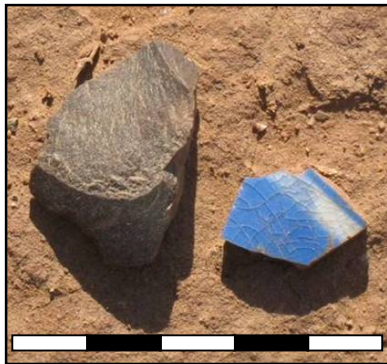
Here just two artefacts, one historical and one Stone Age, were found (Figure 30). One is a Stone Age flake of indeterminate age and the other a historical plate fragment. This point is essentially the southern limit of the farm werf which consists of a few buildings. The one at this point is modern (1992) but a smaller outbuilding further north seems older. The main homestead has three components². The original wing, closest to the river, is approximately 200 years old with the extension forming a T being slightly younger. The second addition turned the house into an H in 1989. The house was not visited as all these structures are well away from the study area.

Figure 30: Artefacts at BD-03. Scale in cm.

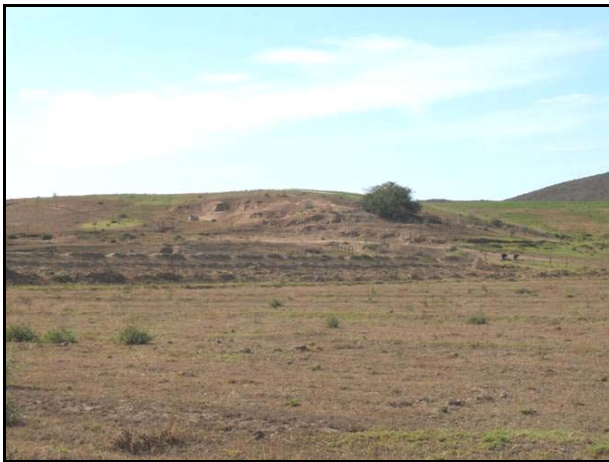
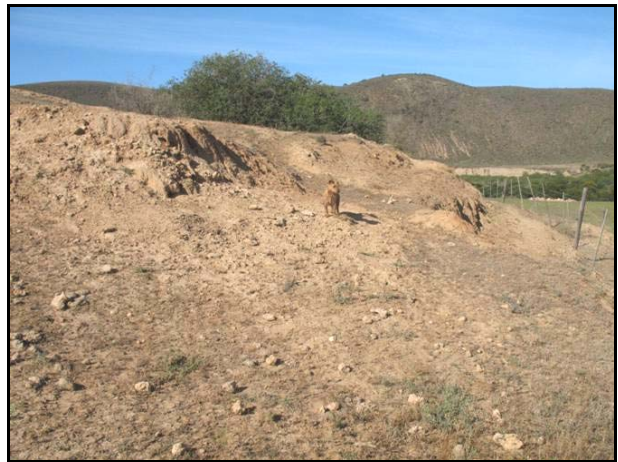
This site lies on the edge of the uppermost river terrace and its content is being revealed through natural erosion (Figure 33 & 34). It probably represents a location where people camped overlooking the river. Items noted were stone artefacts of quartzite as well as ostrich eggshell fragments and a bovid tooth (Figures 35 & 36). The deposits appear to contain quite a low density of archaeological material but the potential for *in situ* remains to be preserved is good. Inclusion of MSA material cannot be discounted.

Figure 33: View of site MD-02 on the edge of the uppermost river terrace.

Figure 34: Close up of the eroding deposits at MD-02.

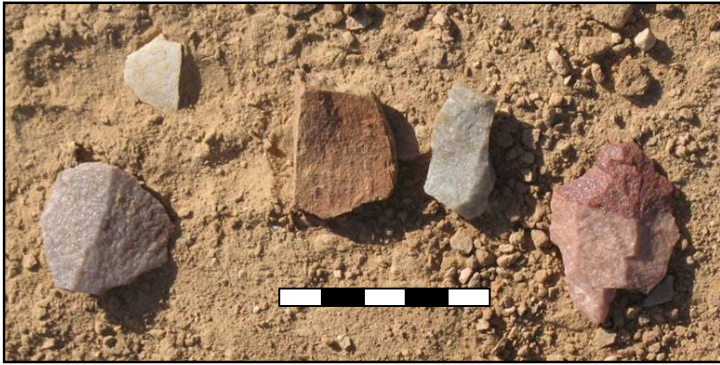
Figure 35: Quartzite artefacts from MD-02. Scale in cm.

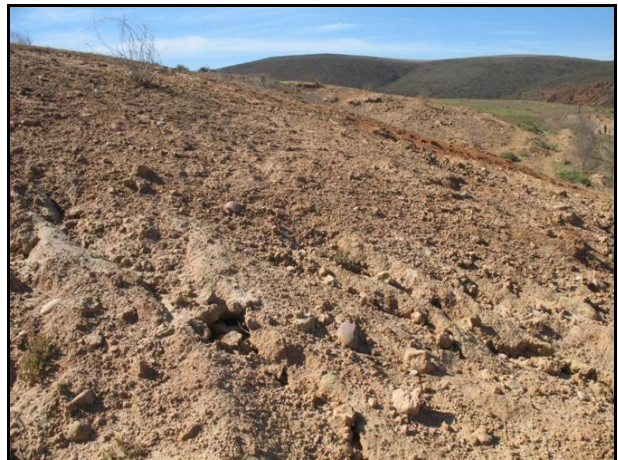
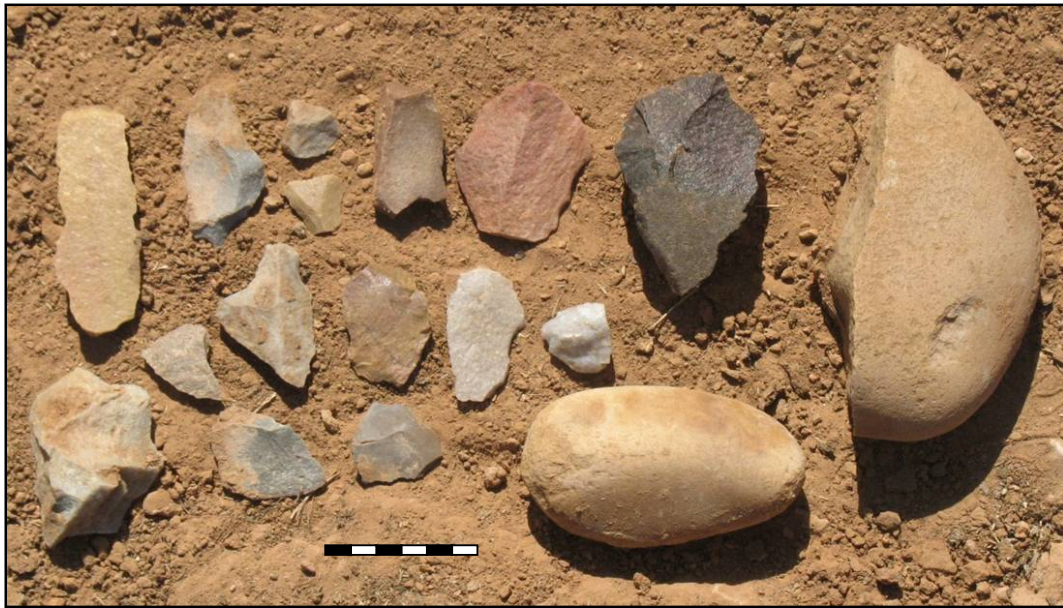
This site is again along the upper edge of the river valley and artefacts are eroding from the edge of the terrace. Artefacts were very numerous here (Figure 39) but no organic materials were seen. Although the vast majority of artefacts are of quartzite, one each of silcrete, quartz and another unidentifiable material were present. The range of artefacts includes flakes and cores as well as one hammer stone and one grindstone. The potential for *in situ* material exists. Again the possibility of there being MSA material at this site cannot be excluded.

Figure 38: The context of MD-04.

Figure 39: Stone artefacts from MD-04. Scale in cm.

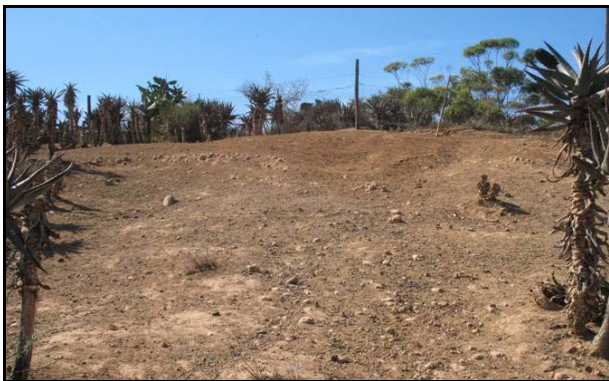
This is yet another similar exposure but is very large; artefacts are visible over a distance of at least 100 m. It is certainly less dense than MD-04 but the large area suggests that something of value may be preserved there. Only quartzite artefacts were seen.

Figure 40: The site at SD-02.

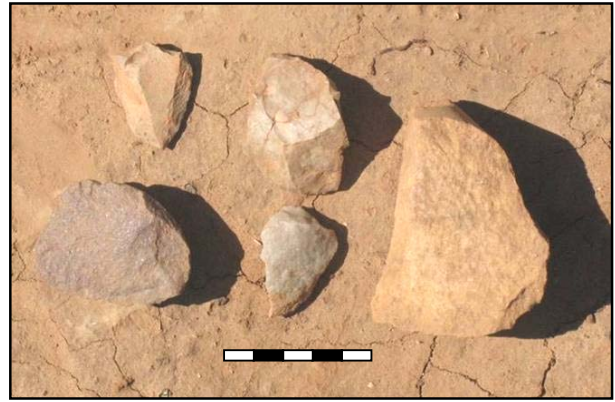
Again this site is an ephemeral scatter of artefacts. It differs only from the others in that it is not located along the edge of the terrace but slightly further back on level ground (Figure 42). It is alongside a small valley that leads down towards the main Gouritz River channel but is interrupted by a ploughed field. Quartzite and silcrete artefacts were noted (Figure 43).

Figure 43: Stone artefacts from SD-04. Scale in cm.

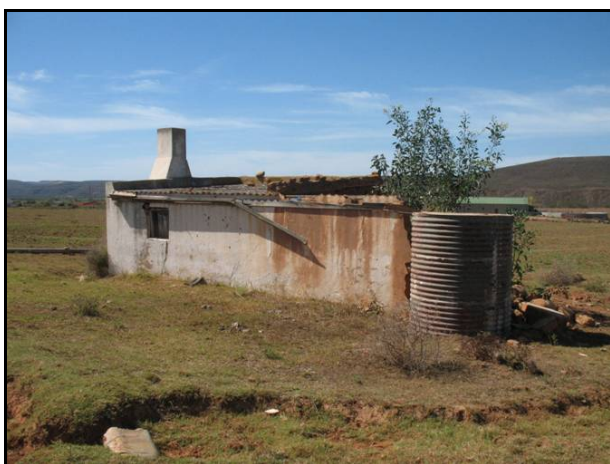
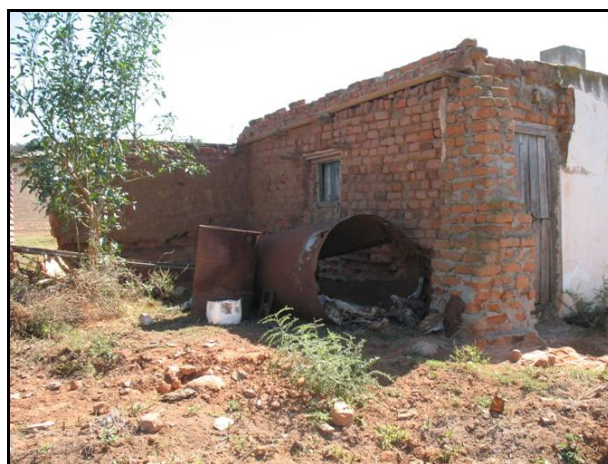
This site is a small labourers cottage located in the middle of a field. It is in very poor condition and has had some modification over time, some of which appears to have been aimed at supporting the failing structure. The original structure is of soft clay bricks and mud and it has a hearth and chimney stack (Figure 47 & 48). It holds very little significance.

Figure 47: The location of SD-06.

Figure 48: The front left corner of SD-06.

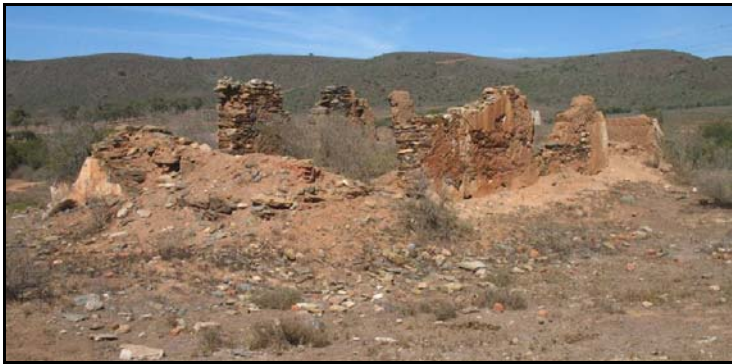
This site is a ruined house that was built from stone and mud with a mud plaster (Figures 52 & 53). It seems wider than a traditional long house but it had its rooms side by side. Its total floor area is about 18 m by 6 m which includes a stoep extending along the front. It faces south. While the age of this ruin is unknown, it must date to at least the mid- to late 19th century.

Figure 52: View of the ruin at MD-06 looking from the northeast.

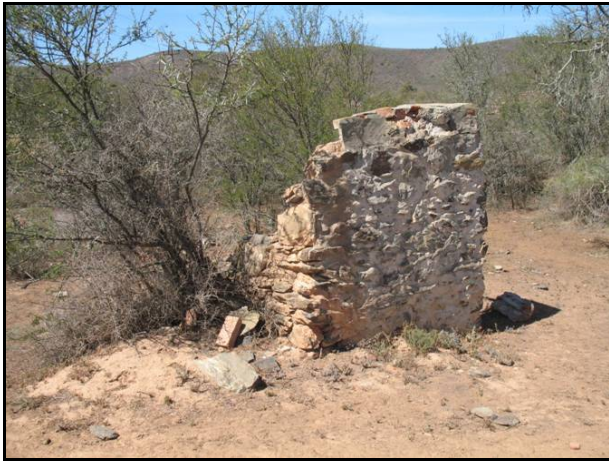
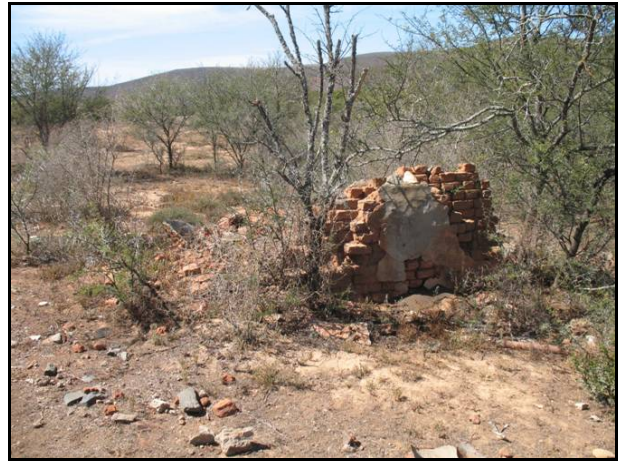
This site consists of two small outbuildings, one of brick and one of stone and brick. Their functions are unknown but they appear to be younger than the ruin at MD-06. They may even be less than 100 years of age.

Figure 54: View of one ruined structure at MD-07.

Figure 55: View of second ruined structure at MD-07.

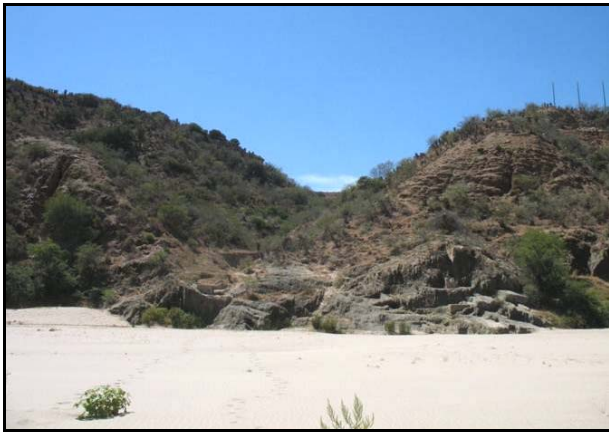
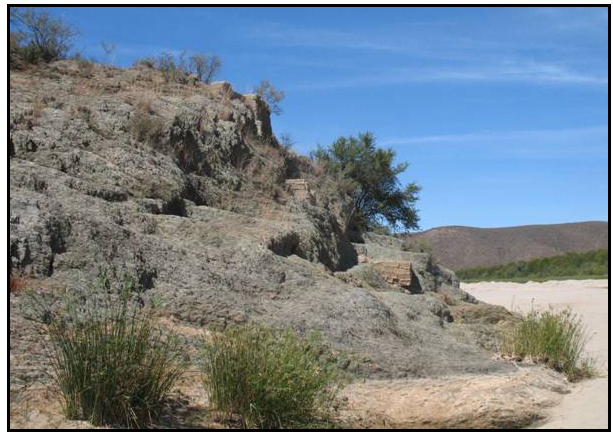
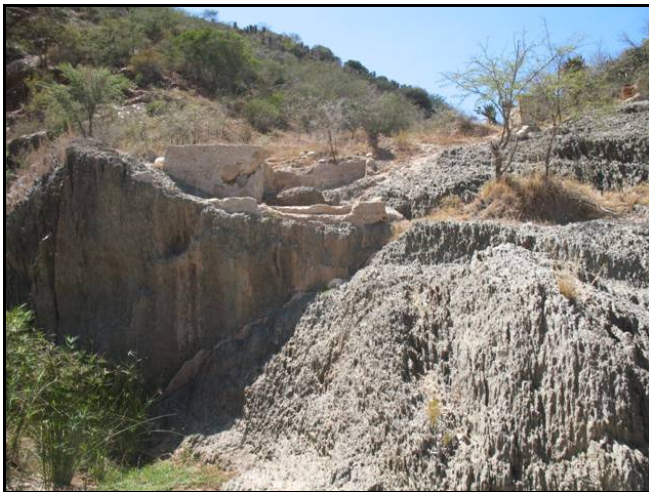
This is a series of cement footings on the cliffs overlooking the east edge of the river channel (Figures 58 - 61). Their function is unknown but four possibilities exist. Immediately overhead is a set of power lines and the footings could represent the bases of an earlier power line crossing. It is known that a formal road crossing used to exist (see map in Figure 2) but this clearly lay between the roads further to the south. It is unknown whether any other sort of crossing existed here but the positions of these footings makes it highly unlikely that they relate to a bridge of any sort. Given the location at the exit point of a small valley, some of the structures could somehow relate to water, and thus most likely be farming infrastructure. However, at least one of the footings looks as though it may have carried a pipe (Figure 61). Nothing is present on the opposite side of the river and this last possibility is considered most likely. The footings are of variable construction with red bricks, cement blocks and river cobbles all being used and they are likely also of differing ages. The blocks are very rough and appear to be locally made. The footings are likely less than 100 years of age.

Figure 58: The location of the footings at SD-08. The footings lie in the valley and on the rocks to the right.

Figure 59: Looking south the some of the footings extending down the rocks.

Figure 60: The footings at the base of the stream valley.

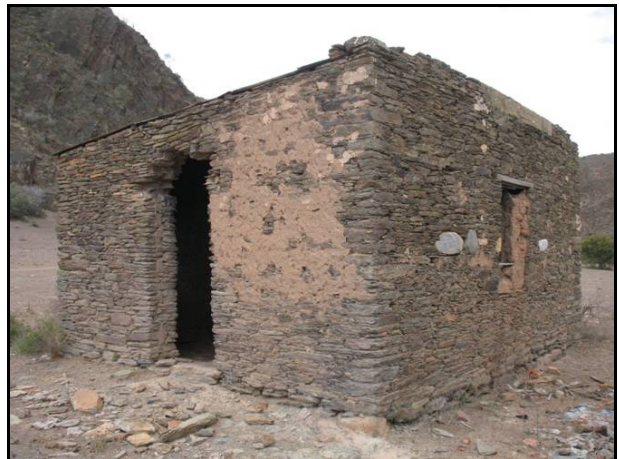
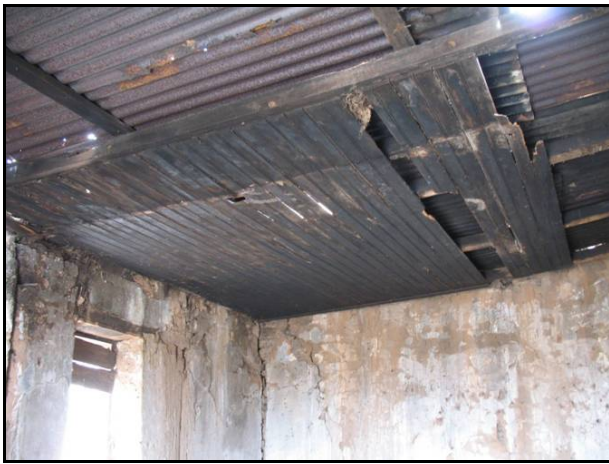
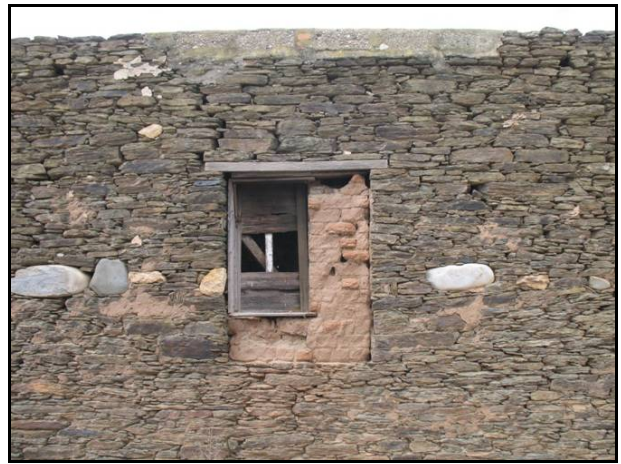
This is a small flat-roofed cottage built of shale slabs and mud (Figure 63). It has a corrugated iron roof and part of the wood-panelled ceiling is still in place (Figure 64). Some minor modifications have taken place over the years but none are very recent. These include resizing of the window facing the river and repairs to the roof (Figure 65).

Figure 63: The structure at OD-02.

Figure 64: The panelled ceiling at OD-02.

Figure 65: Modified window and parapet at OD-02.

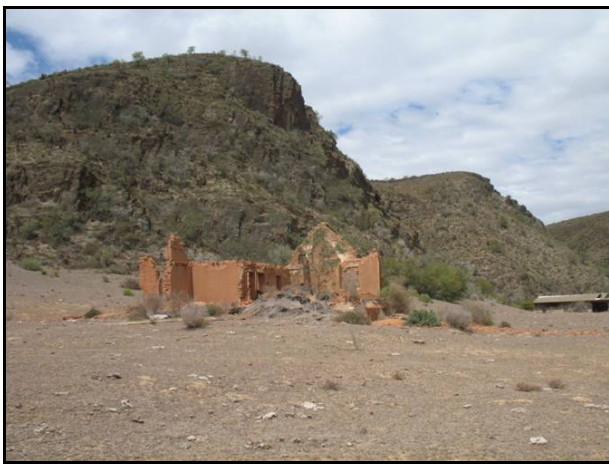
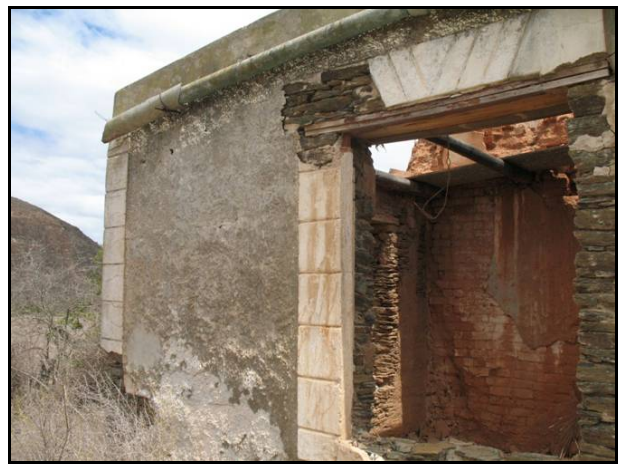
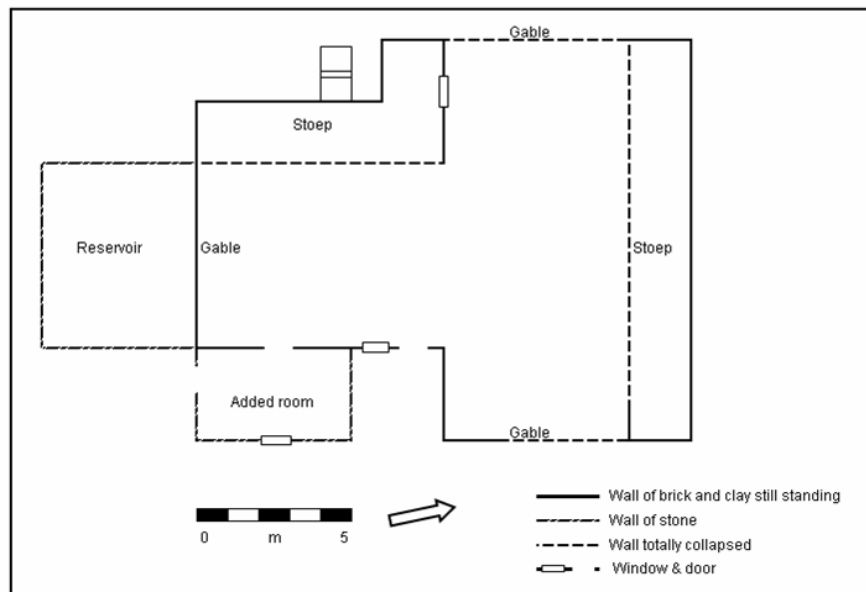
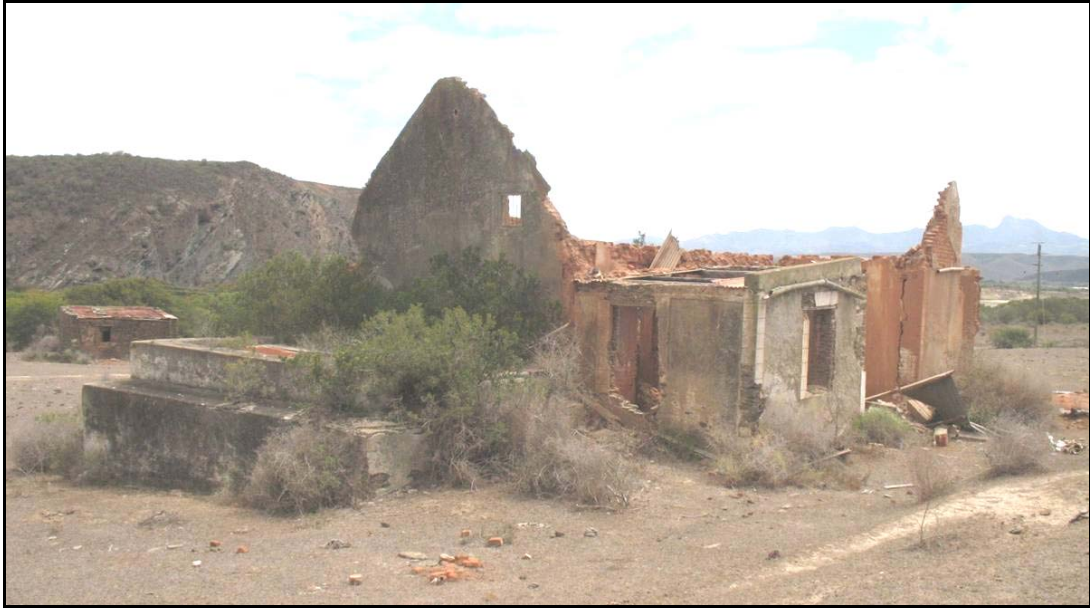
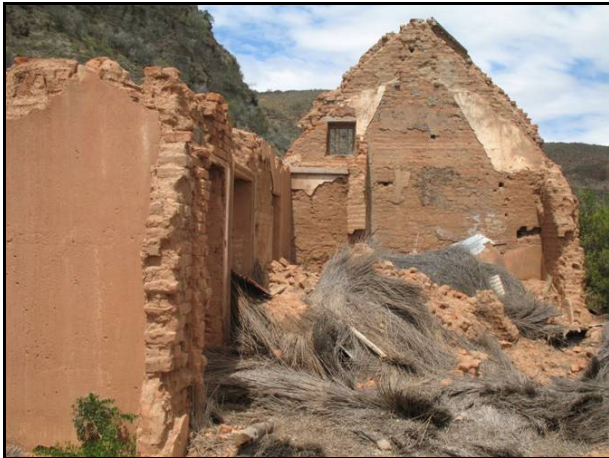
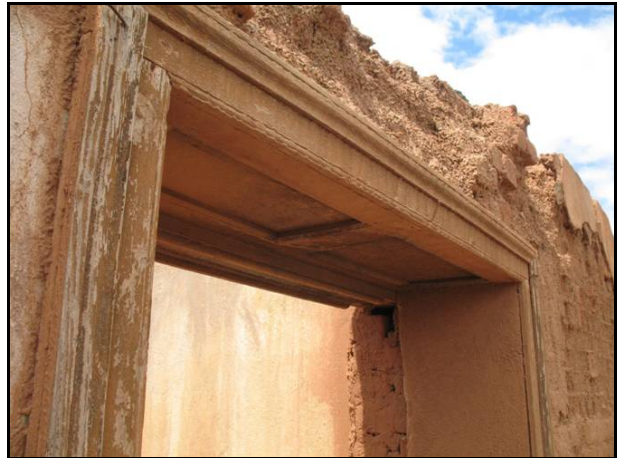
Here were found the remains of a farmhouse built of clay bricks and mud and with a thatched roof (Figure 66). The house was apparently only abandoned and allowed to fall into ruin within the last three to four years. It may have been built in the mid-19th century or later but at least had some work done to it during Victorian times, since there are details that reflect this latter period. These include plaster work on corners and around openings (Figure 67) as well as wood panelling added to the doorway linking the room with the rest of the house (Figure 71). The fact that the Victorian features seem to be restricted to the stone addition supports an earlier construction date for the rest of the house. The house was T-shaped but with additions (Figure 68). One addition is a small room on the east side made of stone, while the other is a reservoir behind the southern end gable and also built of stone. There were stoeps on both the west and north sides and the roof was thatched.

Figure 66: The ruin at OD-03.

Figure 67: Victorian detail at OD-03.

Figure 68: Plan of the ruin at OD-03. Arrow denotes north. The scale is approximate, measured only by pacing.

Figure 69: View of the ruin at OD-03 from the southeast. The stone additions can be seen (reservoir at left and extra room at centre).

Figure 70: View of the interior of OD-03.

Figure 71: Wood panelling on doorway in OD-03.

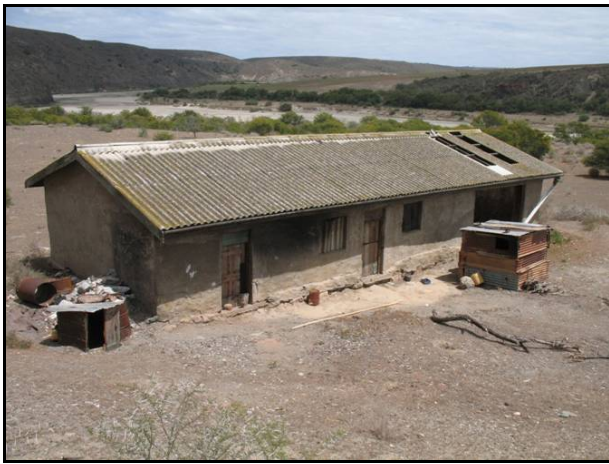
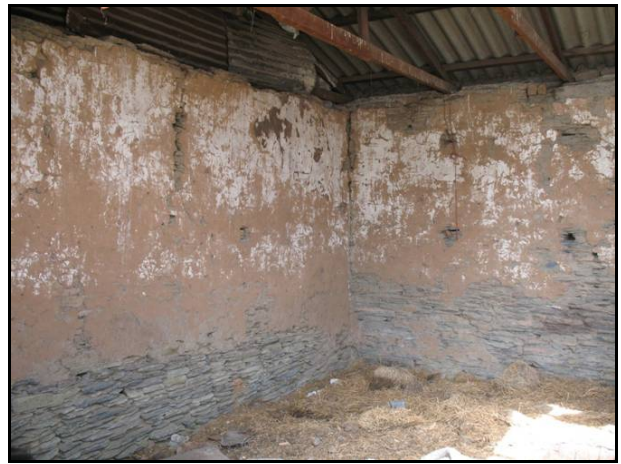
This structure appears to have been built more than 60 years ago as indicated by the stone work that resembles site OD-02. It has, however, been more recently renovated, possibly in the 1960s or 1970s. It has been recently abandoned as reflected by the modern rubbish strewn about the area.

Figure 72: View of OD-04.

Figure 73: Interior of OD-04.

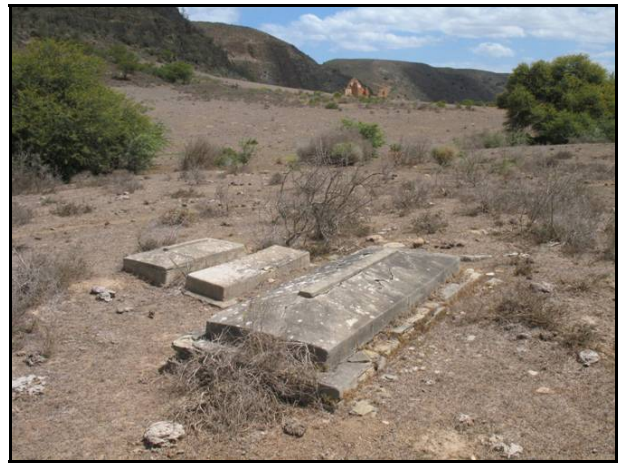
Figure 81: The three graves at OD-07. The farmhouse at OD-04 can be seen in the background.

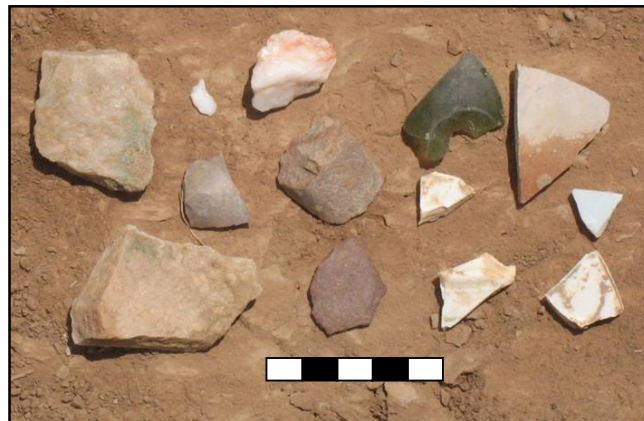
In this eroding area were found a scatter of artefacts of variable age. Included were a flake with a faceted platform that is likely from the Middle Stone Age as well as several other artefacts that could be either MSA or LSA. Some historical material was also present in the form of glass, stone ware and other fragments of white ceramics (Figure 82).

Figure 82: Artefacts from OD-08.
