HERITAGE IMPACT ASSESSMENT FOR A PROPOSED SUBSTATION AND 66 kV DE HOEK POWER LINE AT PIKETBERG, PIKETBERG MAGISTERIAL DISTRICT, WESTERN CAPE

(Assessment conducted under Section 38 (8) of the
National Heritage Resources Act (No. 25 of 1999) as part of an EIA)

15th February 2013

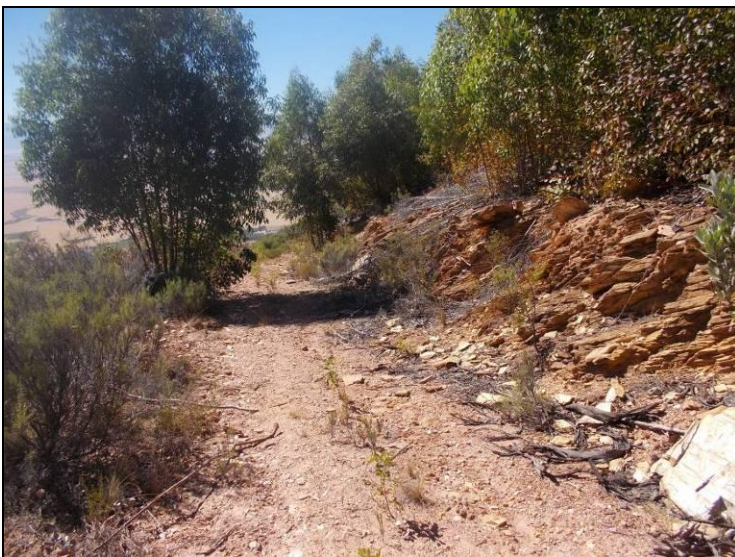
Figure 21: The upper part of the 1899 pass (KV2013/001). This is at point 003.

Specific mention does need to be made of the two historical sites that might be impacted. The old pass (KV2013/001) is crossed by Alternative 6. No alteration of this pass may occur. Should the power line cross the pass, it will need to be ensured that it simply spans the road and makes no physical impact on it. Alternative 5 passes over the historical complex at KV2013/002. Given the location of the complex in a deep valley, it seems highly likely that no physical impact would occur since the lines should be able to span the valley. However, if an access road is planned, it will need to be placed well around the complex (preferably to the west) to reduce the chances of intersecting concealed graves.

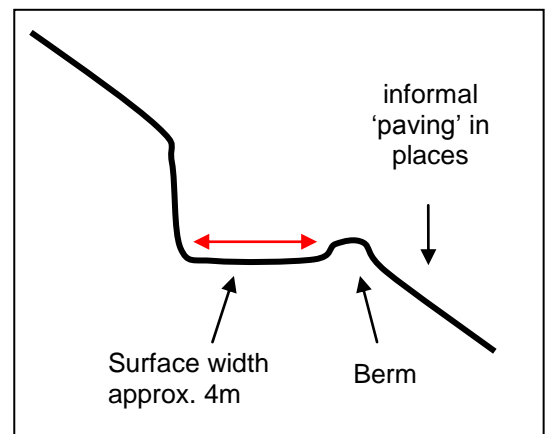
Figure 22: Schematic cross-section through the 1899 pass at point 003.

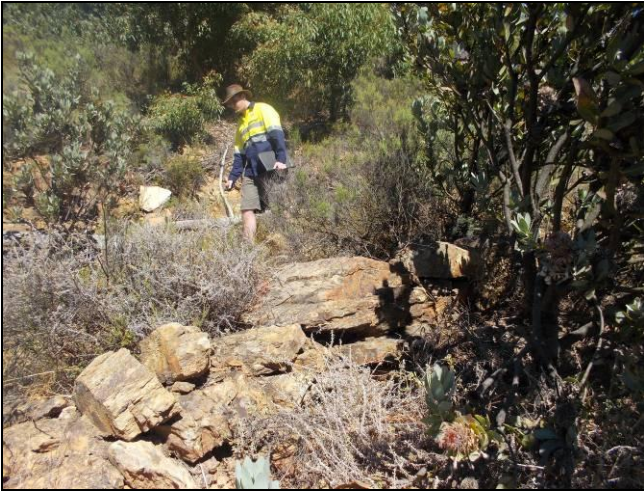
Figure 23: Stones piled alongside the 1899 pass.

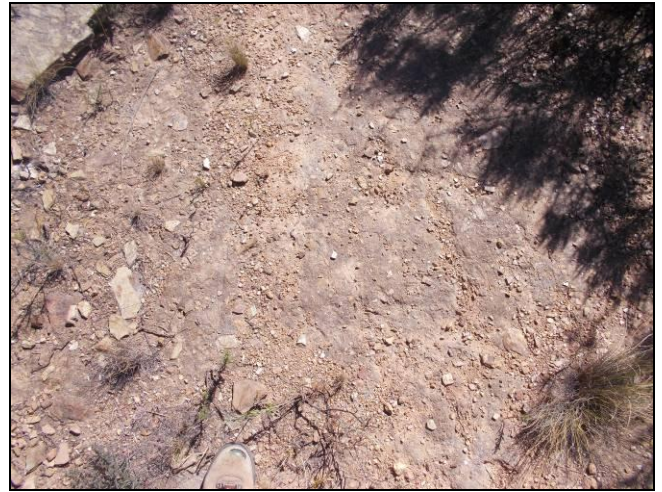
Figure 24: The road surface on the 1899 pass.

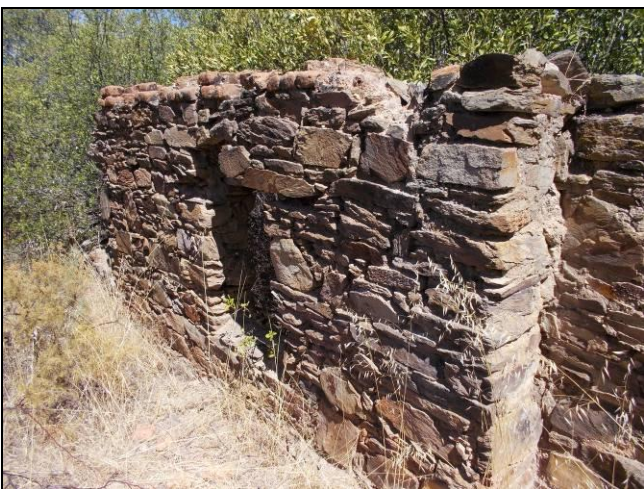
Figure 25: The west end of the northern wall of the house ruin at point 009.

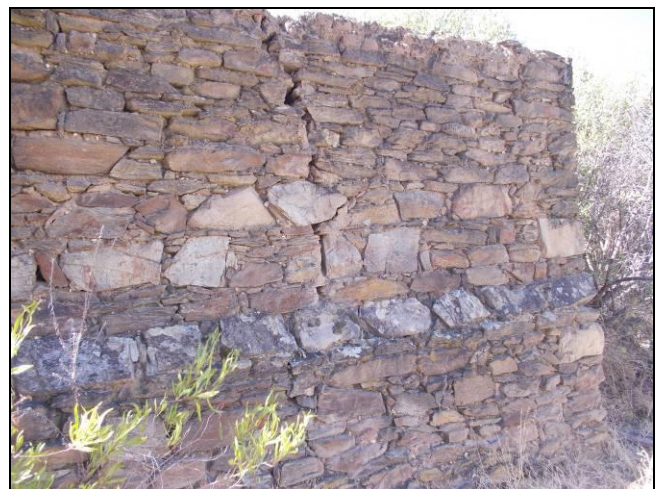
Figure 26: The southern wall of the added on room.

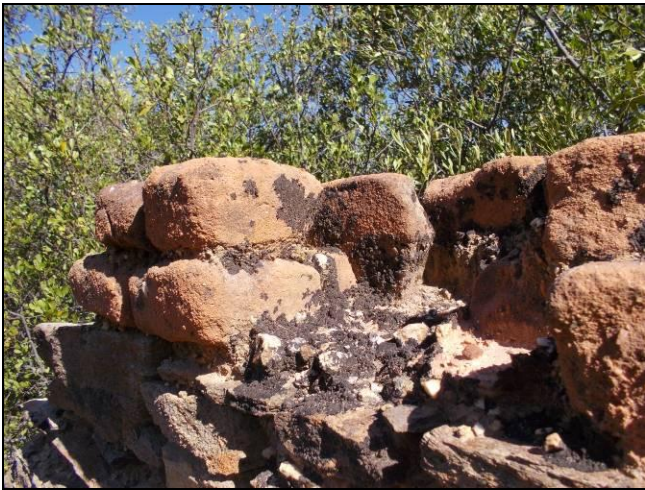
Figure 27: detail of bricks atop the stone walling on the north-western part of the house.

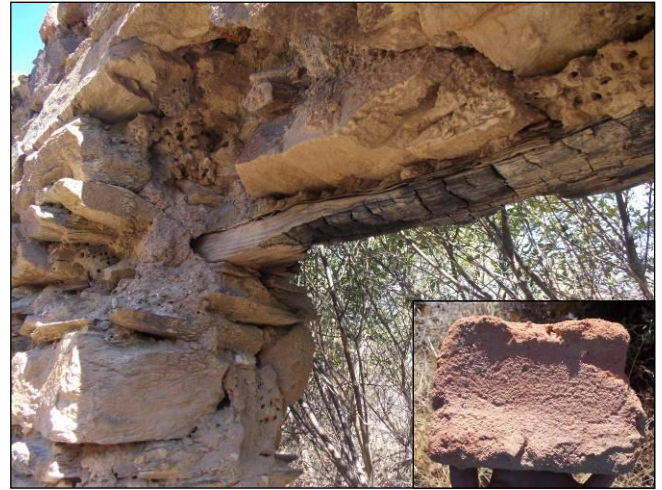
Figure 28: Detail of window in north-western part of the house.

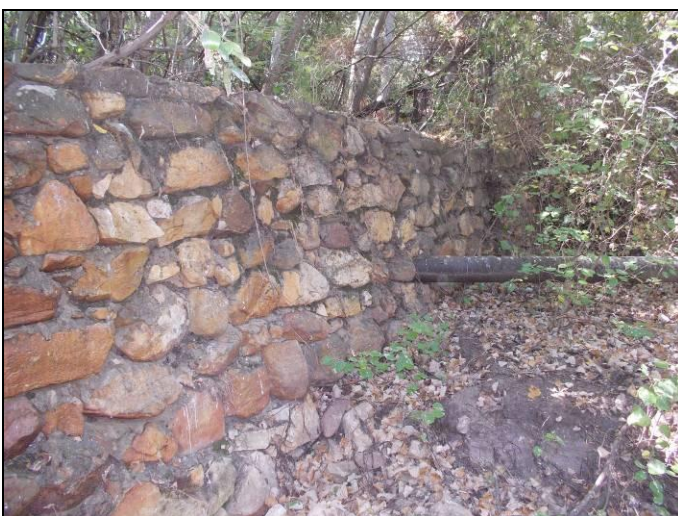
About 80 m west of the house, in a poplar grove, is a stone and cement dam (Figure 30). It is completely silted up and has large trees growing inside it. The stream is now being diverted out of the southern edge of the dam and is undercutting the wall there (Figure 31). An iron pipe exits the base of the stone wall. Point 011 represents a probable stone feature alongside the eroded stream bed. It is of entirely unknown function and appears only to be packed stones.

Figure 30: The dam wall at KV2013/002 (point 010).

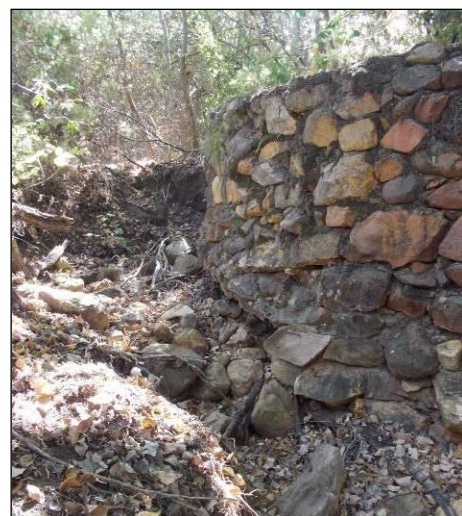
Figure 31: The undercut part of the wall.

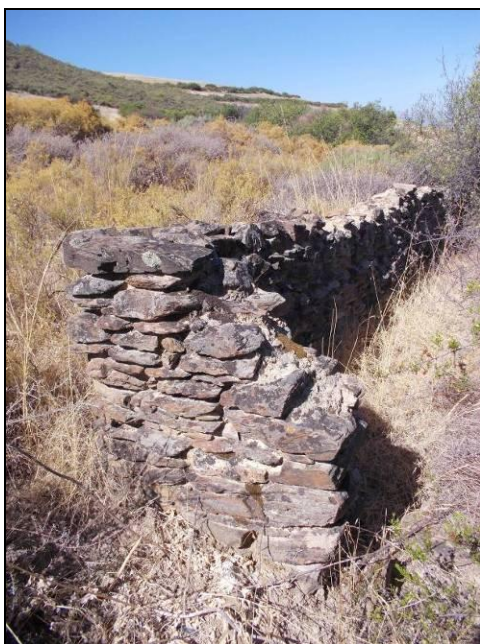
The third built component of the KV2013/002 site is probably an outbuilding, perhaps related to housing animals. It appears to have only had walls extending to about 1.4 m above ground level (Figure 32). The walls are again of stone and mud. The southwest corner was completely obscured by very dense bushes. There was an opening to the west and an extension was added to the east end. Within the southern wall of the added room was a small storage area formed by placing a large rock slab over a space in the wall (Figure 33). Part of the newer wall and a wall from the original building both were broken down where they extend northwards. Inside the north wall were two pieces of iron fastened into the wall. They are perforated and have wire tied on to them (Figure 34). In the southern wall of the addition was a small recess with two pieces of barbed wire fastened into the wall suggesting that they once supported a pole in the recess. Figure 35 shows a plan view of the structure.

Figure 32: The outbuilding at KV2013/002 (point 012).

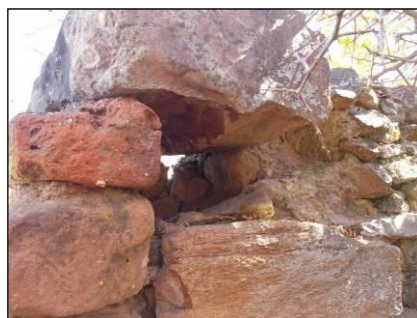
Figure 33 (top): The storage space in the wall.

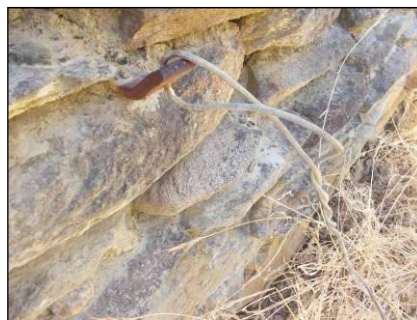
Figure 34 (bottom): Iron and wire fastened in wall.

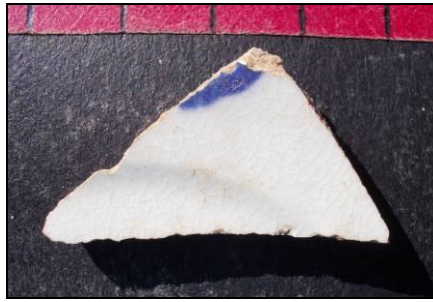
Figure 36: The single fragment of historical ceramic found close to the outbuilding.

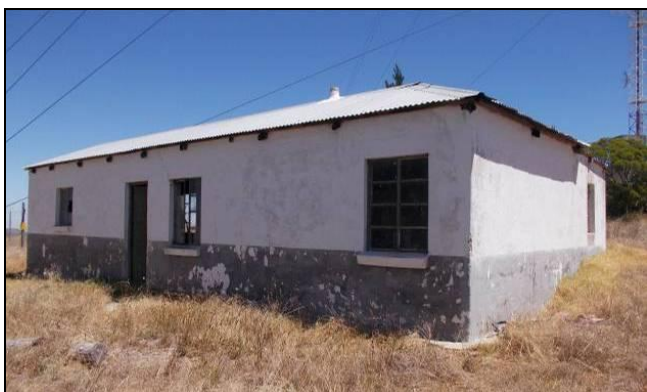
Figure 38: Mid-20th century cottage at point 008a. It has a corrugated iron roof.

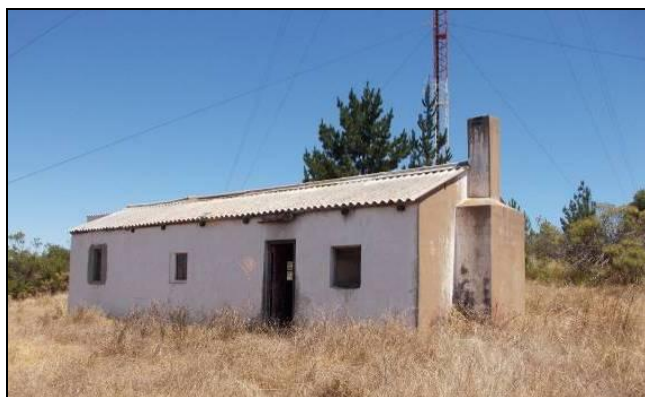
Figure 39: Mid-20th century cottage at point 008b. It has an asbestos roof.
