**ARCHAEOLOGICAL IMPACT ASSESSMENT
OF THE PROPOSED EXTENSION OF THREE BORROW
PITS IN THE ROAD RESERVE (NODEWEE 141) AND
MERTENHOF 586, CEDERBERG,
CLANWILLIAM DISTRICT, WESTERN CAPE**

(Assessment conducted under Section 38 (8) of the National Heritage Resources Act as part
of a Heritage Impact Assessment)

AUGUST 2012

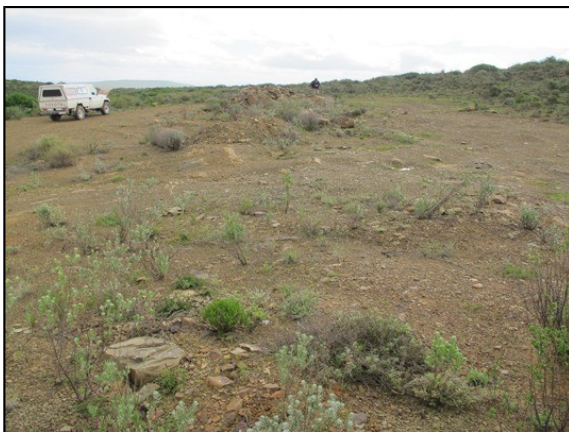
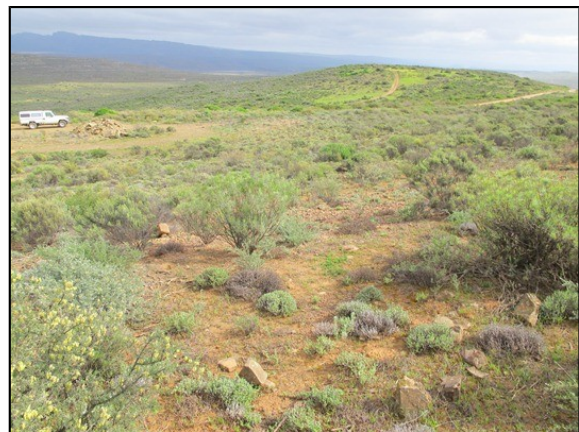
Figures 3 and 4: Pit 107 – view across the existing pit area towards the north; view across the proposed extension from the south-eastern corner of the affected area.

Results of the survey: No archaeological remains of any sort were observed.

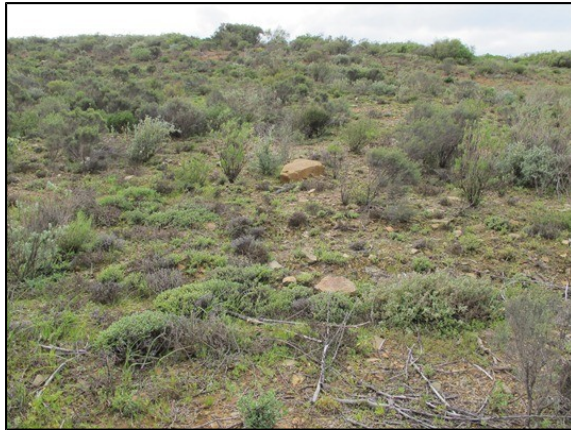
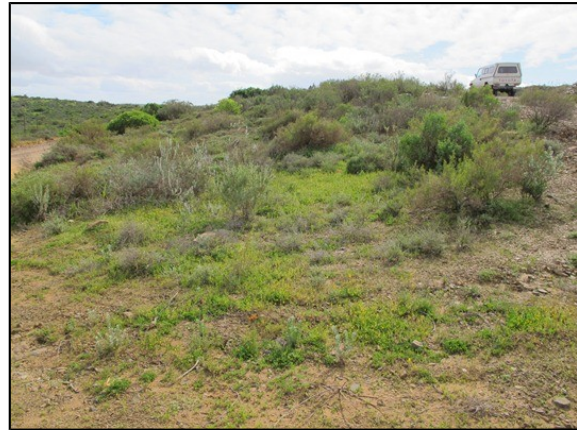
Figures 5 and 6: Pit 107 – view up the slope towards the eastern fence; denser vegetation in the western area between the road and the existing quarry.

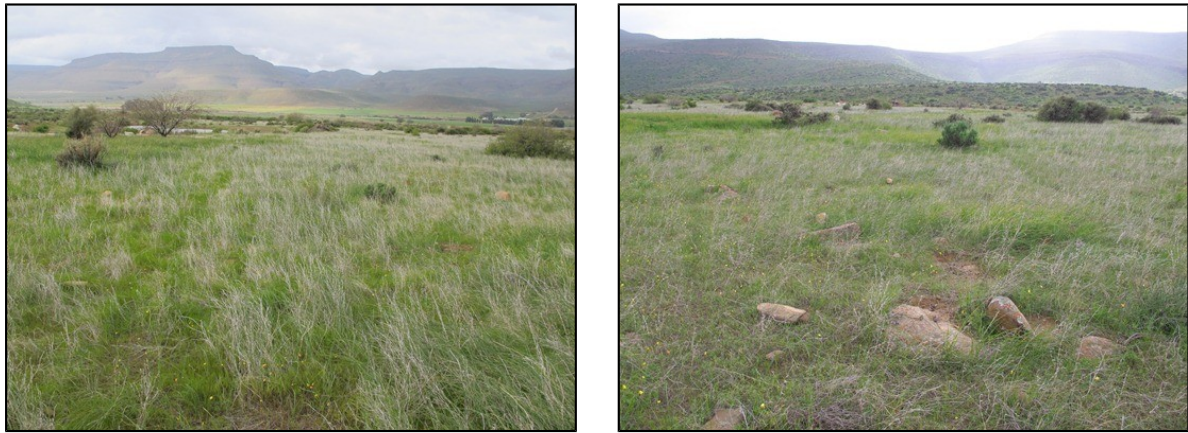
Figures 9 and 10: Pit 108 – view across the affected area towards the south-east with the existing pit located beyond the tree on the left of the photo; view across the site towards the Uitkyk Pass. Scattered sandstone blocks are visible in the foreground.

Results of the survey: No archaeological remains were observed on the ground of the affected area. If there are any rock paintings on the nearby cliff and rocky slope they should be far enough away not to be directly affected by quarrying activities.

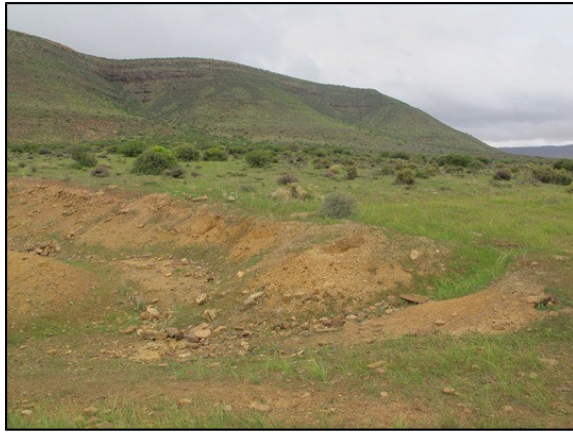
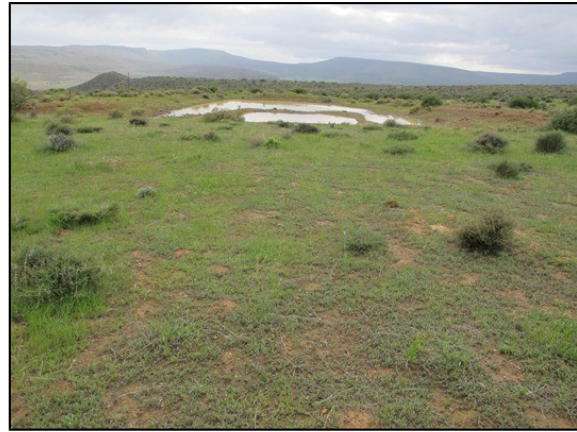
Figures 12 and 13: Pit 109 – view towards the south-east from the south-western edge of the existing pit; view towards the north with the existing pit in the middle ground. The sparse covering of fresh grass does not impede archaeological visibility.

Results of the survey: Although chunks and small blocks of quartzite suitable for the manufacture of stone artefacts were observed, none of them showed any signs of flaking. No other archaeological remains were observed.

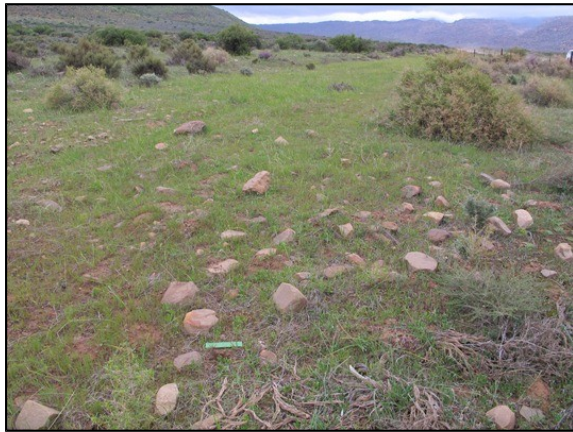
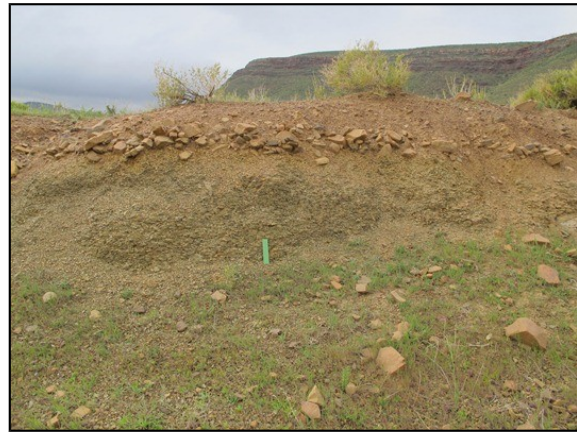
Figures 14 and 15: Pit 109 – view towards the southwest showing scattered, unflaked sandstone blocks; section in the existing pit wall showing the infilling channel with layer of larger sandstone blocks overlying weathered mudrock. The ruler is approximately 15cm in length.
