**HERITAGE IMPACT ASSESSMENT:**  
**PROPOSED DEVELOPMENT OF THE SPRINGHAAS SOLAR PV FACILITIES**  
**CONSISTING OF SEVEN NEW SOLAR PV FACILITIES AND ASSOCIATED**  
**INFRASTRUCTURE NEAR DEALESVILLE IN THE FREE STATE PROVINCE**

Required under Section 38(8) of the National Heritage Resources Act (No. 25 of 1999)  
as part of a Heritage Impact Assessment.

**Dr Jayson Orton**  
**ASHA Consulting (Pty) Ltd**  
23 Dover Road, Muizenberg, 7945  
Tel: (021) 788 1025 | 083 272 3225  
Email: [jayson@asha-consulting.co.za](mailto:jayson@asha-consulting.co.za)

Final report: 12 April 2022

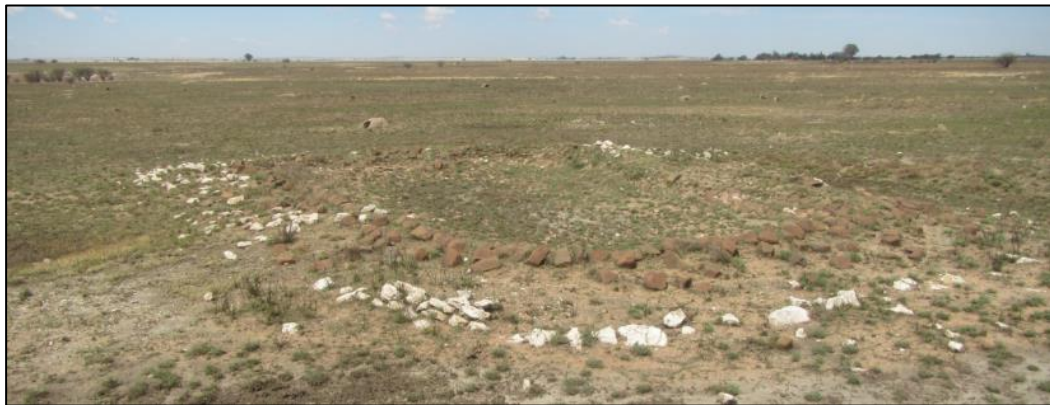
**Figure 29:** *The remains of a stone-lined water reservoir at waypoint 378.*

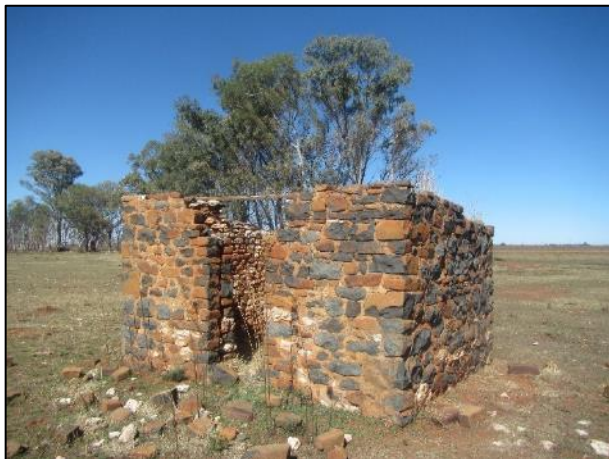
Several historical farm complexes were seen in varying states of repair, with a few of the structures perhaps better suited to reporting as built environment features. However, to keep them together, they will all be discussed together here. These are undoubtedly the most significant archaeological remains in the study area and illustrate the traditional building techniques and styles of the 19<sup>th</sup> and early 20<sup>th</sup> century. Figure 30 shows a small cottage at waypoint 293 built with the typical double skin method. Interestingly, while the outer skin is made almost entirely from dolerite cobbles with rare calcrete inclusions, the inner skin is the reverse pattern (Figure 31). This may have been due to the availability of stone but, given that calcrete does appear in the outer skin of this and a number of other ruins, it seems more likely to have been a stylistic decision. The door frame is missing but the wooden window frame survives. The flat roof is entirely missing.

**Figure 30:** *Stone ruin at waypoint 293.*

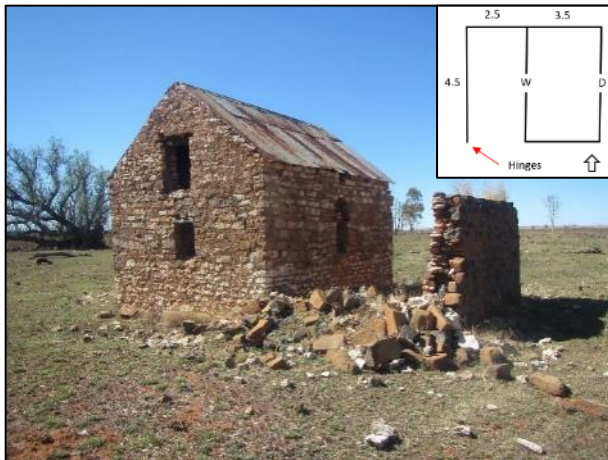
Another small gabled stone cottage with a loft under a tin roof was better preserved, although an addition to its west face was partially collapsed (waypoint 294; Figure 32). There are again patterns in the walling. The lowermost 1 m is almost all of calcrete, while above this there is a mix of calcrete, dolerite and shale. Shale blocks have been used for the windowsill and display some wear (Figure 33). Alongside this cottage was a brick ruin with at least half its walls collapsed and its roof missing (waypoint 295; Figures 34 to 36). This was undoubtedly the main house of this farm

**Figure 32:** Stone ruin at waypoint 294. Inset: plan view showing door hinge location.

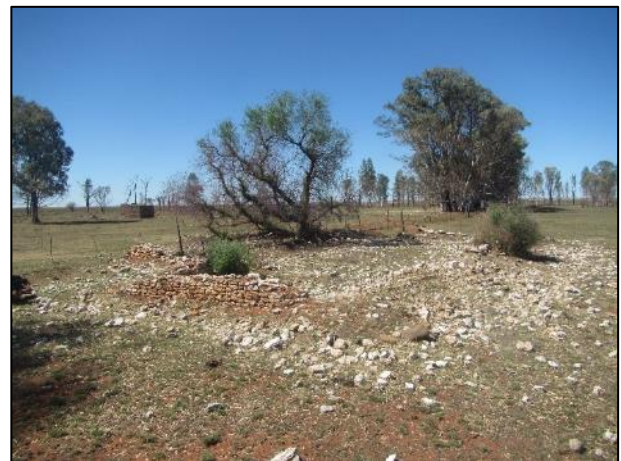
**Figure 37:** The remains of a calcrete-walled structure at waypoint 298.

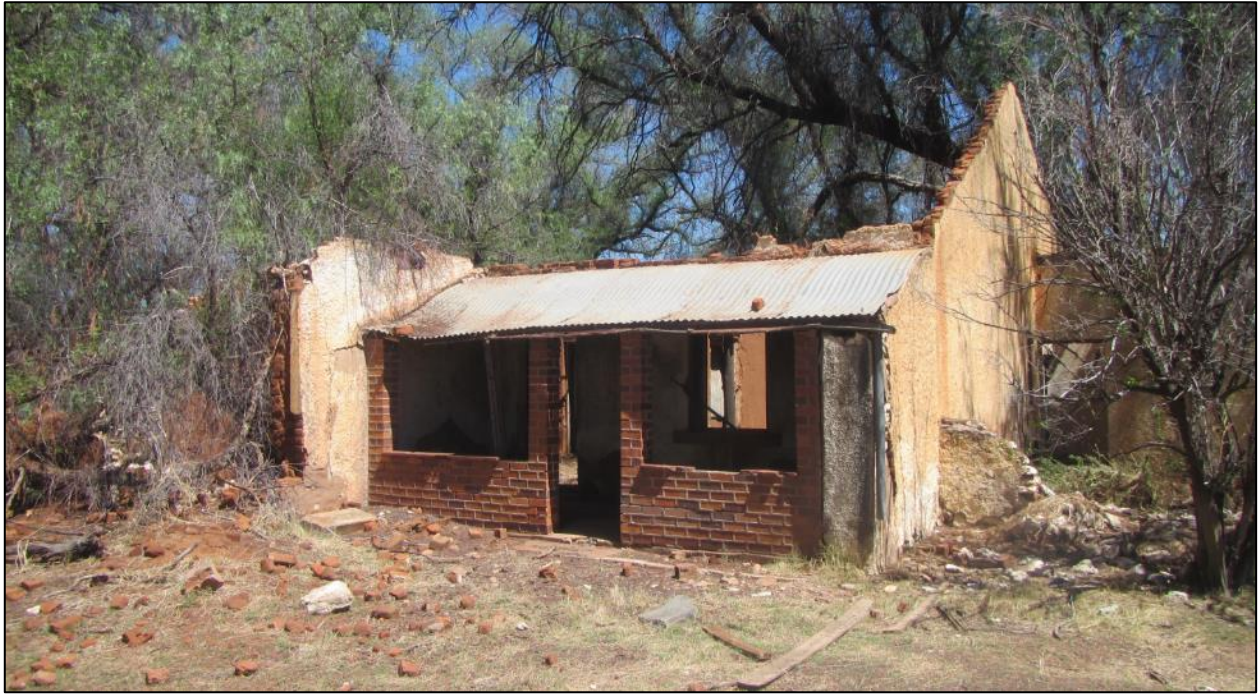
Another farm complex that was heavily surrounded by trees also has a main house of brick. It is ruined with its roof missing and some walls damaged (Figure 38). One gable has collapsed. It appears to be a late 19<sup>th</sup> century structure, perhaps having been built just at the start of the Victorian period. Some joinery is missing, while other items are still present. The extant windows show some variety. Most are wooden sash windows, but two wooden casement windows occur and there are three steel casement windows (Figures 39 to 40). Figure 41 shows that the house had a living room (voorkamer) with most other rooms leading off it. The bathroom to the north was a later addition, presumably added once sanitary ware became easily available. Also part of this complex is a brick-walled shed which has had one of its gabled end walls collapse entirely; the wall has been replaced with corrugated iron (Figure 42). This shed adjoins a stone kraal which is also somewhat damaged but which has been made useable by the addition of some brickwork and internal wooden fences.

**Figure 38:** Façade of the house at waypoint 301. The newer bathroom addition is just visible at far right.

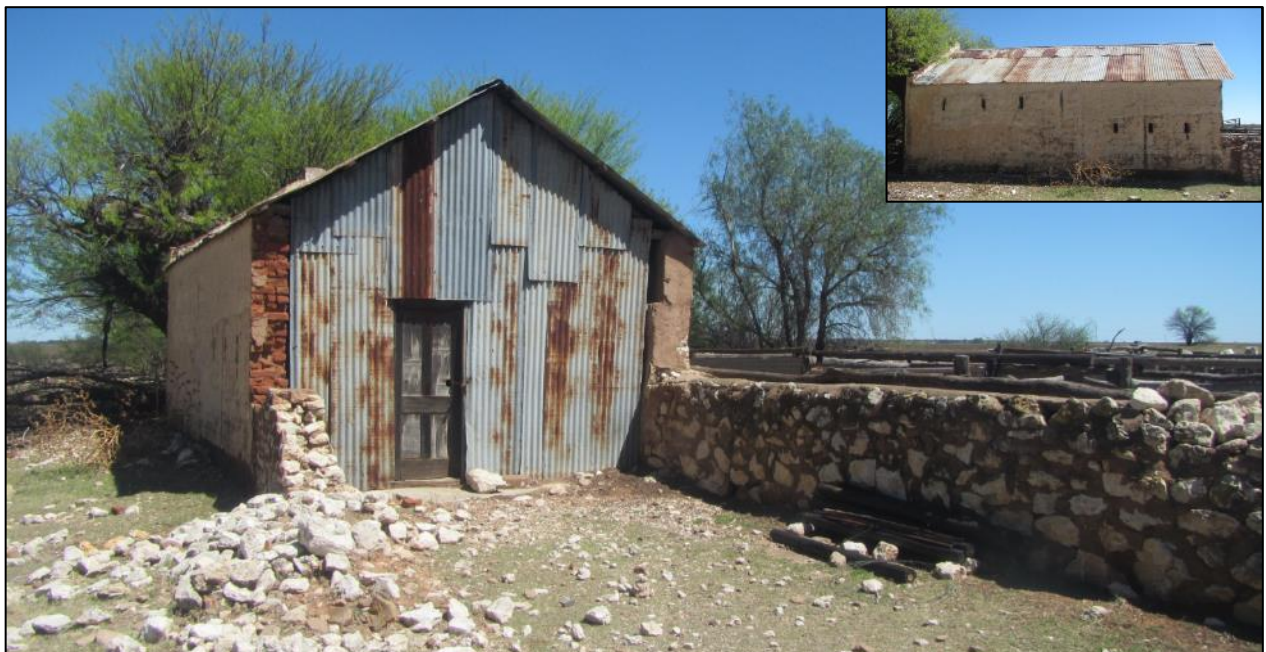
**Figure 42:** Brick shed with an end wall missing at waypoint 300. Inset: the south wall with several small opening and the western gable intact.

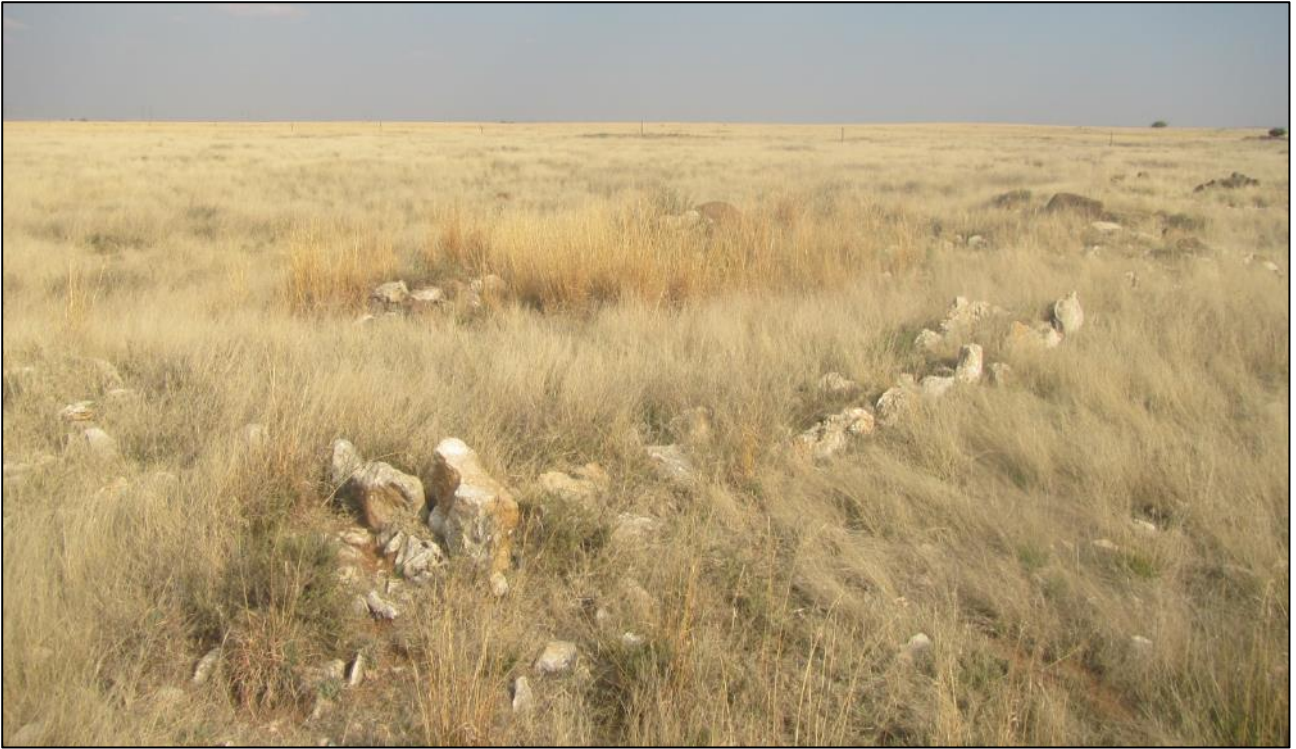
**Figure 46:** The poorly preserved remains of what was likely a house at waypoint 399.

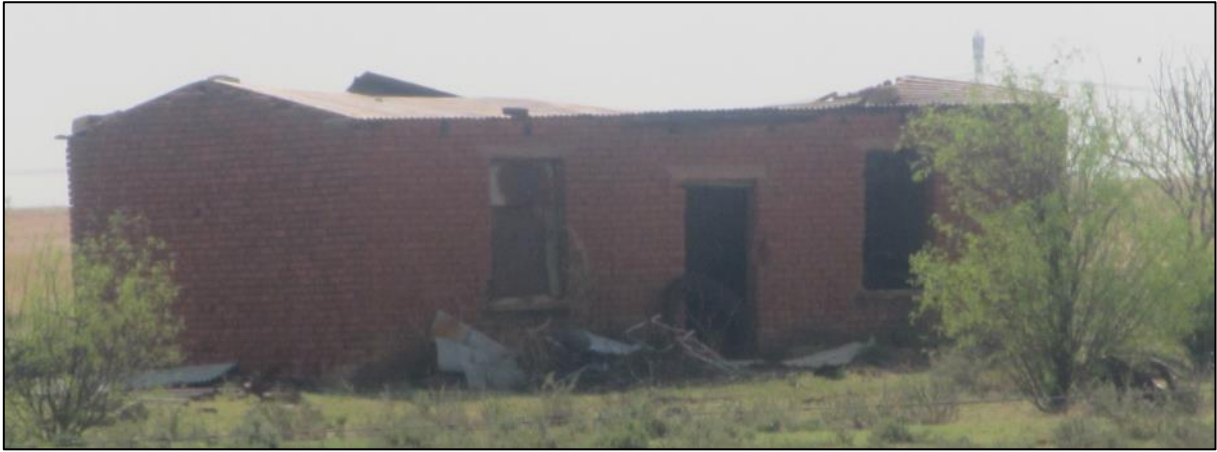
A short distance further north again is another small farm complex comprised of a modern shed, a modern cottage and a historical cottage. The latter is in very poor condition with some internal walls demolished, some external walls crumbling, all joinery removed and some roof sheets missing (waypoint 388; Figure 48 & 49).

**Figure 48:** *View of the south end and east side of the ruin at waypoint 388.*

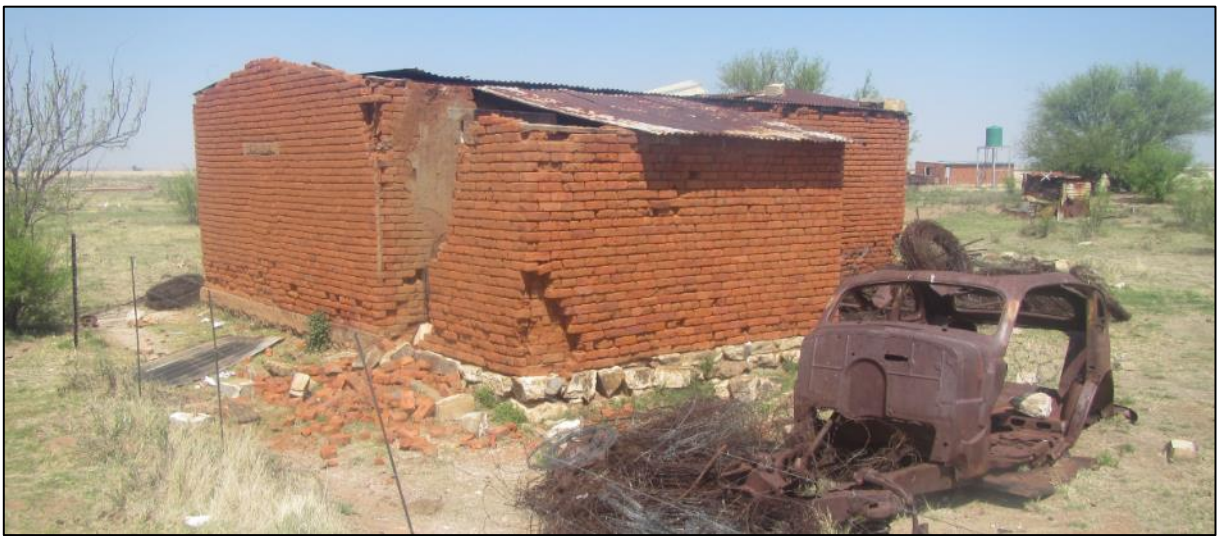
**Figure 49:** *View of the north end and west side of the ruin at waypoint 388.*
