PROPOSED EXPANSION OF KEMPDALE DAM, KOKSTAD, KWAZULU-NATAL

Phase 1 Heritage Impact Assessment

15 April 2021

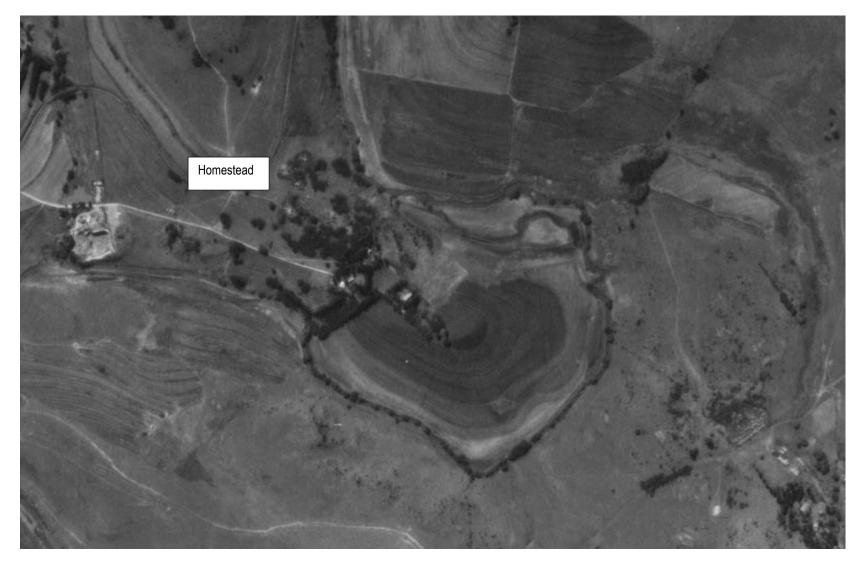
Figure 5: 1978 aerial image of Mzintlava River and surroundings

By 1978, much of the stone walling on the eastern and southern banks of the river has disappeared as can be seen in **Figure 5** and more structures are visible within the bend of the river. Extensive cultivation of the area is ongoing.

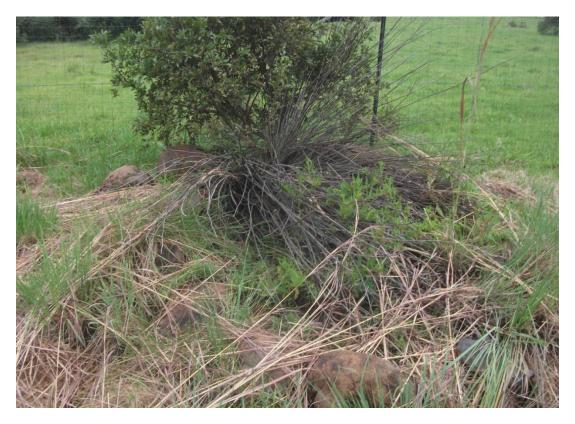
Figure 7: Single grave outlined with stone

During the inspection, the location of a grave was pointed out to the specialist by the landowner of the property. The grave (**Figure 7**) is located below the farmhouse and is outlined with stone. It is situated on the boundary fence between the garden and fields that lead down to the dam.

COORDINATES	DESCRIPTION	MITIGATION
30°32'04.1" S 29°27'55.1" E	Single grave (Figure 7); high heritage significance	At this stage, no mitigation as grave falls outside dam expansion level
30°32'04.5" S 29°27'54.8" E	Stone walling (Figure 8); low heritage significance	None required as stone walling falls outside dam expansion level
30°32′01.2″ S 29°27′53.4″ E	Stone walling crossing rocky outcrop towards dam / river; low heritage significance	None required as stone walling falls outside dam expansion level
30°31'59.3" S 29°27'50.6" E	Stone walling crossing rocky outcrop towards dam / river; low heritage significance	None required as stone walling falls outside dam expansion level
30°32'17.3" S 29°27'44.9" E	Remains of stone walling (Figure 12). Low heritage significance but protected by KZN Heritage Act	A section of the wall falls within dam expansion level hence this section will be inundated; permit to be obtained from the Institute prior to inundation.

No mitigation measures are required as the grave is situated 67m from the expansion extent of the dam. Flooding of the grave is unlikely but the location of the grave must be kept in mind, when plans are made in the future to again expand the dam.

• The location of the grave must be kept in mind when future plans are made to expand the dam further.

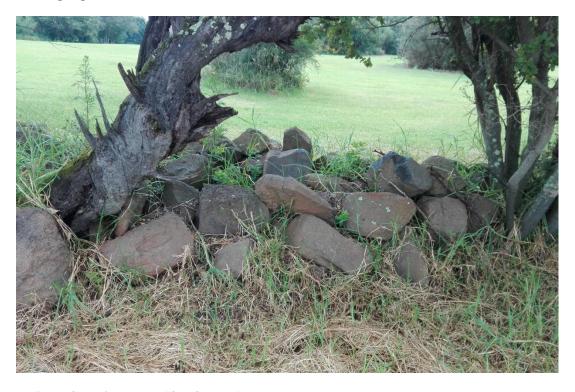
Figure 8: Remains of stonewalling in garden

About 6m behind and west of the grave, the remains of stonewalling that now form part of the garden of the farmhouse were found. The wall stretches for several metres in a roughly north-south direction.

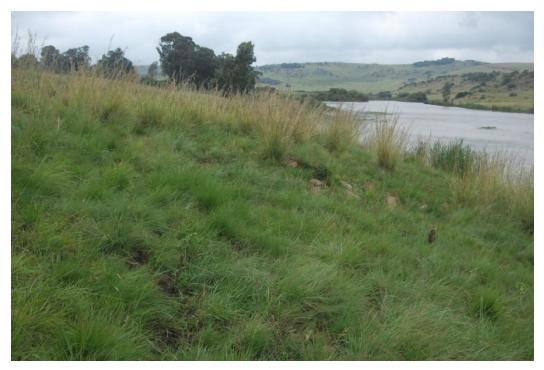
Figure 9: Northern banks of dam

More stone walling was found crossing the rocky outcrop which is located approximately 40m north of the grave described above. Beyond the rocky outcrop, the vegetation was so dense that

no heritage sites were observed; however, due to the presence of a kraal / homestead as indicated in **Figure 6**, as well as the presence of a single grave in fairly close proximity, it is recommended that prior to inundation and once the vegetation is less dense or has been burnt or cleared, the specialist return to the area in order to establish if there are any heritage resources (such as graves, or remains of the homestead) in the area north of the rocky outcrop until the northern end of the dam.

Due to the extremely dense vegetation in the area north of the rocky outcrop located near the farm houses, it is recommended that once the vegetation has been either cleared, burnt or has reduced naturally in density the specialist undertake a follow-up inspection to establish if there are any heritage sites in this area prior to inundation.

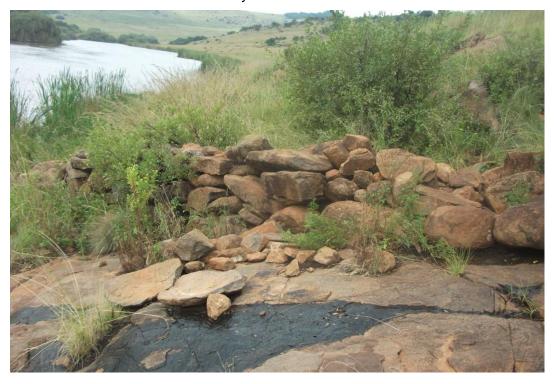
Figure 12: Section of stone walling

On the southern bank of the dam, there has been cultivation of a portion of the area about 180m east of the dam wall. The remains of the terracing of the fields can still be seen. Further east of this area, three stone walls were found during the inspection which were in fair condition but with disturbance from human and animal activity.

30°32′15.9″ S	Fairly intact stone wall about 180 m in length.	
29°28'18.2" E	Low to moderate heritage significance,	inundated by dam. Permit to be
	protected by KZN Heritage Act	obtained prior to inundation

- Application to the Institute for permission to inundate sections of the stone walling. Inundation can only occur once permission is granted
- Prior to inundation, the affected section of the stone wall must be documented and photographed and this record
 must be provided to the Institute for record keeping or any other institution as directed by the Institute.

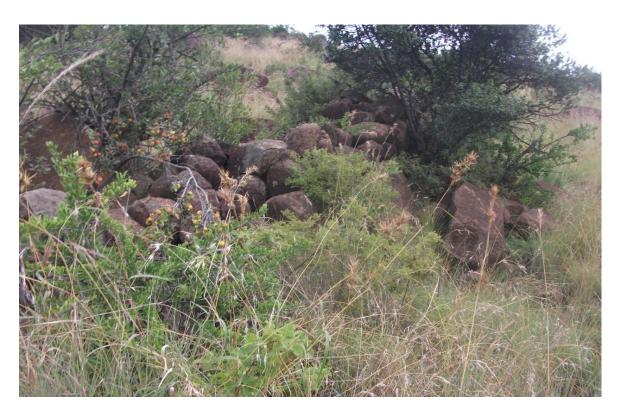
Figure 13: View of section of stone walling

30°32'26.7" S 29°28'00.4" E	Remains of stone walling (Figure 13). Low heritage significance, protected by KZN Heritage Act	A section of the wall falls within dam expansion level hence will be inundated; permit to be obtained prior to inundation.

The low stone walling found in the project area are protected in terms of section 40 of the above Act that refers to the protection of archaeological sites. In terms of section 40 (1), no person may destroy, damage, excavate, alter, write or draw upon or otherwise disturbed any battlefield, archaeological site, rock art site, palaeontological site, historic fortification, meteorite or meteorite impact site without written permission of the Institute having been obtained on written application to the Institute. This refers the inundation of sections of the stone walls as inundation will lead to damage or alteration of the walls.

The application process to the Institute for permission to alter / destroy sections of the stone walling must follow the process as set out in Section 5 of the KwaZulu-Natal Heritage Regulations of 2012.
