**Report on the assessment of potential graves by means of Ground Penetrating Radar (GPR) and archaeological test excavation at the Dwarsrivier Mine, Limpopo Province**

Project number 23076

July 2023

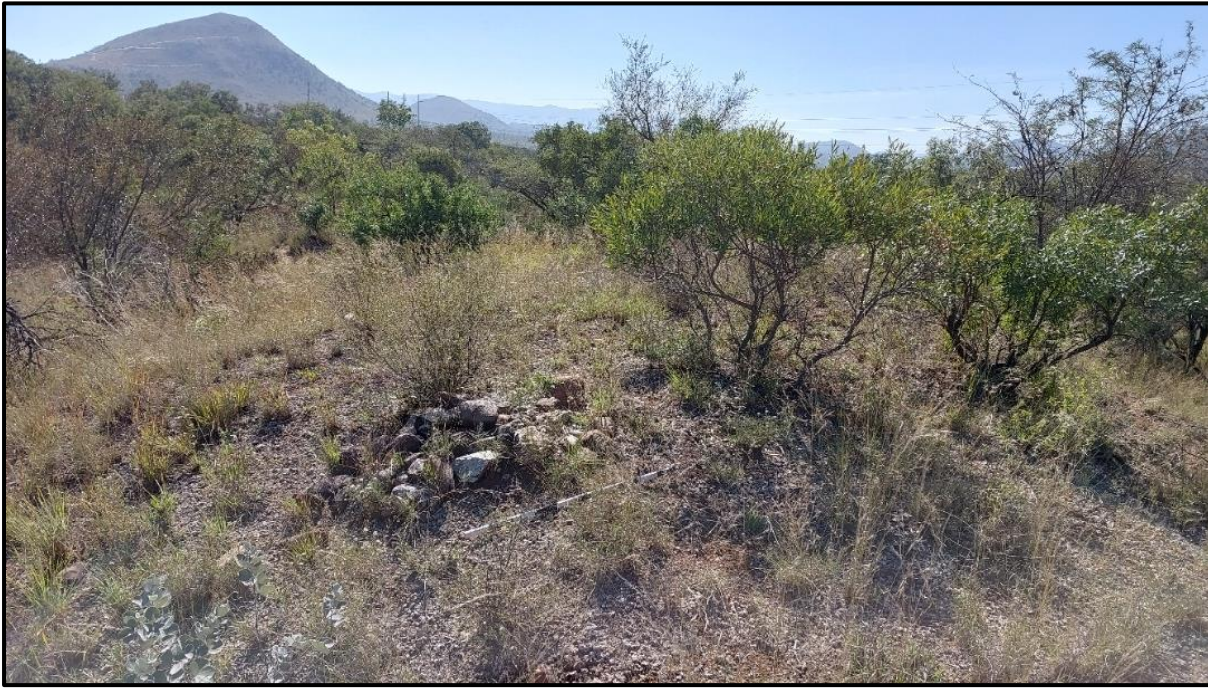
Figure 3.4. General site conditions surrounding Feature 1- Image showing the small cairn situated on top of an erosion gully with overgrown vegetation surrounding the site.

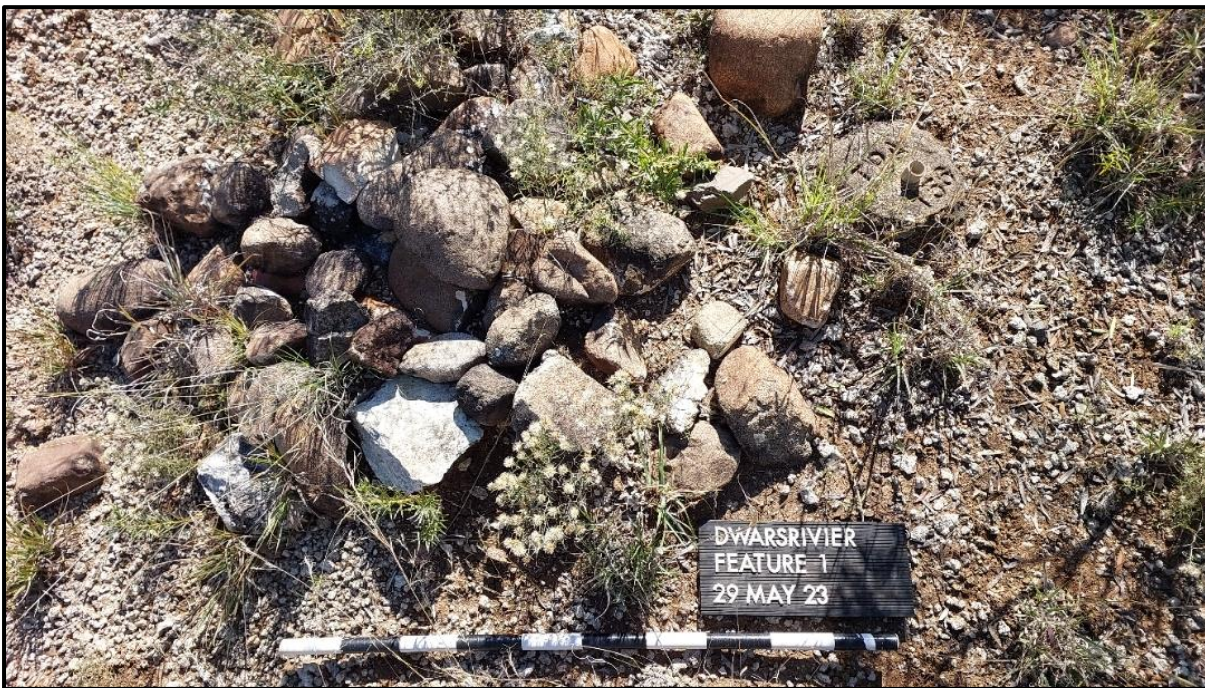
Figure 3.5. Image showing the Cairn with the small cement marker right next to it. The marker reads TPA 156.

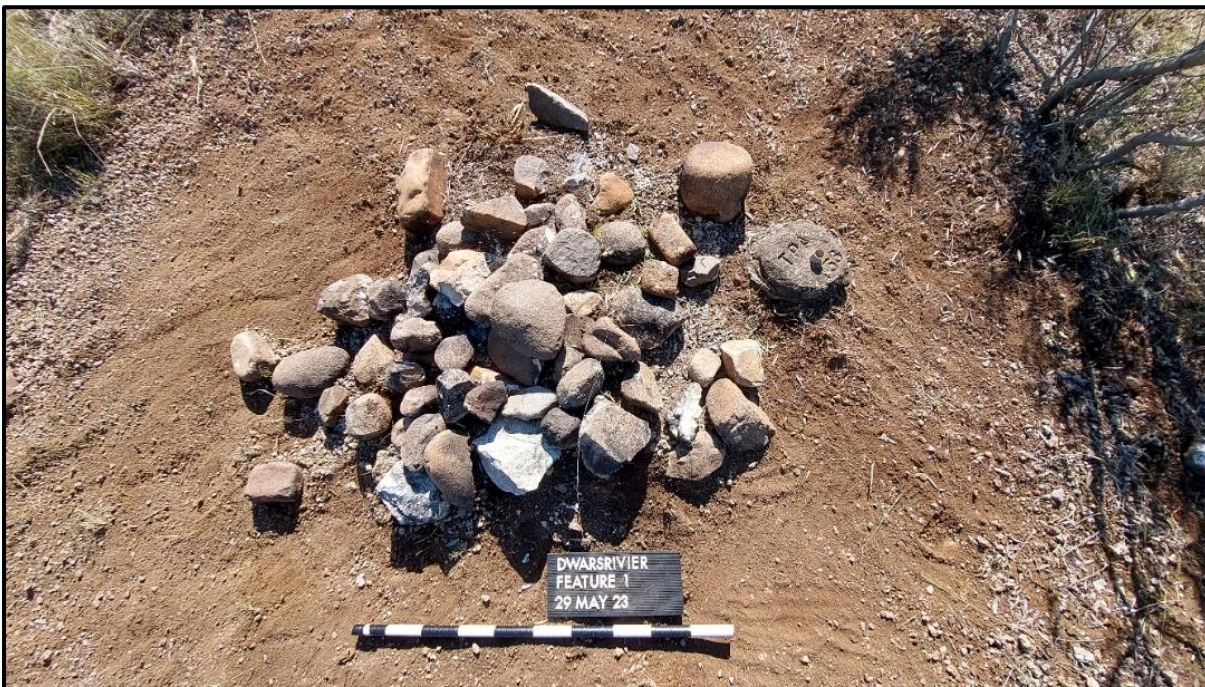
Figure 3.7. Image showing Feature 1 after the surrounding vegetation had been cleared. The white paint on some of the rocks within the cairn can be seen on this image.

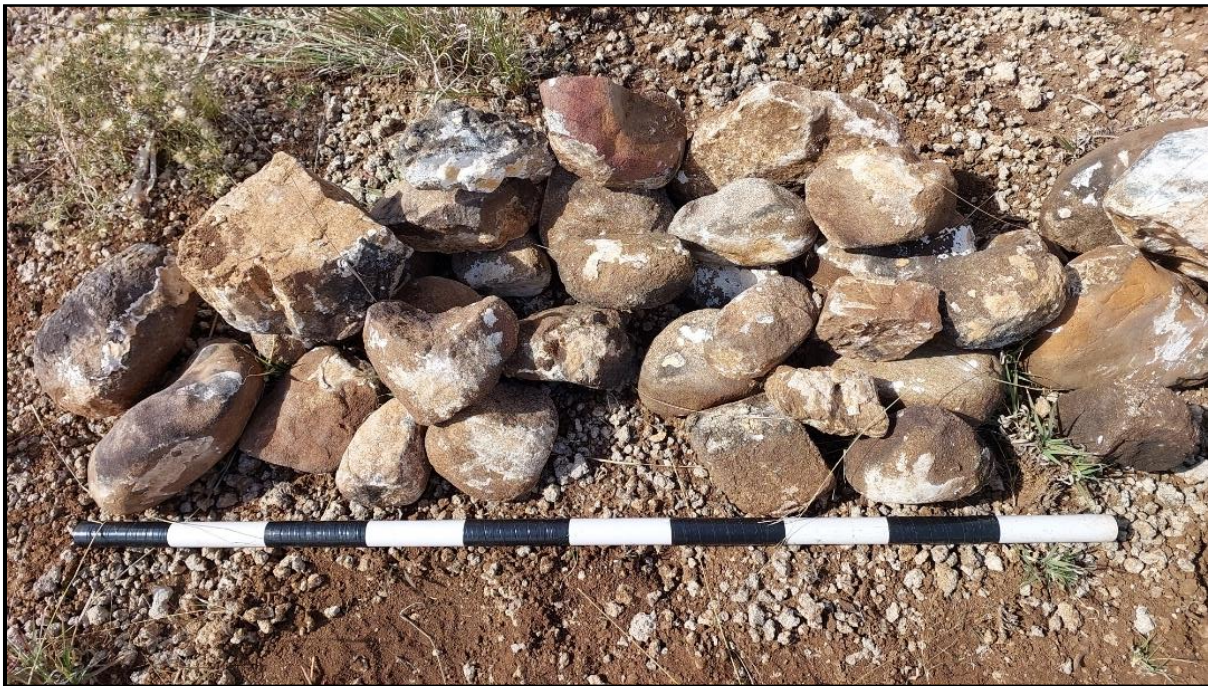
Figure 3.9. Image showing the removed stones with some evidence of white paint.

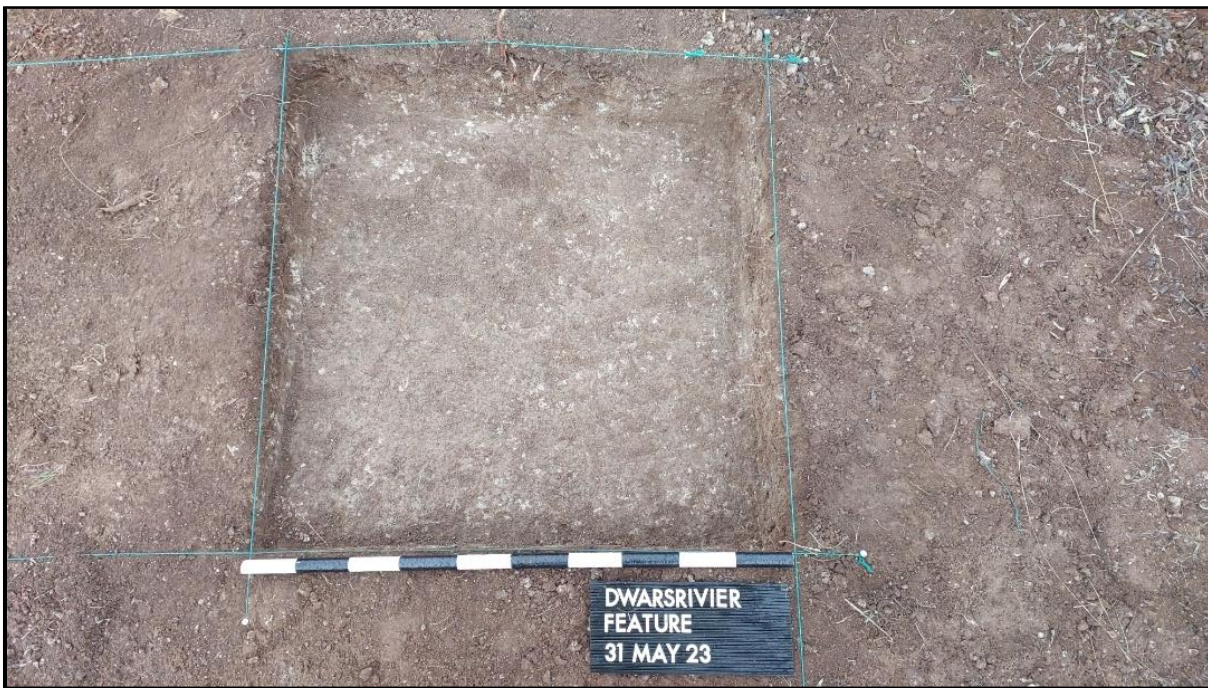
A small 1x1m test trench was set up over feature 1 to establish whether there may be a burial or any indication of a burial pit. No Evidence of a burial pit was identified during the excavation and sterile soil consisting of compacted gravel were encountered ~6 cm from the present surface level and the excavation was terminated in this undisturbed sterile layer (Figure 3.13 to 3.19).

Figure 3.13. End of excavation – Image showing sterile soil at the bottom of the test trench at feature 1.

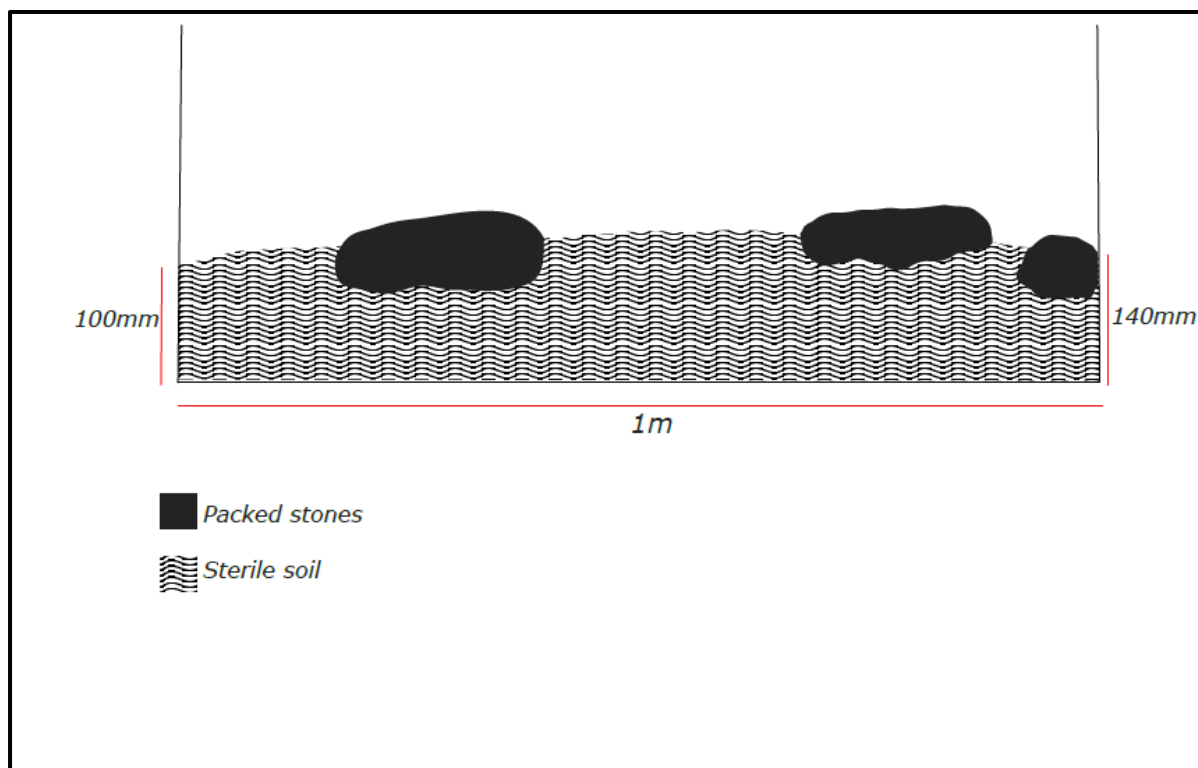
TP1 was set up on the western edge of section 1 to establish if the stones were packed or dumped at this location. It seems that the rocks were dumped here as no evidence consistent with stone wall foundations were recorded and no anthropogenic deposit noted. TP1 consists of a 1m x 0,5m Test Pit set up right over the edge of the packed stone feature (Figure 3.29).

Figure 3.29. Feature 6 TP 1 – West facing profile.

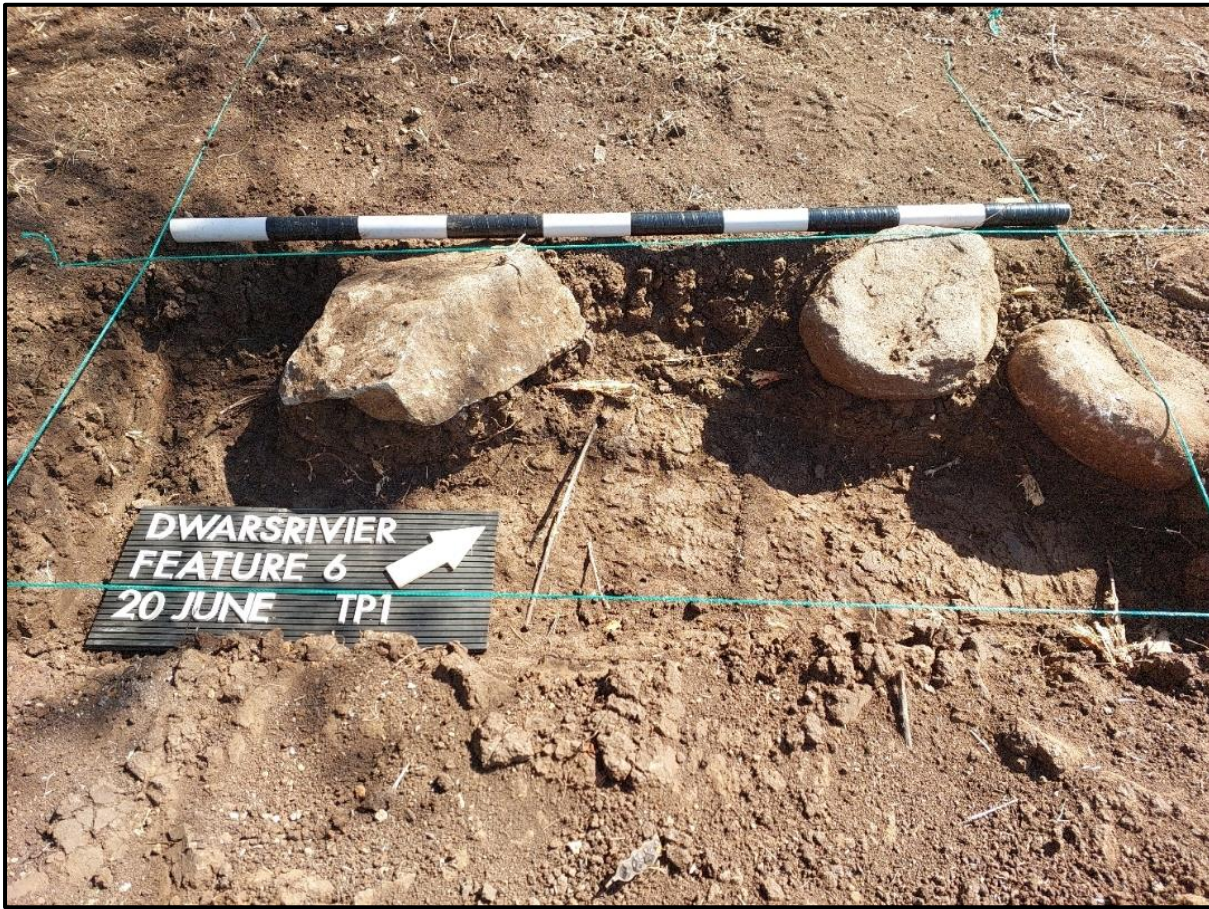
Figure 3.30. Image showing the southeast facing profile. The packed stones sit on the surface of the feature. The stones were located about 60mm from the surface. This resembles a packed stone foundation or section of walling.

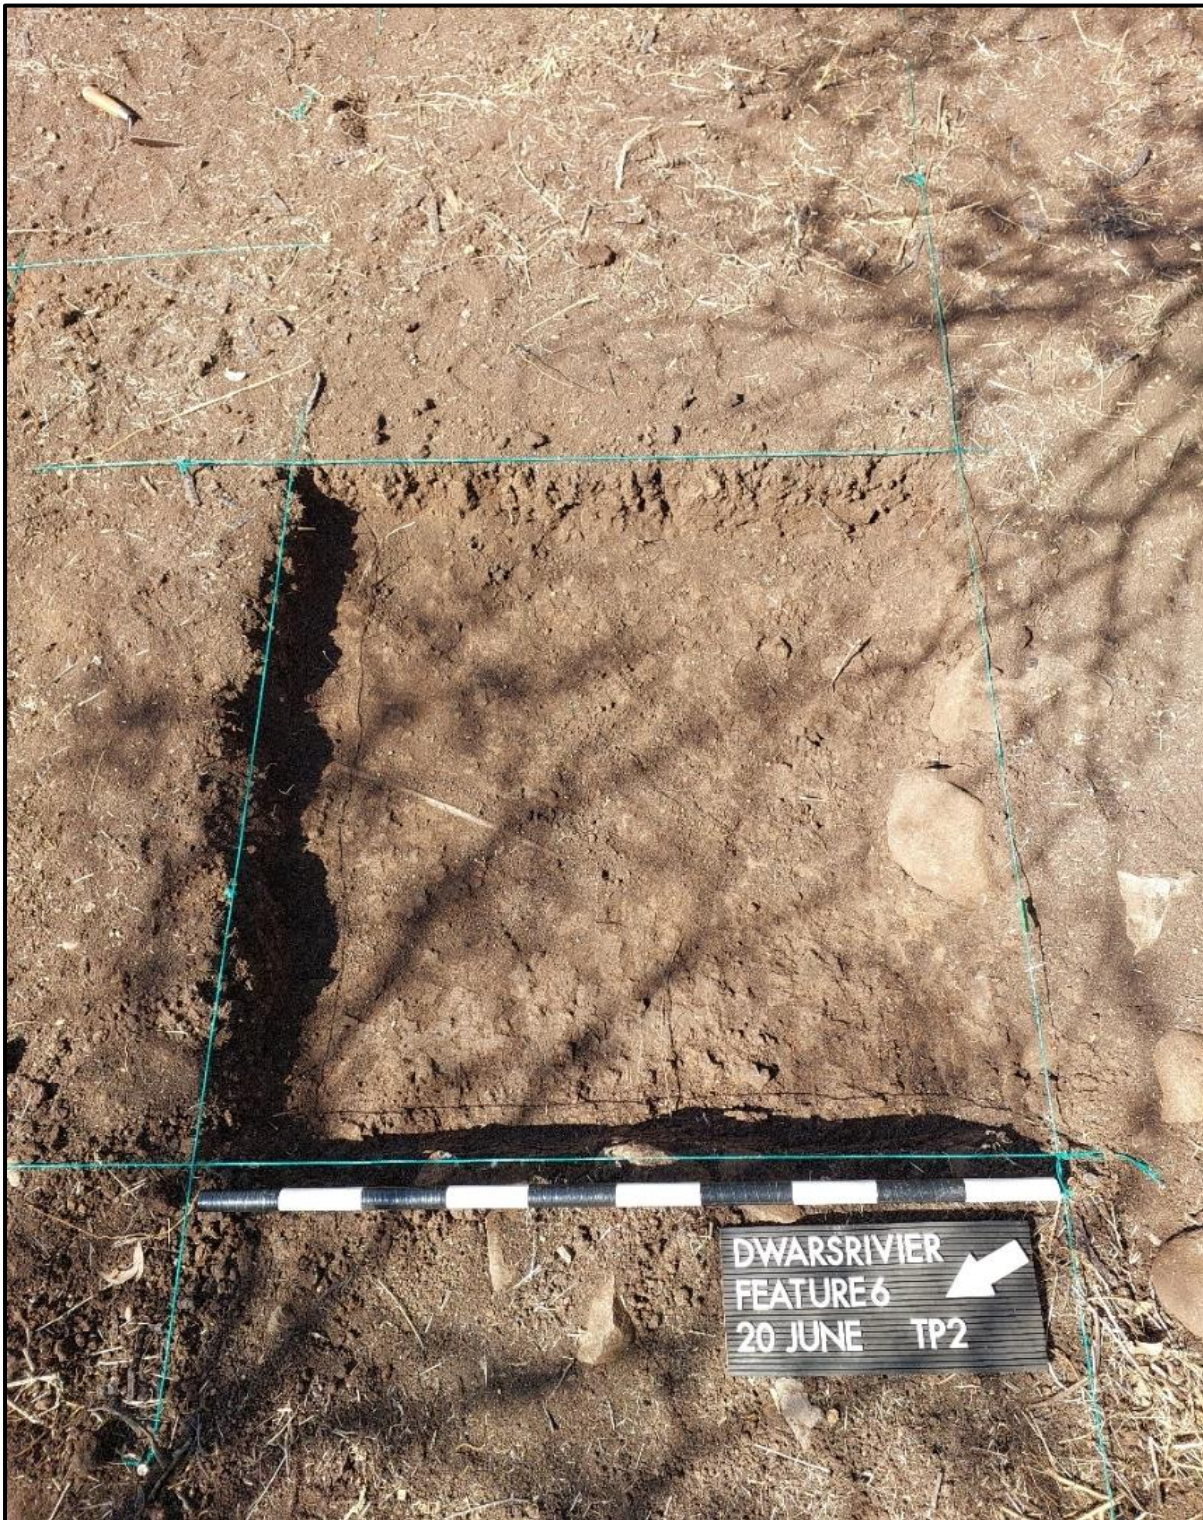
TP2 was set up to establish the depth of the packed stone feature at section 3. The grid was set up as a 1mx 1m square.

Figure 3.31. TP2 after excavation ending on sterile soil.

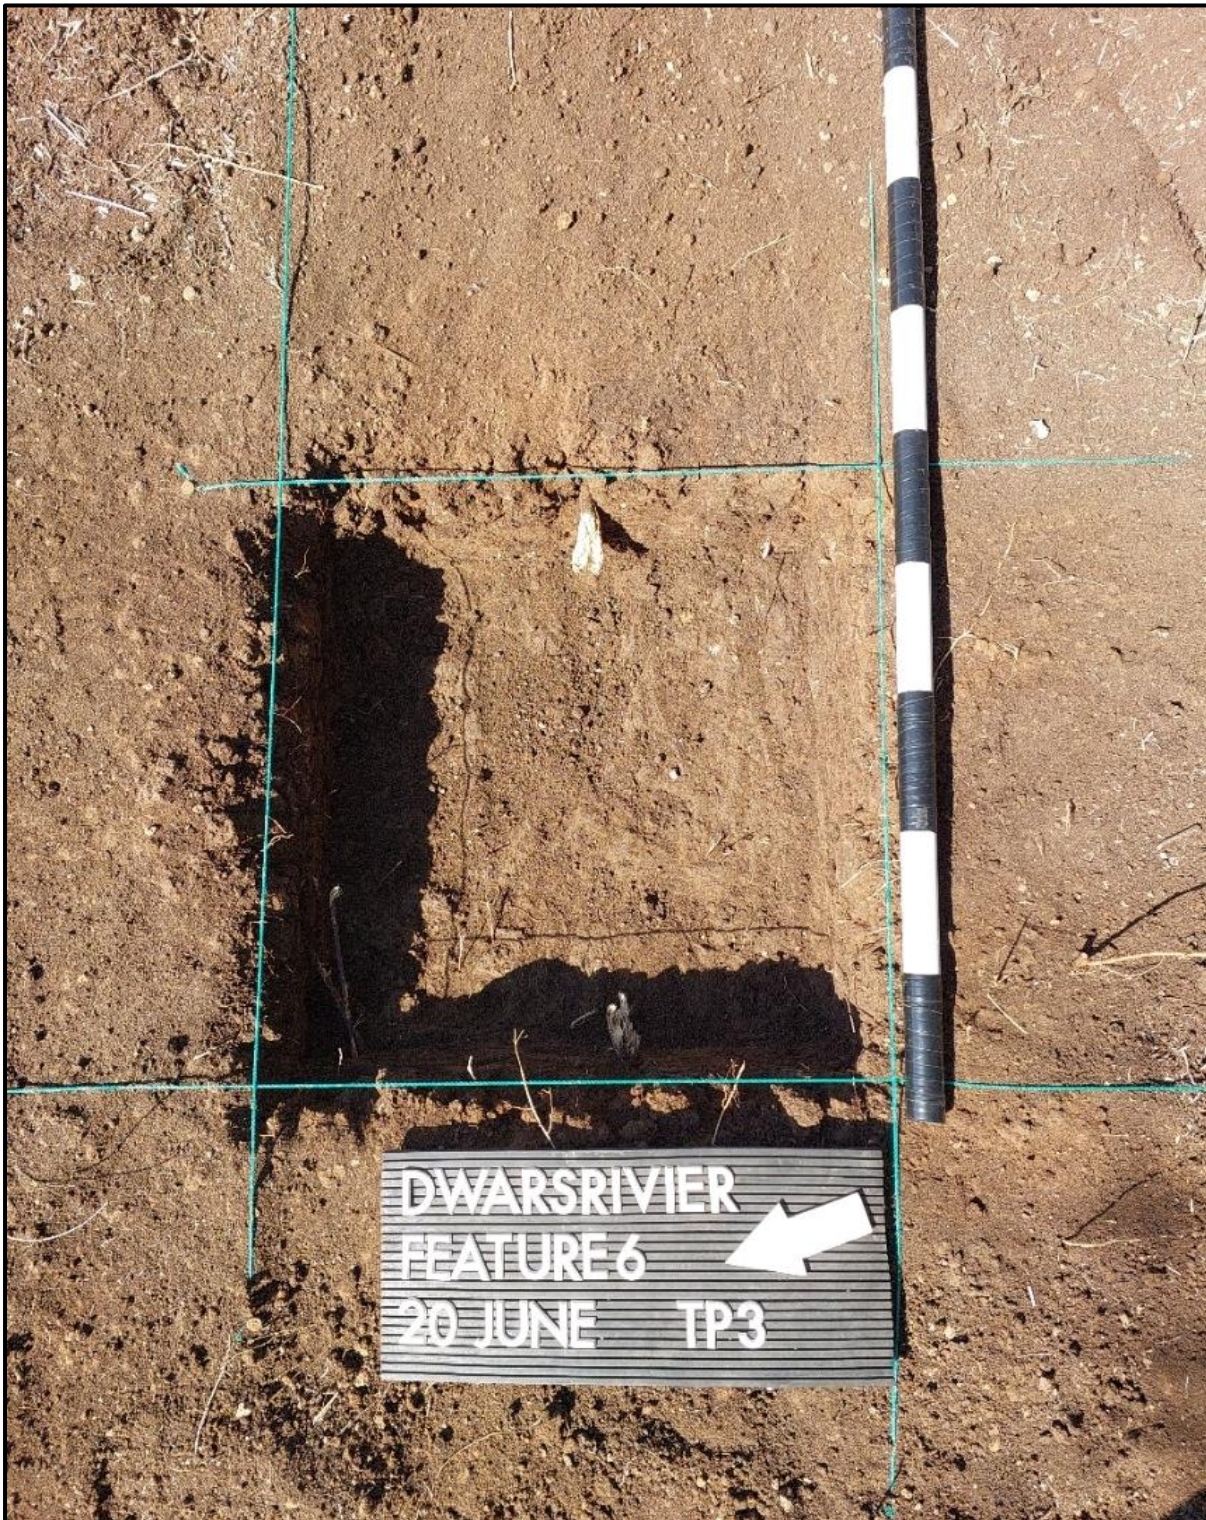
Figure 3.32. Image showing TP3 post excavation.

TP3 showed no difference in the soil layers from the other excavated pits. TP3 ended on sterile soil.

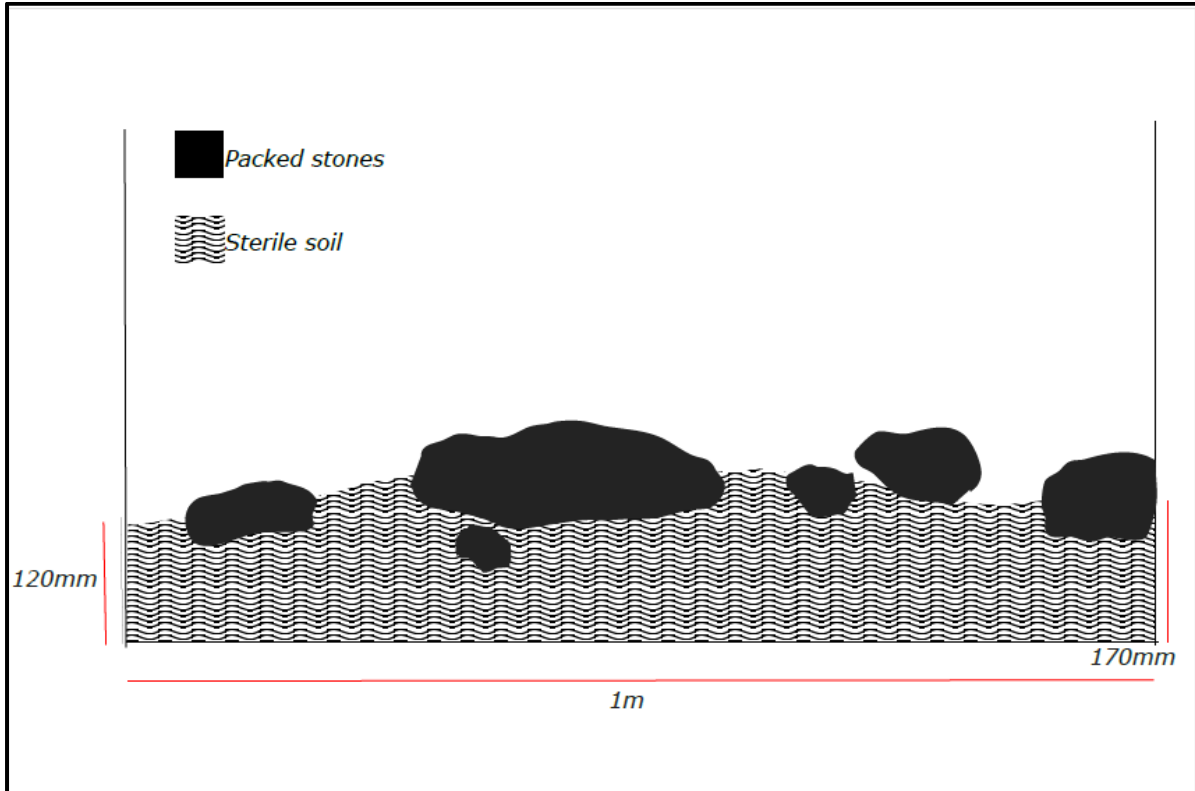
TP4 was set up as a 1m x 0,5m square on the edge of the packed stone feature in an effort to establish if the stones were packed or dumped at this location. It seems that the rocks were dumped here as no evidence consistent with stone wall foundations were recorded and no anthropogenic deposit noted. The stones are on the surface with the stones only sitting 60mm below the surface (Figure 3.33).

Figure 3.33. Feature 6 TP 4 – Northeast facing profile.

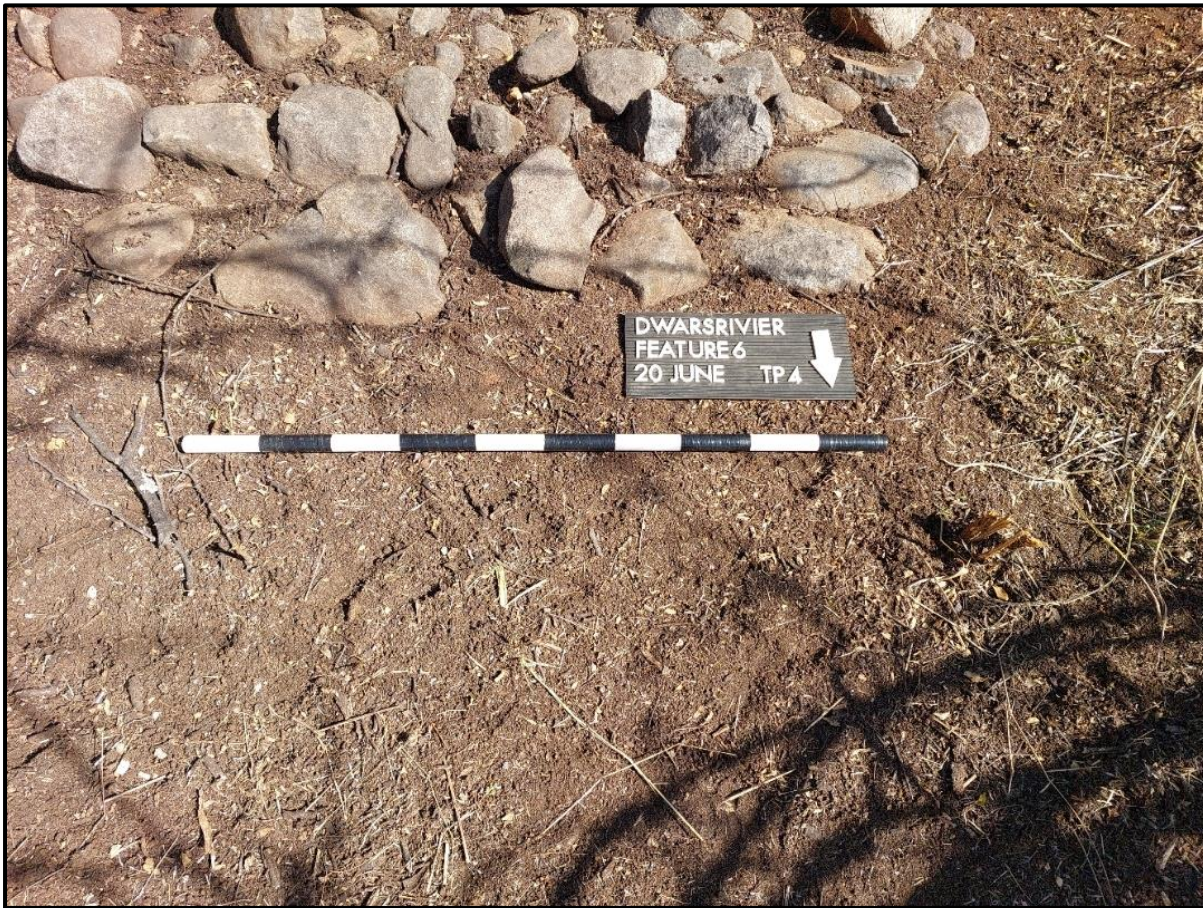
Figure 22 – A shovel test pit was set up on the north facing edge of section 4 in an effort to establish the depth and relationship of the packed stone feature.
