HERITAGE STATEMENT

NIEUWEDORP, FOUNDERS' ESTATES, BOSCHENDAL FARMLANDS, DWARS RIVER VALLEY, STELLENBOSCH

**Application submitted to SAHRA in terms of Section 27 of the NHRA
(Act No. 25 of 1999) for:**

29th November 2013

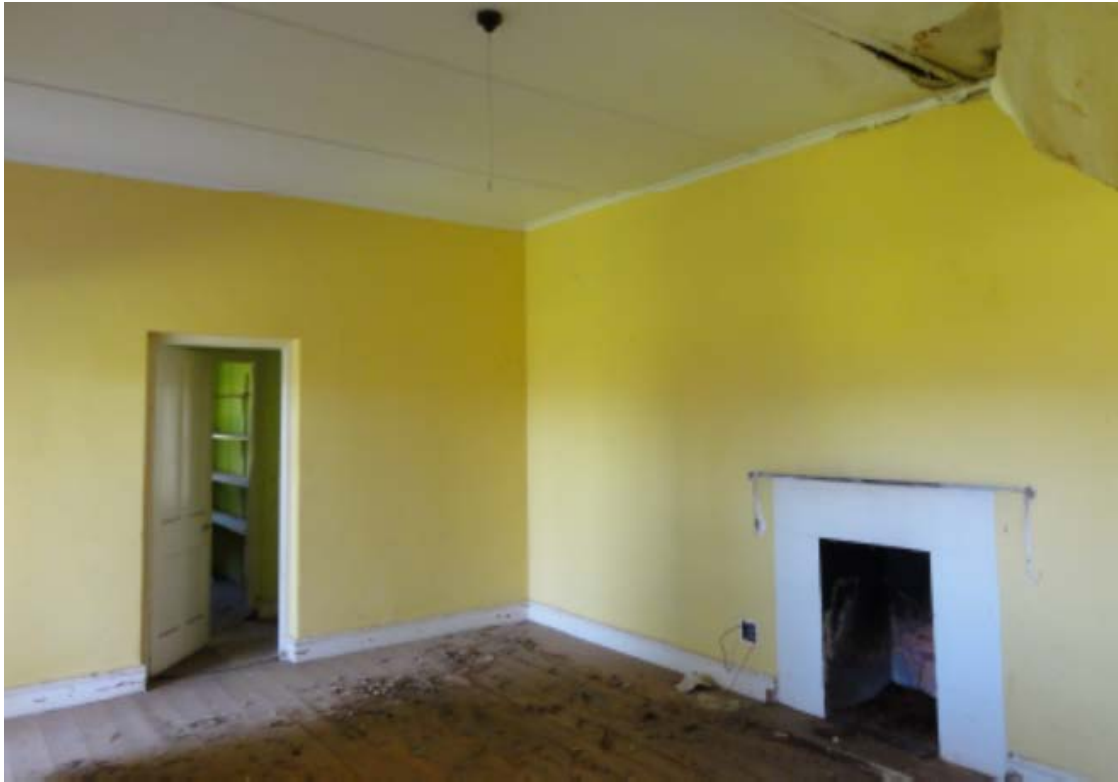
The inside of the homestead has been badly vandalized, although surviving fabric indicates that the interior would have been unexceptional, even while still intact (Figure 6). Its timber floors still survive, as do a number of four panel early 20th century doors, and the front door. Some timber casement windows remain on the front façade, although those in the projecting front bays appear to be subsequent meranti replacements, now also vandalized. Fenestration in the other facades is steel framed and clearly replaced earlier timber windows. The interior contains at least some beam and boarded ceilings, although it difficult to determine whether they extend throughout the house due to subsequent dropped ceilings. Timber ceilings are visible in the kitchen and pantry areas (Figure 7). The courtyard which once existed between the two rear wings of the building has been roofed over and enclosed.

Figure 6: The architecturally non-descript interior of the Nieuwedorp homestead. A surviving four-panel early 20th century door is visible on the left. The very plain fireplace has lost its mantle and it clearly never had a fireplace surround other than some plain joints run into the plaster simulating a stone surround. The plain plasterboard and cover strip ceiling may conceal a timber ceiling similar to that indicated in Figure 7. Although there is a floor skirting, note the absence of picture rails and door architraves. (Image: Graham Jacobs, 21 November 2013).

- A number of the homestead's internal four panel doors survive, including one found in the northern end of the long barn. These must be retained and re-used, focusing on the area around and visible from the central living/dining room. All other surviving homestead doors are also to be retained or where necessary, reinstated including the back door to the kitchen.
- The heights of the proposed new openings leading off the living/dining room should align with the lintol heights of existing doorways.
- The extent of the period beam and board ceilings in the house is unknown due to the subsequently installed 'dropped' plasterboard ceilings in some of the rooms.

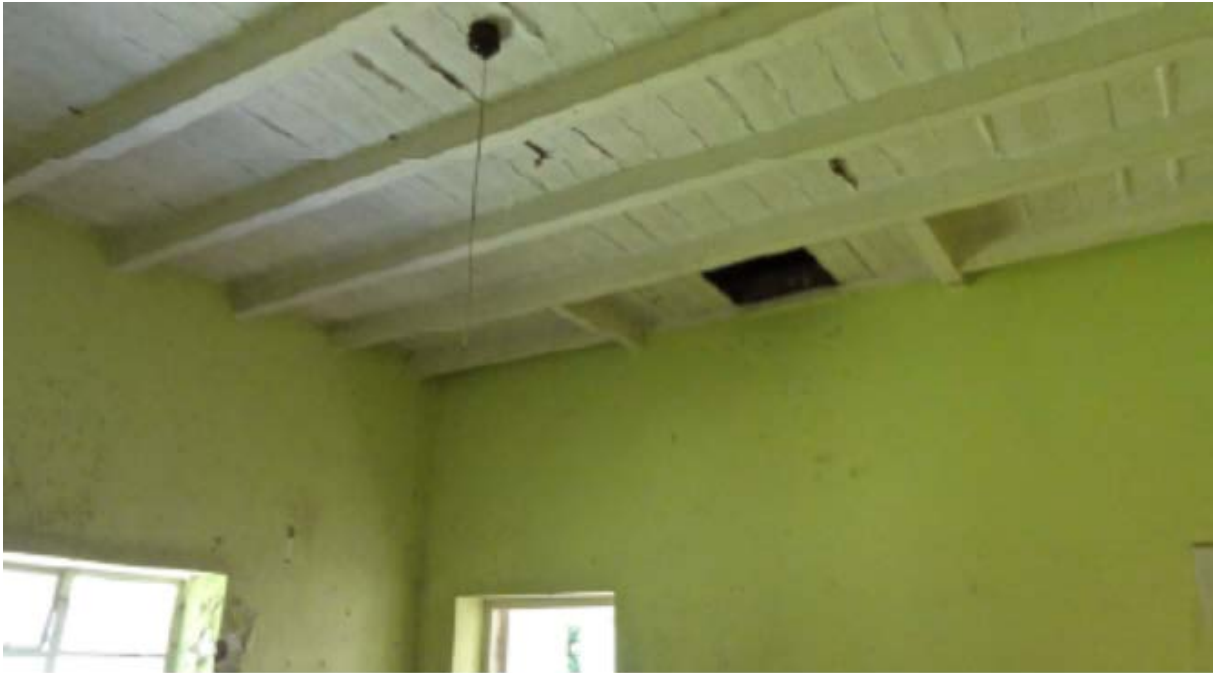
Figure 7: Plain un-moulded beam and board ceiling in the kitchen. Similar ceilings are visible in the adjacent pantry and one of the bedrooms on the opposite side of the house. Other similar ceilings may exist above dropped ceilings in the remainder of the house. The kitchen stove alcove has long since been removed. (Image: Graham Jacobs, 21 November 2013).

Wherever beam and board ceilings are encountered, these should be retained, renovated and left exposed as part of the interior.

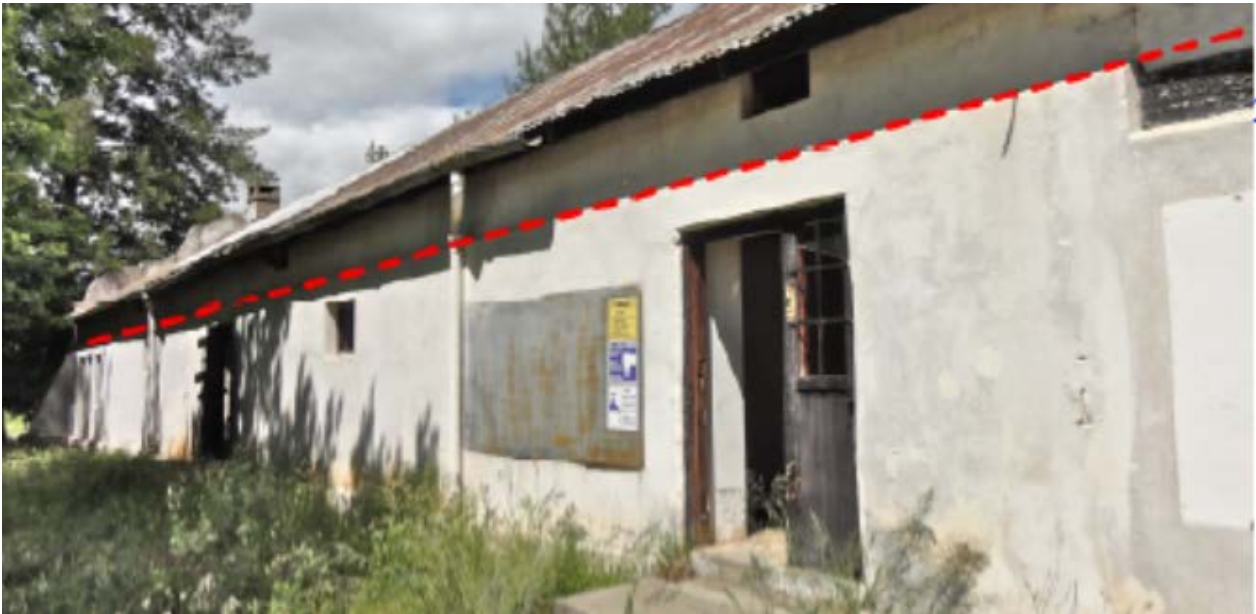
Figure 9: Close-up view of the Nieuwedorp long barn indicating the old thatch eaves line (indicated with the broken red line). Wall fabric below this line is thicker and clearly earlier. The masonry above this line indicates where the walls were raised to incorporate loft vents at the time the roof was converted from thatch to corrugated iron. (Image: Graham Jacobs, 21 November 2013)

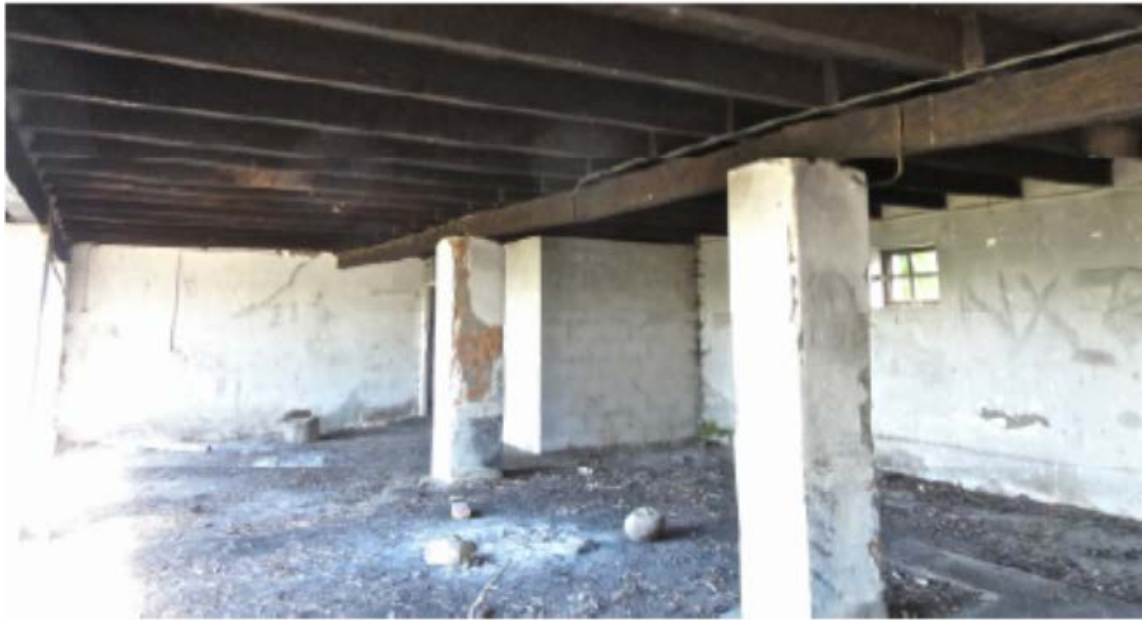
Figure 10: Close-up view of the Nieuwedorp long barn north end interior showing the substantial timber lintol/rafter and spine beam construction required to support the loft floor across the wide span of the building. (Image: Graham Jacobs, 21 November 2013)

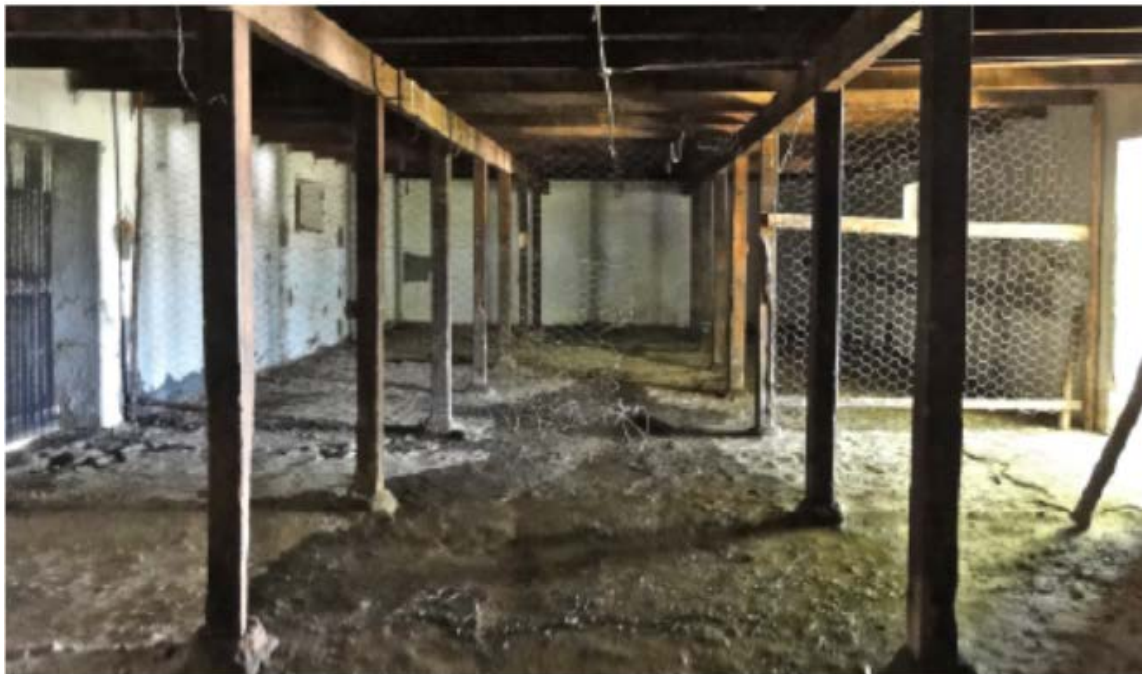
Figure 11: Interior view of the second interior section of the barn showing a different spine beam construction compared to Figure 10. This area has a cobbled floor and animal stalls. (Image: Graham Jacobs, 21 November 2013)

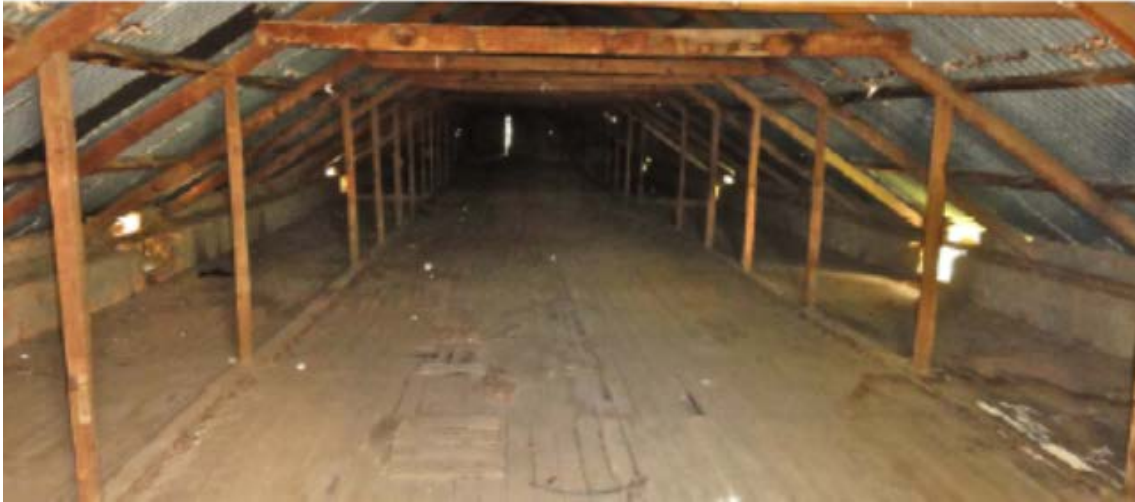
Figure 12: Loft interior of the long barn showing the typical lightweight construction associated with a corrugated iron roof. (Image: Graham Jacobs, 17 October 2013)

- In order to properly secure the external envelope of the building, various windows will need to be repaired and re-glazed, and a number of doors will need to be reinstated. No details of replacement/reinstated doors have been supplied by the architect, although there would be no objection in principle to the use of simple, vertically boarded flb type doors on the structure. It is particularly important that the loft doors are properly secured, as the loft floor does not appear to be all that stable.

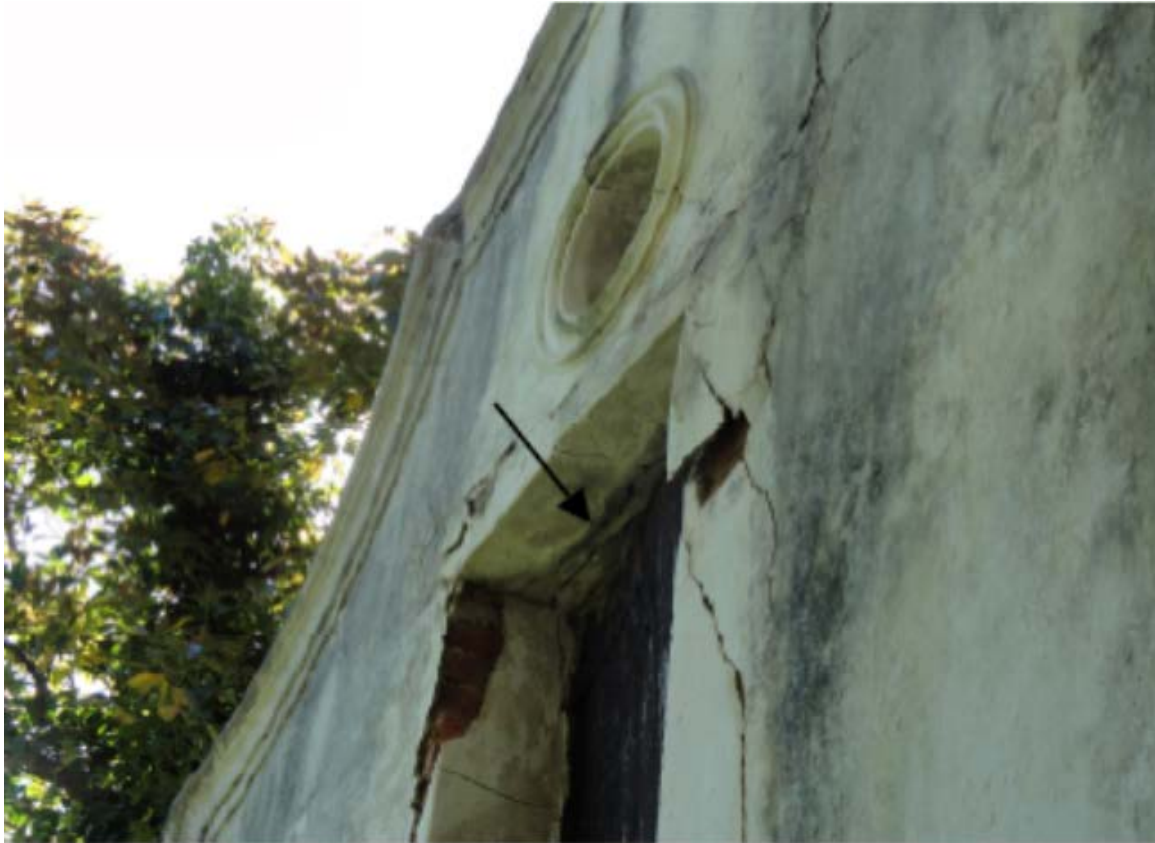
- There are strong signs of structural cracking on the southern end of the building, which appear to be the result of outward thrusting loads in the vicinity of the loft door. Refer to Figure 19. This will require the attention of a structural engineer with input from the heritage architect.

Figure 19: The southern gable end of the barn indicating structural cracking around and above the loft door. Note also the signs of earlier patching (arrowed). (Image: Graham Jacobs, 21 November 2013)

- Repair and stabilize structural cracks in the southern gable end: to structural engineer's specification prepared in conjunction with an accredited heritage architect.
- Replace all roof sheeting with corrugated iron longspan roof sheets.
- Replace all gutters – preferably with ogee profile seamless aluminium gutters and PVC round section downpipes.
- Fix all roof and other leaks; make good using materials compatible with the affected existing fabric.

- All exposed cracked gable and parapet cappings are to be carefully prepared and coated with 'Midas Fiberforce' or equal approved, and over coated with an approved 'breathable' acrylic paint, all as stated in v) above, while taking care that the 'Fiberforce' does not extend onto outward facing gable faces, particularly if these are to be limewashed.
