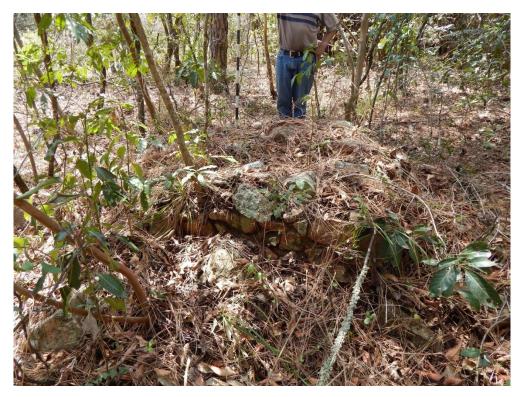
Fig. 21: Ruins on the farm in the eastern section (outside of the study area)

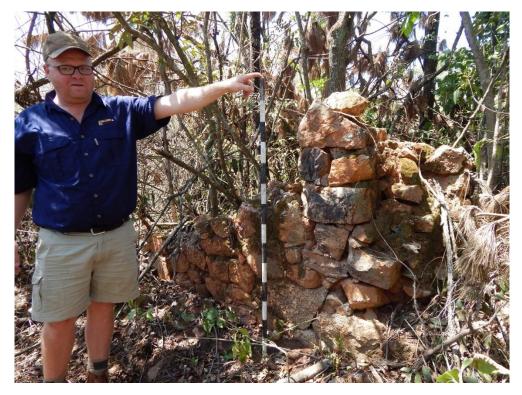
Fig. 22: Square ruins of an old house in the eastern section (outside of the study area).

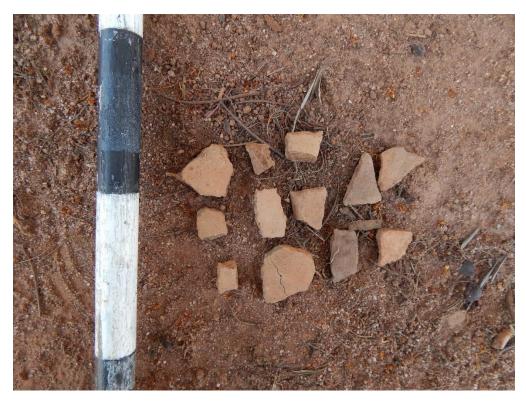
Fig. 23: Fragments of clay potsherds in the eastern section, which are associated with the ruins in figs. 21 & 22 (outside of the study area).

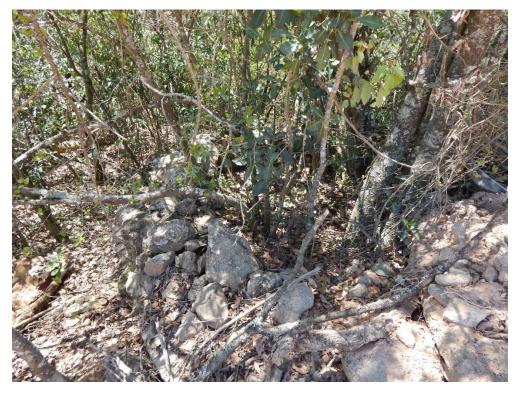
Fig. 24: A Late Iron Age stone wall in the eastern section (outside of the study area).

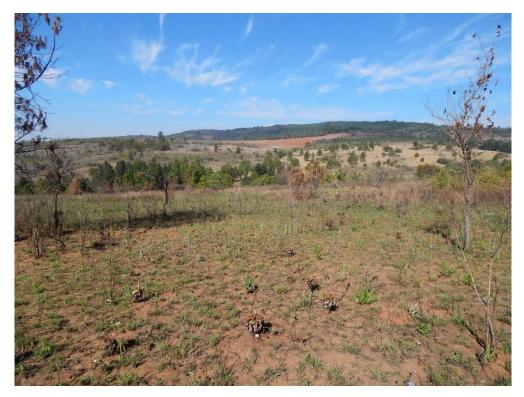
Fig. 25: The area, roughly in the middle of the farm was previously cultivated lands.

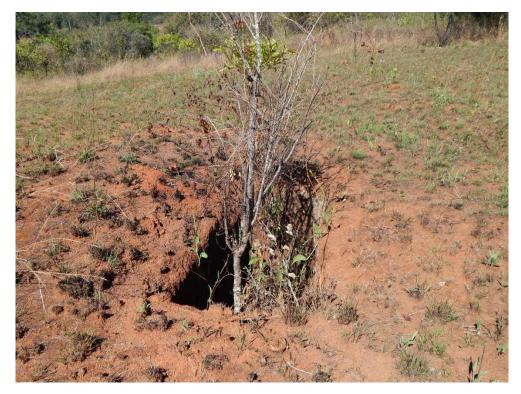
Fig. 26: A recent prospecting trench.

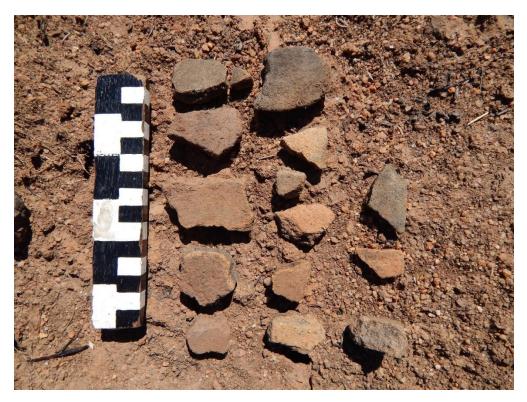
Fig. 27: Many fragments of clay potsherds were observed in the previously cultivated fields.

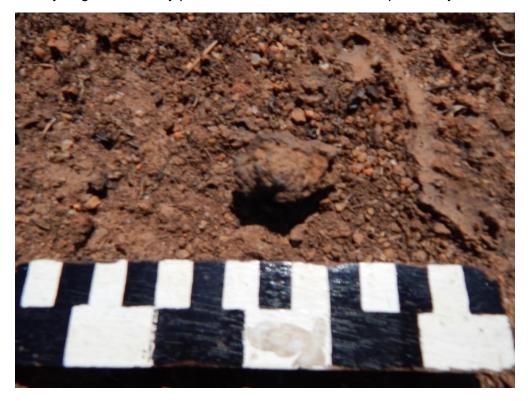
Fig. 28: One piece of iron slag was found in the middle of the study area.

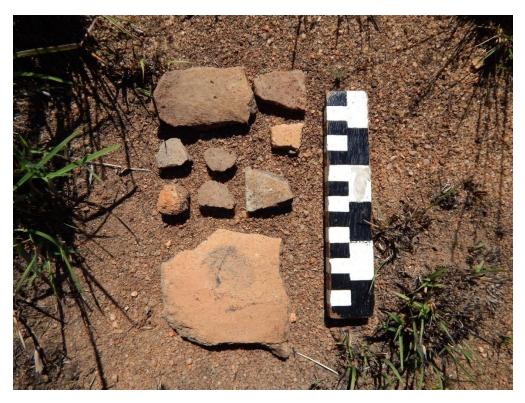
Fig. 29: The clay potsherds varied in color and thickness.

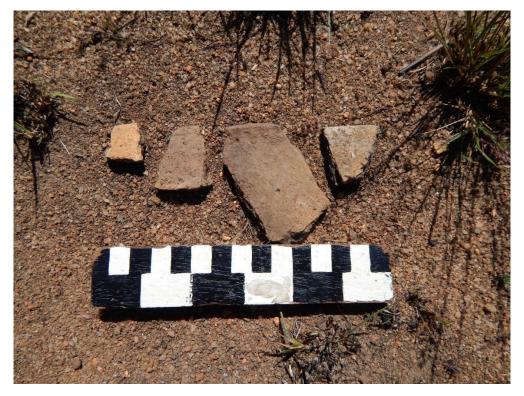
Fig. 30: A few clay potsherd fragments with rim sections.

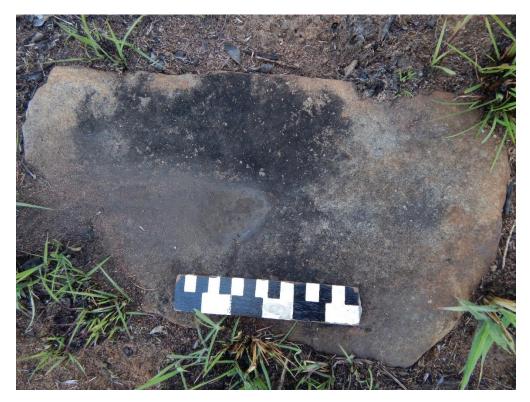
Fig. 32: A lower grinder in the southern section.

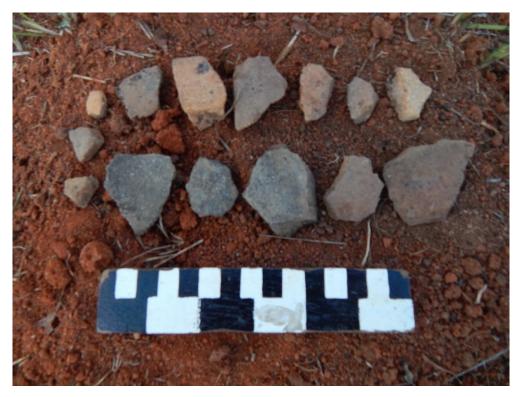
Fig. 33: Fragments of clay potsherds in the southern section.

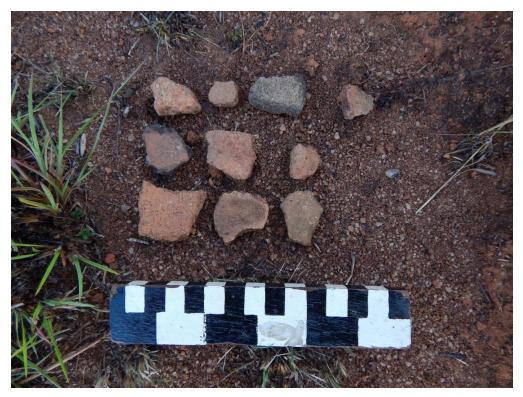
Fig. 34: More fragments of clay potsherds in the southern section.

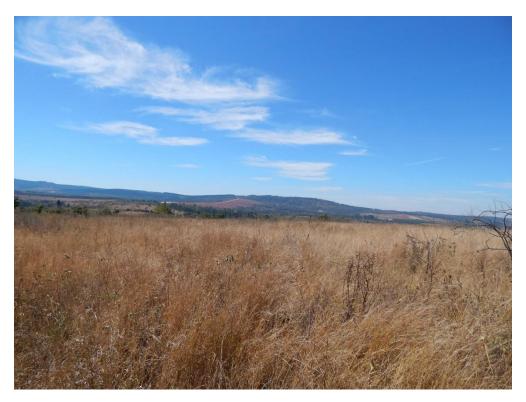
Fig. 35: Sections in the middle of the study area did not burn, which made visibility difficult. However, the 1936 aerial maps show these areas as previously cultivated lands.

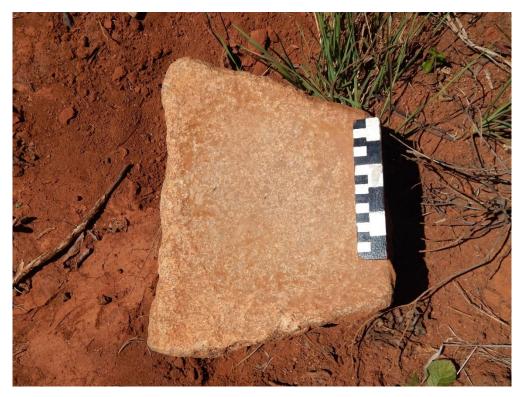
Fig. 37: A lower grinder in the middle section.

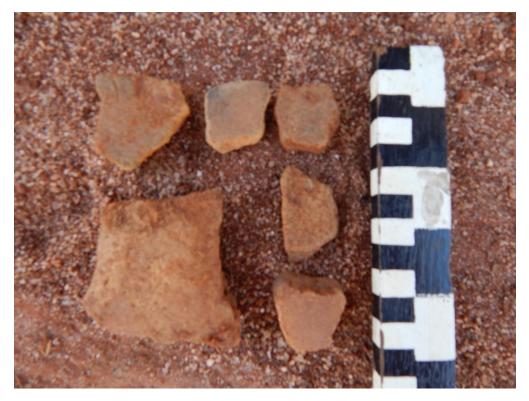
Fig. 38: Some clay potsherds in the middle section.

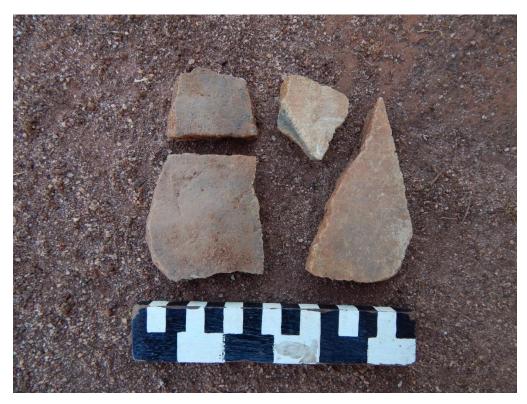
Fig. 39: More clay potsherds in the middle section.

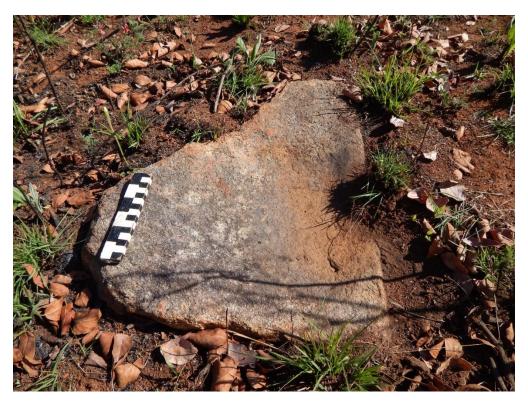
Fig. 41: The north-eastern section of the study area: Lower grinders and potsherds were observed in previously cultivated lands

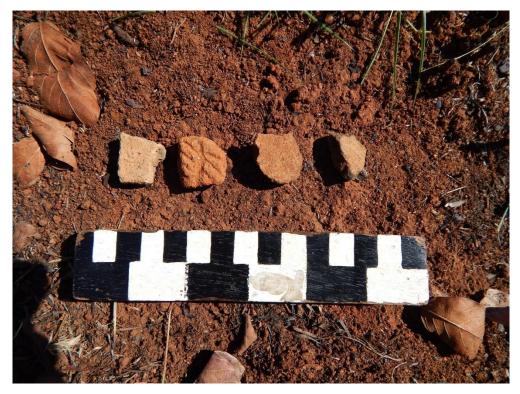
Fig. 42: One clay potsherd had a distinct incised pattern.

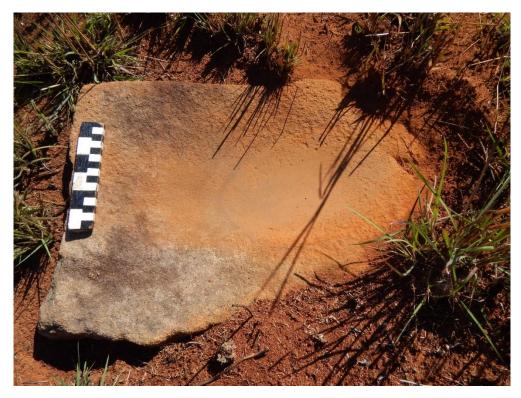
Fig. 43: Several lower grinding stones were observed in the northern section.

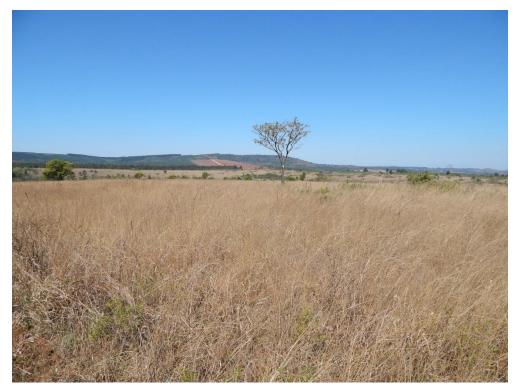
Fig. 44: Sections which did not burn were difficult to survey, but these sections were previously cultivated lands.

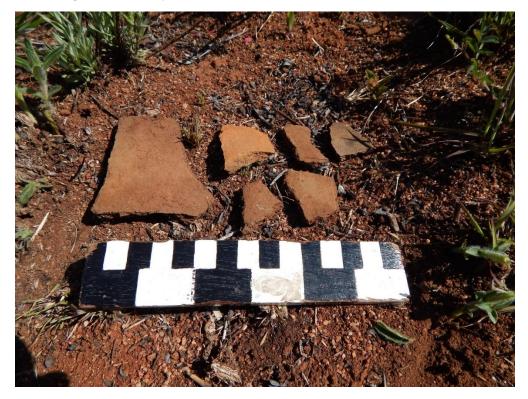
Fig. 46: Clay potsherds were scattered in the northern section, and even in the access roads.

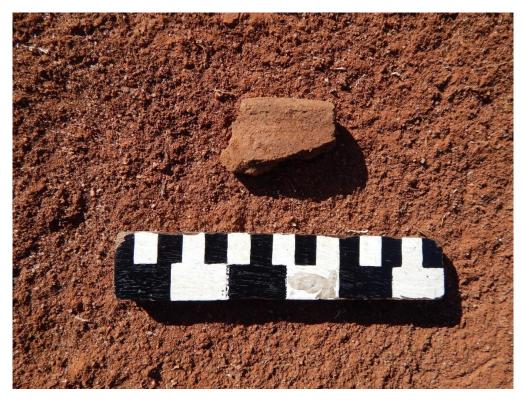
Fig. 47: A clay potsherd with a rim in the northern section.
