APPENDIX 2: PHOTOGRAPHIC DOCUMENTATION LOWS CREEK 2022

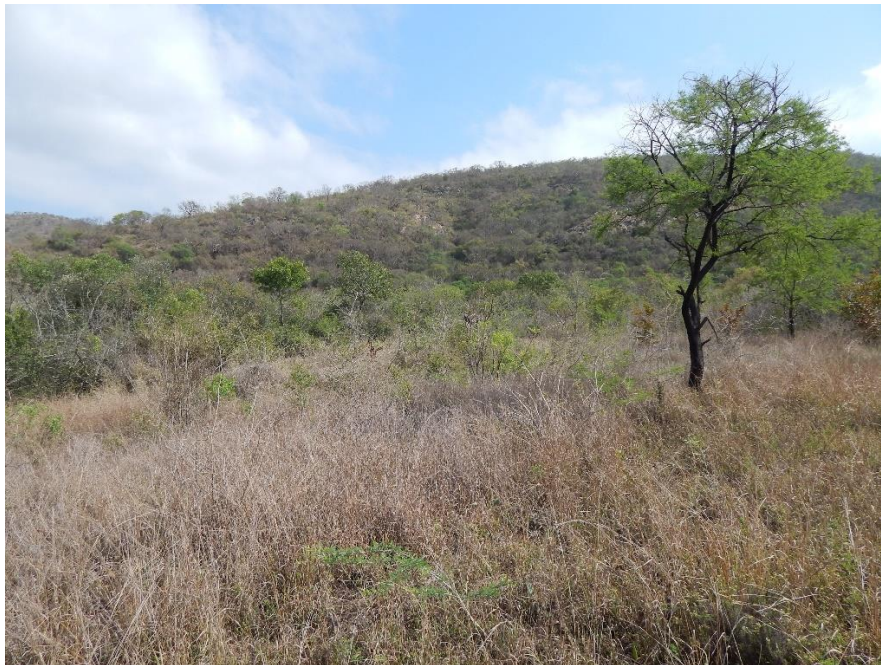
Fig. 2: The western section was overgrown, but also infested with Sickle Bush.

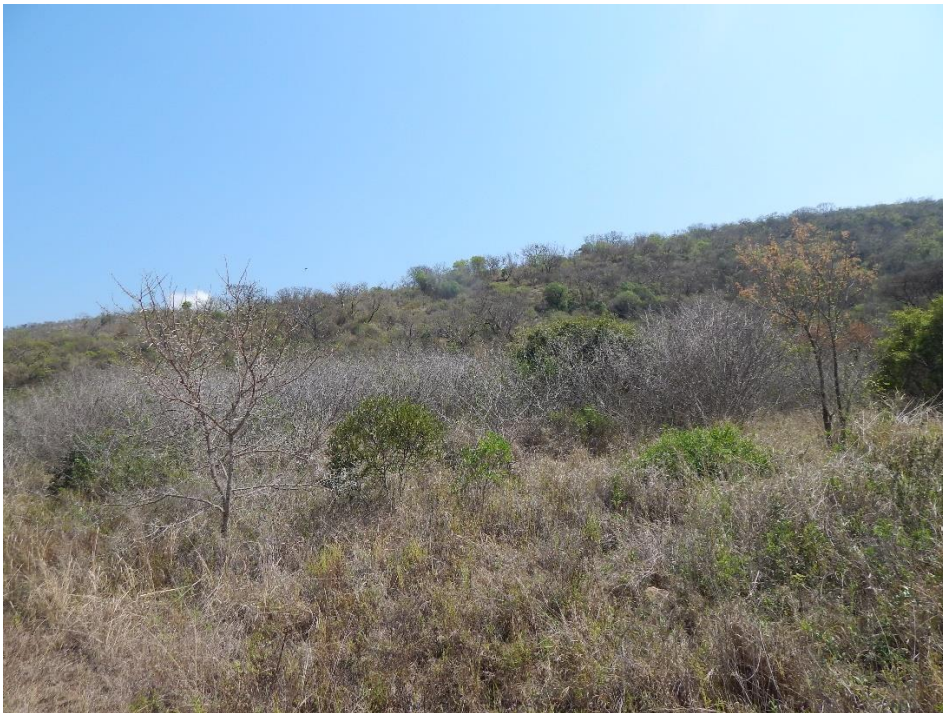
Fig. 4: Sickle bush has taken over large areas in the western section.

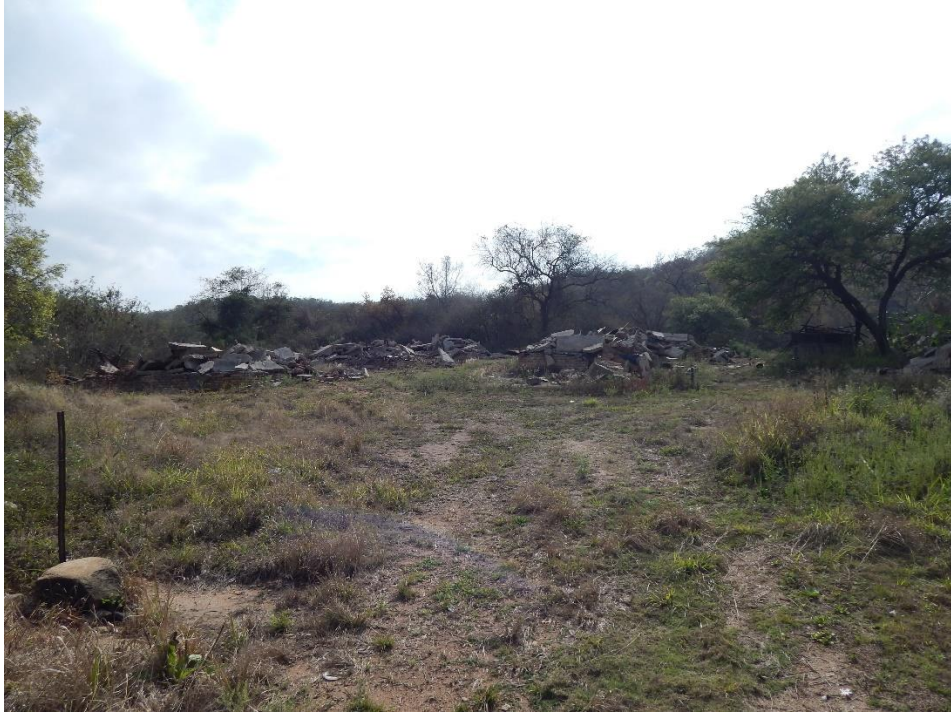
Fig. 9: A large hostel was present on the farm, but was recently demolished by the owner.

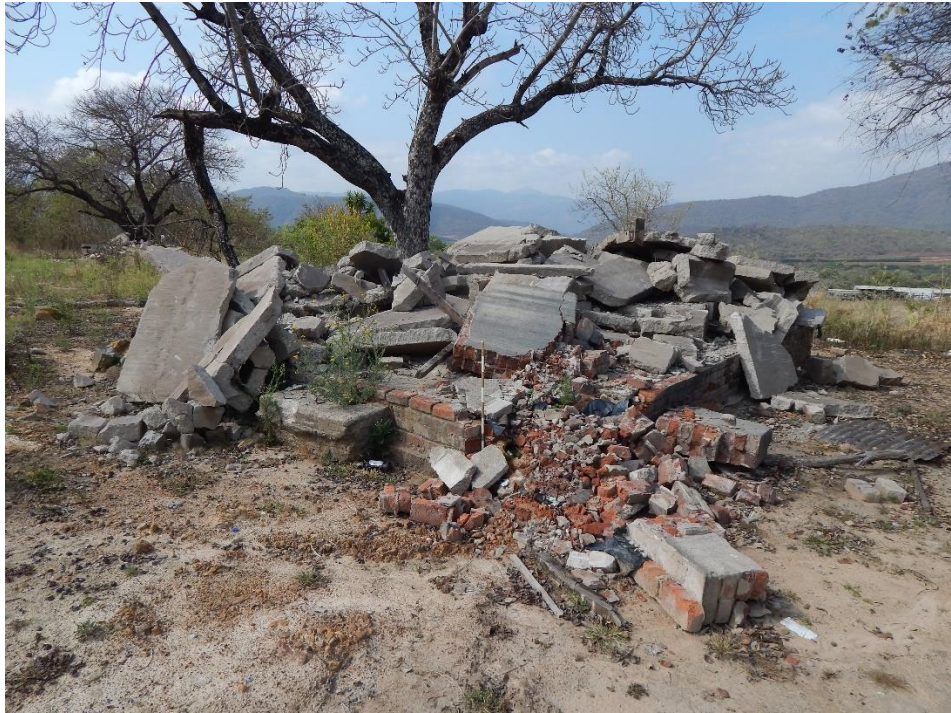
Fig. 10: The hostel / compound area is of a recent nature and is of no significance.

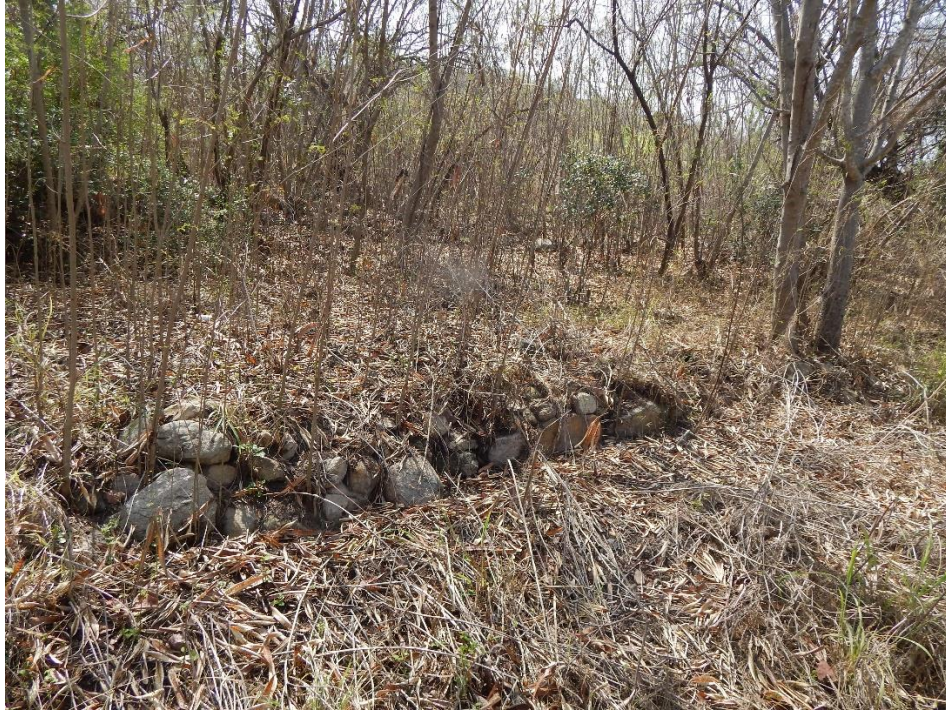
Fig. 11: Stone foundations towards the east, indicate where more compound / hostel houses were, before they were demolished. It is currently covered with alien vegetation.

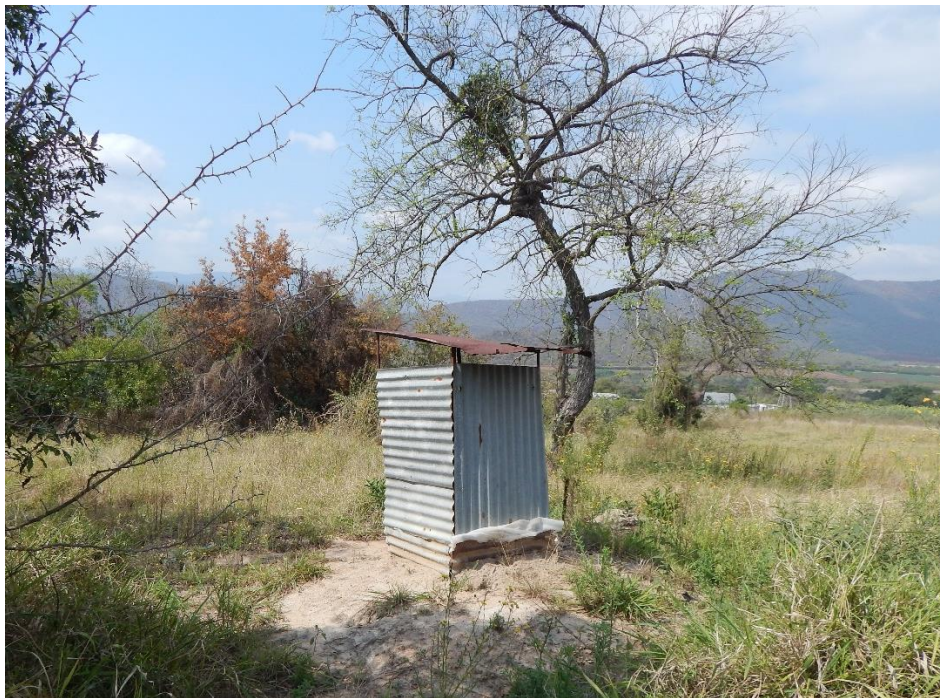
Fig. 12: A pit toilet is still visible near the hostel, and close to the southern border.

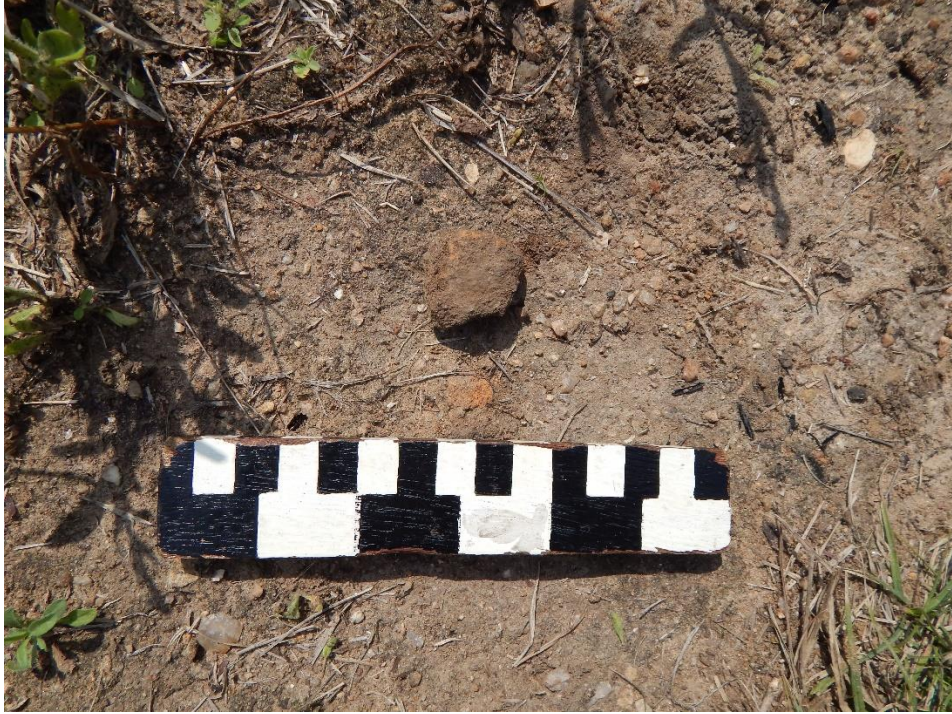
Fig. 15: A single clay potsherd was observed within a disturbed road section.

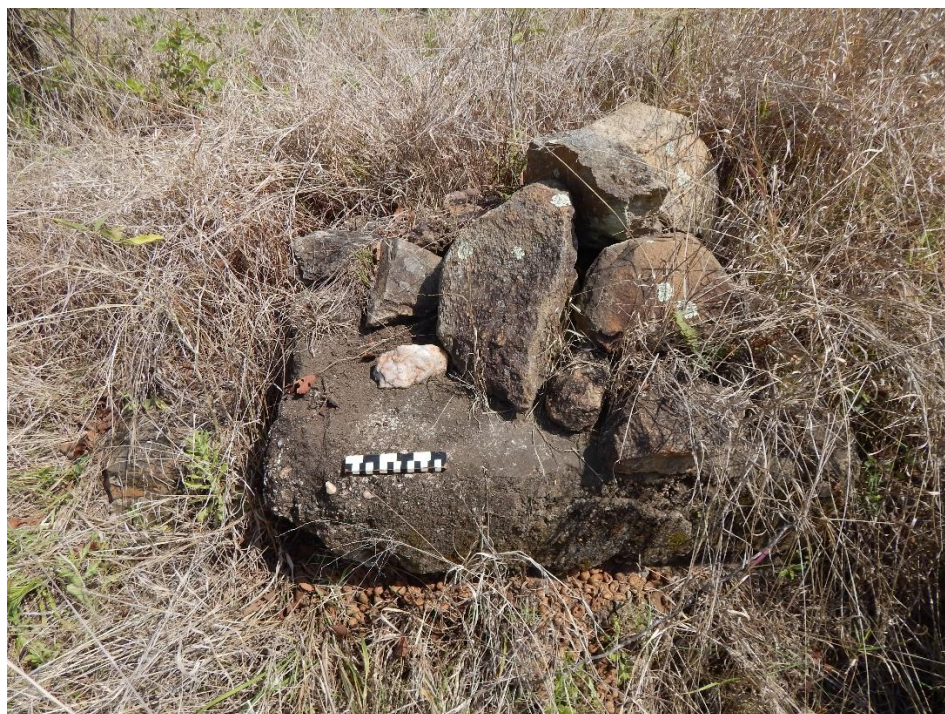
Fig. 18: A concrete foundation was observed in the eastern section, a few meters from the water canal, but the previous or current owners did not know what the use of this structure was.

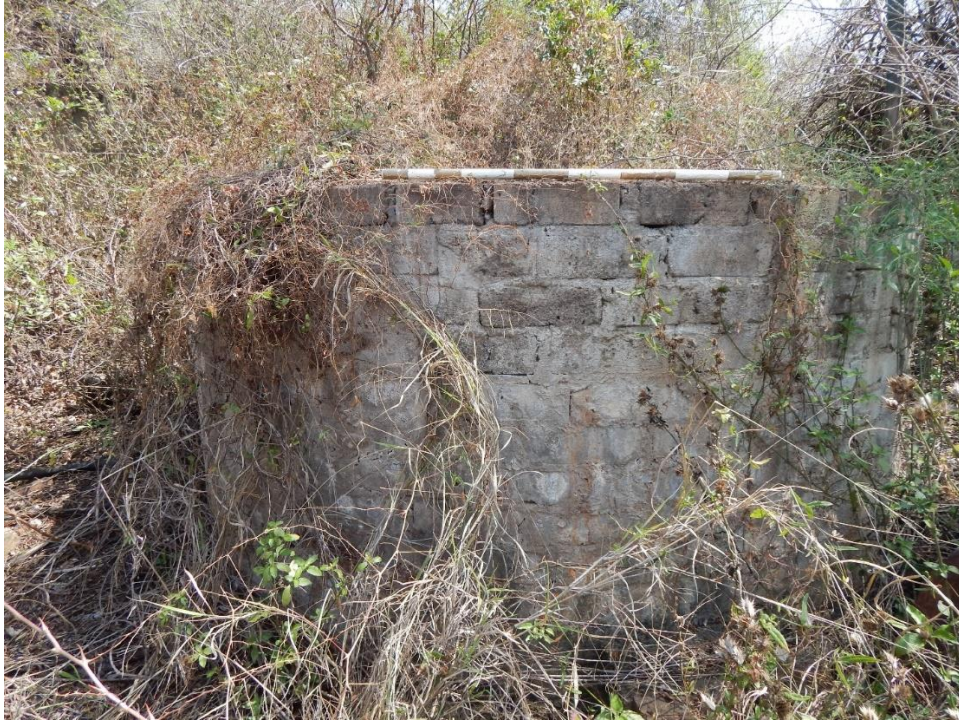
Fig. 21: Concrete / brick water tanks were observed in the eastern section of the study area. Water for the Clinic, was supplied from here in the past.

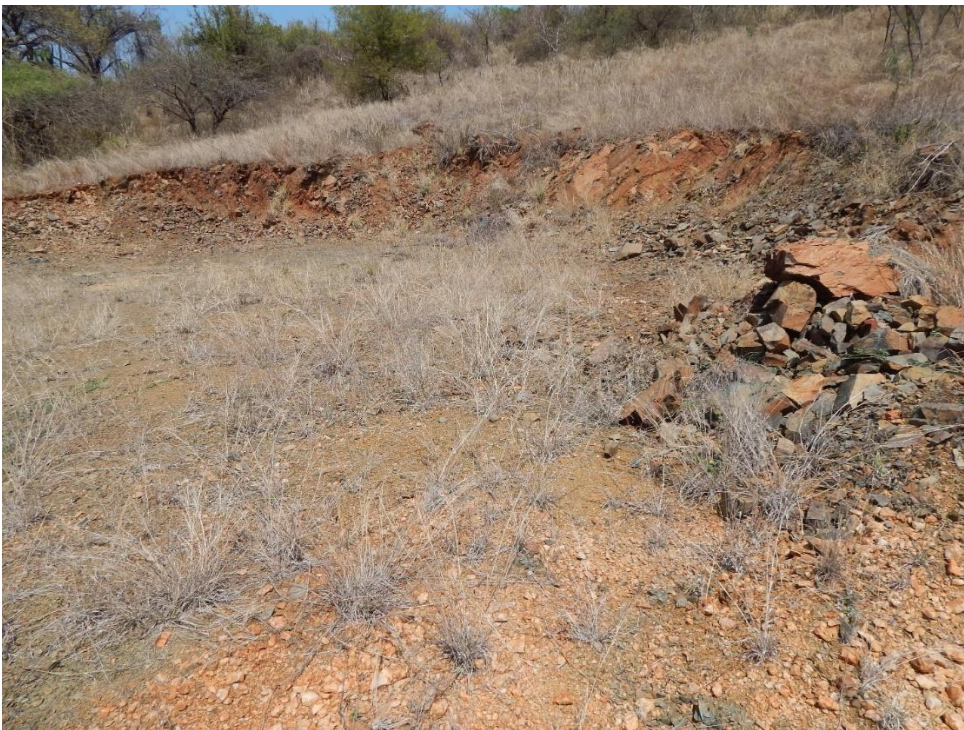
Fig. 24: A gravel pit was observed in the north eastern section of the study area. This pit is still in use today.

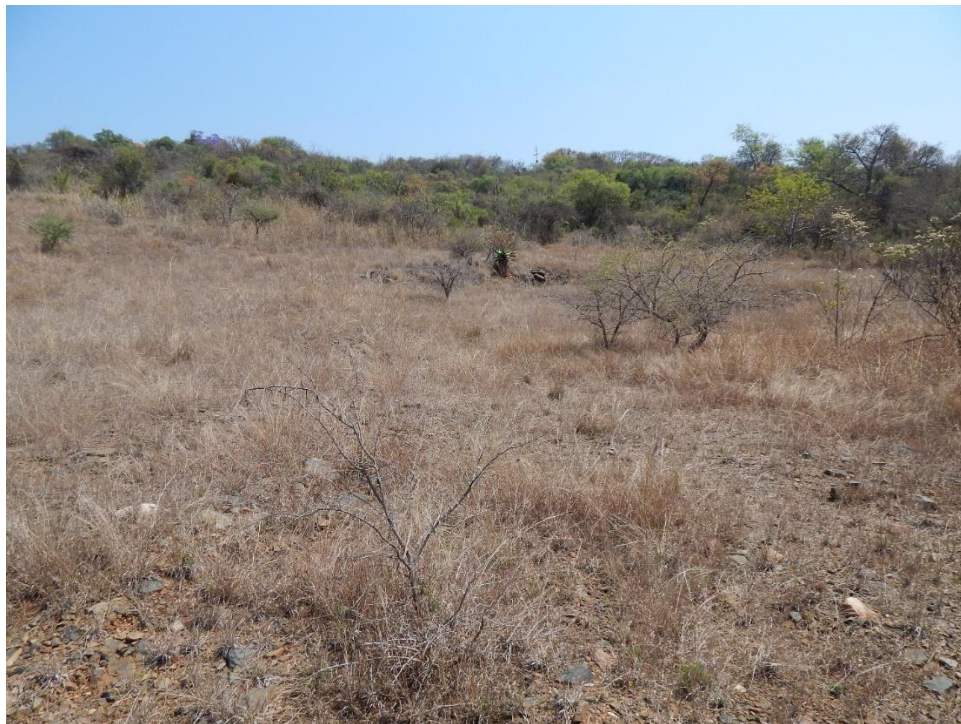
Fig. 26: A large overgrown quarry was observed in the south-eastern section of the study area.
This quarry is no longer in use.

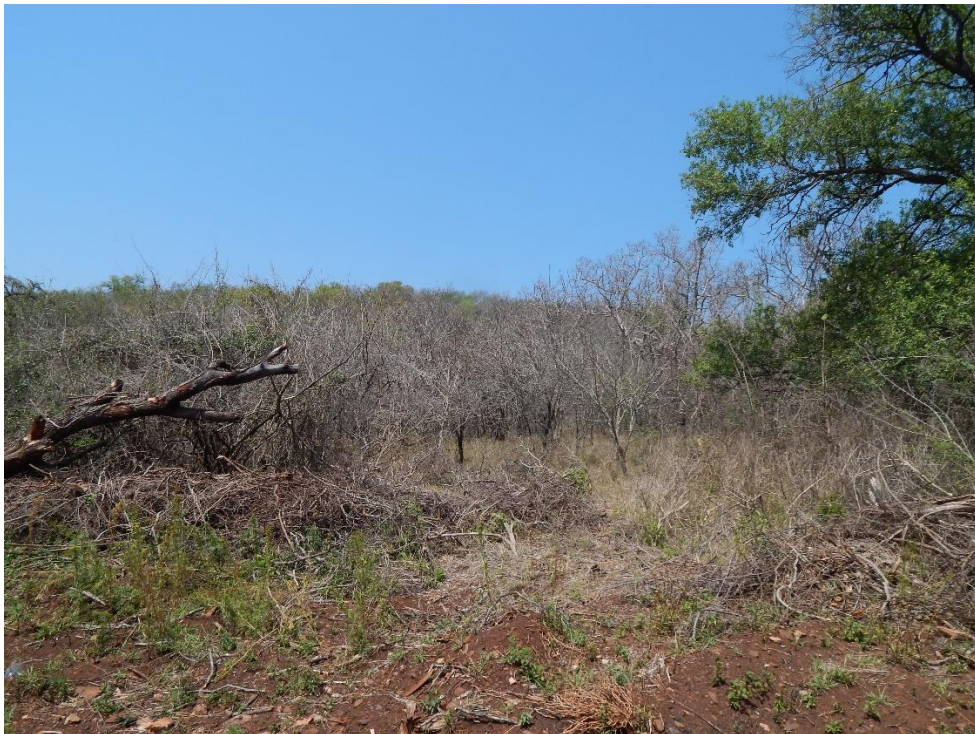
Fig. 32: Sickle bush has infested large sections in the northern section. Bush clearing has taken place along the railway line and access road.

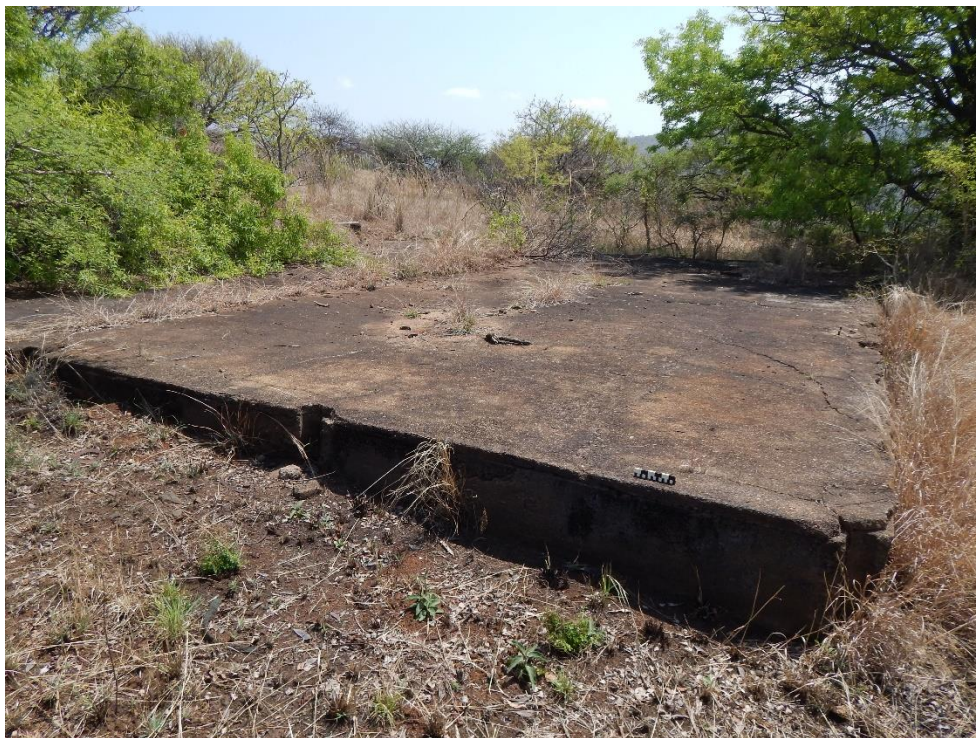
Fig. 35: The foundations of an old sawmill, which burnt down in the 1980's.

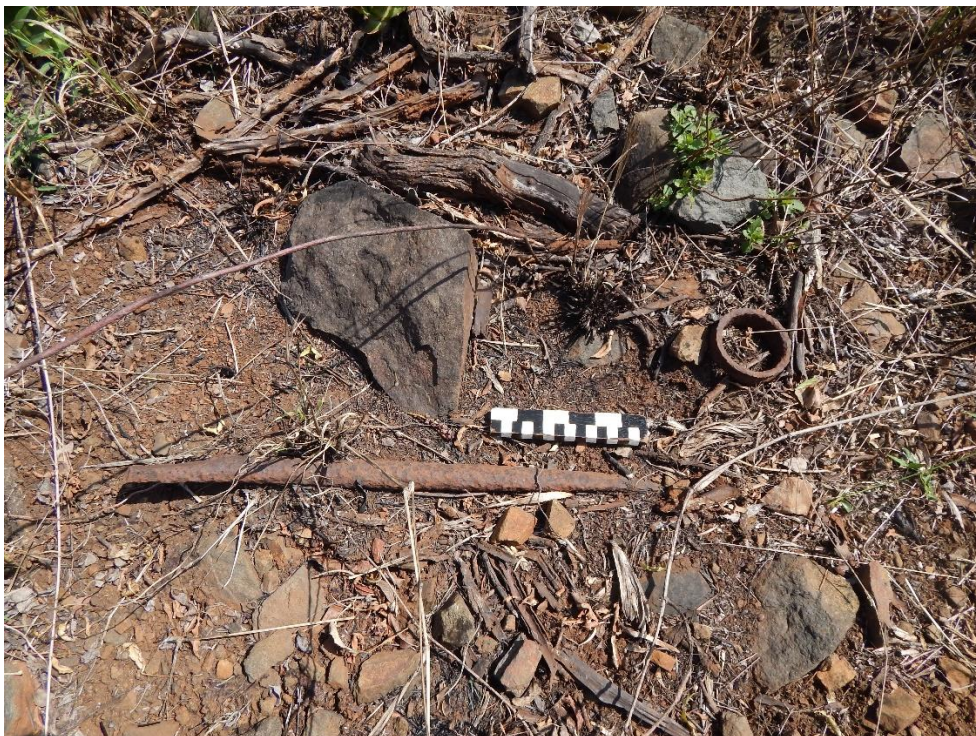
Fig. 36: Visible evidence of iron remains which were used at the sawmill.

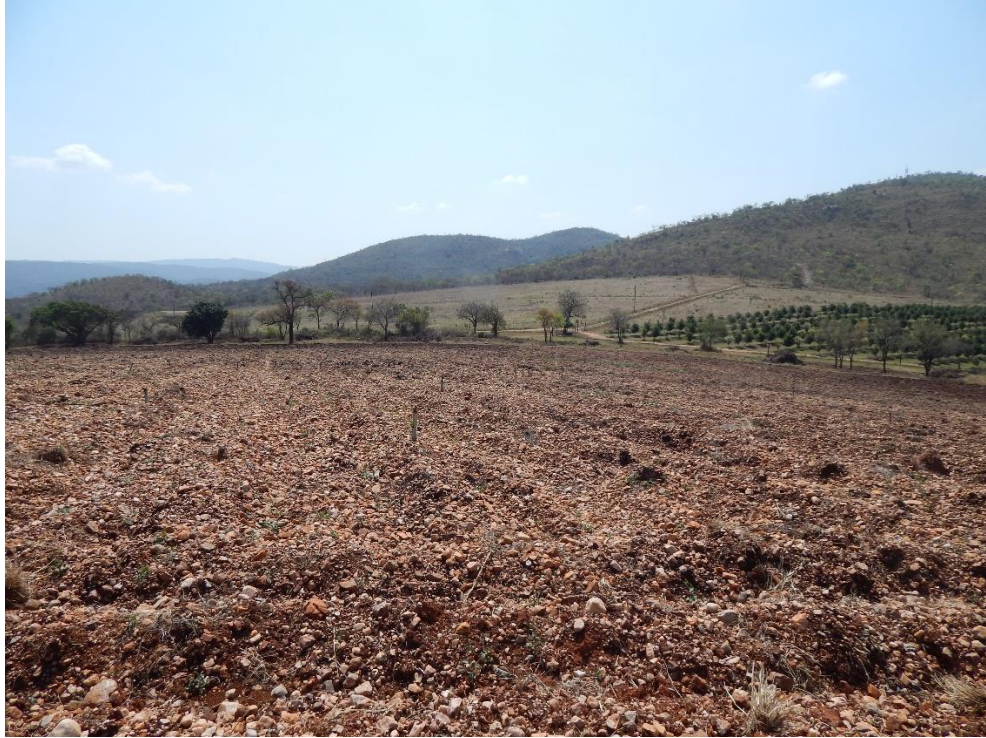
Fig. 45: The western section was historically a citrus orchard, and was previously disturbed.
