Heritage Impact Assessment of the proposed Amakhala-Emoyeni Wind Energy Facility, Cookhouse District, Eastern Cape.

Savannah Environmental (Pty) Ltd

October 2010

Dave Halkett, Lita Webley, Jayson Orton and Hugo Pinto

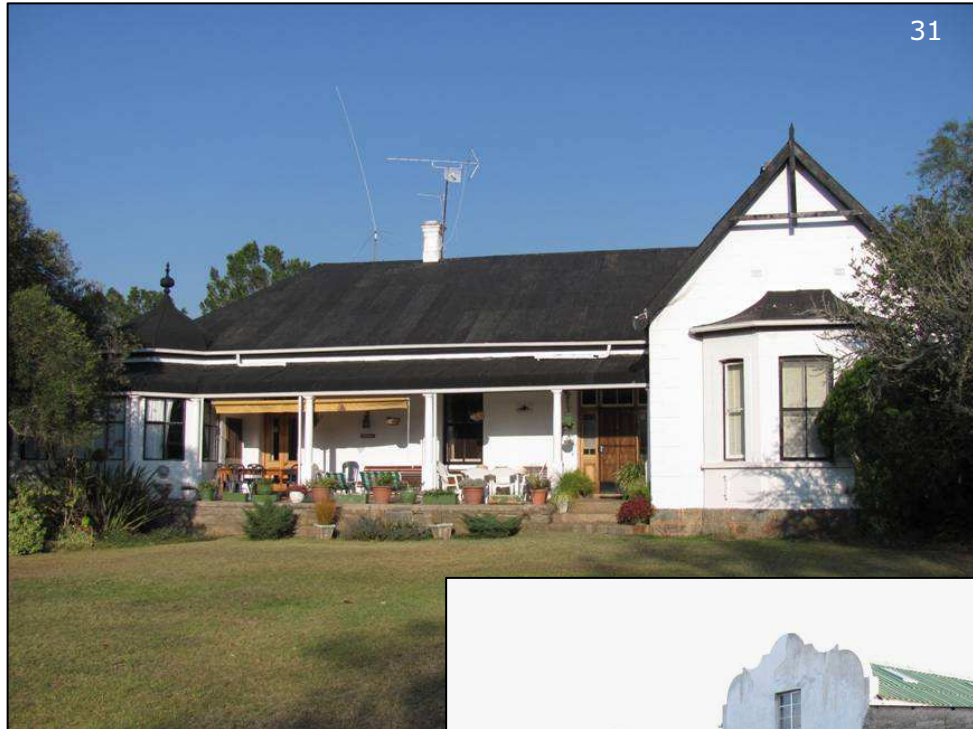
31

- 31.** F260/3 Victorian farmhouse in excellent condition (occupied)
- 32.** BEF/9 Small cottage (occupied)
- 33.** GKF/5 Ruined one-roomed stone and brick cottage
- 34.** F225/1 Homestead, old stone buildings, Victorianised with additions,
- 35.** BEF/2 Stone and mud shed with later plaster and additions

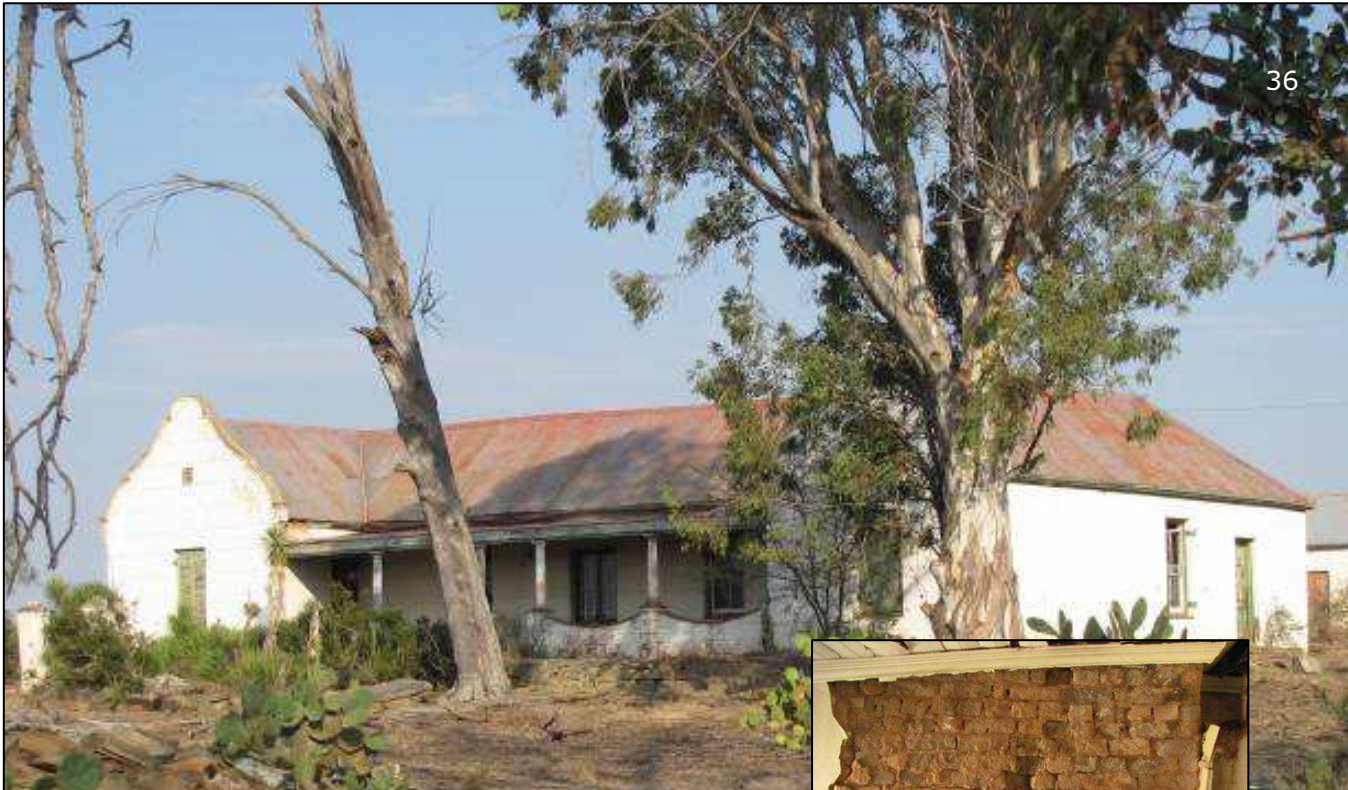
36

- 36. F259/2 Abandoned post - Victorian farmhouse. Many original elements
- 37. F259/2 Abandoned post - Victorian farmhouse
- 38. Coal/wood stove in the kitchen
- 39. Paraffin iron
- 40. F259/2 Stone and corrugated iron outbuilding
- 41. VF/2 Abandoned farm building

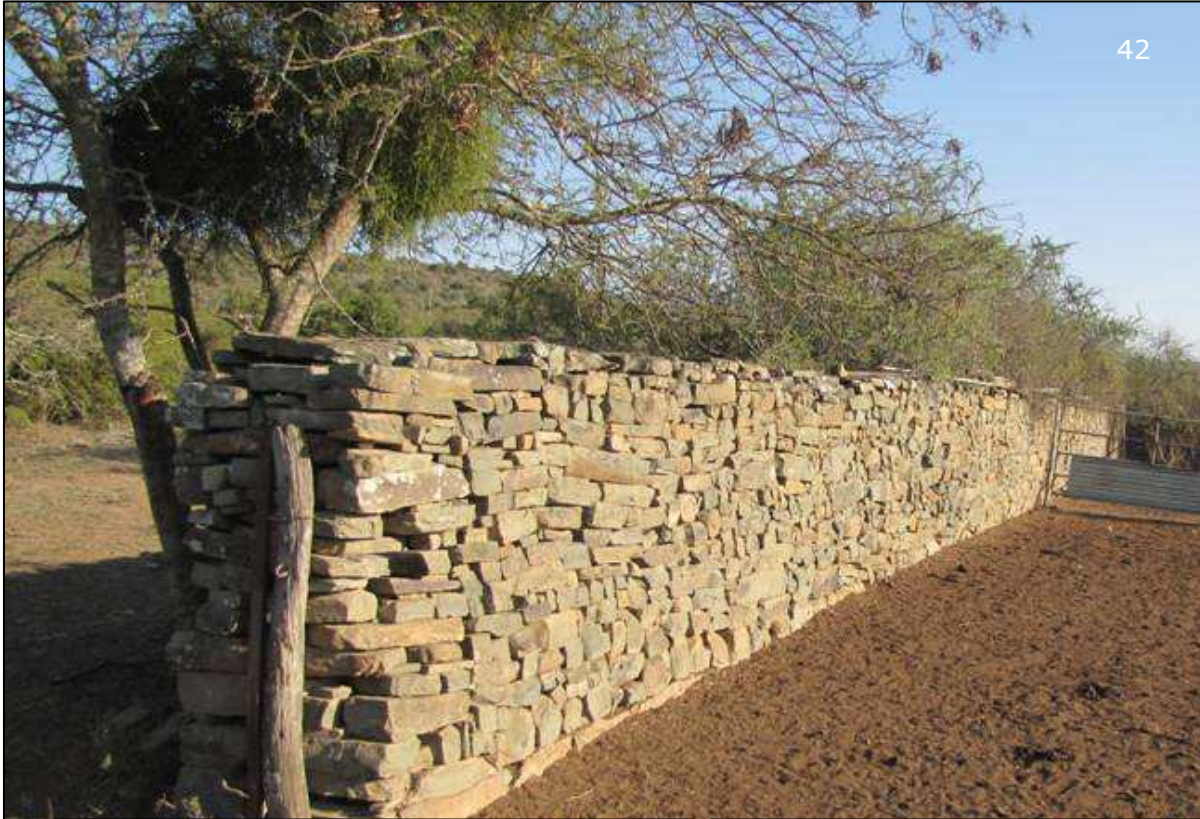
42

- 42. OWE/4 Big stone kraal with internal metal fences, 50 x 30 m. Still in use and in very good condition.
- 43. KL/8 Kraal complex
- 44. KL/6 Stone kraal with several enclosures, paved floor.
- 45. OWE/31 Stone kraal near modern house along main road
- 46. KL/6 Stone kraal with several enclosures, paved floor

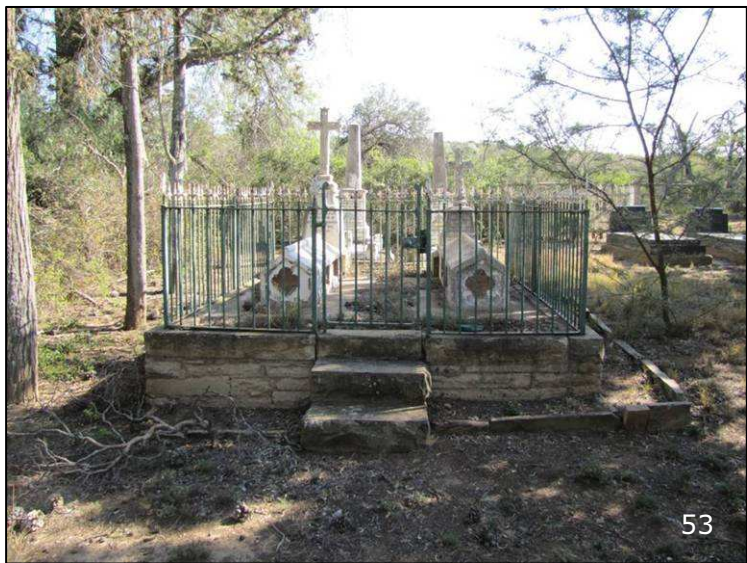
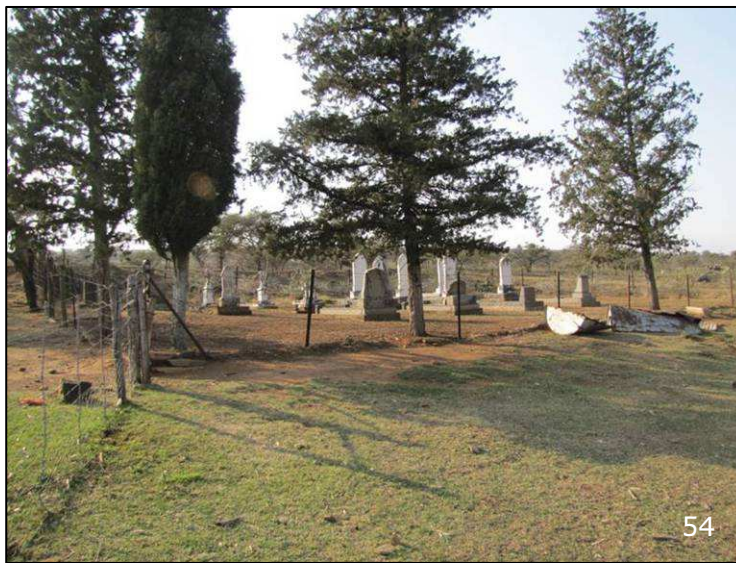
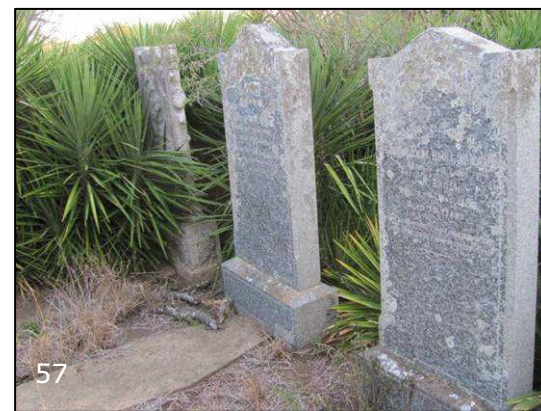
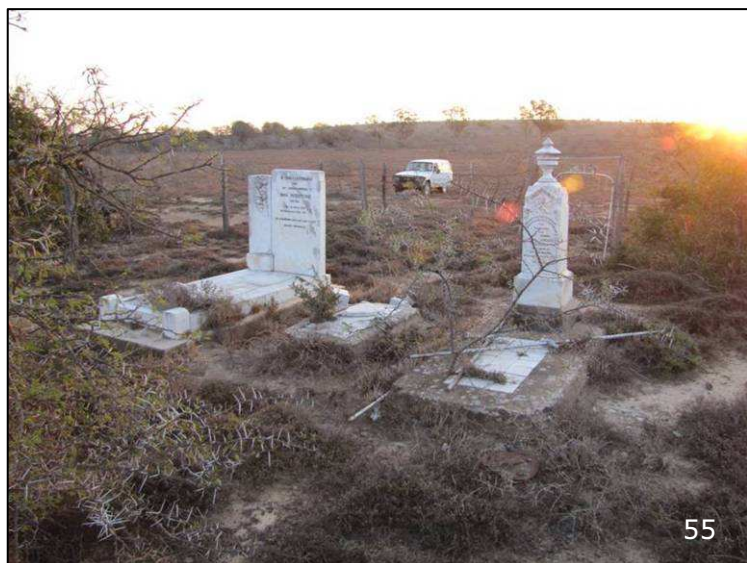
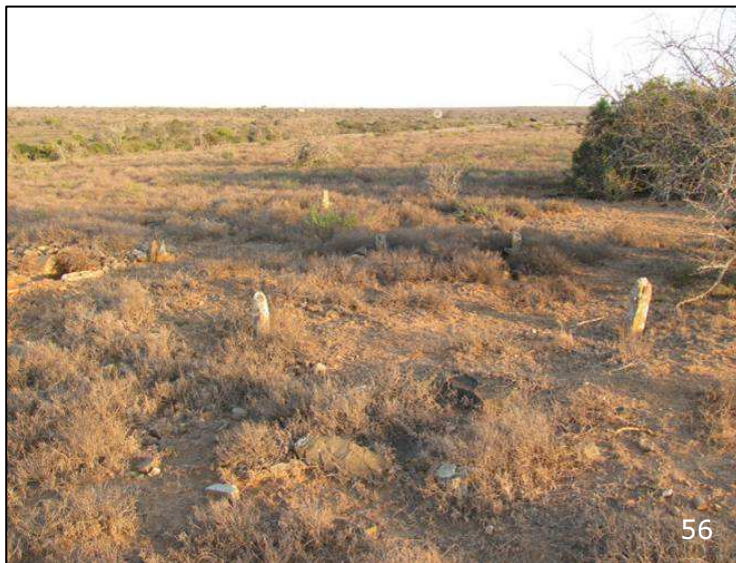
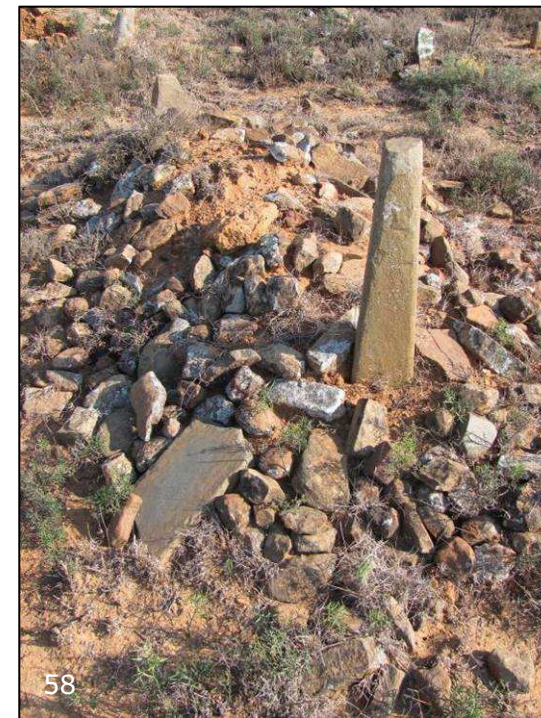
- 53.** SSF/14 Family graveyard ringed by fence and tall poplar trees. 8 graves, (Bowker, Palmer and Taylor) Dates 1895 through 1942.
- 54.** F242/3 Graveyard. Mostly Vosloo. (Might be in next farm - boundary unclear).

- 57.** LF/8 Graveyard, 8 graves, 3 with slate top, 1 without, 4 with gravestones (1 fallen). Marine shells on 1 grave). Broli, Green, Weichman, dates 1816-1914

- 58.** F260/9 Unfenced farm workers' graveyard ~76 graves. Mostly packed with small cobbles but a few have larger rocks. 2 at NE corner have lower grindstones on them (one with a shallow but well developed groove). 2 cement headstones with 1965 (in middle of area), 2 metal "signs" with 1993 & 1994 (these at south end). Also several LSA flakes noted in the area (see also plate 61).

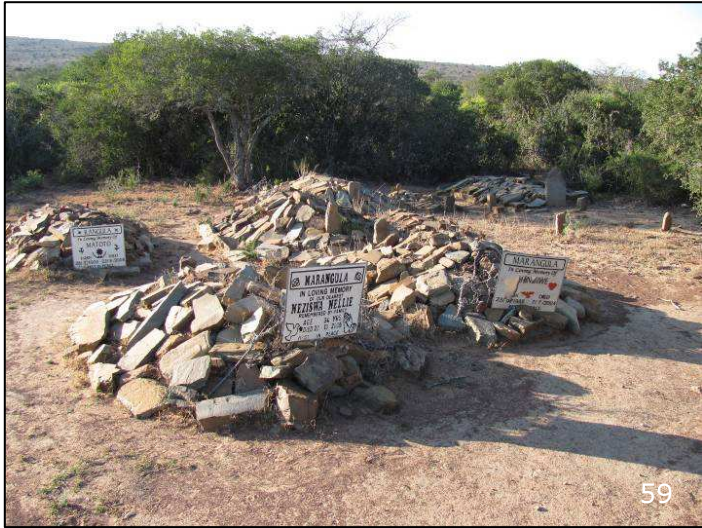
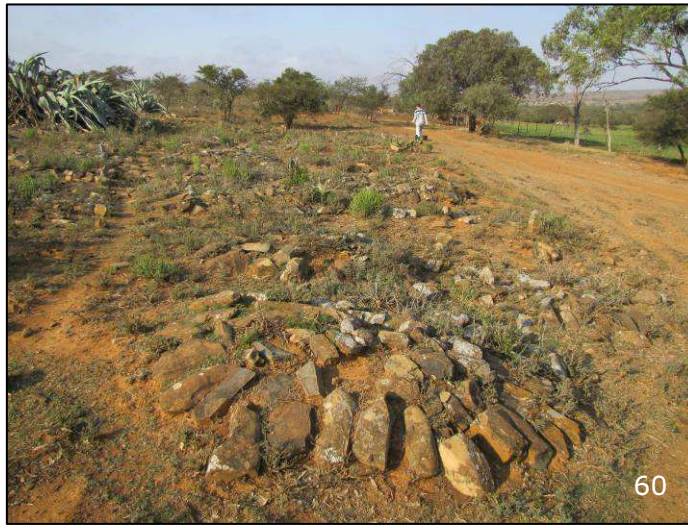
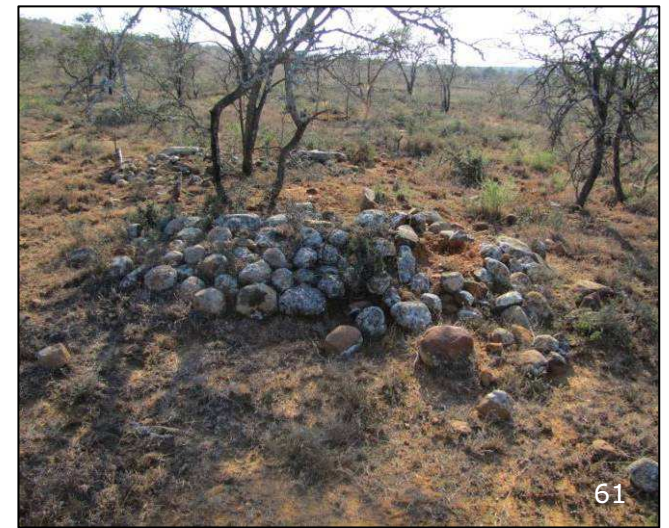
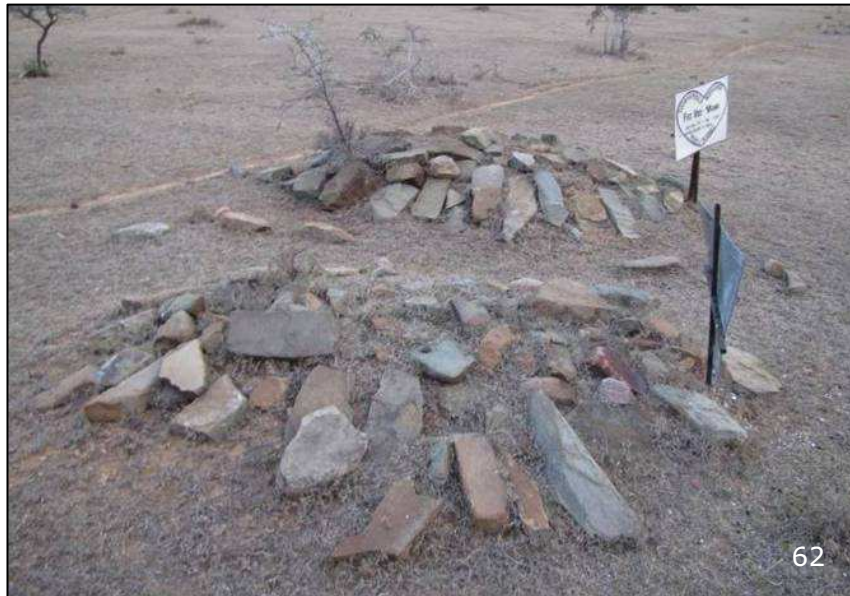
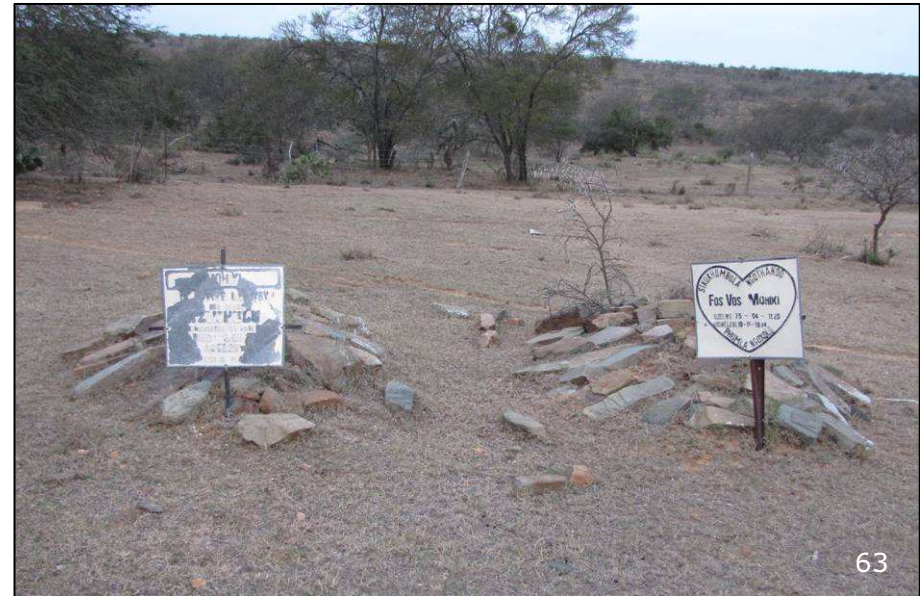
59. SSF/2 Farmworkers graveyard containing approx 30 farm graves dating ~1930 onwards, aligned E-W. GPS N and S ends

60. F242/4 Farm workers' graves. ~43. Open area, no fence.

61. F260/9 Typical grave with rounded stones forming the mound (see description for plate 58)

62 & 63. F260/27 Two graves. One dated 1994, other date fallen off but likely similar period. Many recent workers' graves have these "number plate" style markers with the deceased persons details.
