Heritage Impact Assessment of a proposed Wind Energy Facility to be situated on portions of farms Arolsen 69, Farm 148, Farm 148/1; Rooidraai 146, Baviaans Krans 151, Baviaans Krantz 151/2, Klip Fonteyn 150/2, Roberts Kraal 281, Zure Kop 74/1, Zure Kop 74/2, Van Wyks Kraal 73/2 and Van Wyks Kraal 73/3 in the Cookhouse District, Eastern Cape.

Undertaken as part of an EIA in terms of Section 38(8) of the National Heritage Resources Act (No 25) of 1999

Savannah Environmental (Pty) Ltd

November 2009

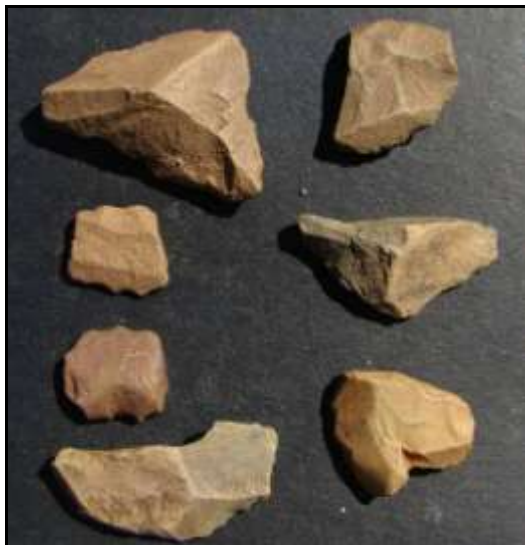
Diffuse and isolated scatters of stone artefacts were recovered on a number of farms. In general, they appear to be of Middle Stone Age date and comprise very heavily patinated (weathered) cores, chunks and flakes (Plate 5). Some of the flakes appear to have retouch along one or more margins and are generally made on indurated shales (hornfels) with the exception of one core made on a dark grey quartzite. These stone tools are frequently found along the margins of small pans or bedrock depressions (Plate 6). However, some stone tools were found along rocky terraces. There also appeared to be an association between stone tools and calcrete exposures. A few large, side-struck flakes could represent the Early Stone Age although no definitive artefacts of this period (handaxes) were observed. None of the surface scatters of stone tools appeared to be in primary context nor associated with non-lithic remains and their significance, in terms of their information value, is therefore considered to be low.

Plate 5: Sample of Middle Stone Age implements found around the pans and on rocky ridges. **Plate 6:** Shallow pan in bedrock on farm Klip Fonteyn (KFN 6).

No mitigation of pre-colonial archaeological material is therefore recommended during the construction, operation or decommissioning phase of the facility.

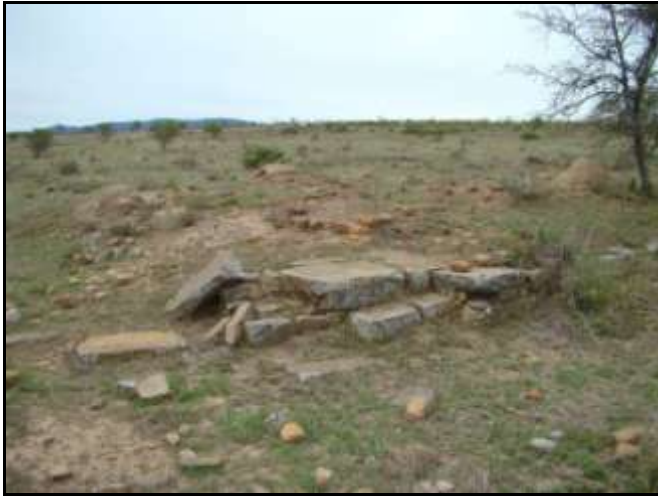
Plate 7: The ruins of the so-called "Ferreira's" house on Roberts Kraal (RK3) . **Plate 8:** 19th century transfer printed refined earthenware ceramics from the one of the refuse dumps.

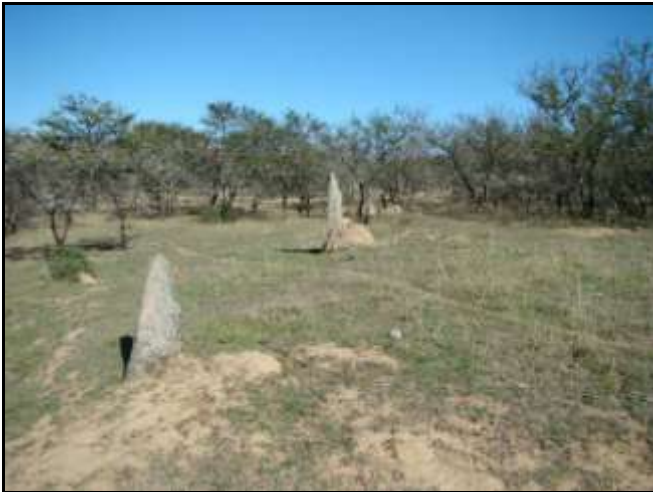
Plate 9: The stone boundary/fence posts at Klip Fonteyn (KFN 4). Plate 9a: KFN5: Quarry and spring. We believe that some of the local stone boundary posts originated at this quarry.

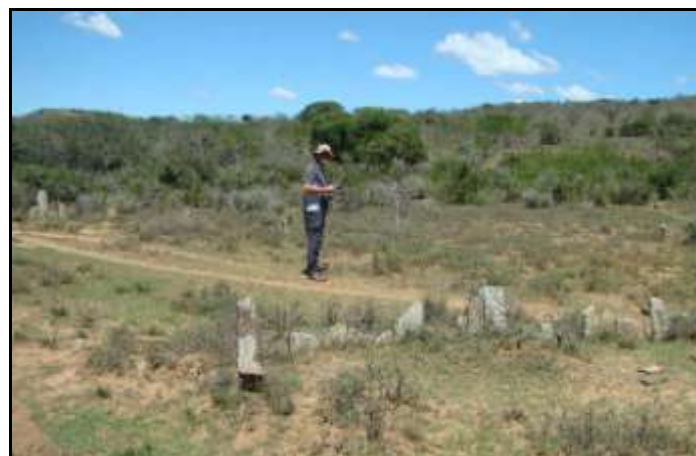
Plate 10: The threshing floor at Klip Fonteyn is surrounded by upright stones (KFN 12).

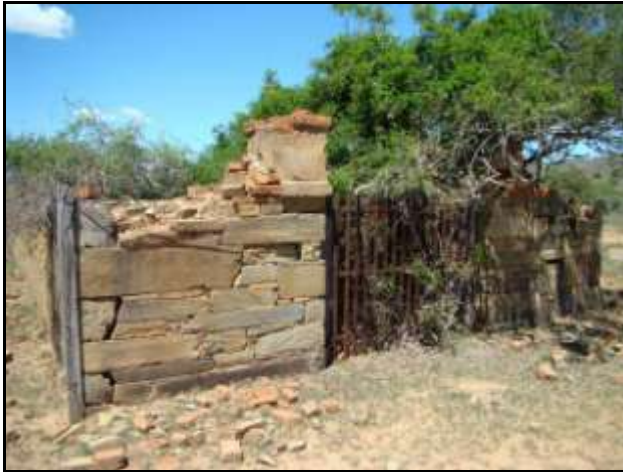
Cemeteries and graves could be subjected to physical damage by the construction of access roads. In addition, the construction of turbines in close proximity to graveyards will impact on their sense of place.

Plate 11: The entrance to the stone walled cemetery at Klip Fonteyn (KFN 13). **Plate 12:** One of the numerous graves on the outside of the walled cemetery with its distinctive circular rock covered grave mound.

Direct impacts on identified historic structures are not expected. However, marked buffer zones around cemeteries and graveyards will need to be implemented to ensure that they are not damaged during the construction of access roads or by other related construction activities. A significant negative impact will result from the destruction or disturbance of graves.

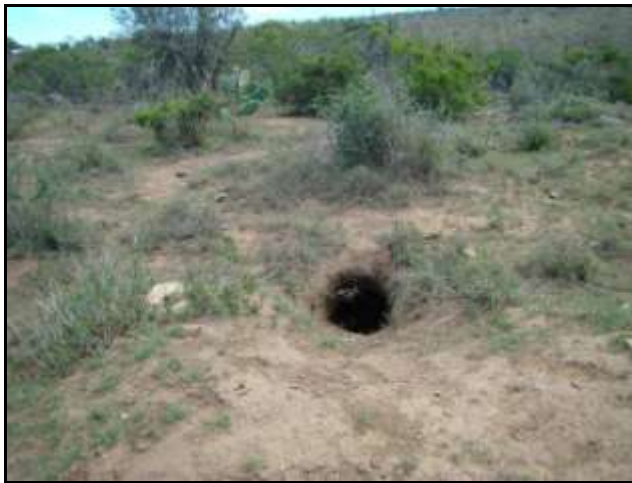
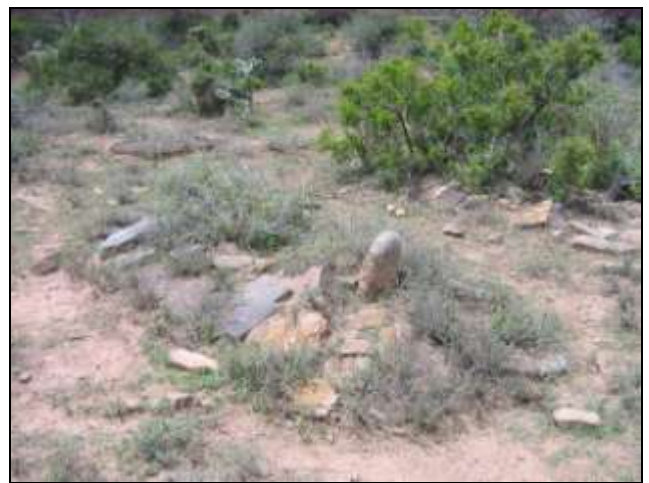
Plate 13 and 13a: An earth grave mound with ant bear burrow (KFN 14). A more formal stone covered mound also at KFN 14. Stones offer some protection from burrowing animals.

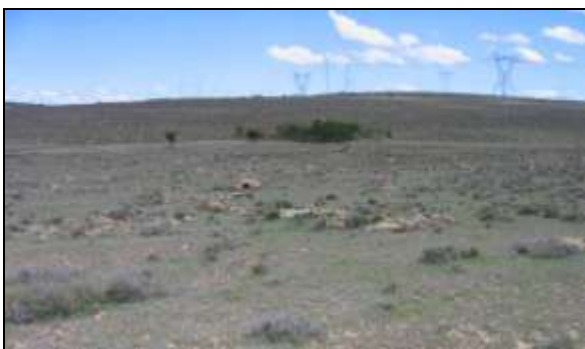
Plate 14: 12-15 stone covered graves on an exposed slope at Klip Fonteyn (KFN 1). **Plate 15:** 50 -100 stone covered graves lie immediately to the east of the entrance road at Roberts Kraal in an informal cemetery (RK2).

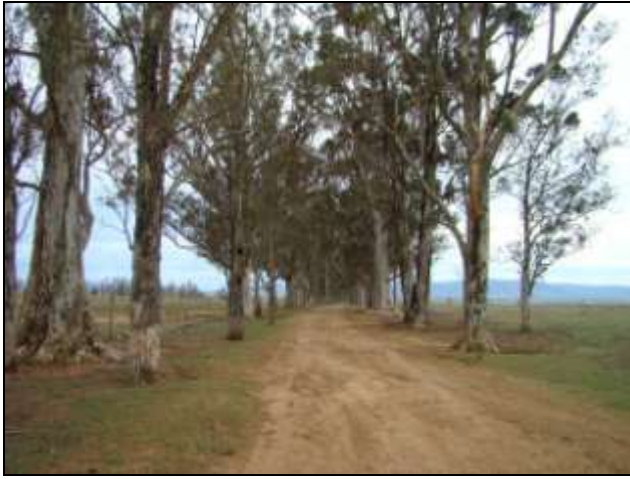
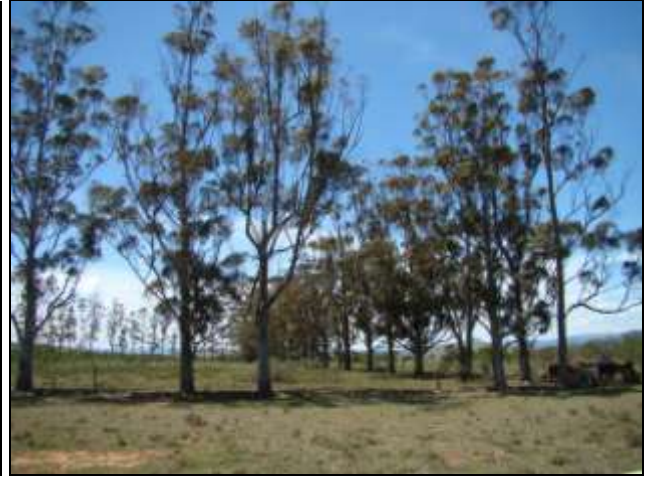
Tree-lined avenues and windbreaks are found on Zure Kop 74/1 (Highlands) and Zure Kop 74/1 (Fairfield). These are distinctive and can be seen from some distance (Plates 16, 16a).

Plates 16 & 16a: A tree lined “avenue” going towards Highlands, and a windbreak around an old field next to the house at Highlands.

Some of the turbines on Zure Kop 74/1 and 74/2 are located in close proximity to historic tree avenues and this report recommends that these avenues are retained. This may require repositioning of some of the nearby turbines.
