HERITAGE IMPACT ASSESSMENT OF THE IMPACTS RESULTING FROM THE RAISING OF THE EXISTING KEEROM DAM, SITUATED BETWEEN MONTAGU AND TOUWS RIVER, WESTERN CAPE

(Assessment conducted under Section 38 (8) of the
National Heritage Resources Act as part of an EIA.)

Nuy River Irrigation Board

David Halkett
ACO Associates
8 Jacobs Ladder
St James

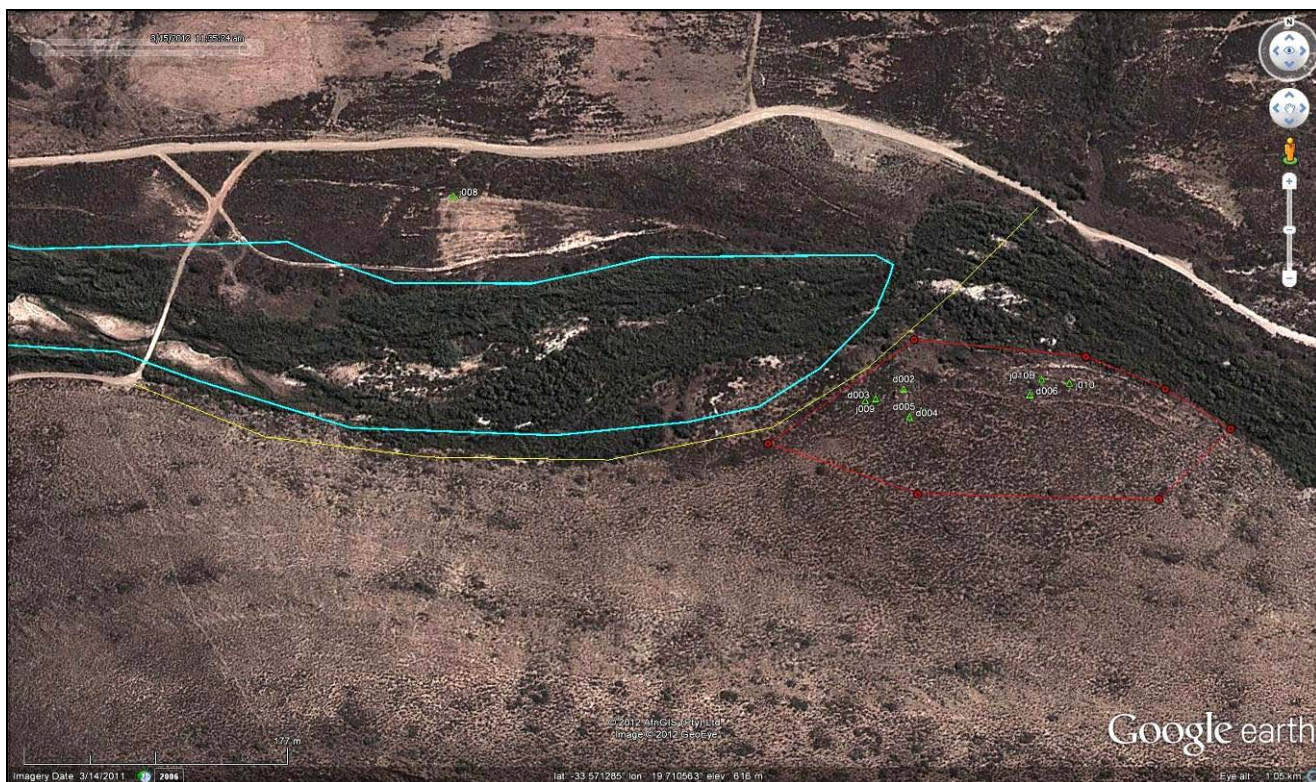
This alignment is moderately more difficult from a heritage perspective. The proposed route will have to cross steep rocky slopes, particularly closer to the main dam, forcing it to be as close to the river as possible. A fairly extensive old farm complex is located on the flatter ground (d002-d006, j009, j010 and j010B) at a bend in the river. The remains include a partially standing ruin, foundations of sub-buildings, a dump, retaining walls, fields and remnant tree lines (now only stumps for the most part). This complex probably dates to the late 19th /early 20th c based on the artefactual material, but probably was in use until the 1970's(?). Apart from obvious retaining walls, there are a number of enigmatic stone features, which we believe may be graves. They do not however contain the usual diagnostic characteristics in terms of shape, or any obvious headstones. Nevertheless, caution is advised in this area. Figure 5 shows the proposed alignment in relation to the heritage sites. We have proposed a no go area within the defined red polygon (see Appendix 3 for polygon co-ordinates), which means that if the road remains on the centreline at this point, it will be possible to proceed with minimal impact to heritage. At its closest there is probably a space of about 15-20 m between road and the old farm complex.

Mitigation: There is a narrow margin for manoeuvre where construction machinery is concerned and so we would propose that the eastern edge of the no go area be well demarcated prior to construction and the alignment shifted as far as possible to the west in this area. No machinery is to enter the no go area. An additional caution is that unmarked graves could be present between the farm complex and river. Construction crews will need to be aware of the possibility and know what action to take if graves or human remains are encountered.

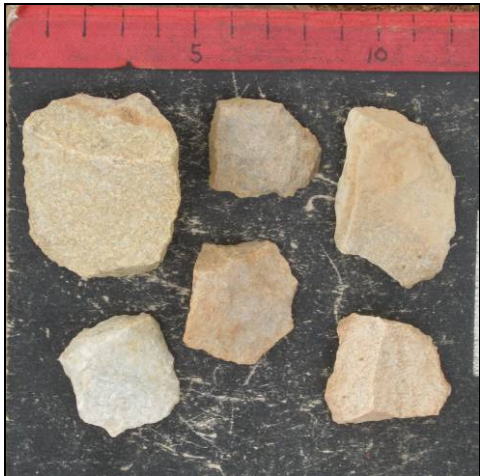
Although we have recorded a number of stone age artefacts around the periphery of the dam, the majority of these are isolated finds (probably ESA or MSA) amongst which no diagnostic formal elements were noted. Areas around d008, j015 and j016 contain multiple artefacts, though none of these constitute significant scatters. A single apparent LSA lower grindstone fragment, broken and with its margin flaked, was found at d008. No other LSA material was observed. No significant impacts are envisioned due to increased water level.

Plate 6: A selection of quartzite flakes from j016 **Plate 7:** The water furrow cut into the softer Karroo rocks on the western edge of the site **Plate 8:** The simple concrete low water bridge crossing the Koo River

- No significant impacts on such material have been identified. No mitigation is required.

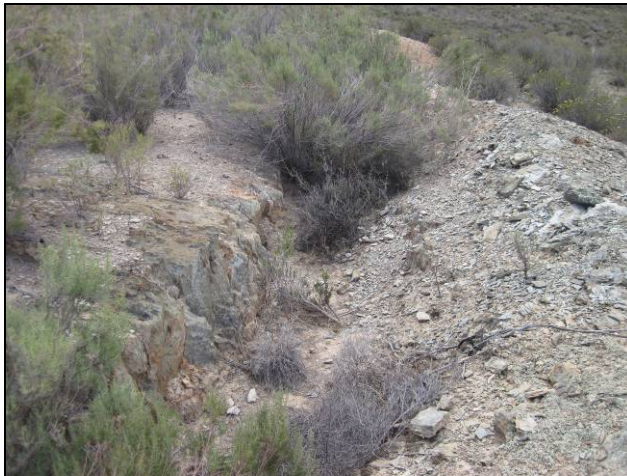
In preparing the NID, we had noticed an extensive linear feature running along the western edge of the dam (see Plate 7). We interpreted this a stone wall, but as we now know, it is in fact a water furrow that carried water from the Huis/Raaswater River into an area now submerged by the existing dam. Whatever features may have been associated with it are thus invisible. Most of the feature lies well above the new FSL, although a small section will be flooded. As it is cut into rock, the feature will not necessary be destroyed in the process. A small breached earth dam (j012) is associated with the furrow.

- **The old water furrow** is marginally impacted by the Huis River road re-alignment and the increased FSL. Significant parts are still preserved well above the FSL and as such the impacts are considered to be acceptable. No mitigation is proposed.

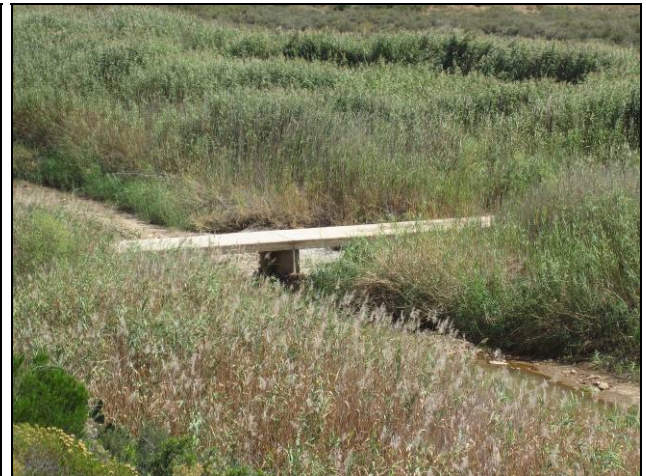
Two more substantial road alignments will be required where the farm roads cross the Huis/Raaswater River (west) and the Koo River (east). At present the crossings are via simple concrete low water bridges (Plate 8), both of which will become impassable when the dam is raised. Two new "bypass" routes have been proposed to resolve the access issues (Figure 2).

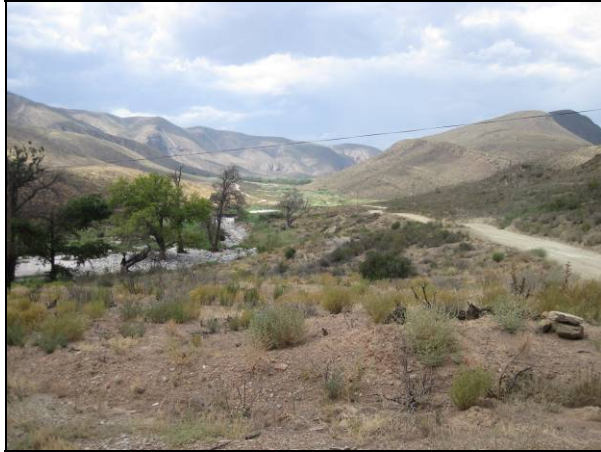
The new alignment runs for some distance on an old track on the northern side of the river after which it crosses and cuts diagonally up to meet the existing farm road. Apart from crossing an old water furrow (d011), no issues were identified in a broad corridor either side of the alignment centreline. The

furrow is extensive, though nowadays inoperative, and given these circumstances, the impact on the feature is considered to be acceptable (the furrow is discussed more fully in section 3.2).

Plate 9: The Huis River road alignment will cross the slope diagonally beyond the trees to link up with the existing road **Plate 10:** Looking towards the west towards the partially ruined building at d002. **Plate 12:** The proposed road would be situated at approximately the position of the large bush in the background (not the palm).

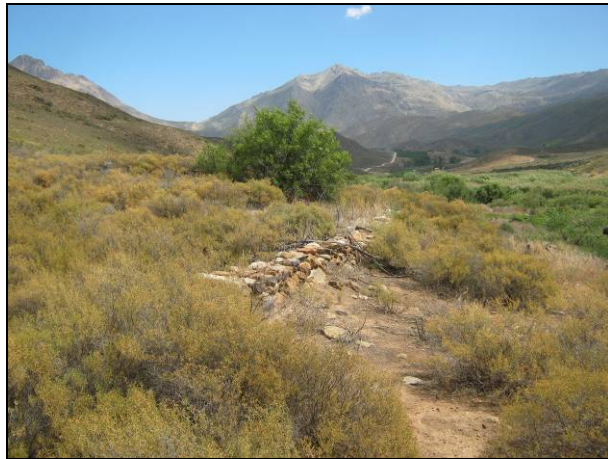
A no longer functioning extensive water furrow traverses the hills to the west of the dam basin. This is indicative of the early farming landscape, which is also dotted with small stone ruins. A single farm complex may be affected by the re-alignment of the road which crossed the Koo River. A partial ruin, foundations of outbuildings, stone embankment walls, a dump, and a number of stone features (perhaps graves) make up the complex.

Plate 13: One of numerous stone retaining walls to the east of the ruins **Plate 14:** A selection of artefacts found in the dump area **Plate 15:** An early 20th c bottle base

- An **old farm complex** has been identified along the Koo River road re-alignment. As it stands, the proposed alignment can probably be entertained as is although there is little margin for manoeuvre. A no go area has been proposed around the historic remains and features. Mitigation: The alignment should be placed as far west as possible in the area of the historic remains. The length of the no go area closest to the road alignment should be clearly demarcated with physical markers during the construction phase, and no machinery is to enter the area.
