INITIAL HERITAGE IMPACT ASSESSMENT OF SMALL AREAS AT LAKE MICHELLE, NOORDHOEK

October 2004

Jayson Orton

Archaeology Contracts Office

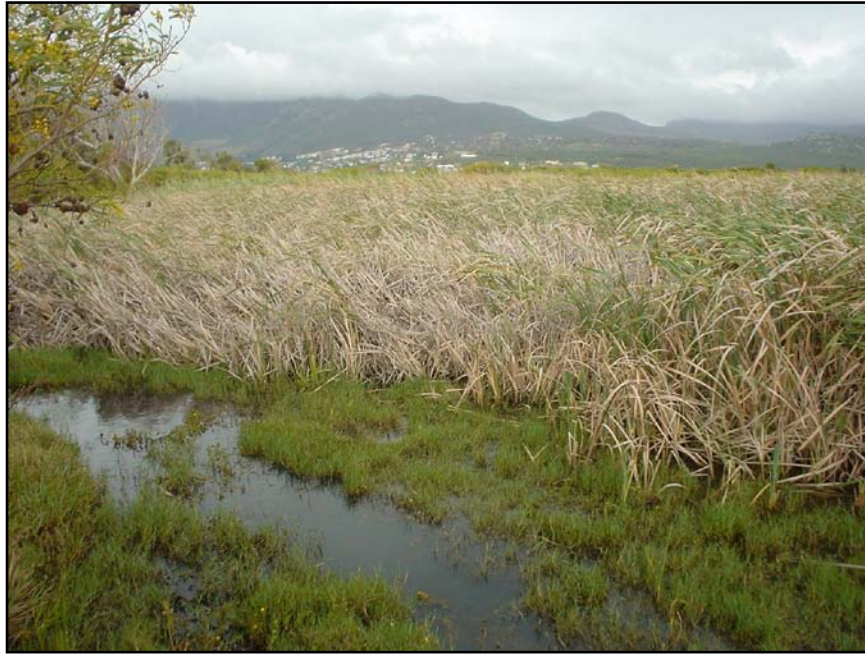
The first area under consideration is a dense marshland through which it is proposed that water from the lake be channelled so as to improve circulation within the lake (Plate 1). Due to the nature of the environment under consideration, little or no *in situ* archaeological or heritage material can be expected, although random sub-surface artefacts may be present.

Plate 1: The marshland at the southern outfall area.

A few scattered shell fragments and stone artefacts near the outfall area testify to the earlier existence of Later Stone Age archaeological sites nearby (Figure 2). These would have been present around the pan prior to its dredging which occurred in the 1970's. Material from the pan was spread around on the north-western side of the pan and this is likely to have obliterated most archaeology in the area. Since the pan is known to have produced MSA artefacts, there is a chance that such artefacts could be encountered in the course of sub-surface excavations in the outfall area. Should this occur, the impact would be low and localised.

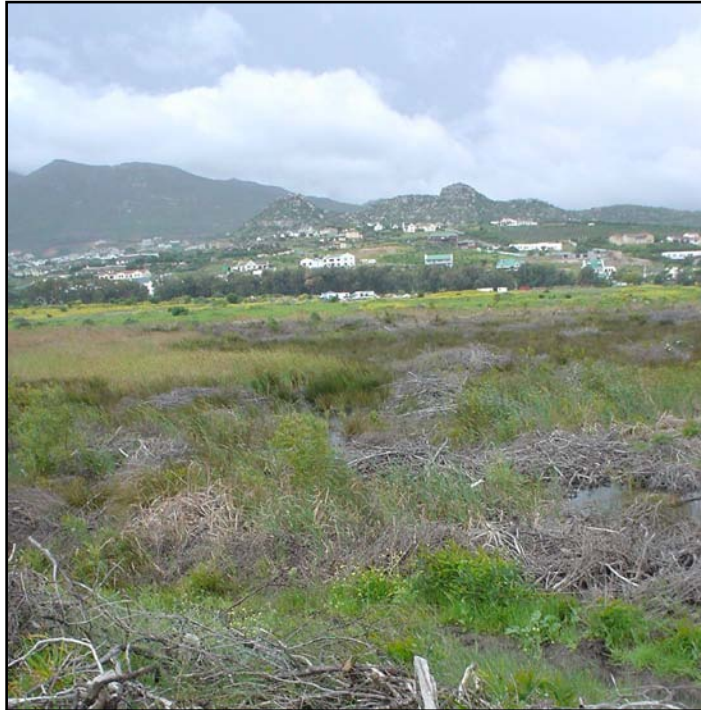
This area is also marshland (Plate 2) and it is proposed that a causeway be constructed across it to provide an access route to the development site. The north-eastern end of the causeway is on a recent rubble tip. As with the outfall area, no *in situ* archaeological material can be expected within the footprint of the causeway.

Plate 2: The marshland at the causeway area. The grassed area with the yellow flowers and site offices between the marsh and the line of gum trees is the rubble tip.

No archaeological material was observed in this area. Again, with MSA artefacts known to occur here, there is the chance that such artefacts could be encountered during construction of the causeway. Should this occur, the impact would be low and localised.

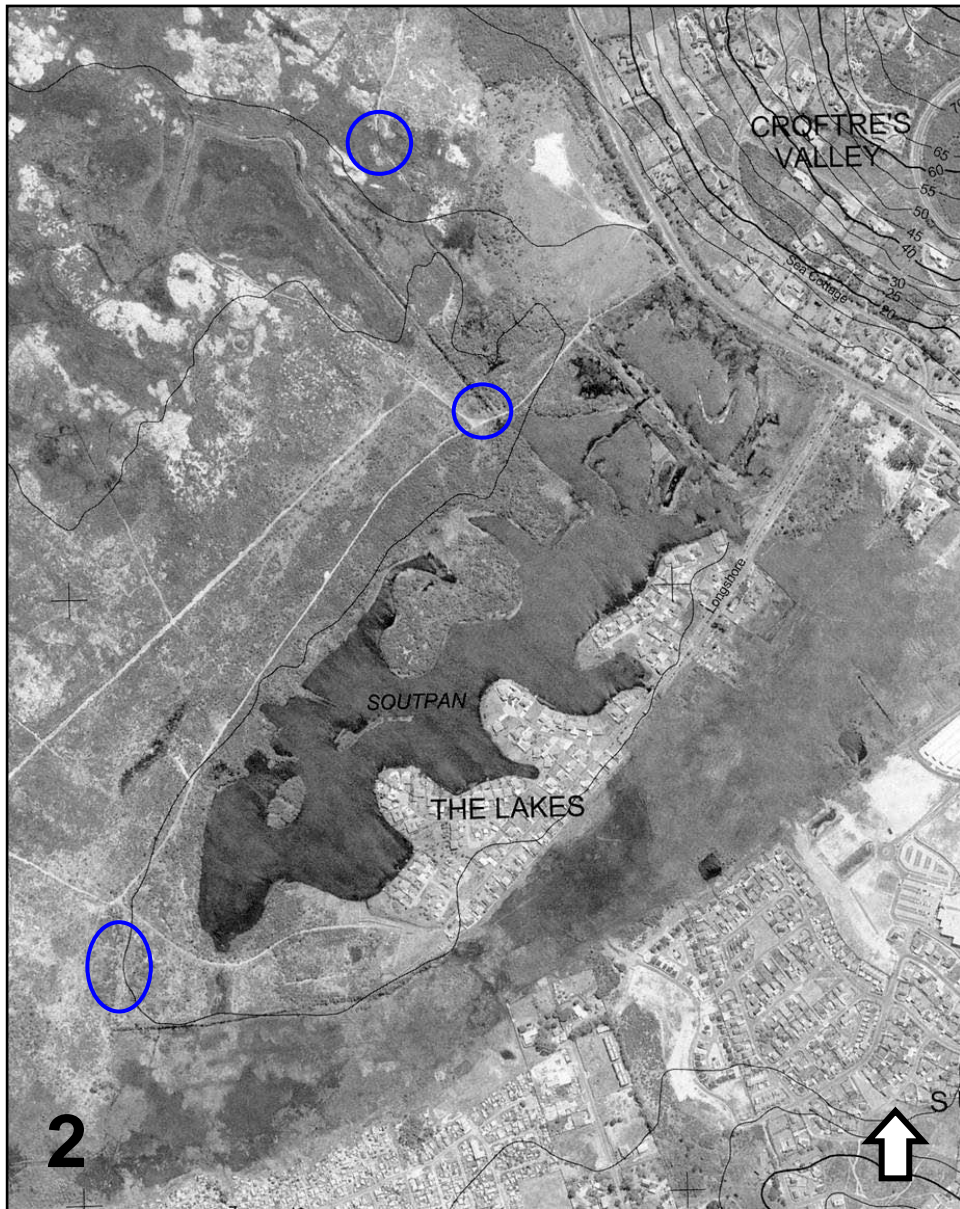
In this area some small shell fragments and stone artefacts were seen. These are clearly in a heavily disturbed environment and again only indicate the earlier presence of LSA archaeological sites in the area. There is a chance that buried MSA or LSA material might be encountered during subsurface excavations in this area. Should this be the case, the impact would be low and localised.

3418 AB 13 Noordhoek (Mapping information supplied by - Chief Directorate: Surveys and Mapping. Website: w3sli.wcape.gov.za). Blue circles indicate areas where scattered archaeological material was observed.

Since no direct impacts will occur, it is recommended that, subject to the approval of the authorities, work be allowed to proceed in all areas assessed. However, since MSA artefacts are known to occur in the area and evidence of LSA material was noted on site, it is recommended that some monitoring of any excavations be carried out by an archaeologist. Since no monitoring occurred during the dredging of the pan, it would be useful to try to ascertain the context of any archaeological material encountered.
