# **Underwater Heritage Impact Assessment for the proposed Deepening, Lengthening and Widening of Berths 203 to 205**

Port of Durban

**UNDERWATER HERITAGE IMPACT ASSESSMENT FOR THE PROPOSED DEEPENING, LENGTHENING AND WIDENING OF BERTHS 203 TO 205, PORT OF DURBAN, KWAZULU-NATAL, SOUTH AFRICA**

**Report #:** 2012/DBN/001  
**Status:** Final  
**Revision #:** 1  
**Date:** September 2012

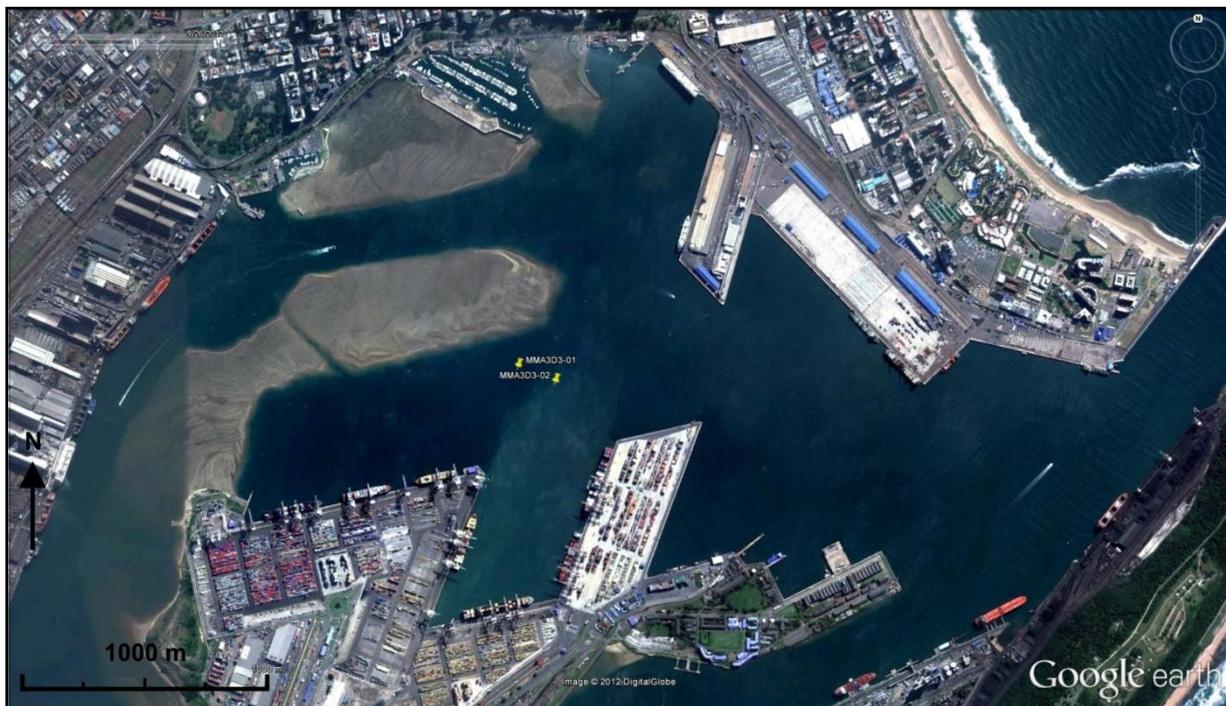
**Figure 3:** Inshore Area – Analysed Field Data Magnetic Anomalies (Google Earth: 2011)

The analysed field data survey results, mapped in Figure 3 and tabulated in Table 2, show a total of 2 hits, 62 meters apart, near the sandbank. The first mark – MMA3D3-01 – had a strength of 80 Gamma and the second – MMA3D3-02 – a strength of 50 Gamma. As the strength decreases, these may represent the same anomaly. As the anomaly strength is relatively low, these hits may be the bow or stern of a vessel with the balance of the vessel being under the sandbank or the hits may be harbour debris.

The first mark – MMA3D3-01 – was dived on, between 15:30 and 16:00. However, from one meter below the surface, the visibility decreased rapidly to 0 meter's visibility at the bottom. A touch search was not initiated due to the risk factors. The dredgers need to be aware that there may be underwater cultural heritage in this area. Mark – MMA3D3-02 – was not dived on due to the failure of the first diver search.

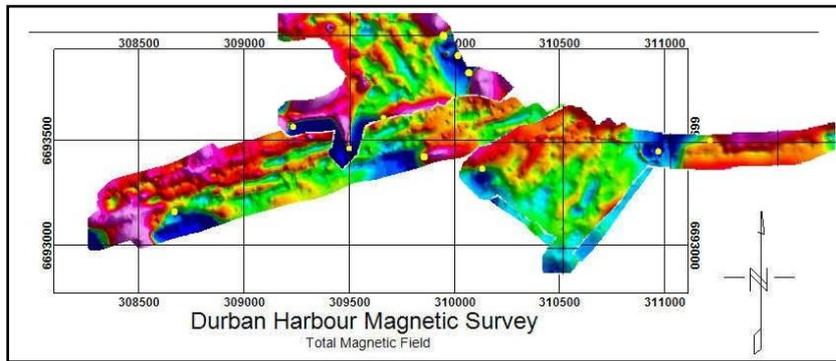
**Figure 4:** Inshore Area – Post Fieldwork Analysed Magnetic Anomalies; the yellow dots within or on the edges of blue zones are magnetic anomalies (Boshoff: 2012)

Further analysis of the data by Boshoff of the South African Museum, Cape Town revealed further magnetic anomalies that may represent heritage sites (Figures 4). Diver searches are unable to be initiated due to the zero visibility previously mentioned. This data is tabulated in Table 3. Once the data was plotted, some of the marks could be attributed to the nearby quay wall and shipping, as mentioned. What was revealed were the marks – AMM02 through 04 – that may indicate the balance of the possible vessel mentioned above, on the

sandbank side of the channel markers. Furthermore, one other anomaly was seen that needs to be watched during dredging, this is the mark – AMM-11 (Figure 5).

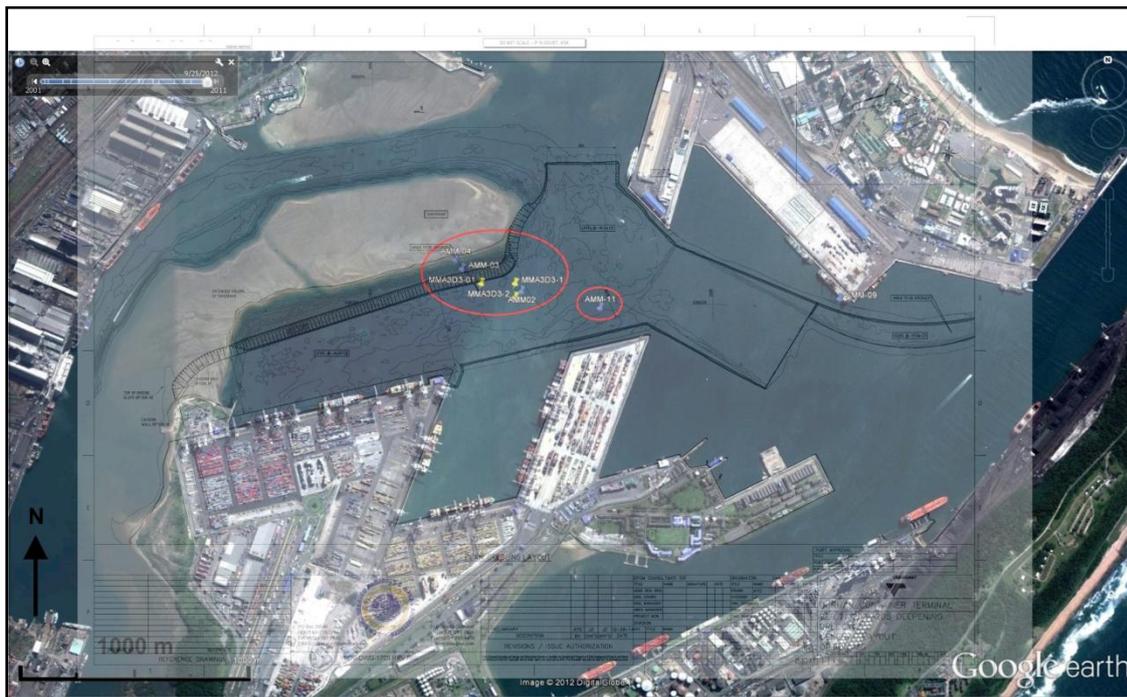
**Figure 5:** Inshore Area – Combined field and analysed magnetometer hits overlaid with dredging layout option 3G (Google Earth: 2012; ZAA Engineering Projects & Naval Architects: 2012).

In my opinion, the only real area of possible concern is the cluster of hits, circled in Figure 5, just off the sandbank.
