AN ARCHAEOLOGICAL WALKTHROUGH SURVEY OF THE FINAL LAYOUT OF THE PROPOSED NOJOLI WIND ENERGY FACILTY NEAR COOKHOUSE, BLUE CRANE ROUTE LOCAL MUNICIPALITY, BEDFORD DISTRICT, EASTERN CAPE PROVINCE.

Date: April 2014

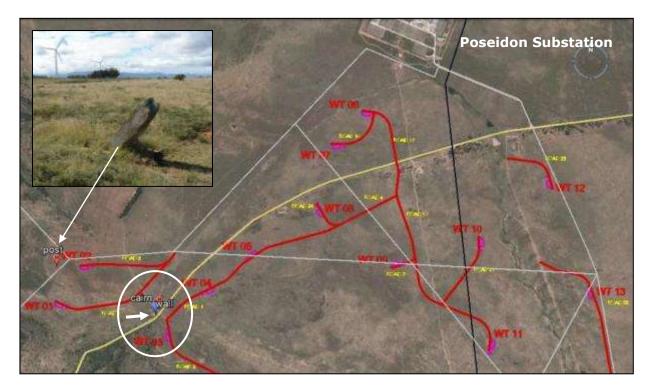
Map 3. An aerial image of the northern part of the Nojoli WEF in the vicinity of the Poseidon Substation (south, south-east and south-west). The location of the stone dam wall is marked by the blue bubble and white arrow in the lower left corner. The stone post is of low significance and falls outside the area of development.

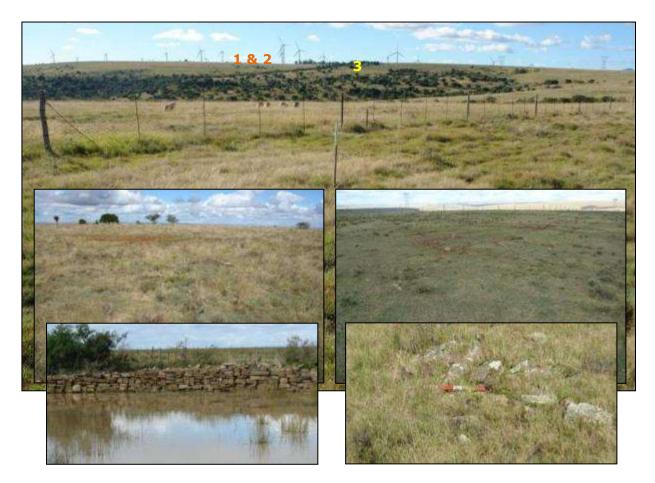
The only historical heritage structure observed within the layout zone was a dry stone packed dam wall next to the gravel road to Cookhouse and Bedford (Map 3, Figure 1 bottom inserts)(Appendix A). A stone cairn was identified by the ACO survey in 2009 approximately 50 metres north-east of the dam wall. The origin/significance of the cairn is unknown, but should not be disturbed in case it is a burial. During the same survey a stone post was also identified which is near turbine position 2, but is of low significance and falls outside the development area (Map 3, insert image). However, on the other hand there may be sites/materials covered by soil and vegetation. The stone dam wall has an important everyday functional value, but is of low heritage significance. Although it is about 100 metres from the nearest point of the development, care should be taken that it is not damage during the construction of the nearby turbines and access road.

Figure 1. A view from turbine position 17 towards positions 1, 2 and 3 (main image) on the ridge, general views of the turbine positions 1 and 2 (left insert), position 3 (right insert), the stone dam wall (left insert) and stone cairn (right insert).

Although the stone dam wall, cairn and stone post are of low heritage significance care should be taken that they are not damaged during the construction of the nearby turbines and access road. Marked buffer zones must be placed around structures before construction starts to protect them from damage/vandalism.

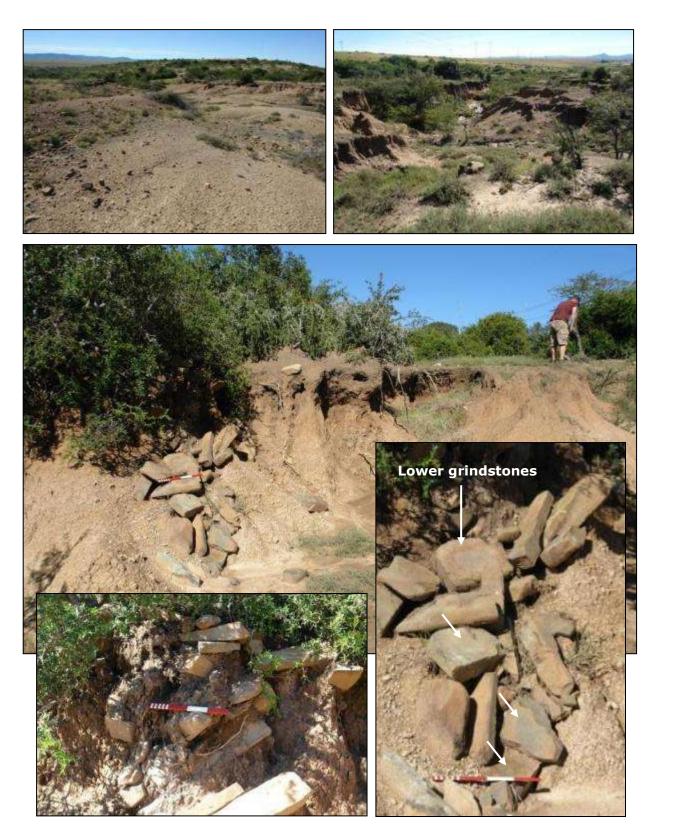
Stone filled burial hollows were recorded and excavated in the wider Eastern Cape Midlands by amateur archaeologists (Records in the Department of Archaeology at the Albany Museum) and it is possible that the lower grindstones were added to the other stones as a symbolic statement/meaning. The first archaeological excavation/investigation in South Africa was conducted on such a stone cairn near Cookhouse in 1776 by Anders Sparrman, the well-known Swedish early traveller.

A second scenario for the origin of the stone pile is that some time ago the grindstones along with the other stones were used to fill-in an erosion gully to prevent further erosion (common practice by farmers to fill gullies with stones). The grindstones were in close proximity of the gully, most probably associated with the Khoi San campsite, and were unceremoniously used as fill.

Unfortunately it would appear that part of the original Khoi herder site has been destroyed by the severe soil erosion in the area. Other archaeological materials observed exposed by the gully erosion included Earlier and Middle Stone Age stone tools (dating between 1.5 million and 30 000 years old) (Figure 7, bottom right insert). Time unfortunately did not allow for a comprehensive investigation, but the brief walkthrough of the gully and adjacent areas suggested that it is a sensitive archaeological landscape and must not be disturbed. There are two possibilities; the first is to reallocate the turn-around area and access road between turbine positions 27and 28 with at least 50 metres from the archaeological sites. The second option is to appoint an archaeologist to collect/remove all the archaeological material in the area that will be affected by the development. This may be a time-consuming and costly exercise.

Figure 6. The pile of stone with lower grindstones exposed in the side of an erosion gully(main image and inserts). The KhoiSan living site is to the top right where the person is standing (main image). The two top inserts are general views of the surface and deep soil erosion adjacent to the site.

1. The pre-colonial KhoiSan living site is of high significance and must not be disturbed during the development. The turn-around area and access road between turbine positions 27 and 28 must be reallocated with least 50 metres from the archaeological sites; or,

2. Appoint an archaeologist to collect/remove all the archaeological material in the area that will be affected by the development. This may be a time-consuming and costly exercise.

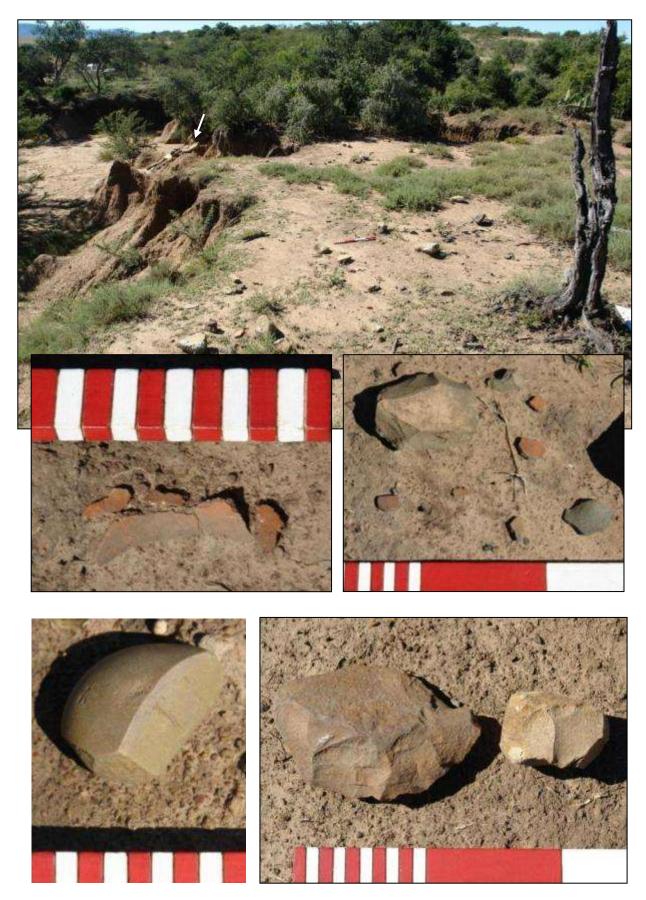
The second site (N2_pottery) is situated near road 10 at the proposed turn-around area between turbine positions 27 and 28. This significant site is situated in the side of a deep erosion gully. It comprises of a pile of stones that contained at least four large lower grindstones. The origin of the feature is not clear, but it could be a burial hollow lined/filled with stones. Although the outline of a hollow is visible in the profile of the donga, the presence of the lower grindstones in the pile is puzzling. The origin of the surface next to the gully and stone pile. The lower grindstones in the stone pile most probably were associated with this occupation floor. Grindstones were also observed in the general vicinity. The occupation floor comprised many pottery fragments and stone tools. A part of a buried ceramic container is still visible surrounded by stone flakes, cores and a fine example of a well-used rubber (upper grindstone). The site represents a Khoi San living/campsite and the pottery date within the past 1 800 years, but the stone tools may date older.

Figure 7. A view of the khoiSan living site with the stone pile in the background (main image), images of a buried Khoi pot (top left insert), stone tools and pottery fragments (top right insert), a rubber (upper grindstone) (bottom left insert) and a sample of Earlier and Middle Stone Age stone tools from the same area (bottom right insert).

The Khoi San living/campsite and surrounding area which is situated within the proposed turn-around area and access road between turbine positions 27and 28, must be protected from the these developments. There are two possibilities;

- the first is to reallocate the turn-around area and access road between turbine positions 27 and 28 with at least 50 metres from the archaeological sites; or,
- to appoint an archaeologist to collect/remove all the archaeological material in the area that will be affected by the development. This may be a time-consuming and costly exercise.

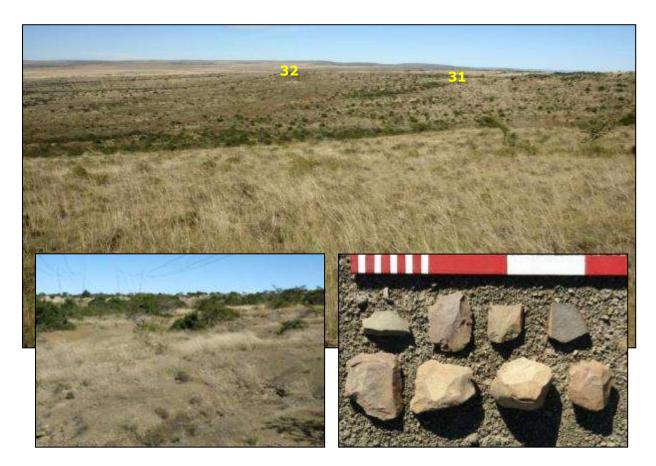
Two archaeological sites were observed in the middle section of the site (Map 1 insert) where the terrain is hillier with prominent drainage valleys, steep gradients and areas of surface and deep soil erosion. One of these sites (N3_msa1) falls outside the development area (about 75 metres away) and comprised of a random scatter of weathered quartzite Middle Stone Age stone tools (dating between 250 000 and 30 000 years old) along a small surface erosion area (Map 6, Figure 8). The stone tools were in secondary context and not associated with any other archaeological remains and are of low heritage significance and therefore need no further mitigation.

Figure 8. A view towards turbines 31 and 32 and the southern section in the far background (main image) and an area of surface erosion (left image) where a number of Middle Stone Age stone tools were observed (right insert).

No mitigation is proposed for the Middle Stone Age stone tool occurrence.
