Table 1: Watercourse Crossing Upgrades and Temporary Bypass Road.

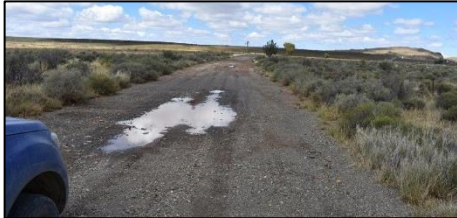
Watercourse Crossing (No. & road)	Current Situation	Province and Municipality	Coordinates (North)	Coordinates (South)	Road reserve Landowners	Photograph
1. DR02314	Drift	Northern Cape, Namakwa DM, Karoo Hoogland LM	31° 46' 37" 22° 4' 22"	31° 47' 2" 22° 4' 26"	Northern Cape Government: Department of Roads and Public Works

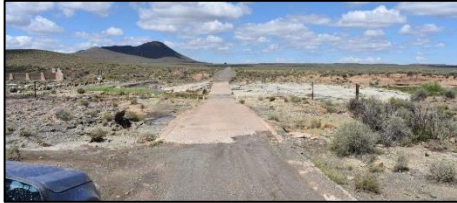
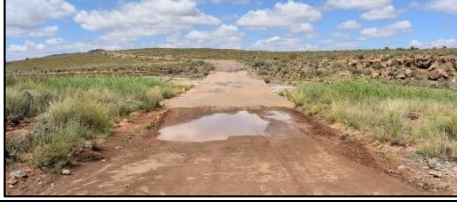
2 & 3. DR02314	Low water cement drift with culverts	Northern Cape, Namakwa DM, Karoo Hoogland LM	31° 48' 36" 22° 5' 24"	31° 49' 43" 22° 5' 42"	Northern Cape Government: Department of Roads and Public Works

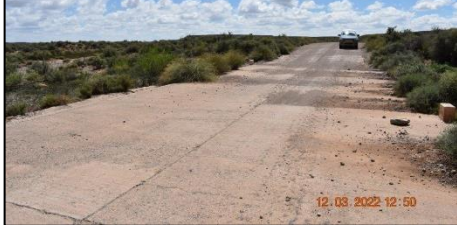
4. DR02314	Low water cement drift with blocked culverts	Northern Cape, Namakwa DM, Karoo Hoogland LM; and Western Cape, Central Karoo DM, Beaufort West LM	31° 52' 49" 22° 5' 21"	31° 53' 2" 22° 5' 20"	Northern Cape Government: Department of Roads and Public Works; and Western Cape Government: Department of Transport and Public Works

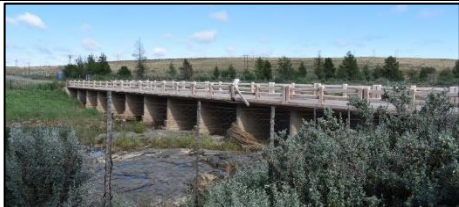
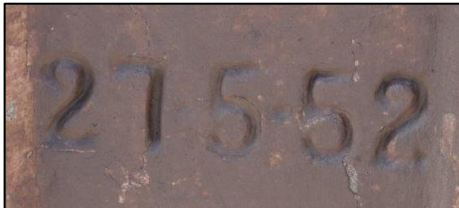
5. R381	Concrete bridge (dated 1952)	Northern Cape, Pixley ka Seme DM, Ubuntu LM	31° 32' 1" 22° 20' 27"	31° 32' 23" 22° 20' 19"	Northern Cape Government: Department of Roads and Public Works

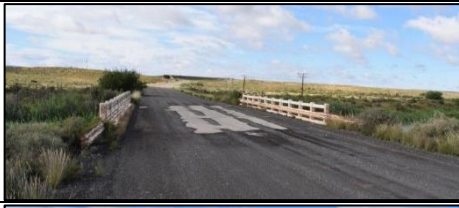
6. R381	Concrete bridge (undated)	Northern Cape, Pixley Ka Seme DM, Ubuntu LM	31° 33' 17" 22° 21' 2"	31° 33' 33"; 22° 21' 7"	Northern Cape Government: Department of Roads and Public Works

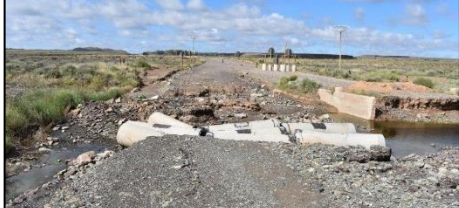
7. R381	Washed away, with recent repairs flood-damaged again in 2022	Western Cape, Central Karoo DM, Beaufort West LM	31° 38' 28" 22° 21' 10"	31° 38' 35" 22° 21' 10"	Western Cape Government: Department of Transport and Public Works
