Scoping Archaeological Impact Assessment

**Proposed Lunsklip Wind Farm on Portion 135 of Farm
Melkhoutfontein 480, Portions 2 and 3 of Farm 630, Remainder Farm
630, Remainder Portion 7 of Farm Luins Klip 472, Portion 1 of Farm
635, Portions 2 and 25 of Farm Luins Klip 472 and Farm 626,
Stilbaai, Western Cape Province**

18 July 2012

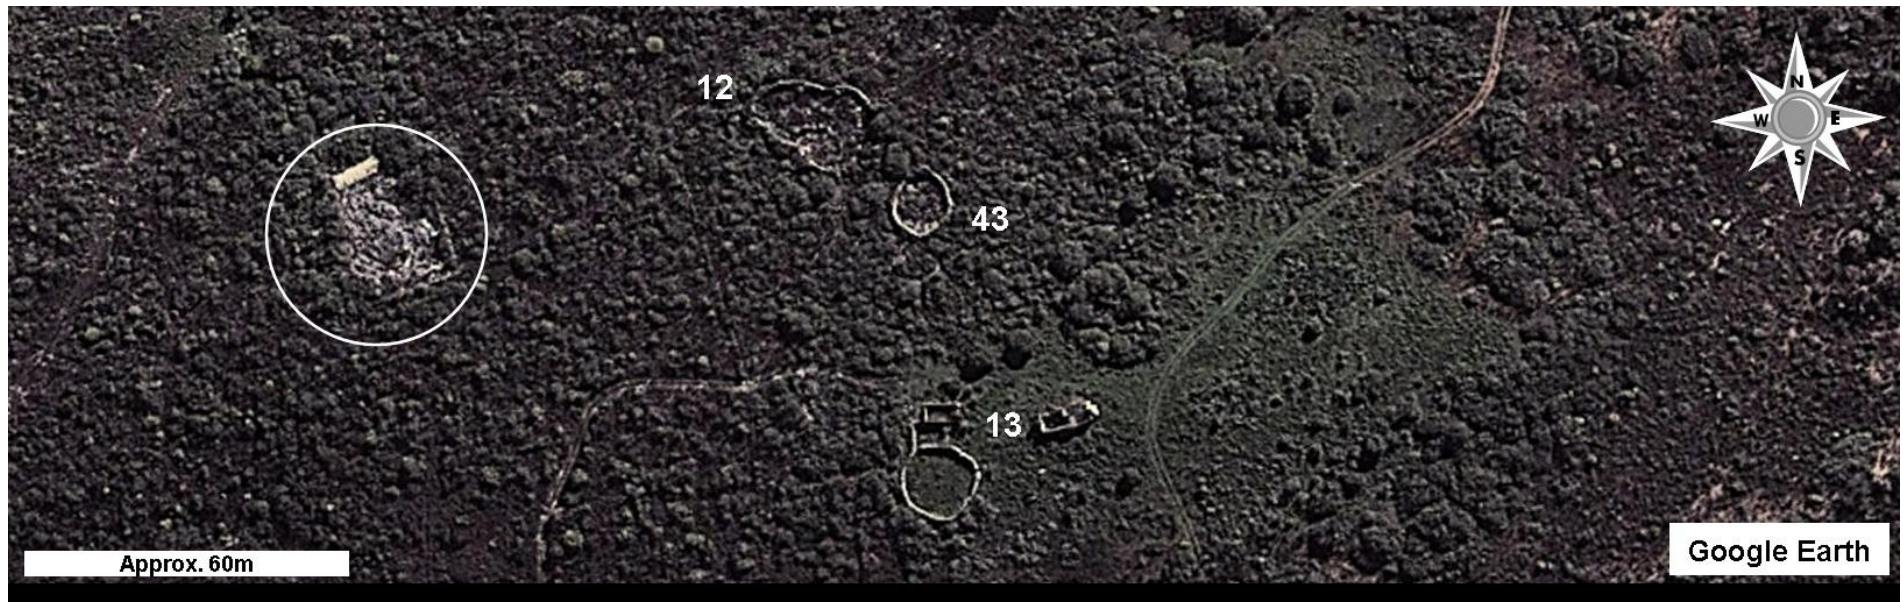
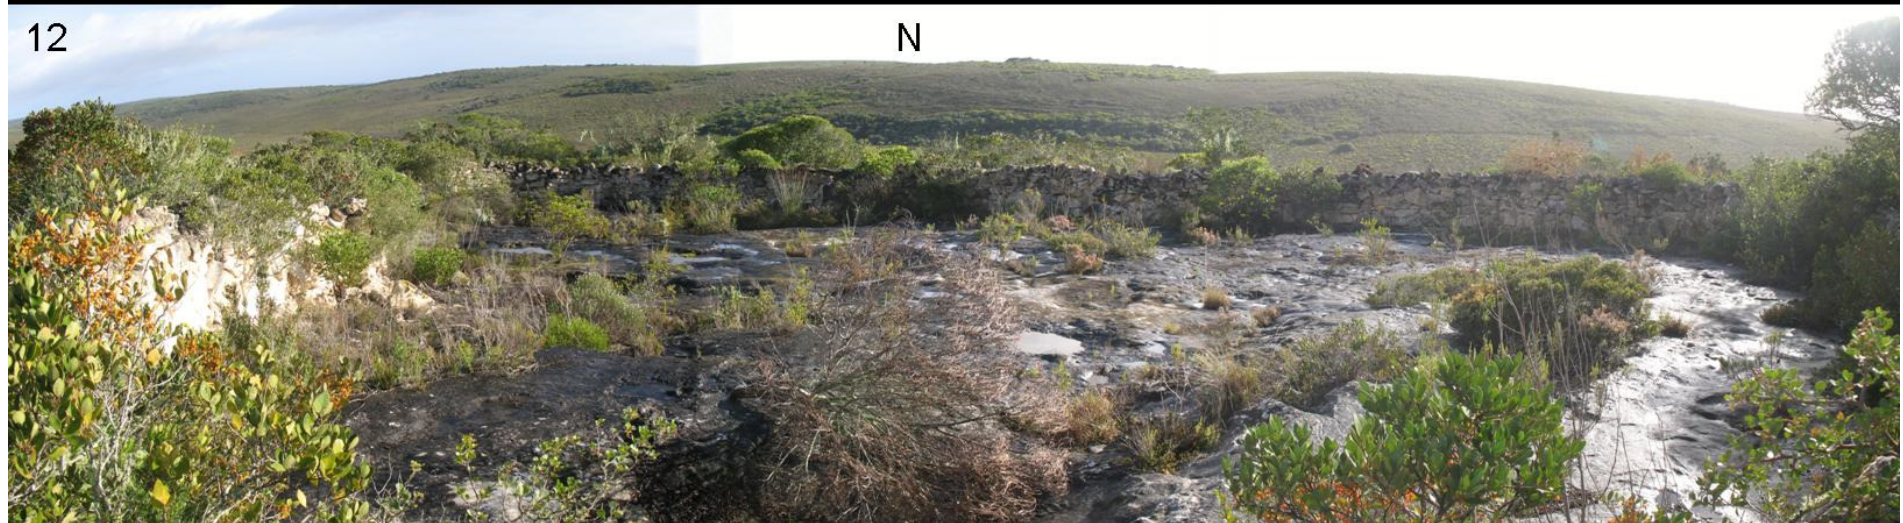
Old, disused water collection structures/features are located at **waypoints 12, 43 and 56** (Figure 6 and Plates 5, 6 & 7). It appears that the circled feature to the west of waypoint 12, as seen on the Google Earth image in Plate 5, is also a water collection structure, but it was not known of or visible during field work. Typically, these features consist of exposed calcrete surfaces that are enclosed with calcrete walling, and according to Mr van Rensburg, the latter serve to keep animals out. Towards the lower lying parts of these walled areas at waypoints 12 and 43 are natural or partly man-made pools that, in places, are lined with plaster (Plate 6). The plaster would render the pools more watertight or seal natural cracks in the calcrete. At waypoint 56, the water collection mode is via a man-made dam (Plate 7). Although still functional, the above features are not currently used or maintained. A restored water collection structure, similar to those described above, is situated at **waypoint 45** where a roofed dam houses collected water (Figure 6 and Plate 8). All these features function in the same way; rain or surface water drains down slope atop the calcrete surfaces and then collects in natural, modified or man-made reservoirs.

Plate 5. Top – water collection features (12 & 43), ruins and kraal (13) and probable water collection feature circled in white. Bottom – calcrete surface and walling at water collection feature (Figure 6 and Table 2).

Although the author has not seen or heard of the above features, they may have been recorded elsewhere. Key to their existence is the presence of sloped, exposed and continuous calcrete surfaces, and therefore, their frequency and distribution is likely to be limited. Through the use of naturally occurring calcrete surfaces and sometimes natural pools, historic and likely earlier inhabitants of the area harvested potable water. Even though they cannot be dated directly, it is likely that some of these features are older than 60 years since two are associated with a ruined structure at waypoint 13 that was occupied early in the 1900s (Mr van Rensburg pers. comm., see Plate 9). The water collection structures/features are considered to be worthy of preservation, but because they lie outside the proposed development area no further archaeological work or mitigation is required. In the event that they will be altered or damaged by the development then this will require a permit application in terms of Section 34 of the National Heritage Resources Act (Act 25 of 1999).

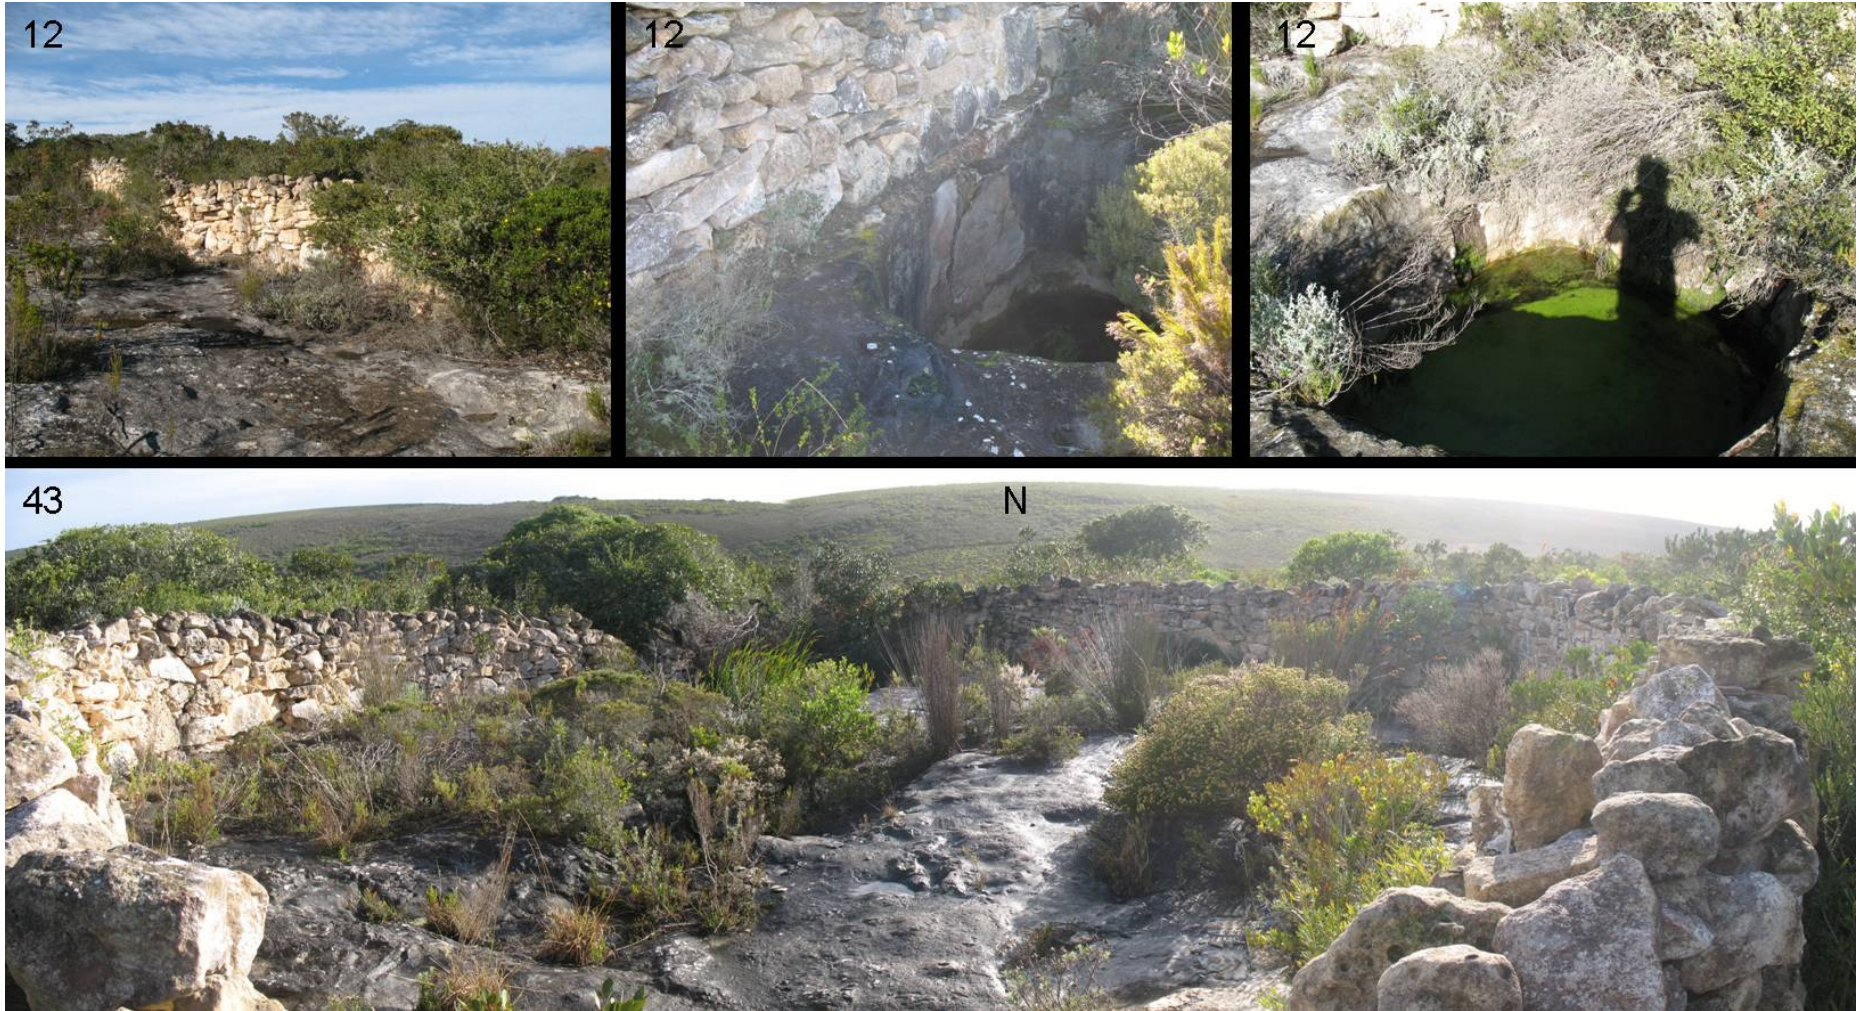
Plate 6. Top – water collection feature showing exposed calcrete surfaces, walling and natural or modified pools that are plastered in places. Bottom – calcrete surface and walling at water collection feature (Figure 6 and Table 2).

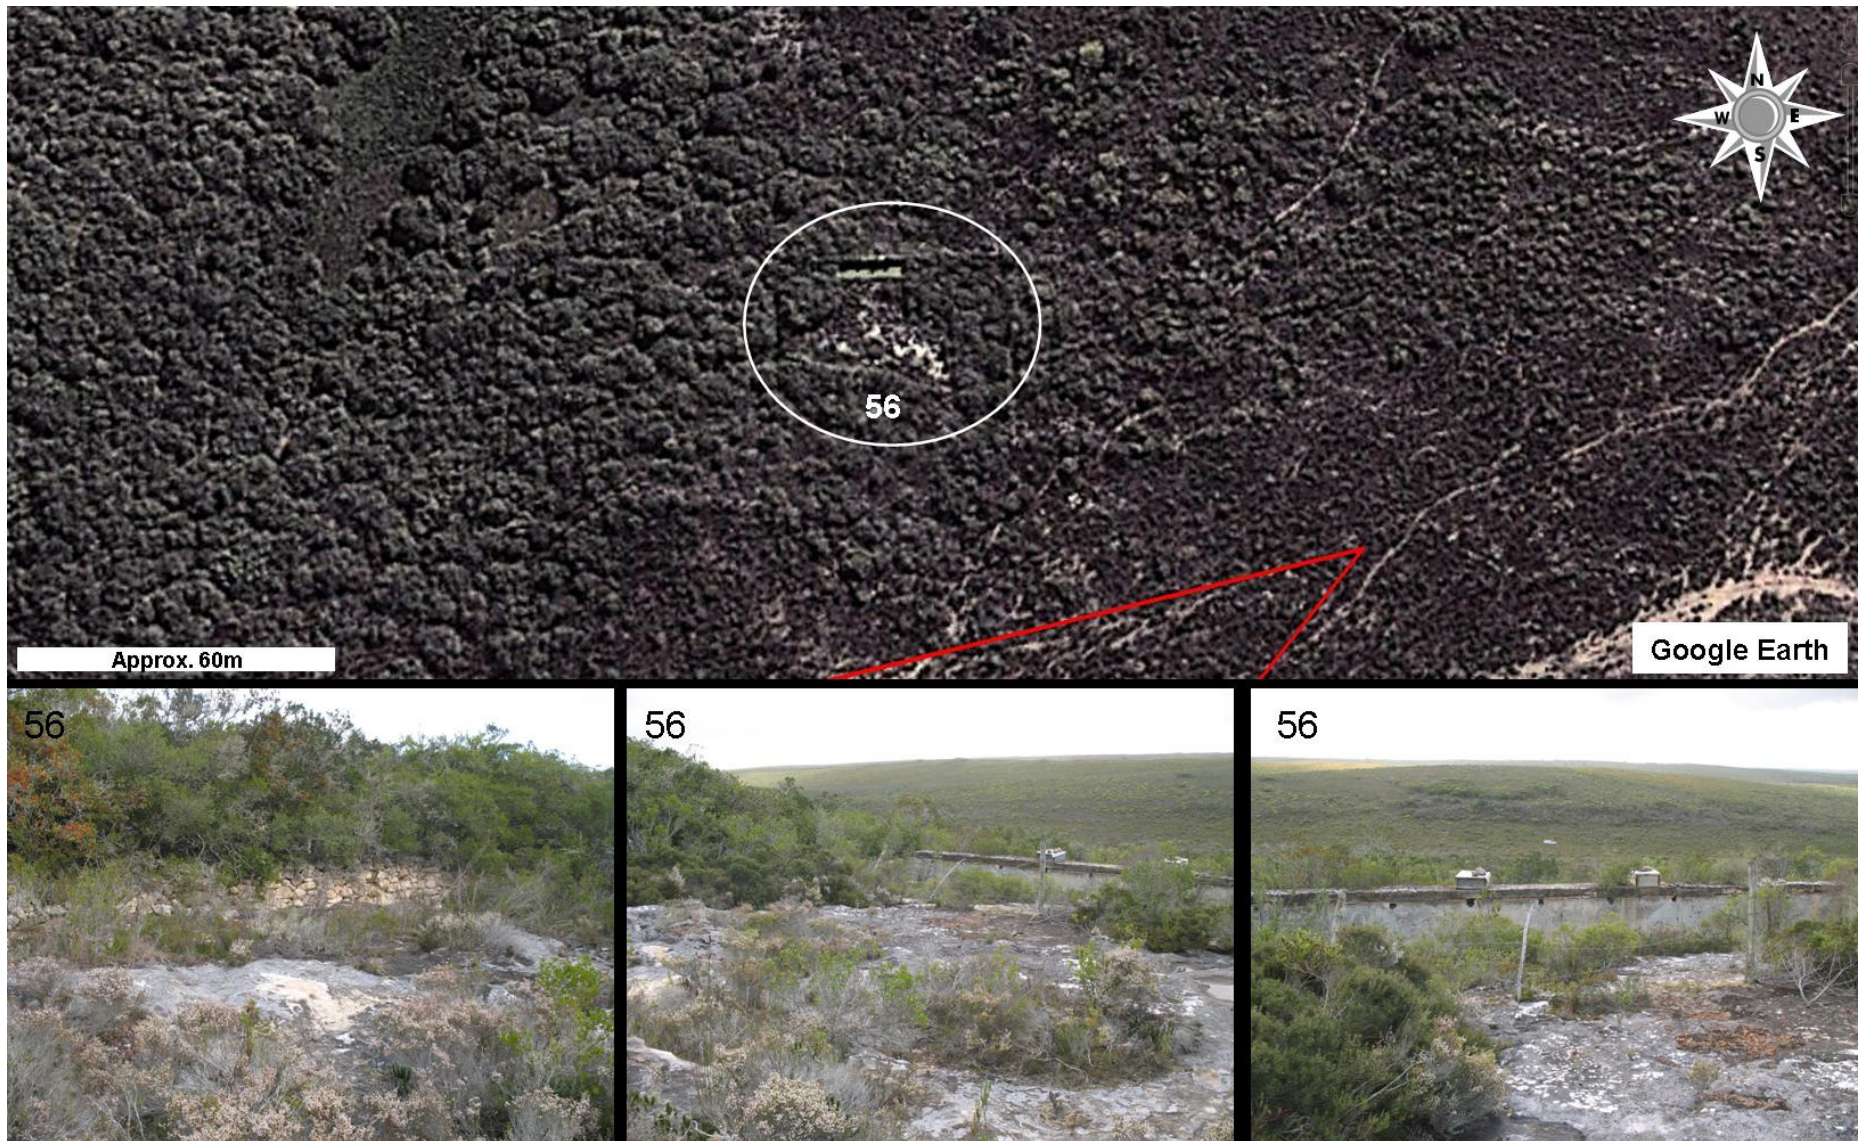
Plate 7. Water collection feature at waypoint 56 showing exposed calcrete surfaces, walling and man-made dam (Figure 6 and Table 2).

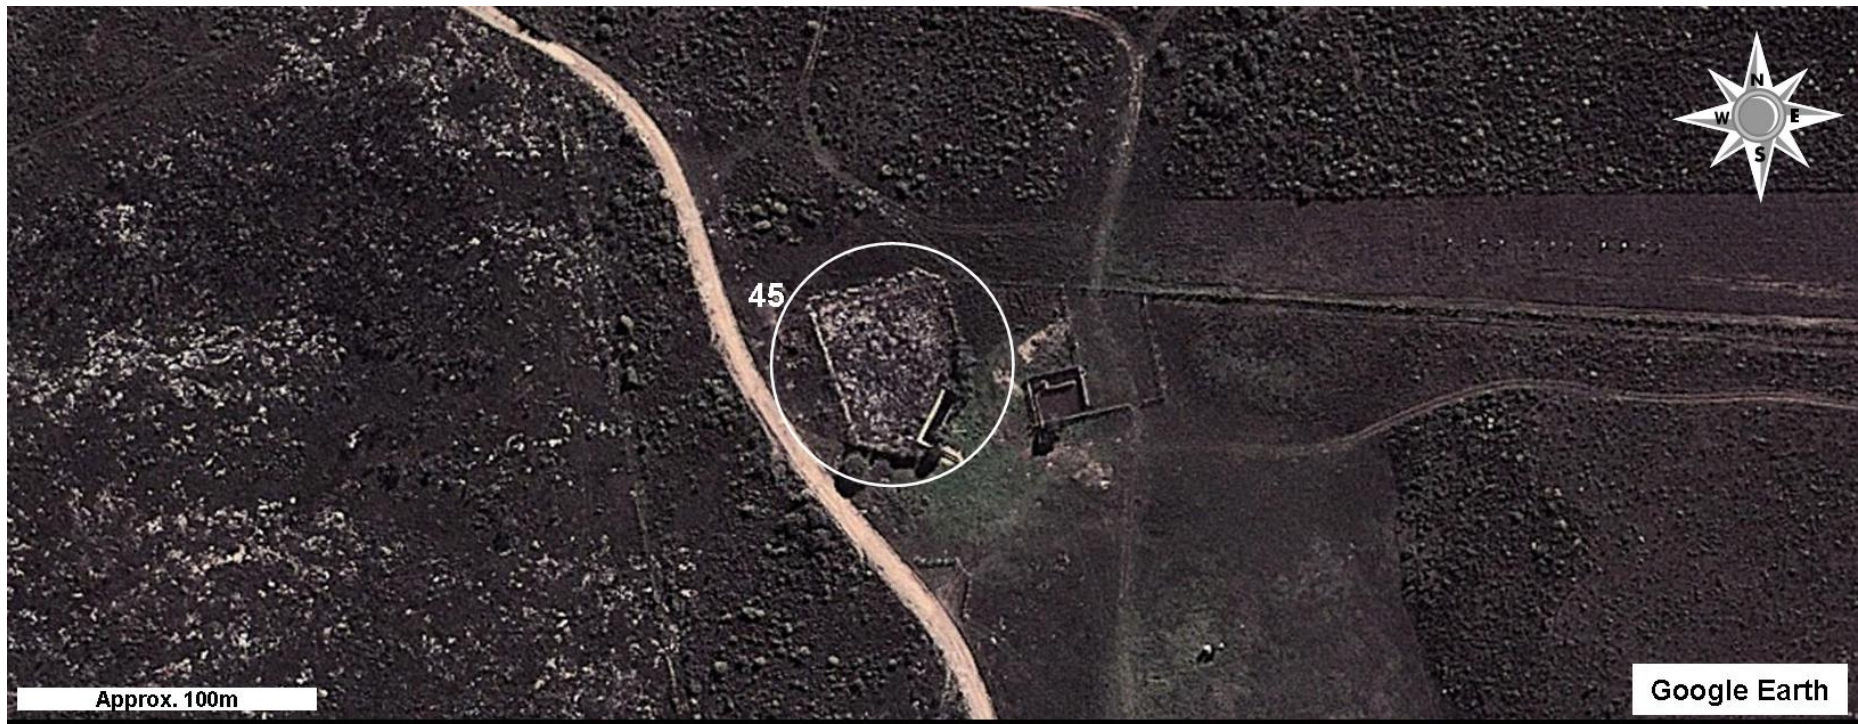
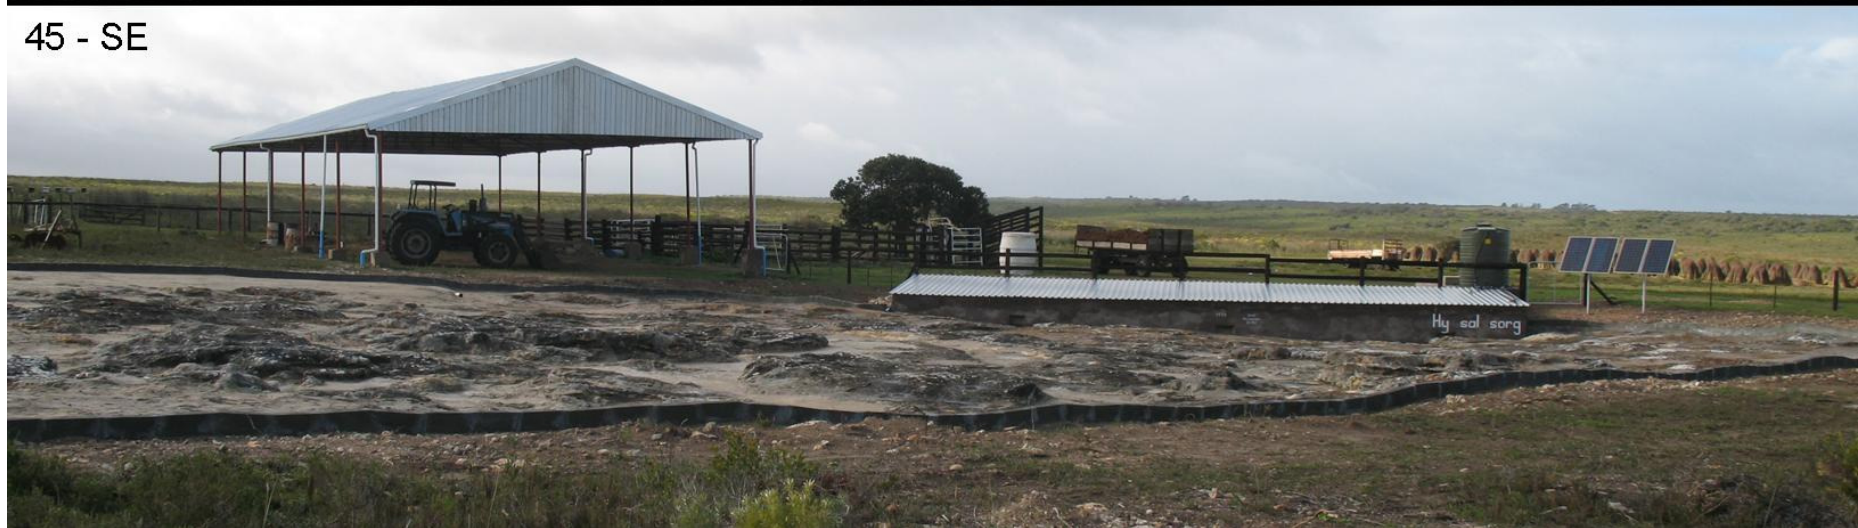
45 - SE

Plate 8. Restored and functional water collection feature at waypoint 45 (Figure 6 and Table 2).

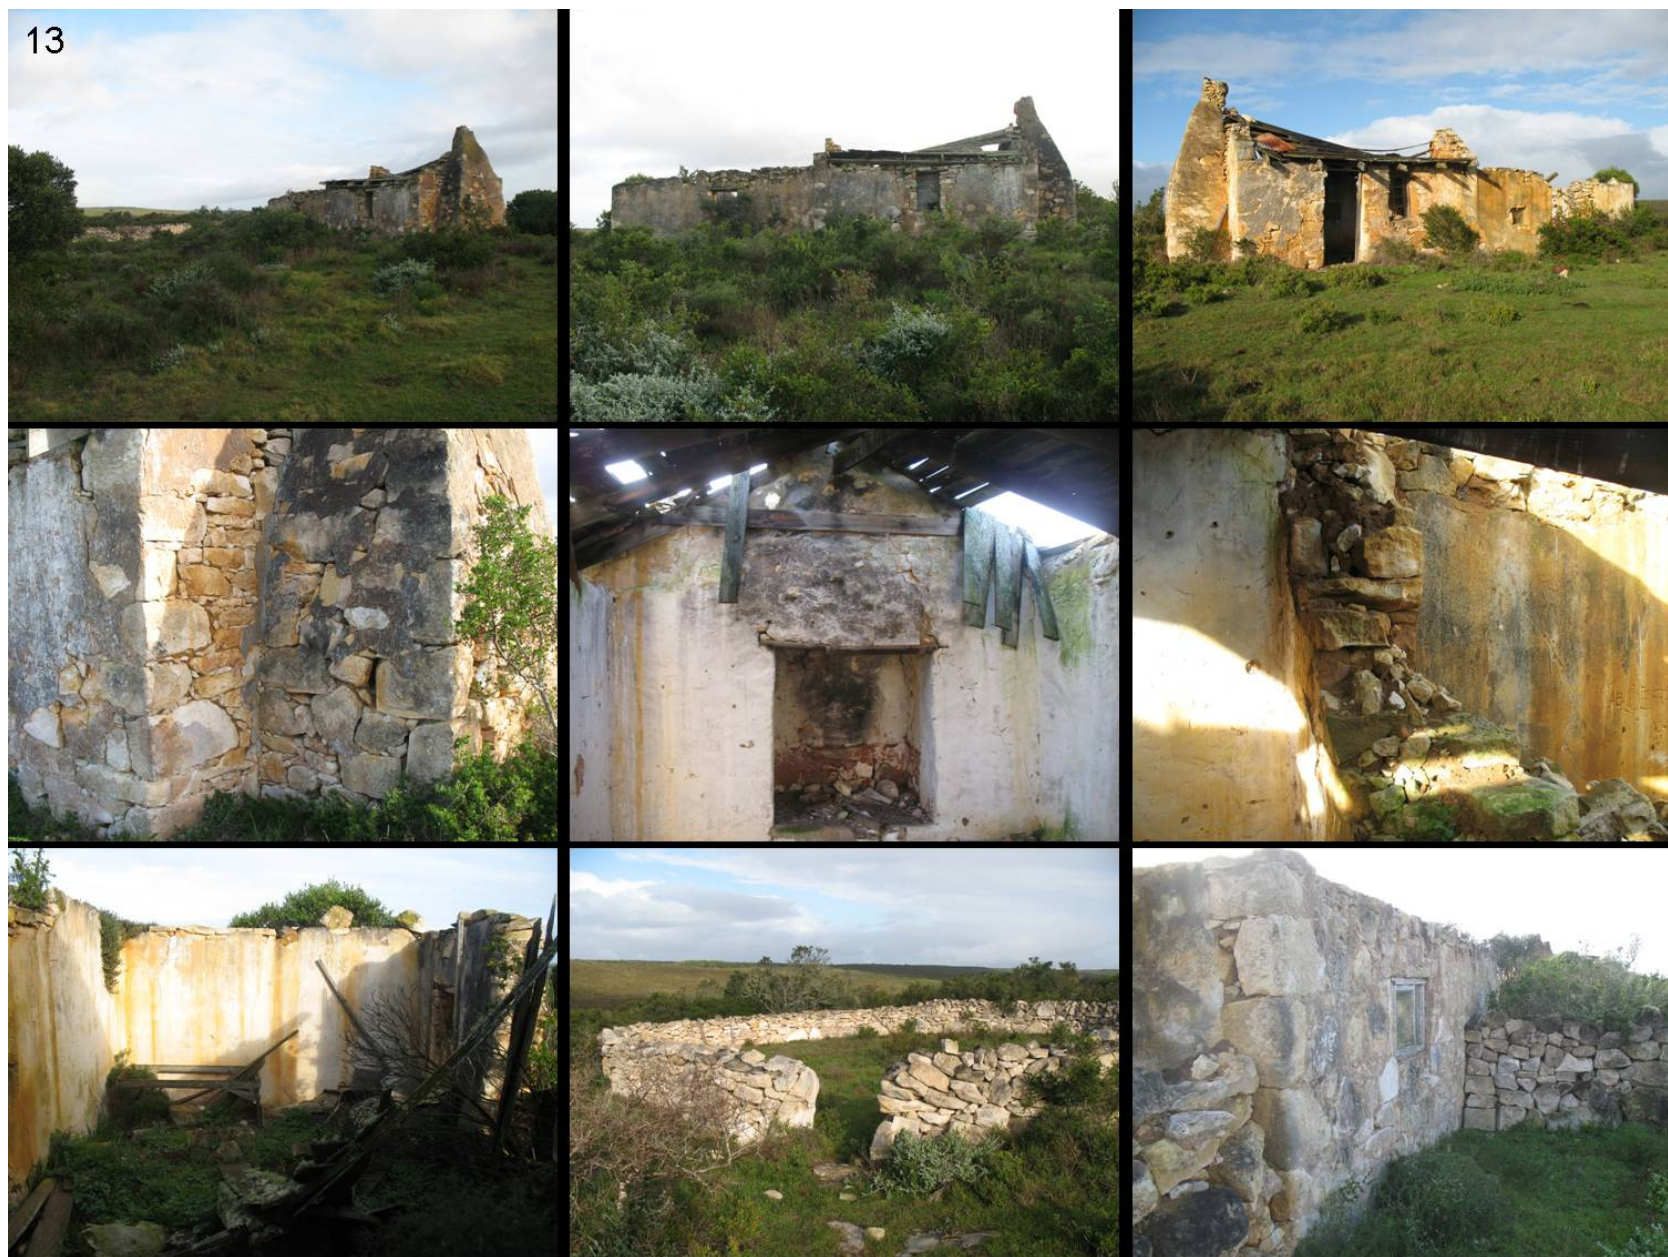
The ruins of an old dwelling are located at **waypoint 13** and according to Mr van Rensburg this dwelling was occupied in the early 20th century (Figure 6 and Plates 5 & 9). Associated with this structure are two water collection structures/features to the NE and a garage/store and kraal to the W and WSW respectively (Plates 5 & 9). All the walls of these structures are made of calcrete, and mortar and plaster is clearly not modern (Plate 9). Measured on the outside, the dwelling is about 14m long by some 6m wide and consists of two rooms with separate external doorways. It is evident that the original structure consisted of only one room - with a fire place and chimney at one end – and that the second room was added later on. Remains of a wooden framework for the roof and the absence of other roofing materials suggest that the structure had a roof of thatch reed. *Restia* species are plentiful in the area. Like the second room, the garage/store and kraal seem to be of later construction. No artefacts of the historic period were seen in the area, but these may be covered by vegetation and/or soft surface sediments.

Plate 9. Ruins at waypoint 13 – dwelling, kraal and garage/store (Figure 6 and Table 2).

Although the ruins are considered to be of low significance, they are older than 60 years and are protected by heritage legislation. The structures lie outside the proposed development area and do not require further archaeological work or mitigation. However, if they will be altered or damaged by the development then this will require a permit application in terms of Section 34 of the National Heritage Resources Act (Act 25 of 1999).

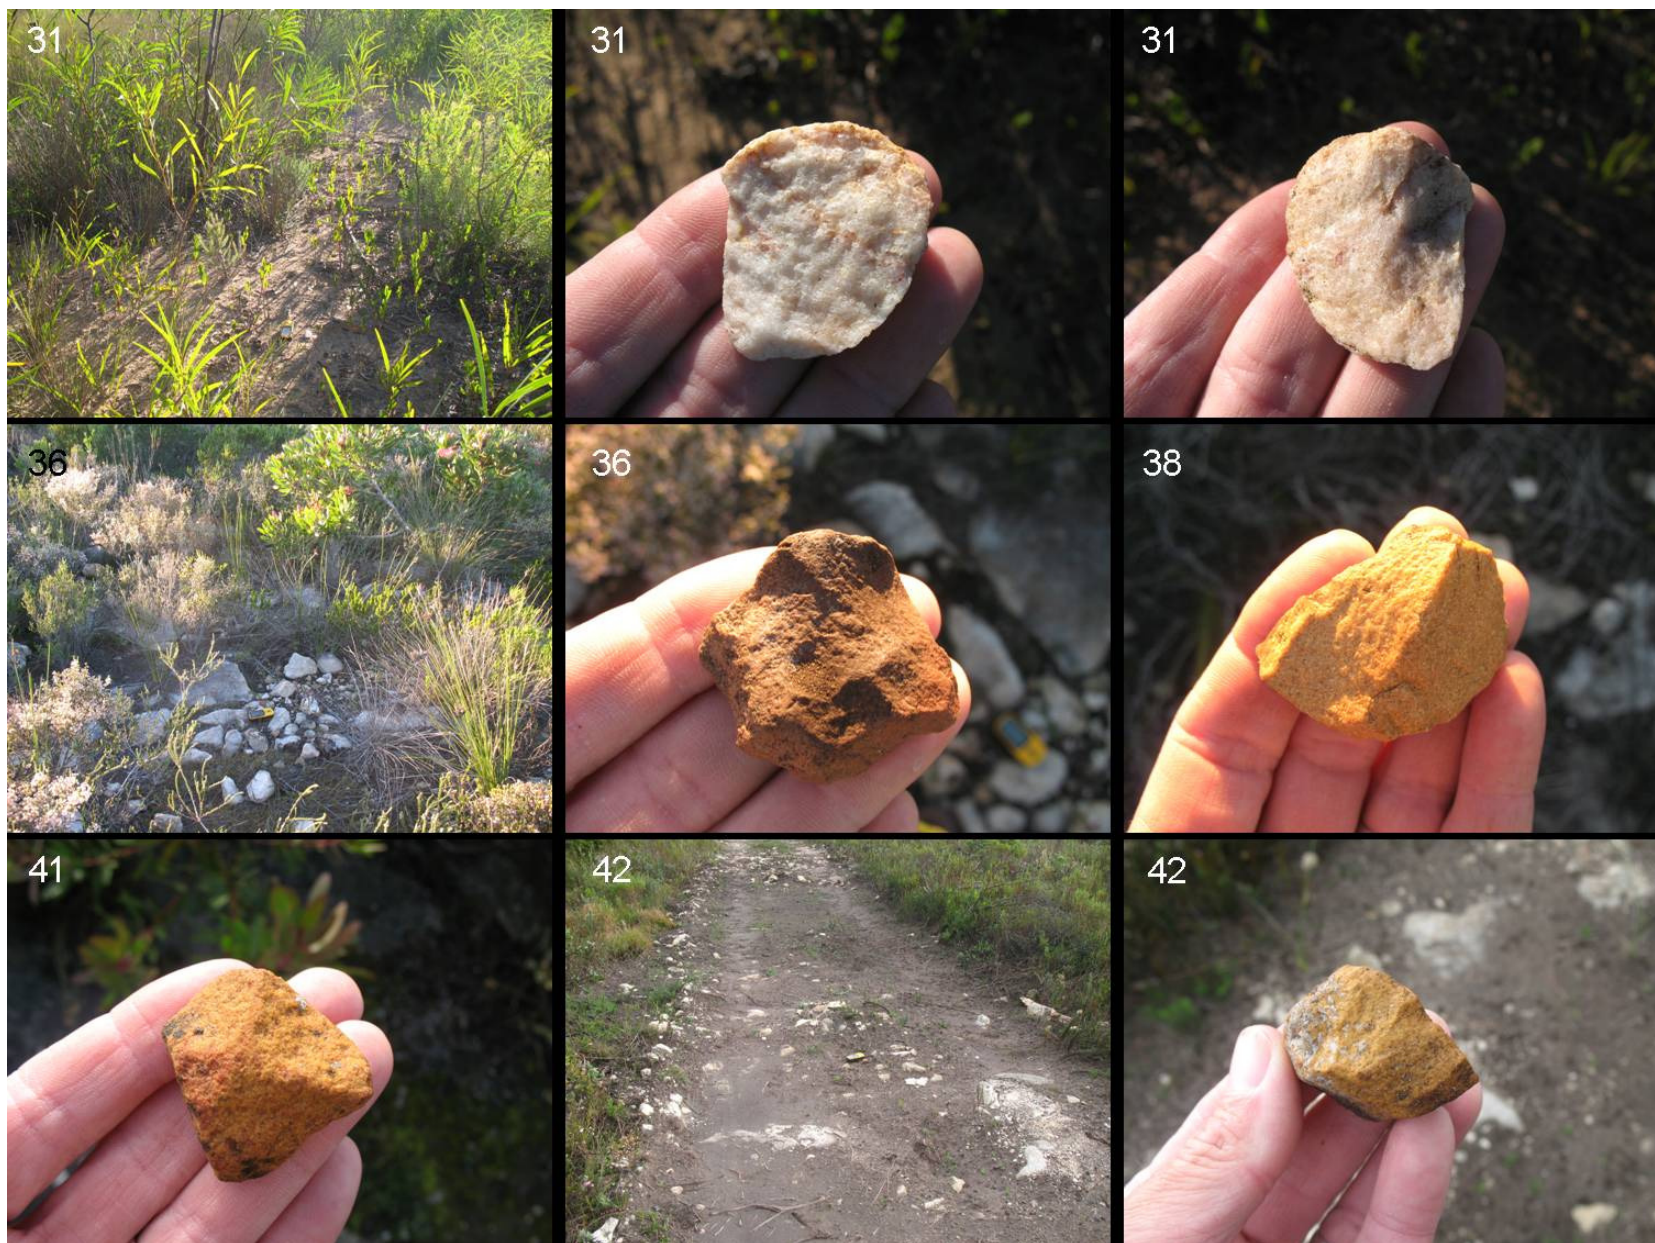
Five isolated stone artefacts of Stone Age origin were identified at waypoints **31, 36, 38, 41 and 42** (Figure 6 and Plate 10). Apart from one, which was found on surface sands, all specimens were found at calcrete outcrops. All artefacts are in quartzite and include two flakes, two flaked pieces and one small core. The latter is likely of Later Stone Age origin while the remainder are nondescript, and based on their heavily weathered surfaces and one faceted platform; they are probably of the Middle Stone Age period.

Plate 10. Contexts and archaeological stone artefacts – flakes, flaked pieces/cores and a small core (Figure 6 and Table 2).

These occurrences are considered to be of no archaeological significance and require no further archaeological recording or mitigation. It cannot be ruled out, however,

that sub surface archaeological resources occur in the development areas. It is recommended, therefore, that part time archaeological monitoring should be conducted by a professional archaeologist during earthmoving activities so as to avoid or minimize negative impact on potential subsurface archaeological resources. Due to the low probability of the latter occurring, it is recommended that full time monitoring is not necessary, but rather, that an archaeologist conducts periodic site inspections during the earthmoving phase of the development.
