**WONDERFONTEIN COLLIERY PROJECT REF NO. 16/5/1, CASE ID 1487**

## Annexure A – Photos of structures and graveyard

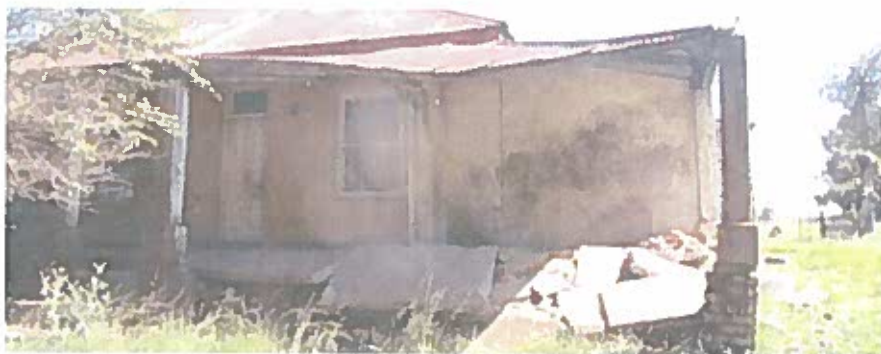
**Figure 1**

Collapsed veranda at house  
(Miller, 2013, figure 175, page 107)

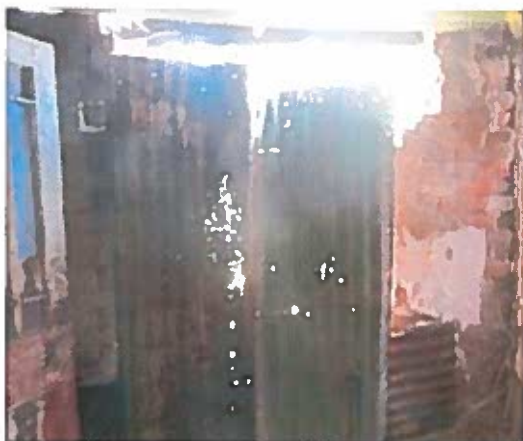
**Figure 2**

The present state for the structures identified as HH02 and the graveyard (GY08) is in a state of neglect. The buildings identified in HH02 are currently in a state of dilapidation. Please refer to Figure 2, which indicate that the buildings have been informally expanded upon through poor workmanship and materials. In addition, parts of the original structure have been demolished. It is therefore, the opinion that these structures have little cultural or heritage value. Please note that families currently residing in these buildings do not own the structures and will be relocated as part of the mining plan. Photos of some of the structures and graveyard are included as Annexure A.

Cover of window opening  
(Miller, 2013, figure 186, page 110)

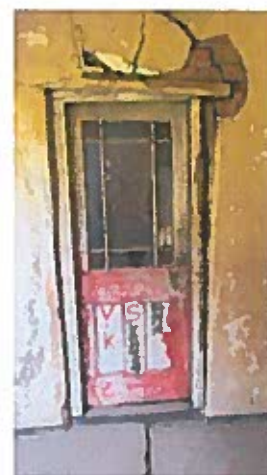
**Figure 3**

Front veranda door  
(Miller, 2013, figure 189, page 111)

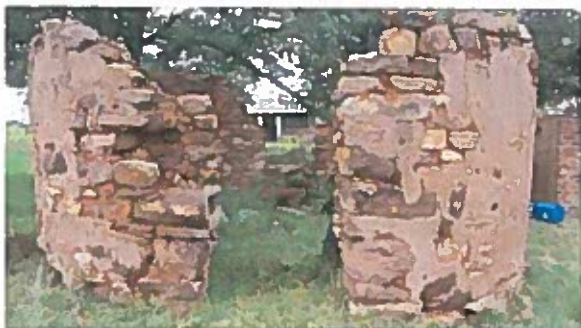
**Figure 4**

Outer kitchen  
(Miller, 2013, figure 252, page 137)

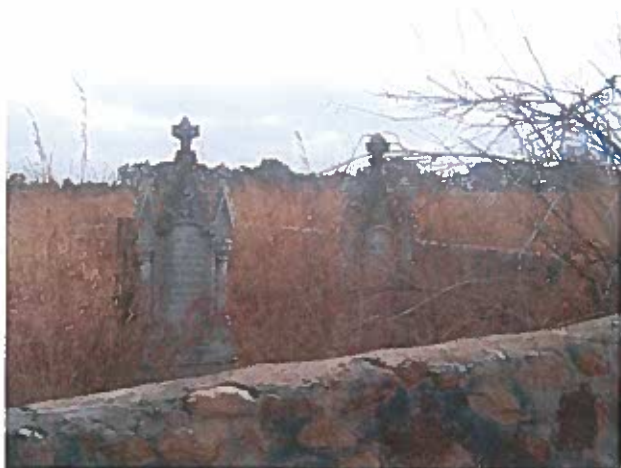
**Figure 5**

Graveyard (GY08)  
(Pistorius, 2008, Figure 6, page 28)
