**HERITAGE SURVEY OF THE PROPOSED
TOBOSHANE VALLEY ESTATE, EAST LONDON**

FOR COASTAL & ENVIRONMENTAL SERVICES

DATE: APRIL 2009

Brief architectural assessment of the properties known as Waterfall Farm, Palm Valley and Horseshoe Farm, East London district

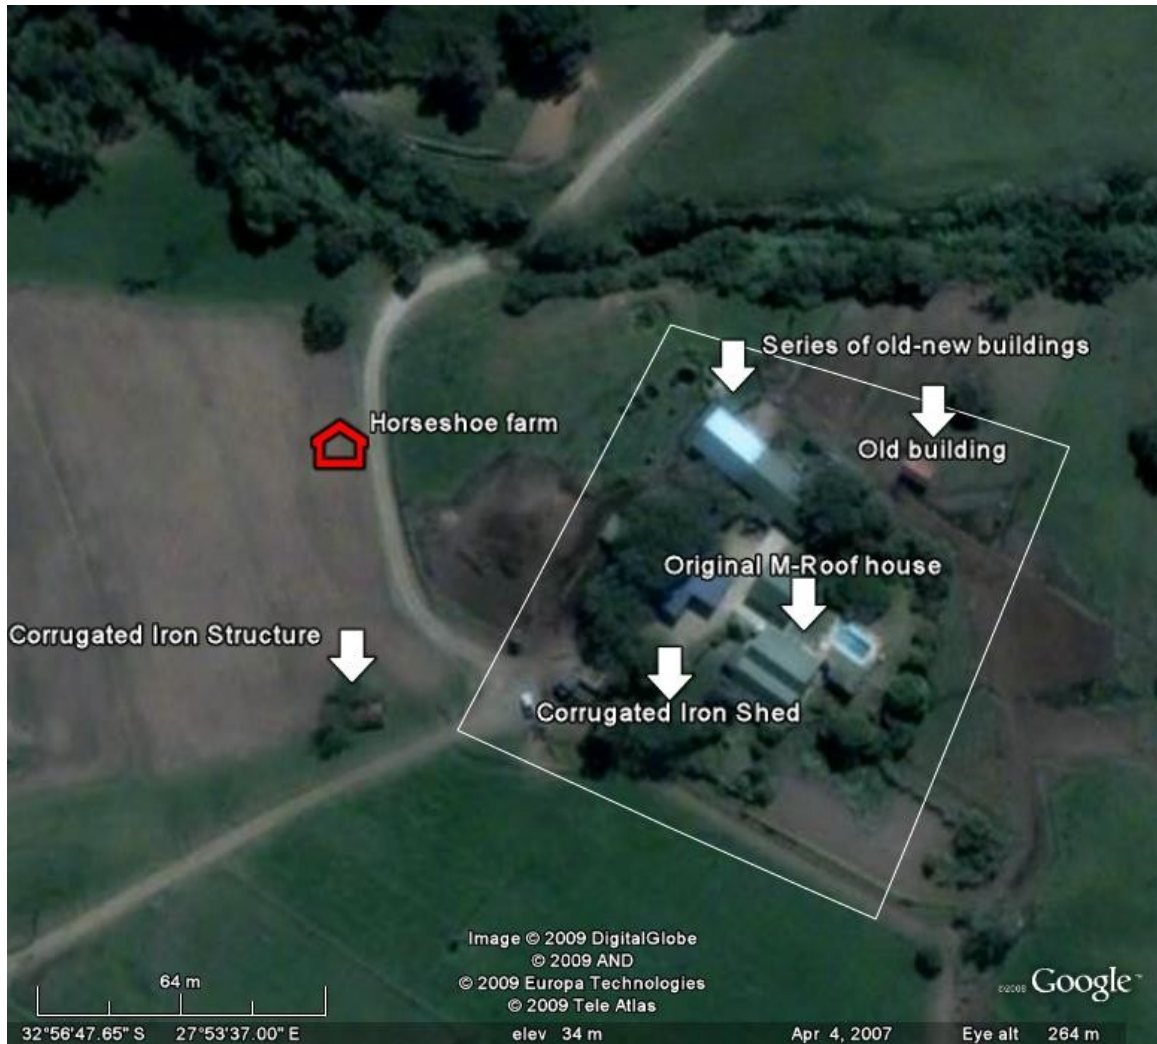
FIG. 3: LAYOUT OF HORSESHOE FARM COMPLEX

Horseshoe Farm consists of several buildings that have been attached to the original house (fig. 3). Whelan (see Appendix B) summarises the building as follows:

Significance: The architectural report (Appendix B) indicates that the building is significant in its architectural style and age.

Mitigation: The development would need to apply for a destruction and alteration permit if any of the buildings are modified. A more detailed architectural survey will then be required.

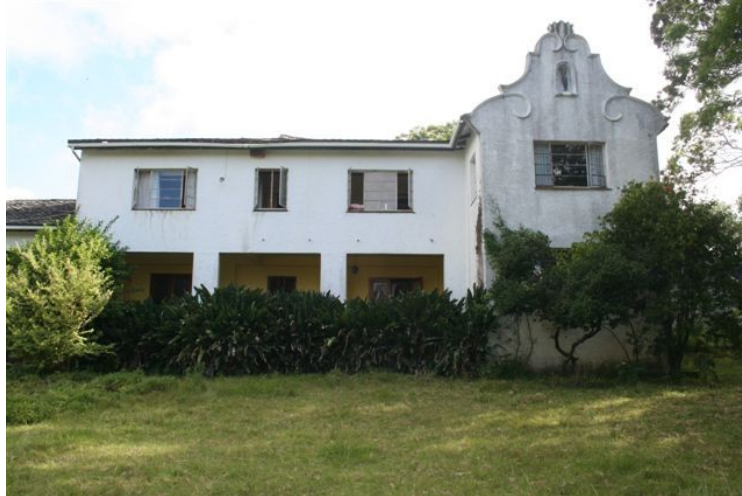
The main house on this property is a much altered double-story structure with a prominent decorative gable in the Cape Dutch fashion. The walls are stucco'ed and painted. The second-story veranda has been enclosed with brick and mortar and steel windows. (see Fig 1)

Fig 1: Showing front elevation of house with gable

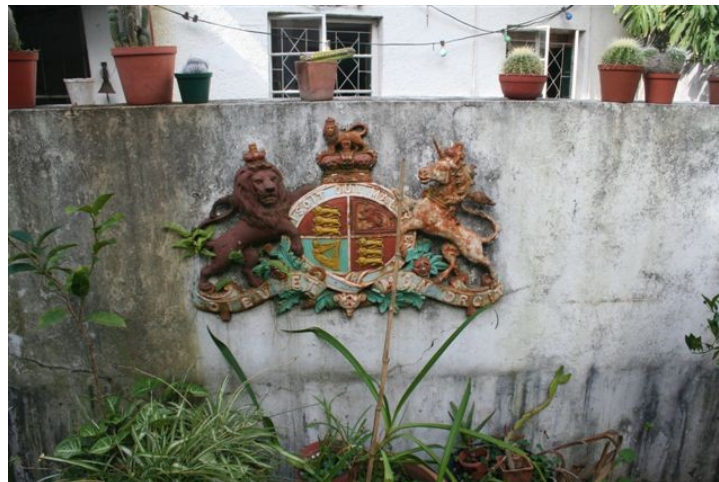
Besides the gable, there is an enigmatic coat-of-arms situated on the wall of the rear courtyard. (see fig 2) It is understood that the Ewing family lived there for a time in the 1970's and that the prominent coat-of-arms could have belonged to this period. An attempt was made to contact the Ewing family in East London, but to no avail.

Fig 2: Showing coat-of-arms to rear courtyard

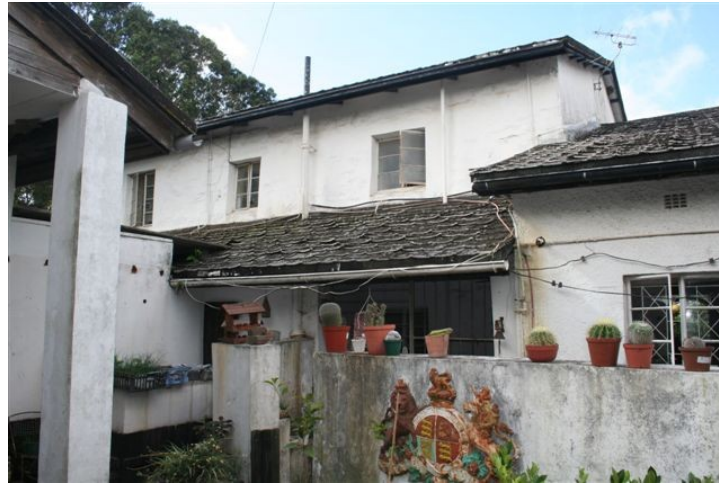
There is little diagnostic material to assist in dating the building, and what is there that is evident dates from the late twentieth century. Most of the windows are standard steel casements, and evidence of non-standard or old construction methods is non-existent. It appears as though the building is roofed with asbestos tiles.

Fig 3: Showing rear courtyard and elevation

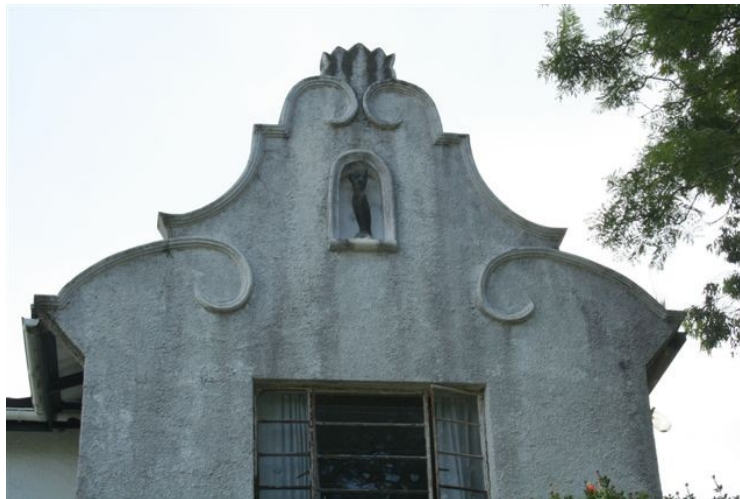
Fig 4: Close up of gable

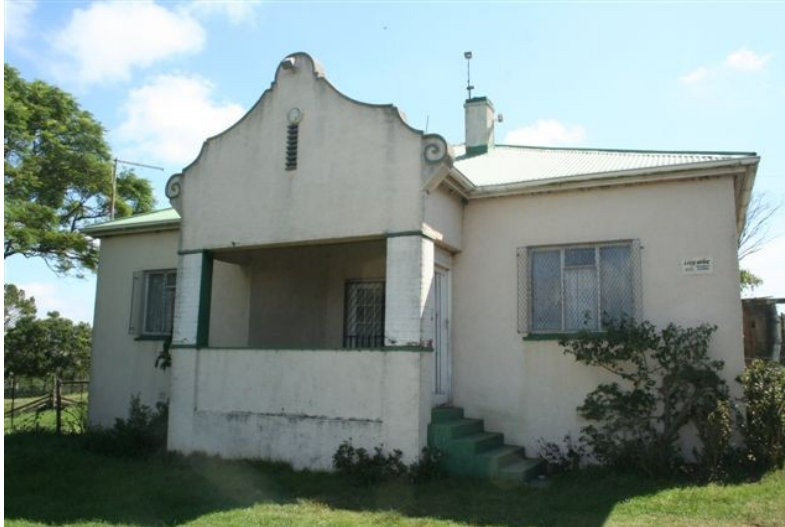
The main structure on Palm Valley Farm is a simple plastered and painted dwelling under corrugated sheeting. There is a simple decorative gable over the main entrance portico. The windows are steel casement.

Fig 5: Showing the main structure on Palm Valley Farm

The structures on Palm Valley farm are good examples of the architectural genre, and possibly one of many similar examples. **They appear solid and suitable for reuse**, and should demolition be required their quality against similar extant structures should be assessed. As in the previous example, any investigations with regard to the historic associations would have to be carried out locally with an appropriate expert, should the need arise.

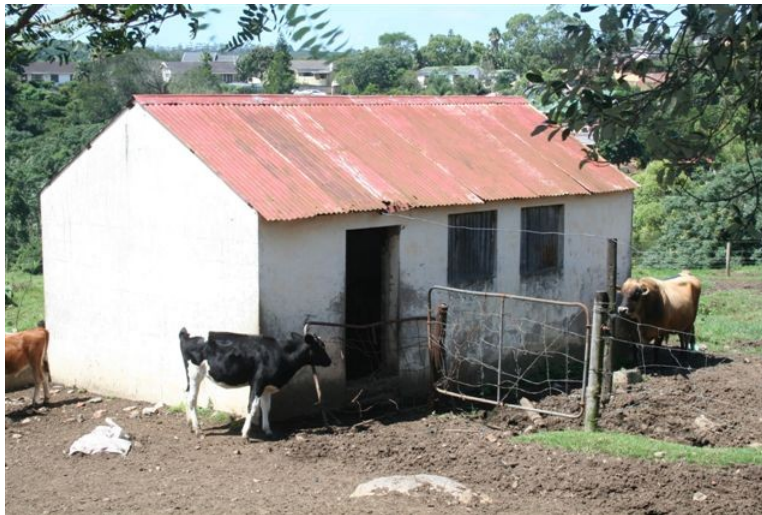
The original deed of grant to the whole farm, then known as grant 318, was in 1862 to one AD Smith. Portion 2 it seems was created in 1934, and sold to Ivor Catherine. It is suspected that this house dates from this period, and certainly the architectural character would be in keeping with this. Other structures such as the shed (see fig 6) are in similar modest form, characteristic of a working farm.

Fig 6: shed on Palm Valley farm

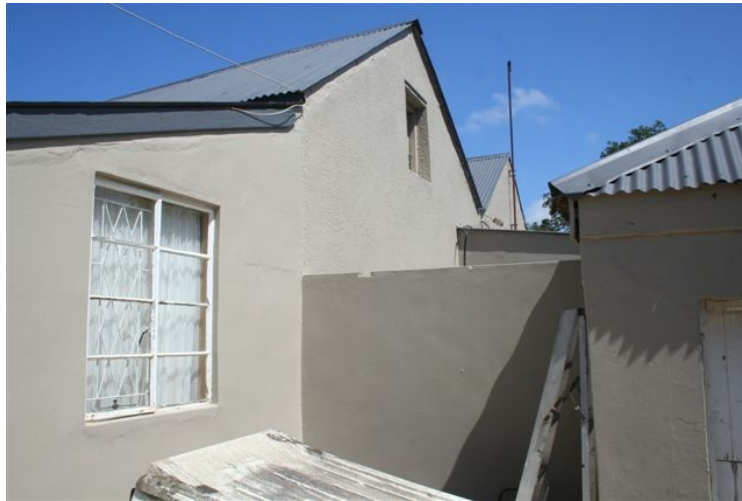
The structures on Horseshoe Farm consist of a main dwelling with an M-shaped roof, and attached outbuildings. These are plastered and painted and under corrugated sheeting. Although the structures have been much altered, the skeleton of the original late-nineteenth century structure can be seen in the M-roof with its valley gutter, and the roof-space ventilator in the gable ends, both characteristic of settler buildings of this period (see Fig 7). The details of the property transfers corroborate this by situating the grant (as above) in 1862 to AD Smith. It is suspected that this structure dates back to the original grant.

Fig 7: roof-space ventilator and M-roof form

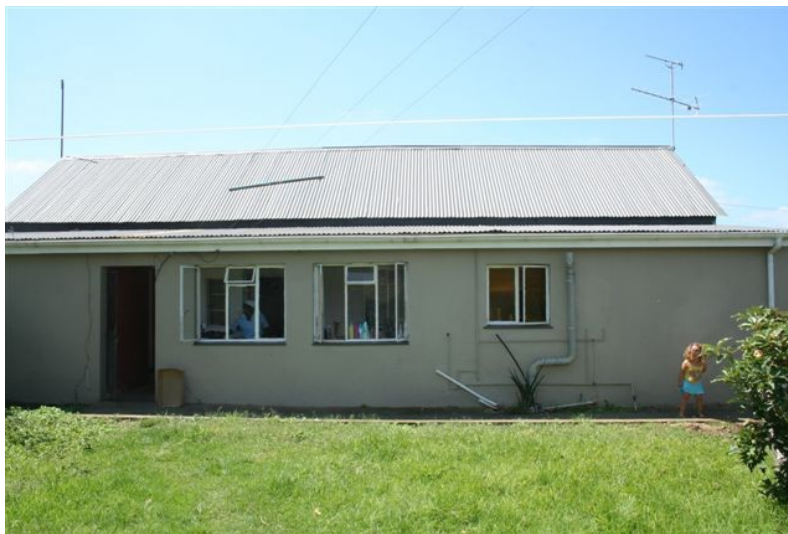
The rear elevation has had an early veranda enclosed with steel fenestration. (see Fig 8)

Fig 8: enclosed rear veranda

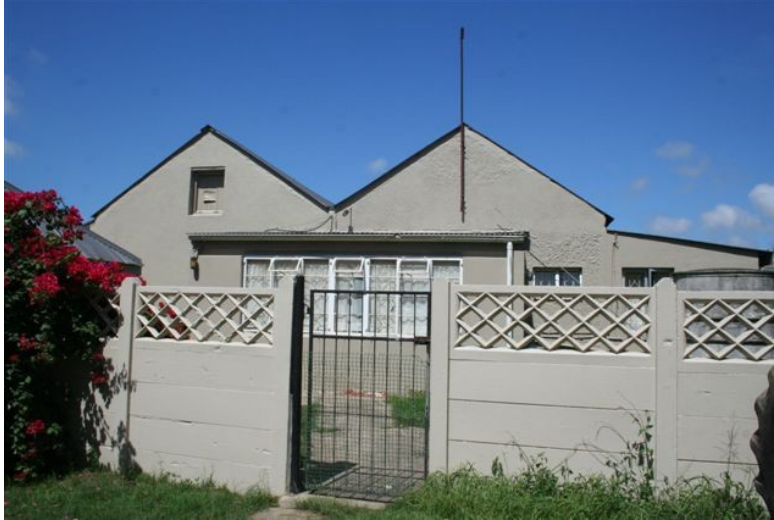
Fig 9: view of M-roof form with valley gutter

It is not easy to ascertain the condition of the structure, given the heavy coat of paint.

This structure is **characteristic** of a farm dwelling from both a scale and proportion point of view, and, although some of its early origins have been lost, these qualities are not compromised to any great extent. It has value in a rural setting. It could **feasibly be reused** in a new development, dictating a scale and an aesthetic quality to new work. As with the other examples, it is recommended that any investigations of an historical nature deemed necessary could be executed by a local specialist.
