DRAFT BASIC ASSESSMENT REPORT:
**UPGRADE OF EXISTING ROADS AND LOW- LEVEL
STREAM CROSSINGS ON ROADS P372, P148, D897,
D30, L1190, L1333, L1351 AND D2286 AT ISADLWANA
AREA WITHIN THE NGUTHU LOCAL MUNICIPALITY,
KWAZULU NATAL PROVINCE**

**APPLICANT: SOUTH AFRICAN NATIONAL ROAD AGENCY SOC LTD
(SANRAL)**

December 2022

QPOINT GROUP

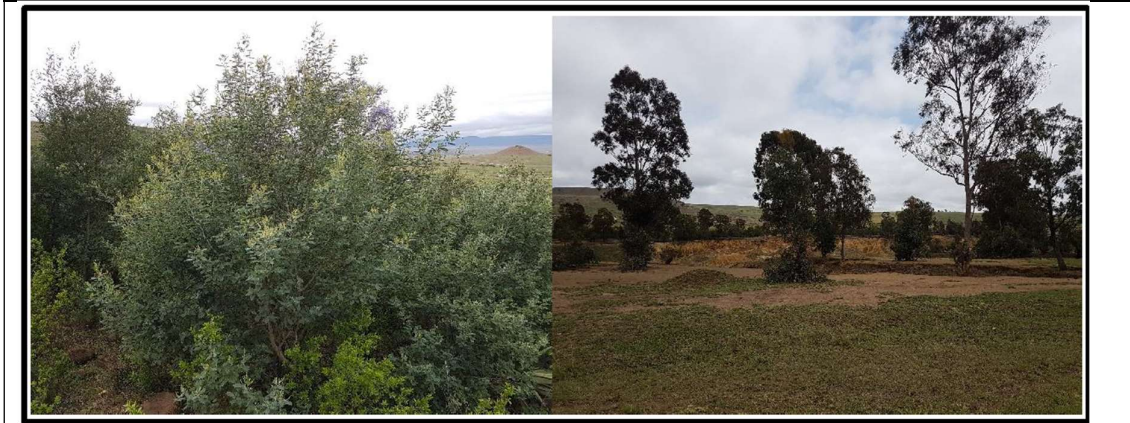
Figure 8.5: Illustration of the secondary habitat located within the study area.

Throughout the route, medium-sized stands of *Eucalyptus sp.* or *Acacia mearnsii* may be observed. This is a typical sight within larger geographical area and is linked to historic plantations. Other parts of the study area are occupied by residential gardens, verges and landscaped gravel driveways, which offer limited habitat and have been planted for their aesthetical appeal, for food (much as mango trees) or as food for livestock. Although much of the secondary vegetation would consist of poor natural habitat, certain species will not differentiate between natural and exotic cover as most of the exotic species found within these areas provide food or refuge, may be attracted into these areas. During the field assessment (as illustrated in Figure 8.5) bird Species of Conservation Concern (SCC) were found within secondary vegetation, foraging for nesting material. This sighting is linked to the presence of a nearby nesting

colony, and suitable habitat located less than 300 m away from the proposed upgrade (along P372).
