THE PROPOSED RESTORATION AND MAINTENANCE OF THE BLUE STONE QUARRY WALL, ROBBEN ISLAND

Revised Maintenance Management Plan

June 2021

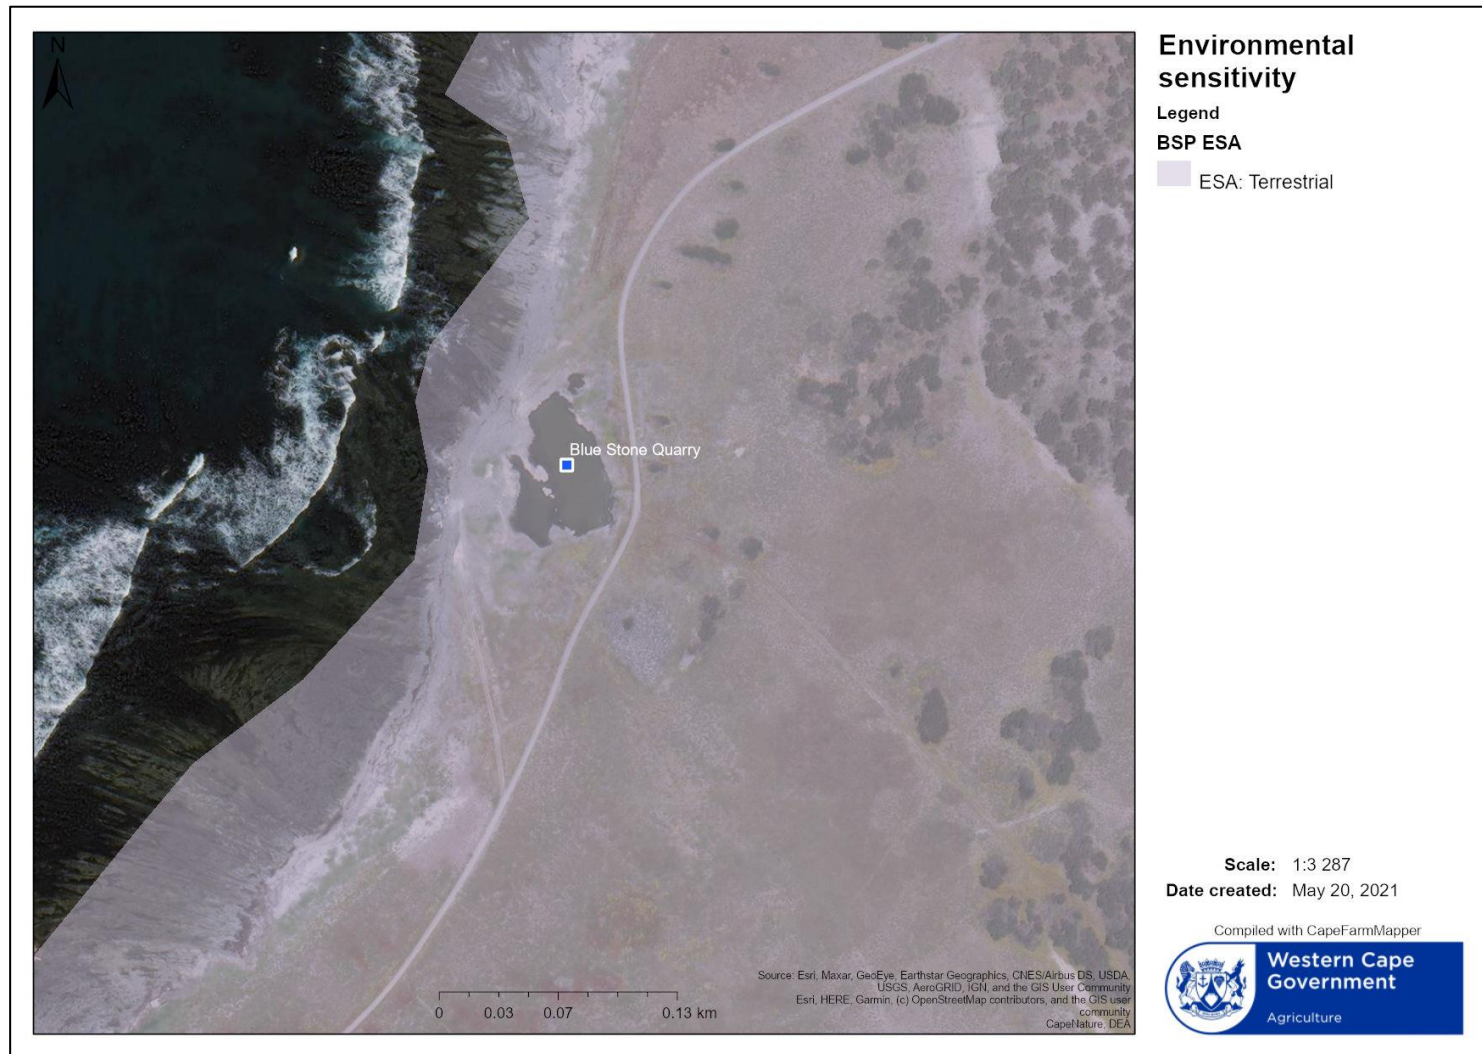
Figure 3 General sensitivity map of the proposed area including areas of conservation concern from the Western Cape Biodiversity Spatial Plan (2017) where “BSP” means Biodiversity Spatial Plan and “ESA” means Ecological Support Area.

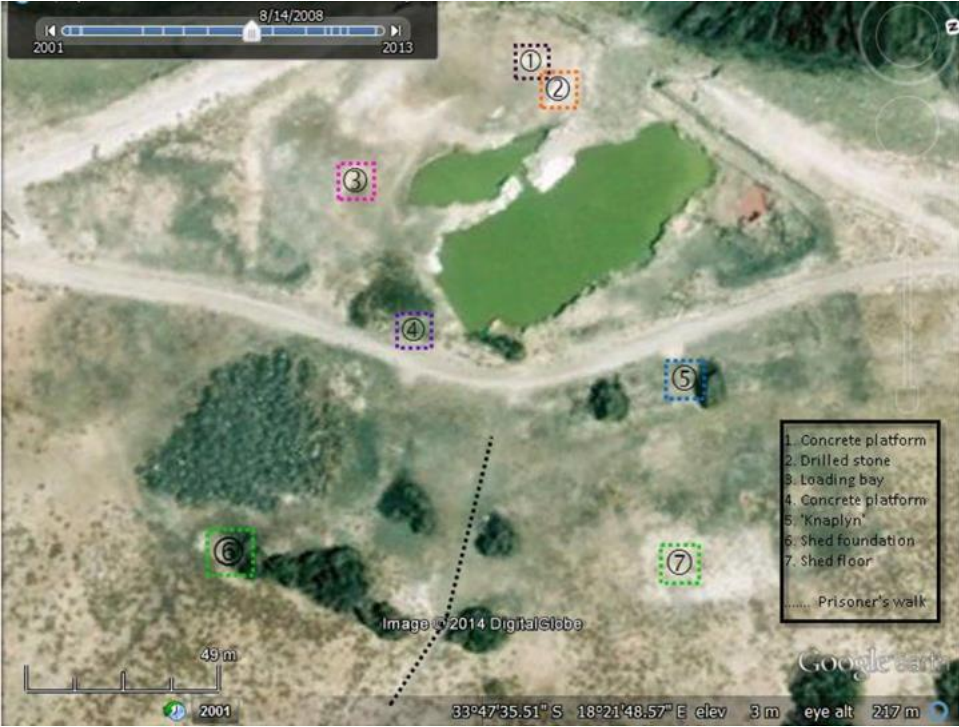
<p>Figure 5 Locality of important heritage structure elements within the Blue Stone Quarry Wall that must be avoided (taken from Alternative Construction Options Assessment, 2015).</p> <p>Please note the area of the areas of each of the sensitive heritage aspects:</p> <ul style="list-style-type: none">• Concrete Platform: 3x8 m• Drilled stone: 2 m long.• Loading Bay: One large bluestone boulder (extent not known but approximately 2x2 m).• Concrete Platform: 2x2 m.• Knaplyn: Rows of blue stones (extent unknown).• Shed foundation: 2x6 m.• Shed floor: Extent not known, but approximately 3x3 m.
--	---
