# **Khangela Emoyeni WEF - Ecological Walkdown Report**

## **Murraysburg, Northern and Western Cape Provinces**

November 2022

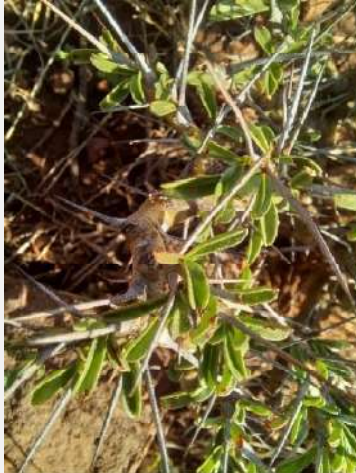
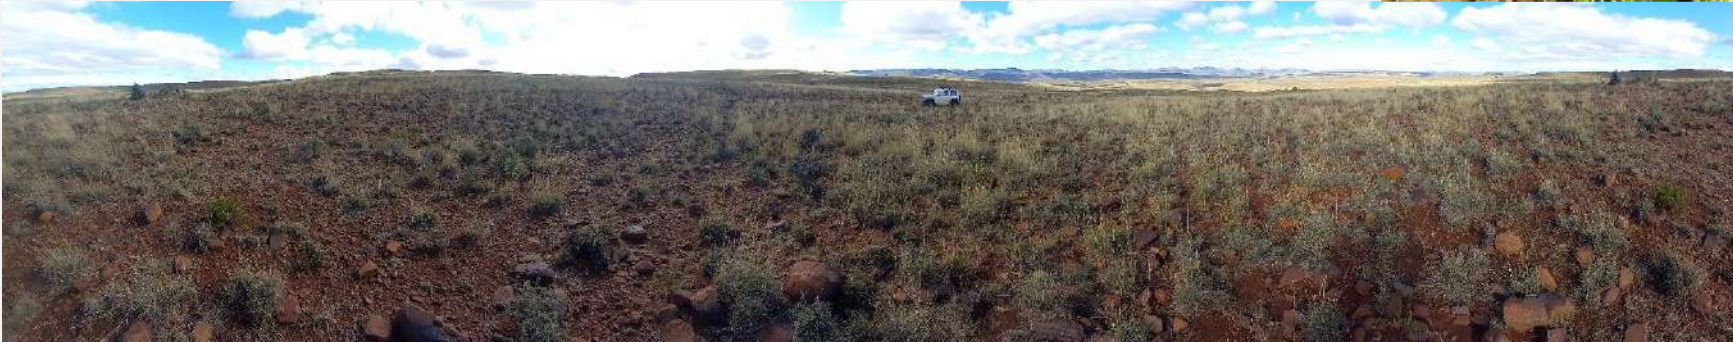
Turbine	Comments and recommendations
9n	<p>Findings: 9n is located adjacent to a rocky slope within a karoo scrub landscape. Soil is rocky in nature with the potential to support geophytic and other species protected by provincial legislation. The listed species <i>Monsonia crassucaulis</i> was found to occur here. These species are listed as Near Threatened and should be relocated if within the turbine footprint.</p> <p>Sensitivity: This particular species, as it is redlisted, make the position of this turbine a High SEI, within an area of Medium SEI. It can be moved slightly to avoid the SCC.</p> <p>Recommendations: The turbine can be moved to avoid the redlisted plants, or the plants can be moved (provided the necessary permits are acquired)</p>

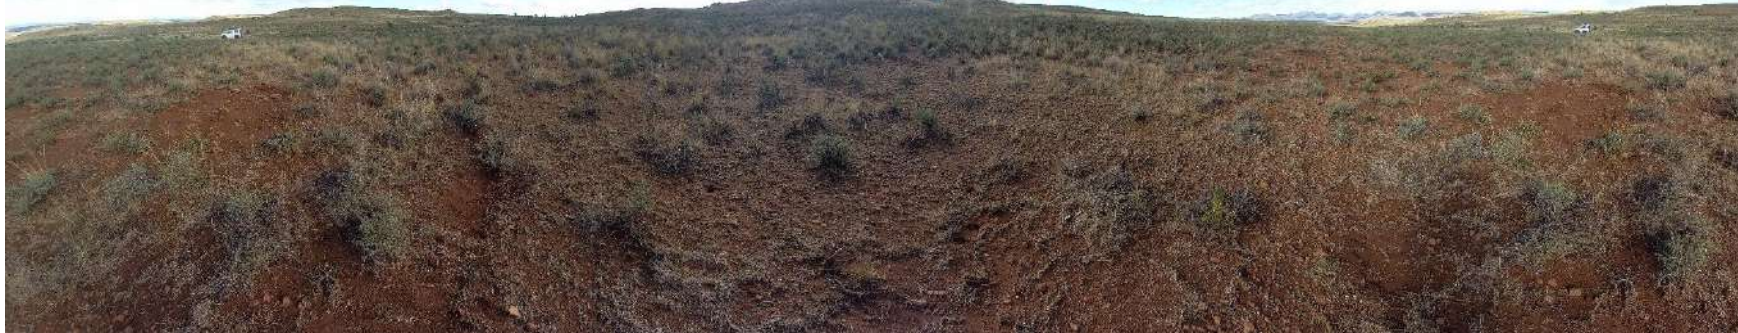
6n	<p>Findings: This turbine point is located in area of wash with deeper soils. It is degraded in this area.</p> <p>Sensitivity: The erosion risk maintains the sensitivity here as Medium.</p> <p>Recommendations: This turbine need not be relocated.</p>

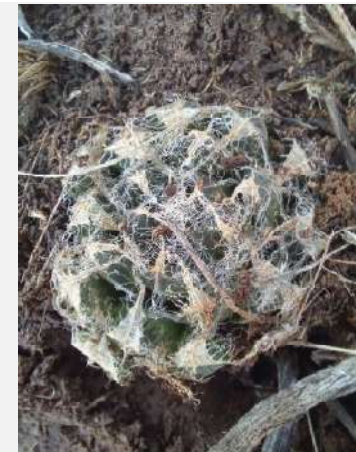
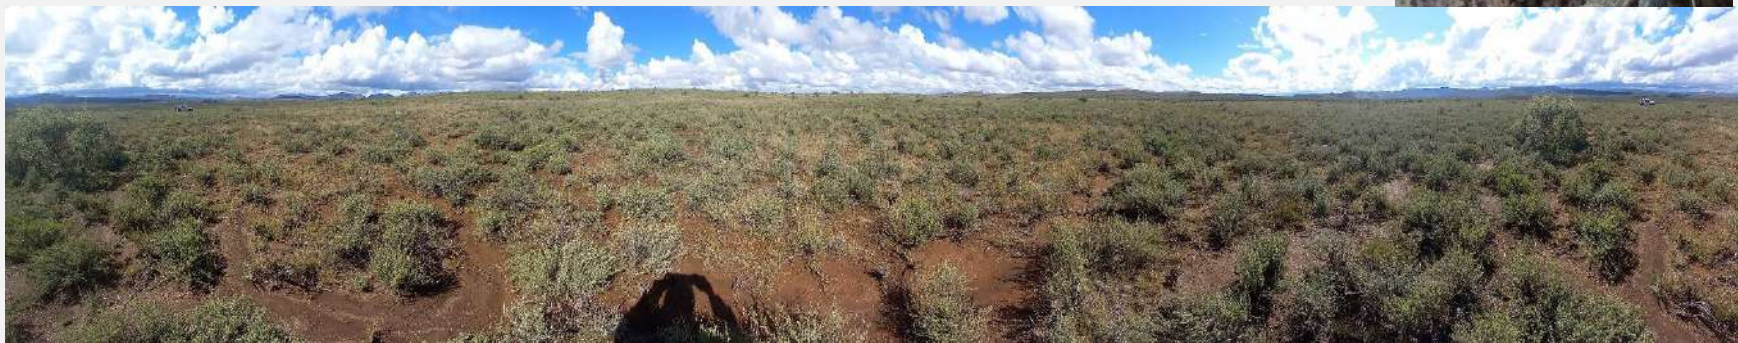
17n

Findings: This turbine is located in a largely transformed area as a result of livestock movement and grazing.

Sensitivity: Sensitivity is Low.

Recommendations: There are no ecological hindrances to placement of the turbine here.

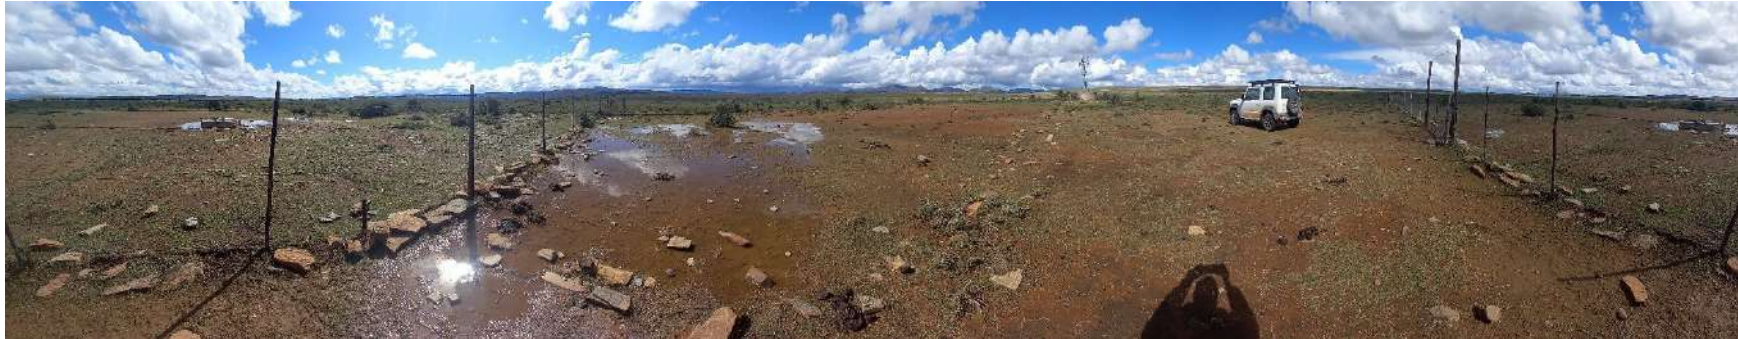
25n

Findings: This turbine is located in a good condition wash area of karroid scrub dominated by dwarf shrubs on comparatively deep soils.

Sensitivity: The presence of *Aloe broomii*. And condition of the vegetation in general indicates that this should remain a Medium SEI. Aloes can be relocated provided the relevant permits are acquired.

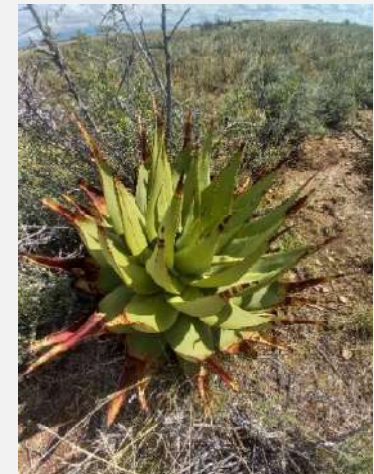
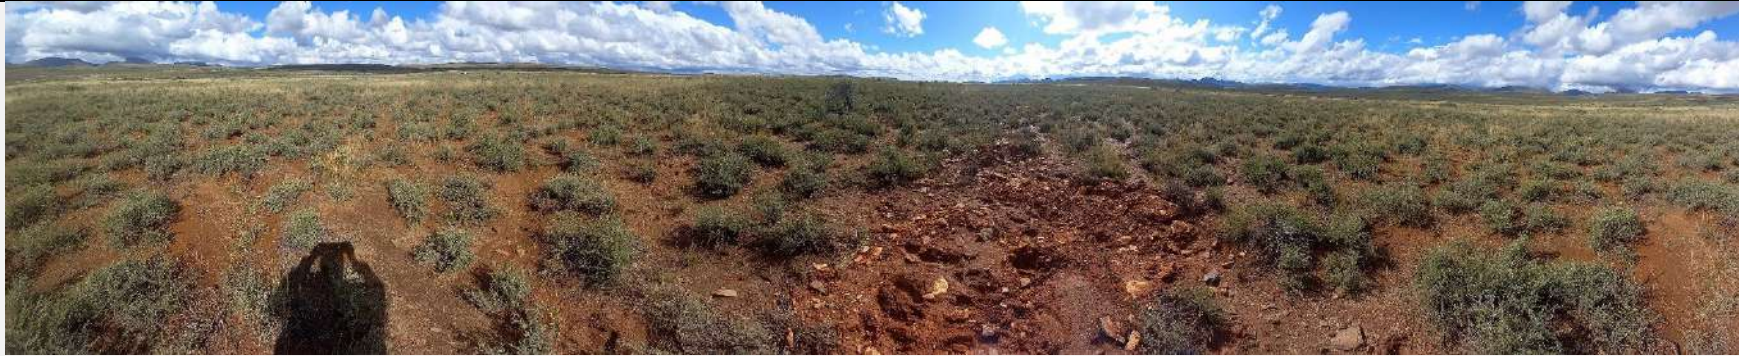
32n

Findings: This turbine is located in a good condition wash area of karroid scrub dominated by dwarf shrubs on comparatively deep soils.

Sensitivity: No SCC were recorded from this site. The potential for high erosion risk associated with construction means that this site is of Medium sensitivity.

Recommendations: Proximity to High SEI areas should be monitored and the strict management measures put into place.

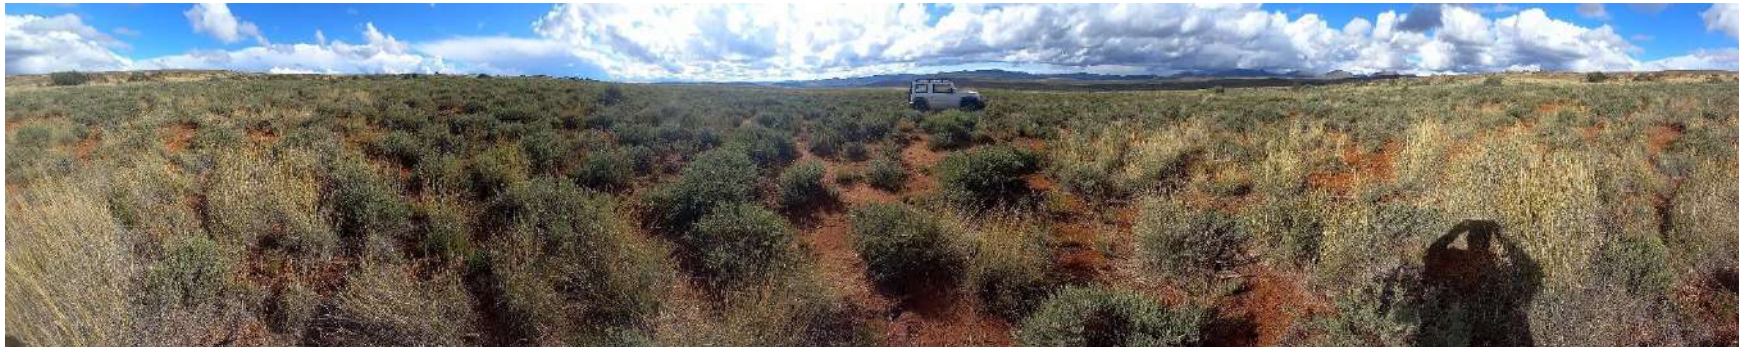
30n

Findings: This turbine is located in a particularly rocky area with some dolerite boulders present. Some geophytic species were recorded from this site, but overall it is somewhat degraded due to grazing of livestock.

Sensitivity: The geophyte *Romulea tortuosa* was recorded from this site, but can be relocated. The sensitivity is maintained at a Medium SEI due to the degradation caused by grazing.

Recommendations: SCC must be relocated once the relevant permits have been obtained.

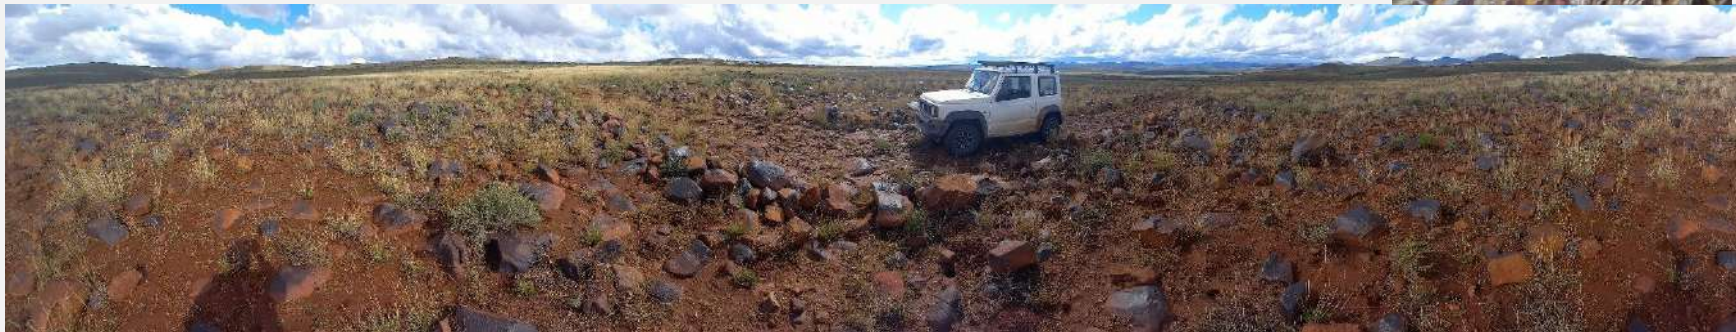
**27n**

Findings: This turbine is located in a moderate to poor condition wash area of karroid scrub dominated by dwarf shrubs on comparatively deep soils.

Sensitivity: No SCC were recorded from this site. The potential for high erosion risk associated with construction means that this site is of Medium sensitivity.

Recommendations: There are no ecological hindrances to placement of the turbine here.
