EXECUTIVE SUMMARY

SANBI propose to upgrade the Administration Facilities at Kirstenbosch NBG in Cape Town. This will include the demolition of two existing prefab buildings, replacing one thereof with a 2.5 storey administration building, making improvements to the existing Fynbos Lodge, a small building with heritage significance, re-arranging and extending the parking area and stabilizing a section of an adjacent stream.

**FRESHWATER ECOLOGICAL ASSESSMENT FOR THE
PROPOSED ESTABLISHMENT OF A NEW
ADMINISTRATION BUILDING AT KIRSTENBOSCH
NATIONAL BOTANICAL GARDEN**

The Freshwater Consulting Group

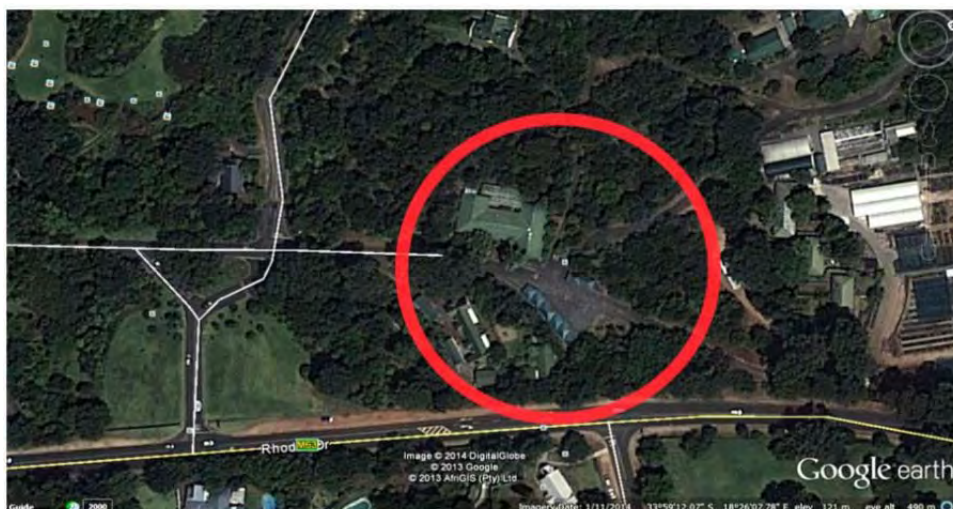
Figure 2 Location of the development areas in the Harold Porter NBG (Source: VMA Architects)

The proposed development and upgrades is to take place in the small developed area (Erf 3040) of the cultivated section of the NBG.

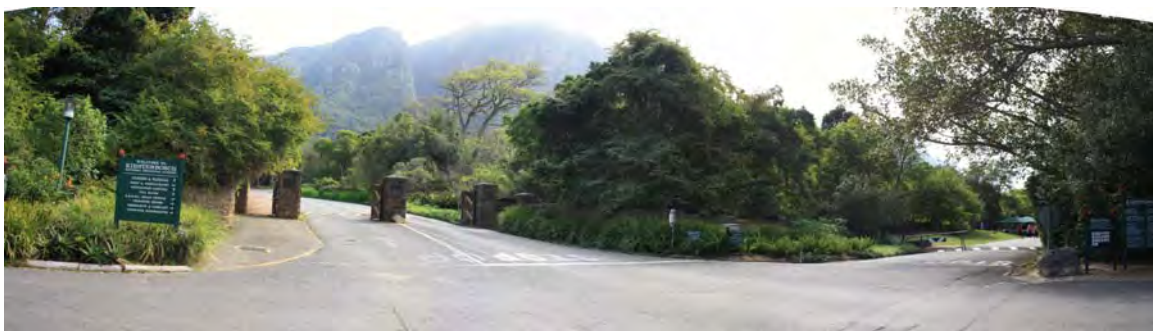
Photo Plate 1 – The eastern mountain slopes above the Kirstenbosch Botanical gardens

The Kirstenbosch estate is on the eastern face and foothills of the Cape Peninsula Mountain Chain and back of Table Mountain. It sweeps down from the steep scree slopes of the sandstone mountains onto the across rocky scree slopes and rolling shale hills. Tree-lined, fast-flowing mountain streams flow across the gardens.

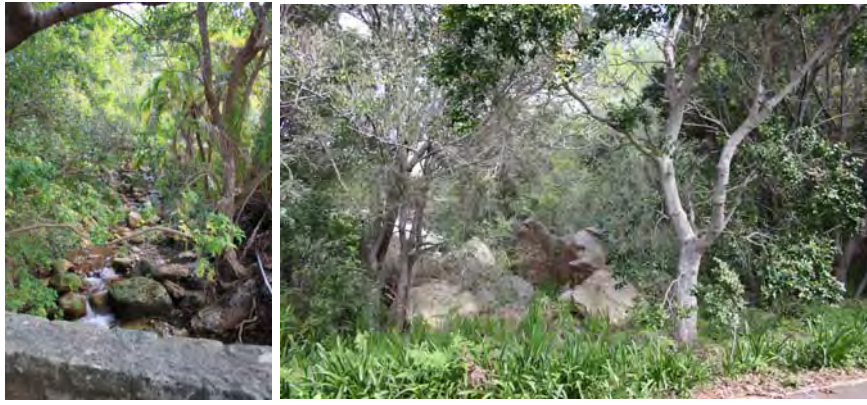
Photo Plate 2 – Typical mountain stream which flows across the gardens and large boulders and forest.

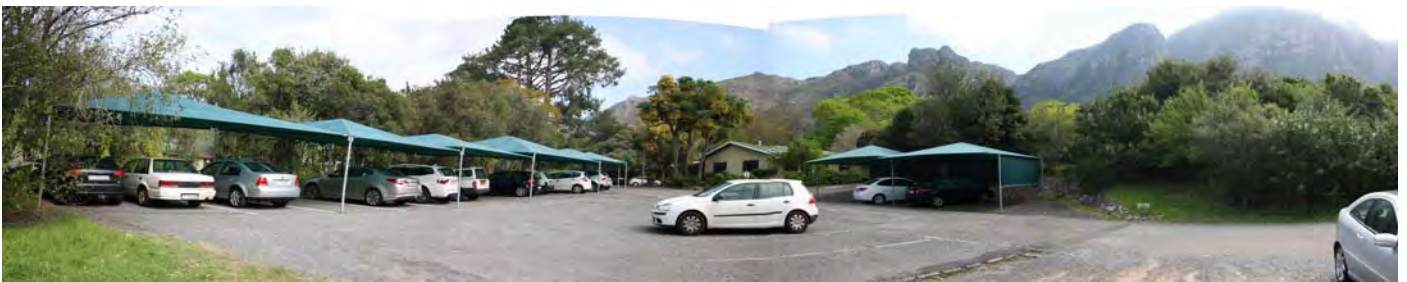
Photo Plate 3 – Existing parking area with the proposed new site in the background

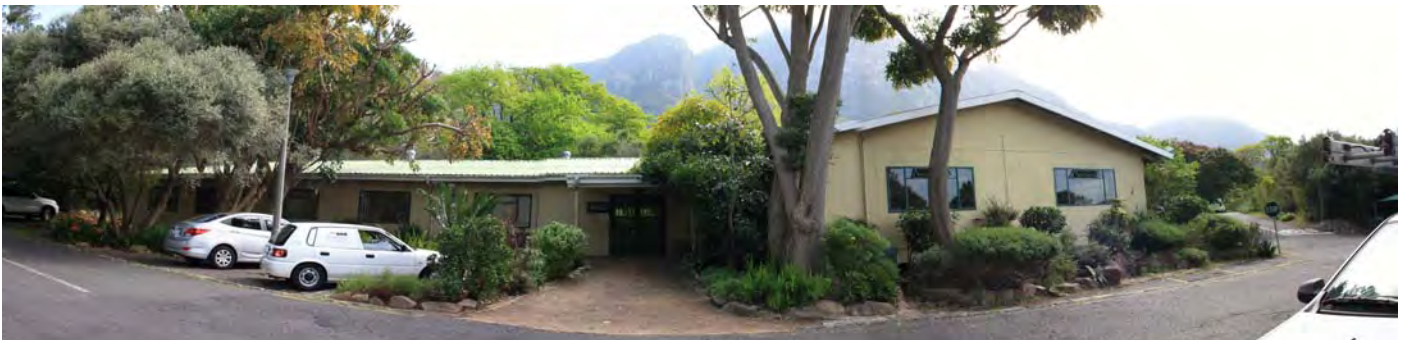
Photo Plate 4 – Existing prefab building, which will be replaced by a 2.5 storey Administration building

The site of the proposed Administration building currently contains a prefabricated single storey building in a wooded area.

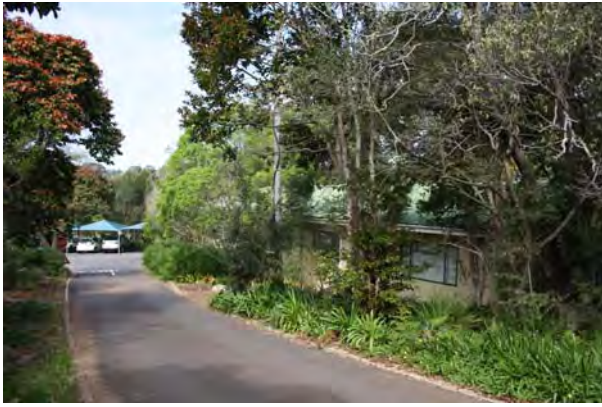
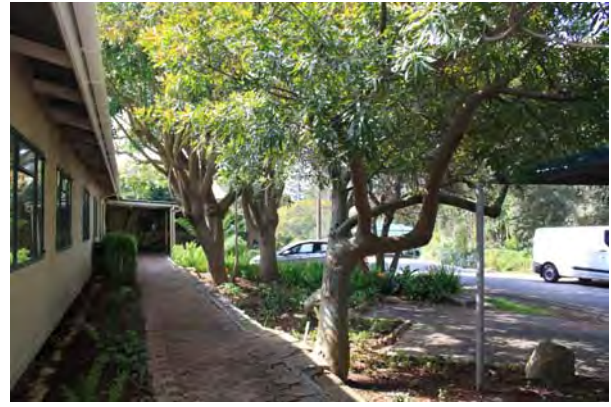
Photo Plate 5 – The existing Prefab office building within a wooded area

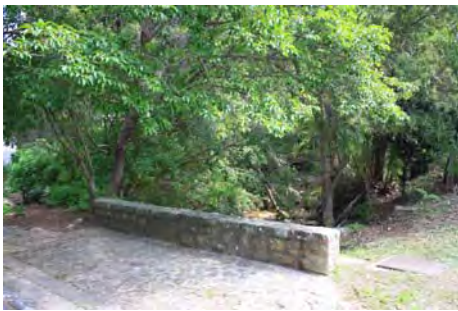
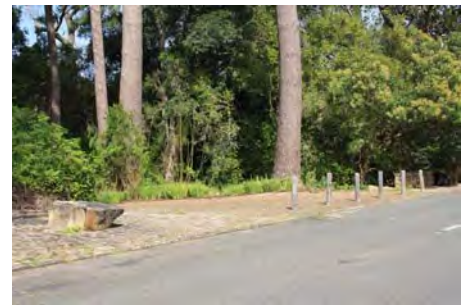
Photo Plate 6 – local rocks have been used extensively in the landscaping

Local rock has been used extensively in the landscape, as retaining walls, bridge headwalls, steps and paving.

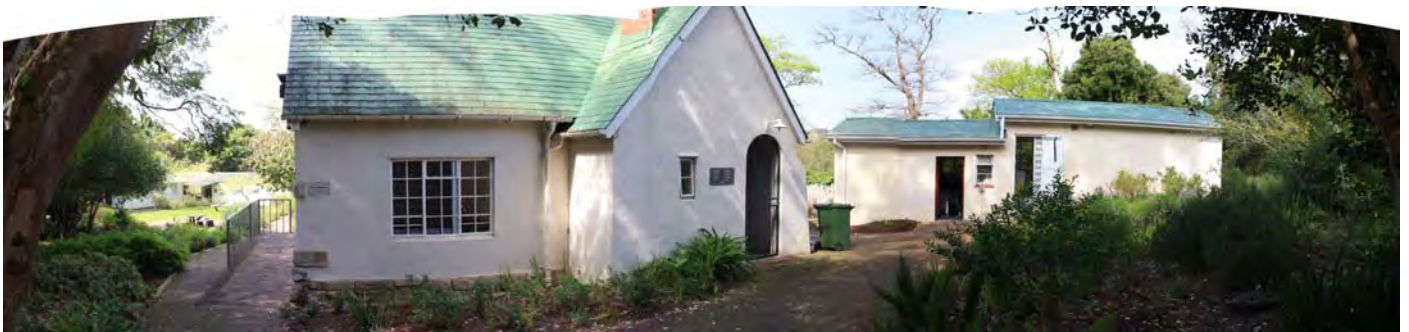
Photo Plate 7 – The existing Fynbos lodge building, left, which has heritage significance and the outbuildings, all of which will be retained.

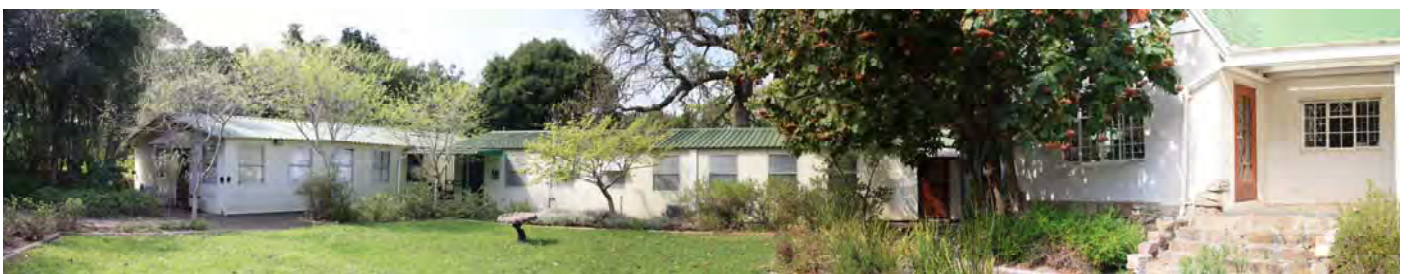
Photo Plate 8– The Fynbos lodge, right, overlooks a lawned courtyard with trees

The Fynbos Lodge and additional building are existing buildings around a lawned and garden area. Parking facilities are between and adjacent to the buildings.

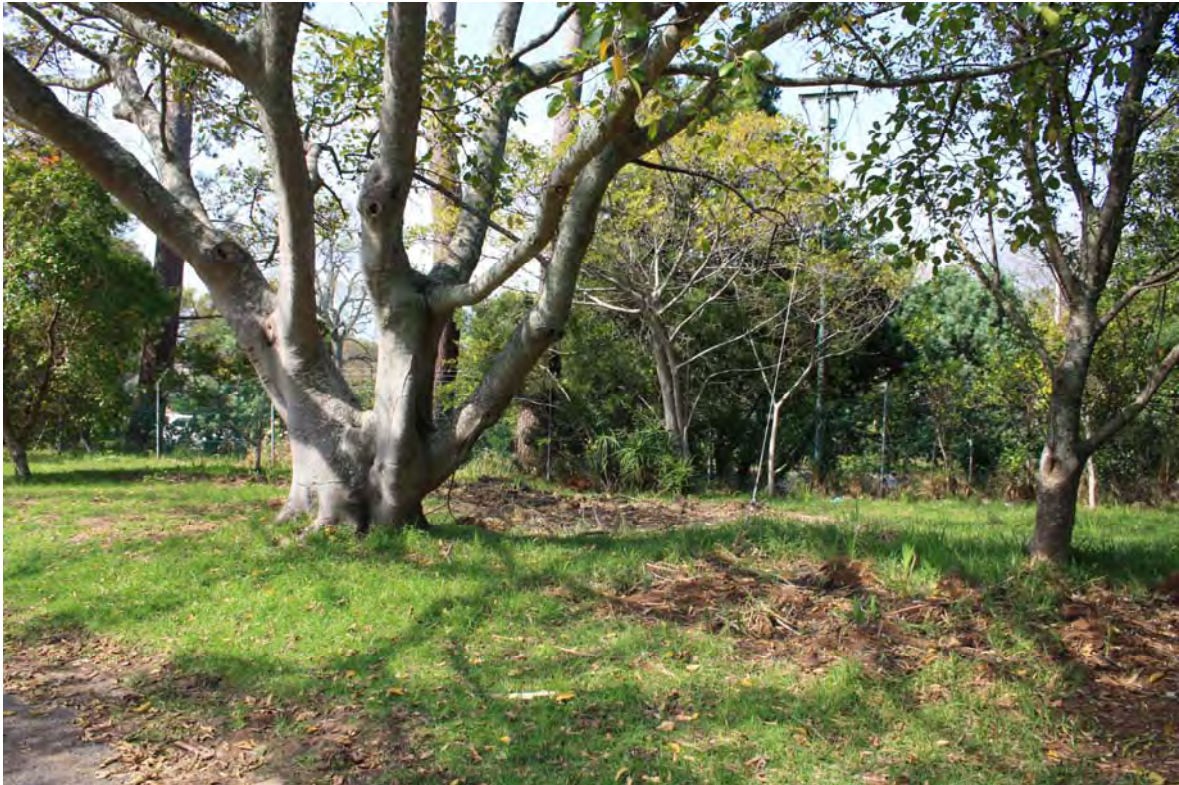
Photo Plate 9 – Rhodes Drive runs past the proposed site of development mainly screened by vegetation

- Tourists visiting the NBG; and
- Users of the scenic Rhodes Drive, which may get a glimpse of the proposed building and parking area when driving by, through vegetation.

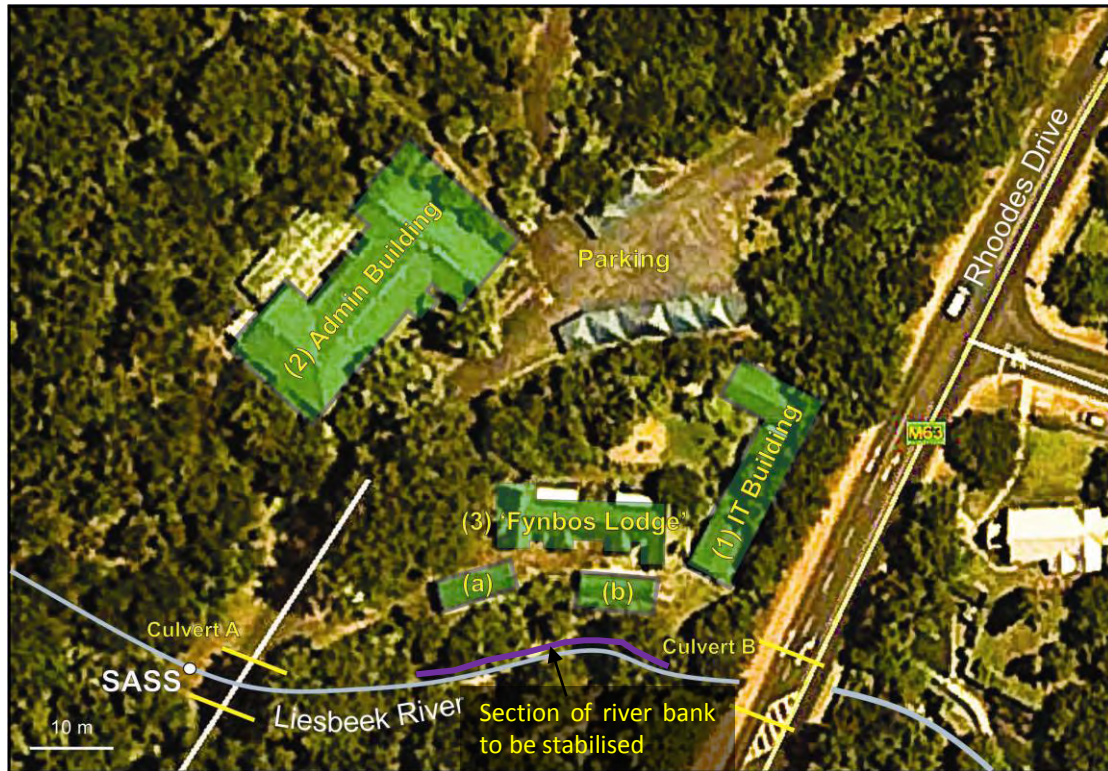
Figure 2 Site Plan showing the existing parking lot, together with: (1) the existing IT building, (2) the administration building and (3) the 'Fynbos Lodge'. The Liesbeek River flows to the south of the proposed development through two culverts between the entrance road to the administration buildings (Culvert A) and beneath Rhodes Drive (Culvert B). The white dot indicates where SASS aquatic invertebrate samples were collected.

The existing administration and IT buildings are located between these two culverts on the northern bank of the river. The nearest existing built structure is c. 10 m from the river banks (Figure 2). The reaches of both Skeleton and Nursery streams upstream of the proposed development are relatively pristine and rise as typical Cape Floristic Region (CFR) mountain streams in Afromontane and riparian forest against the slopes Table Mountain. Further downstream in the vicinity of the existing administration building, however, the riparian zone has been colonized by a mix of alien species including oak, pine, poplar and palms. Downstream of the first culvert (Culvert A, Figure 3 – A(ii)), the channel banks are severely incised (down-cut). This is due to the fact that the channel cross-section of Culvert A is inadequate to cope with the volume of flows routed through it and no consideration has been given to reinforcing the banks immediately downstream. As a result, the increased velocities and erosive capacity of the water channelled through the culvert has led to gully erosion, washouts and disturbances to the riparian belt between Culvert A and B (Figure 3 – B (i), (ii) and C (ii)). Despite this erosion, the bed of the river itself has stabilised and instream habitat conditions are relatively good. During high flows, however, it is likely that large amounts of sediment are mobilized from the banks causing sedimentation downstream.

A total of 13 aquatic invertebrate families were recorded instream at the site just upstream of Culvert A (see sampling point on map in Figure 2). Five of these taxa have a high SASS5 sensitivity score (10 and above), including notonemourid stoneflies and teloganodid mayflies (Table 2), suggesting that habitat and water quality conditions were relatively good.

- No construction activities should be undertaken within 10 m of the outer edge of the river channel (i.e. south of buildings (a) and (b) in Figure 2), except when the river stabilisation work is done (see Section 5.1.4).
- Danger tape should be used to demarcate no-go areas within the recommended 10 m buffer.
- All equipment and materials storage areas should be located at a minimum distance of 10 m from the riparian edge of the Liesbeek River.

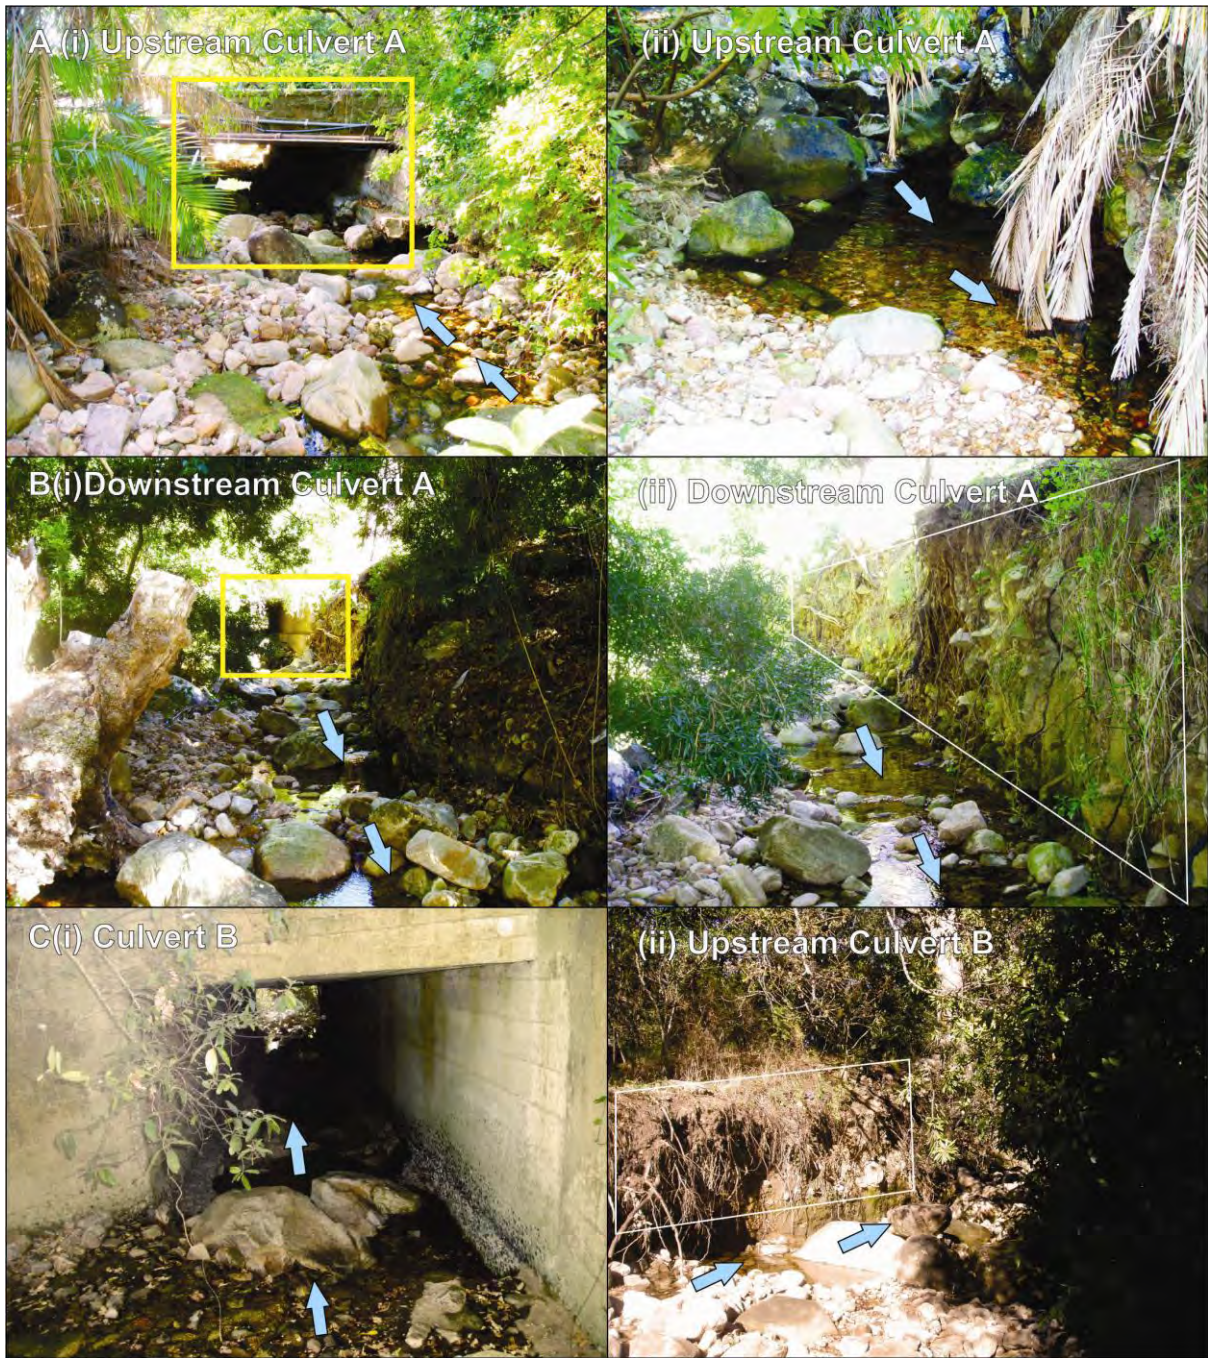
Figure 3

The upper reaches of the Liesbeek River where it passes adjacent the Administration buildings: A(i) upstream of Culvert A looking downstream (yellow box) that runs beneath the entrance road to the Administration buildings, A (ii) looking upstream from Culvert A, B(i) looking upstream towards Culvert A, B(ii) severe erosion immediately downstream of Culvert A, C(i) looking downstream towards Culvert B passing beneath Rhodes Drive, C(ii) bank erosion between the two culverts. Blue arrows indicate flow direction.

As noted above, the riparian zone upstream of Culvert A is geomorphologically stable, but dominated by alien tree species, whereas the riparian zone immediately adjacent to the proposed parking area (between Culvert A and B) is severely degraded by both alien plant species, as well as by down-cutting and gully erosion as a result of elevated water velocities through Culvert A, exacerbated by the absence of erosion mitigation measures. Despite these changes, the bed of the river itself has stabilised and instream habitat conditions are relatively good, both upstream and downstream of Culvert A. These conditions are reflected in the IHI scores (Table 1), which show the instream habitat conditions being relatively good (PES Category B – Largely natural) upstream of Culvert A, whereas riparian habitat conditions here are moderately modified (PES Category B/C). Downstream of Culvert A (between Culvert A and B) instream habitat conditions are largely natural (PES Category B), whereas the riparian zone is largely modified (PES Category D) – this low score being largely attributable to bank erosion and incision.

River bank stabilisation (purple line in Figure 2; photo B(ii) in Figure 3) — Gabions and a reno mattress would be installed along a section of the northern bank of the river reach adjacent to the site, to stabilise and reinforce this eroded area. The gabions would run for approximately 20-30 metres within the existing curvature of the river. The total volume of material to be excavated from the bed and bank of the river to put the gabions and reno mattress in place would be approximately 135 m³.
