Appendix D: Specialist Reports

KIRSTENBOSCH NATIONAL BOTANICAL GARDEN

APPOINTMENT OF A MULTI -DISCIPLINARY TEAM WITH A PROFESSIONAL ARCHITECT AS THE PRINCIPAL AGENT FOR THE FEASIBILITY STUDY, DESIGN AND CONSTRUCTION MANAGEMENT OF A NEW ADMINISTRATION BUILDING AT KIRSTENBOSCH NATIONAL BOTANICAL GARDEN.

NEW ADMINISTRATION BUILDING, PARKING FACILITY AND REFURBISHMENT OF FYNBOS LODGE

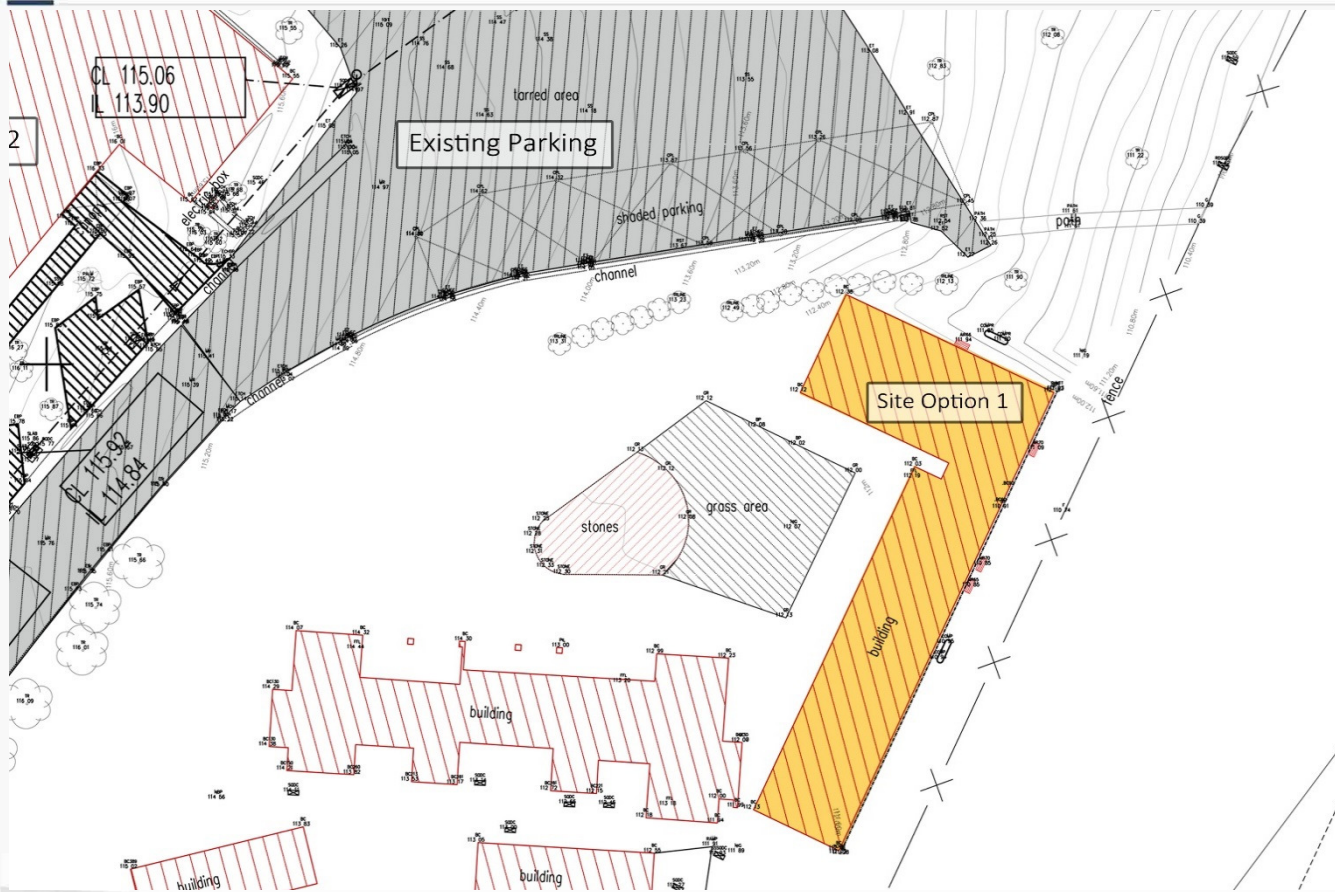
- Footprint too small
- Within 32m of river
- Site too noisy – proximity to roads
- Awkward shape of site
- Too close to Fynbos Lodge

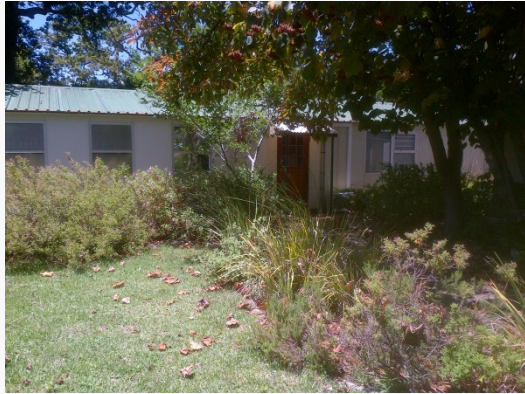
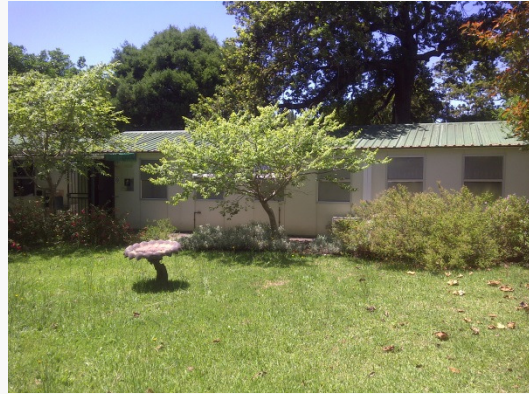
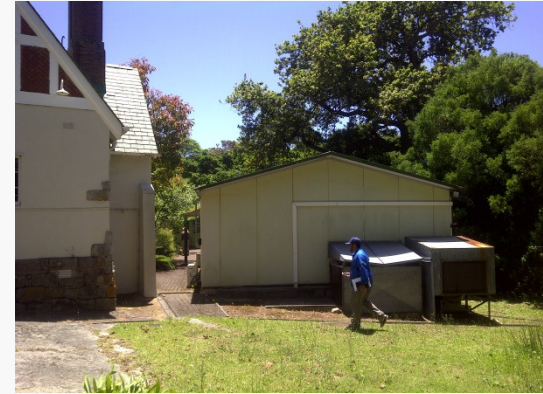
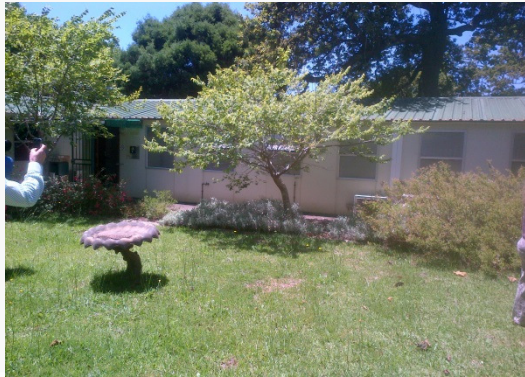
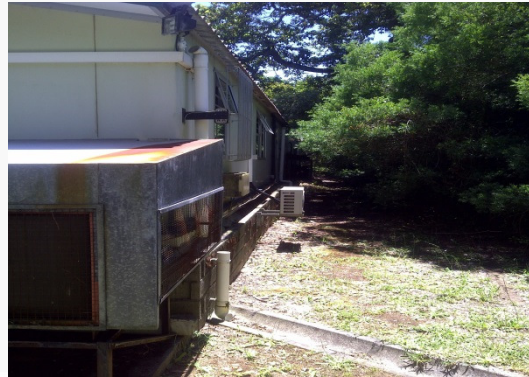
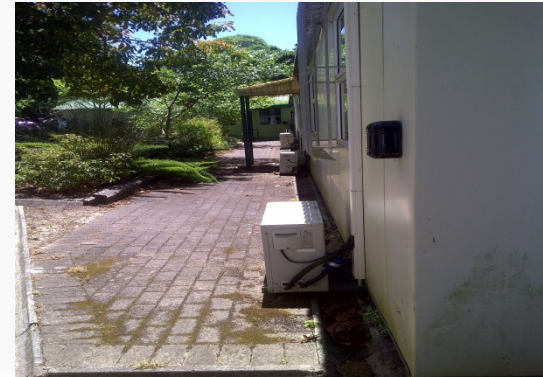
- Existing footprint of 850m s.q.m ideal
- The site is quiet, serene and beautiful
- More than 32m from river
- Building has a better presence due to elevation
- Building can make a positive reference to Fynbos lodge
- Shape of site is better suited
- Excavations and foundations less costly

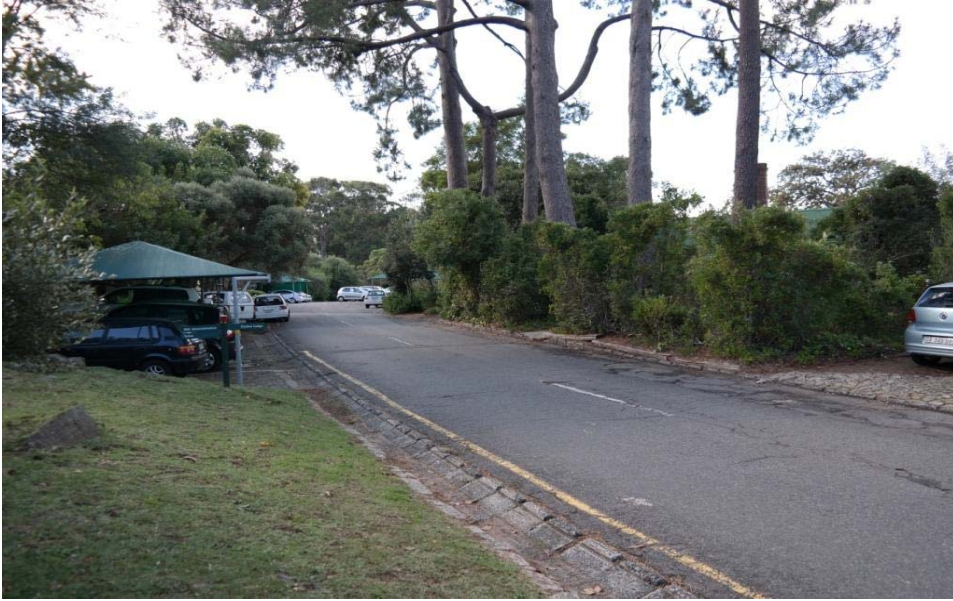
Plate 1: View of the road to the main offices, looking northeast from close to the southern edge of the study area. The green roof of the laboratory area is just visible on the right hand side.

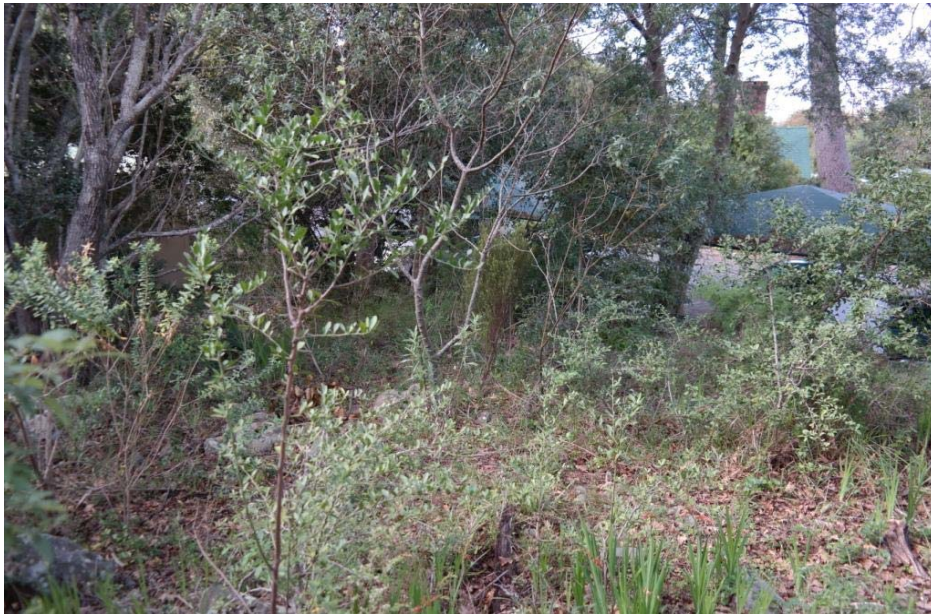
Plate 2: View of forest precursor vegetation south of the admin building, with the spiny shrub *Gymnosporia buxifolia* (pendoring) prominent.

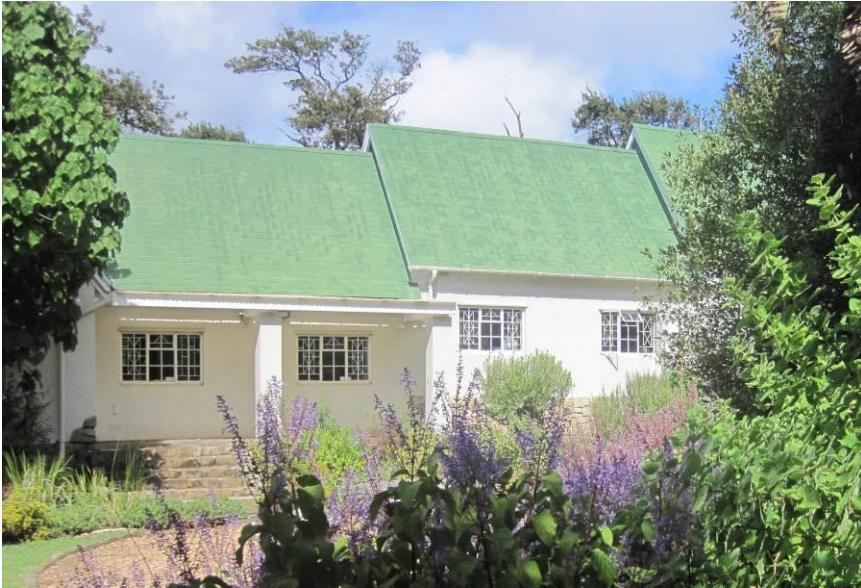
Existing structure greater than 60 years of age (Fynbos Lodge) to be renovated / altered.

Due to the potential heritage value of Fynbos Lodge, no structural changes will occur to the building. The existing asbestos roofing will be replaced with a visually similar material, and maintenance-type renovations will take place in the interior of the building. The prefabricated building as well as the head office building will be demolished and redeveloped.

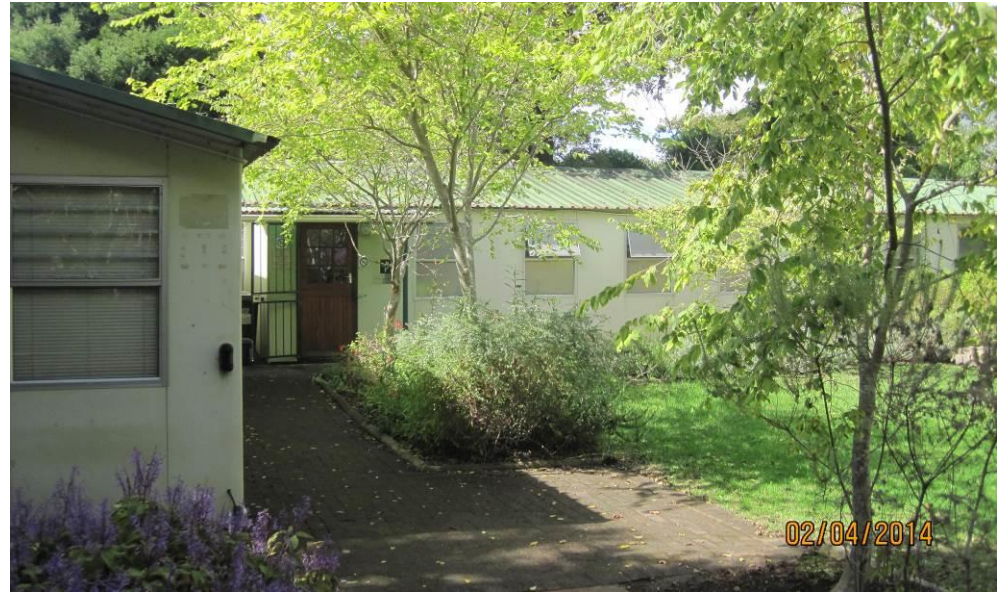
Prefabricated structures to be demolished.

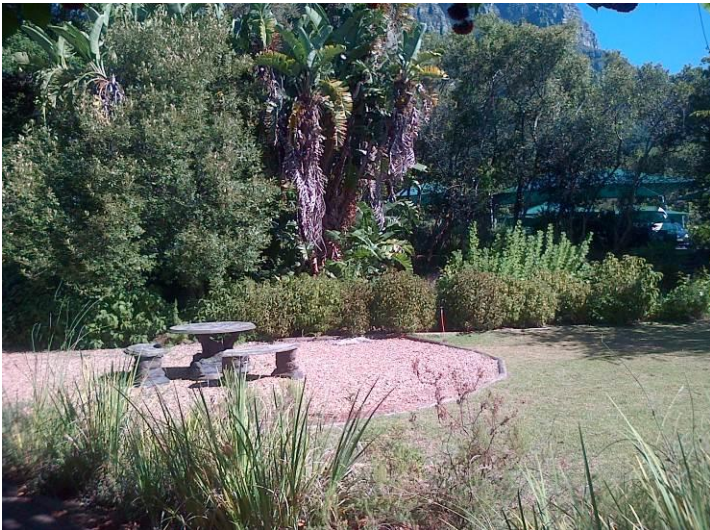
Existing modern landscaping in the centre of the site to the north of Fynbos Lodge.

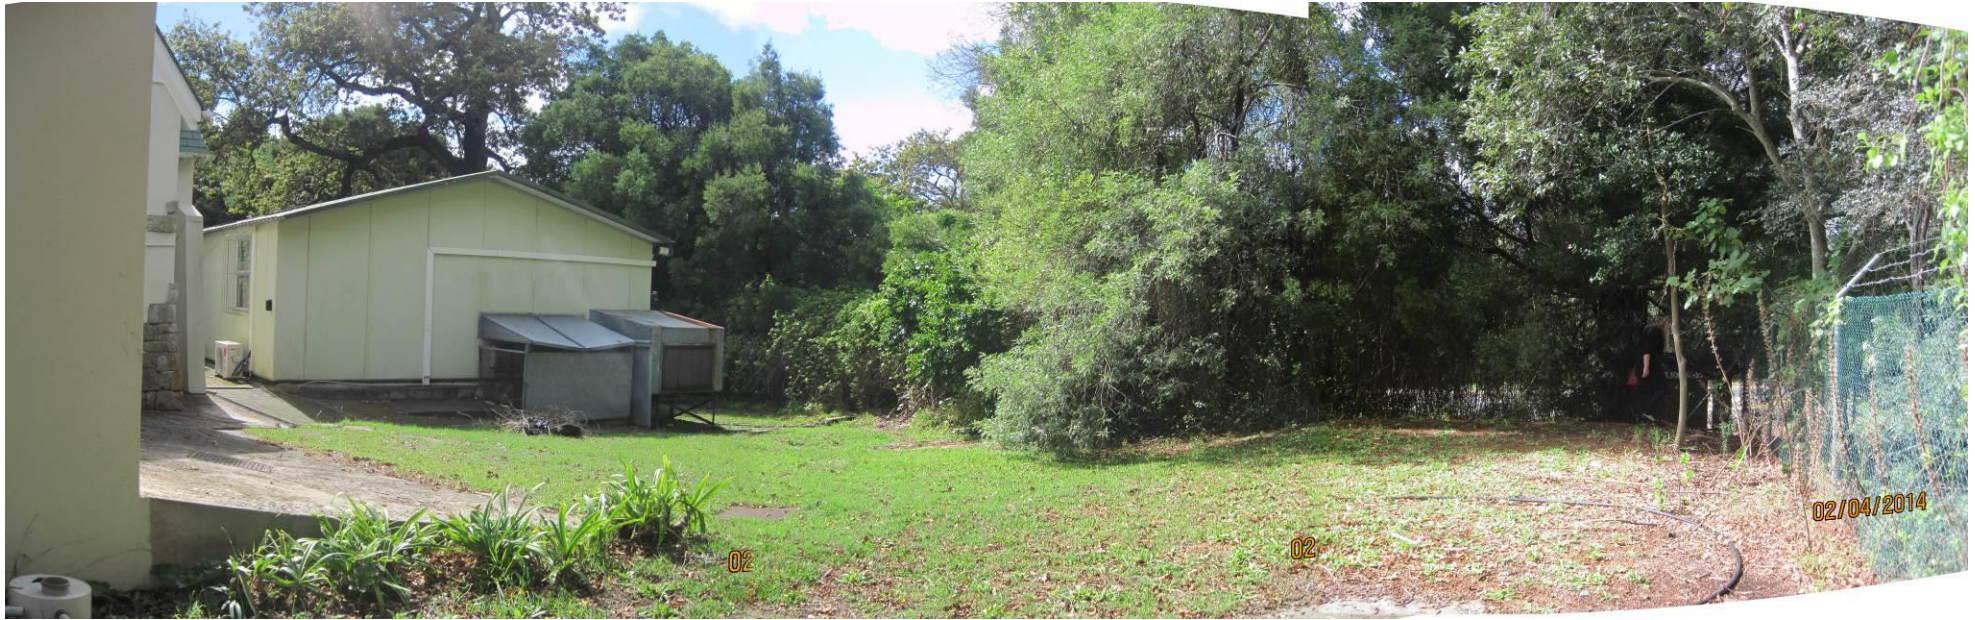
The southern end of the prefabricated structure and the relationship between the site and Rhodes Drive – Rhodes river can just be seen through the vegetation and fence on the right hand side of the photograph. The corner of Fynbos Lodge can be seen on the left in the background (with stone rustication) and another modern outbuilding (to be retained) is on the left in the foreground.

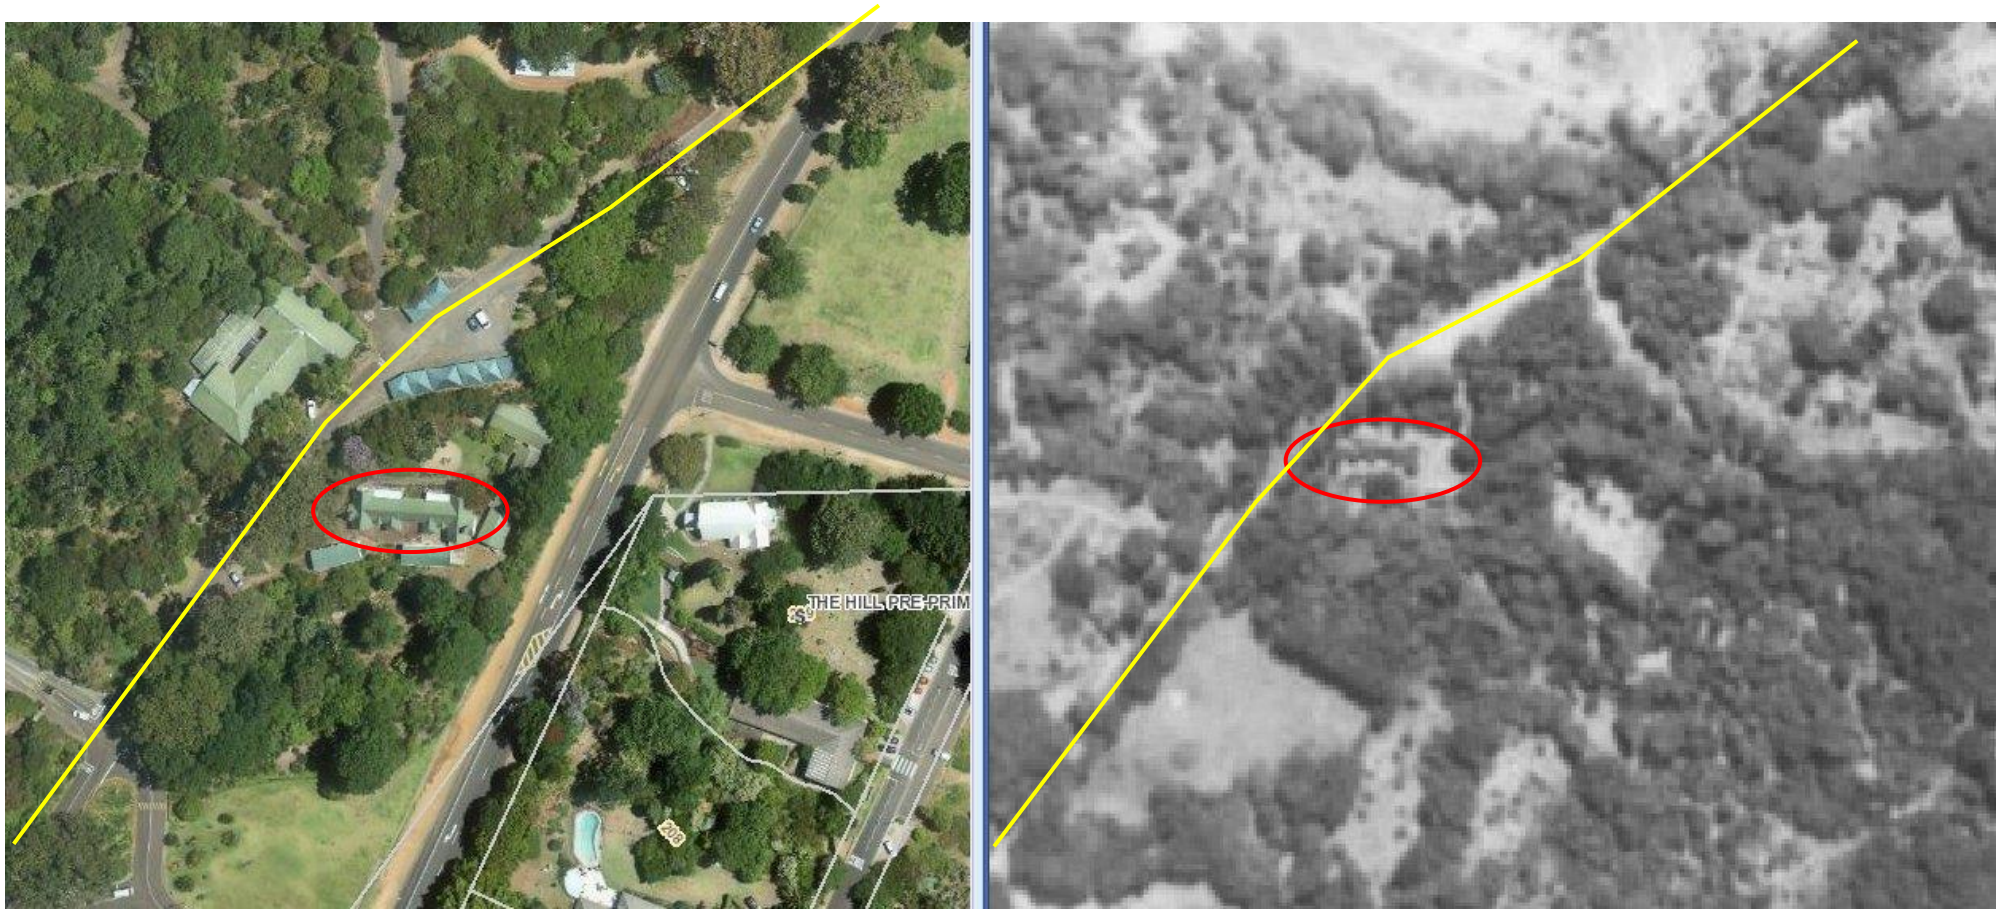
Comparative modern (left) and 1944 (right) aerial views showing the site. The Fynbos Lodge is circled and the old alignment of Rhodes Drive is marked in yellow.

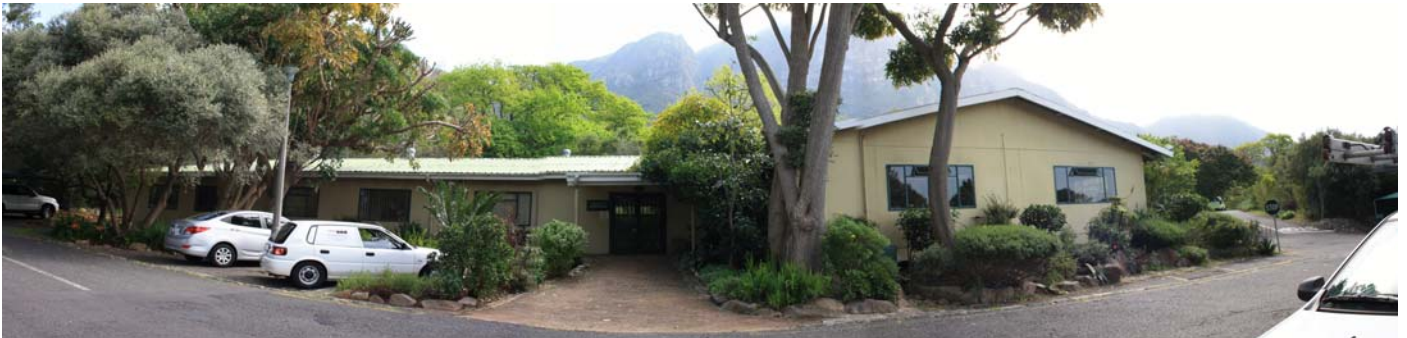
Photo Plate 4 – Existing prefab building, which will be replaced by a 2.5 storey Administration building

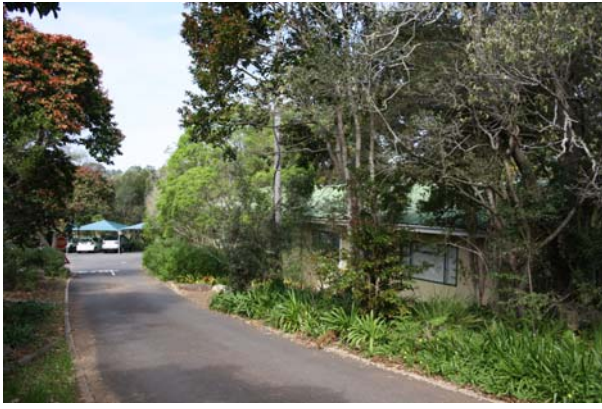
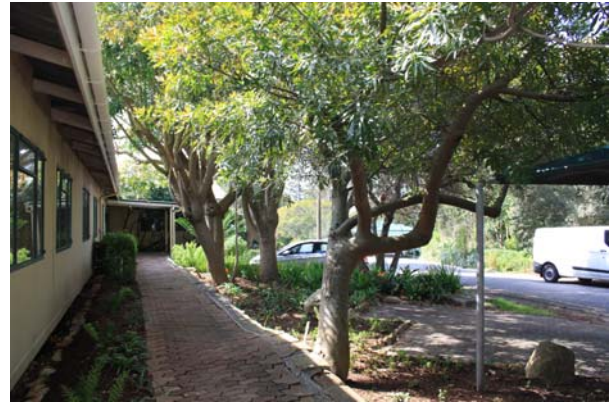
The site of the proposed Administration building currently contains a prefabricated single storey building in a wooded area.

Photo Plate 5 – The existing Prefab office building within a wooded area

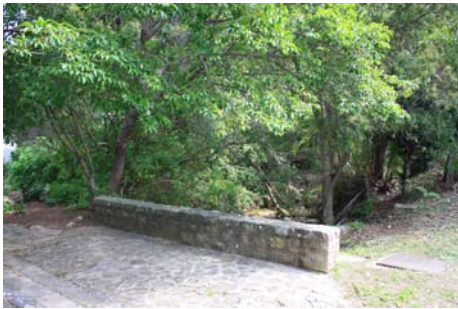
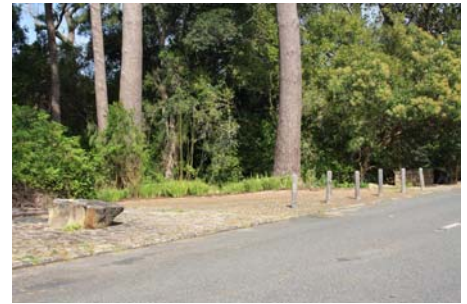
Local rock has been used extensively in the landscape, as retaining walls, bridge headwalls, steps and paving.

Photo Plate 6 – local rocks have been used extensively in the landscaping

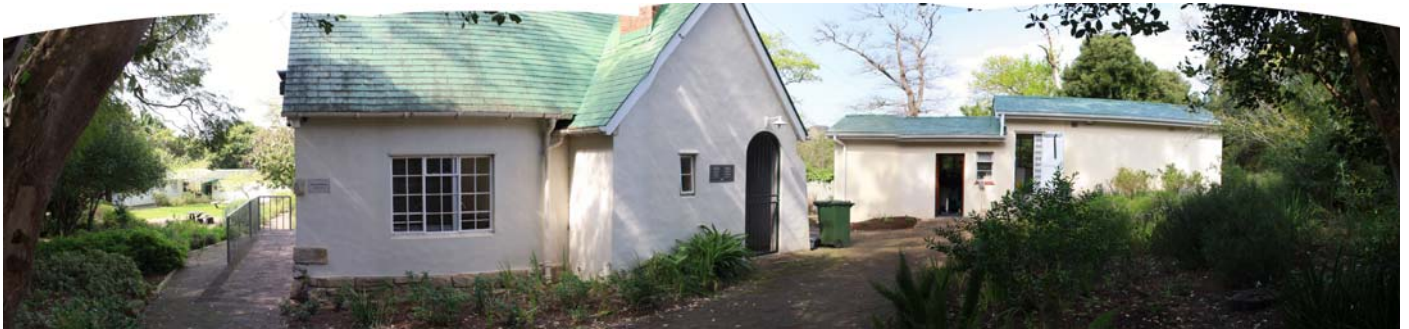
Photo Plate 7 – The existing Fynbos lodge building, left, which has heritage significance and the outbuildings, all of which will be retained.

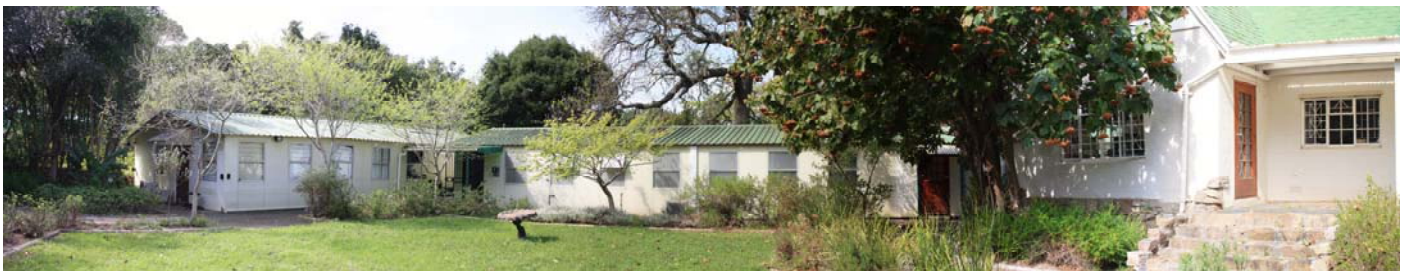
Photo Plate 8– The Fynbos lodge, right, overlooks a lawned courtyard with trees

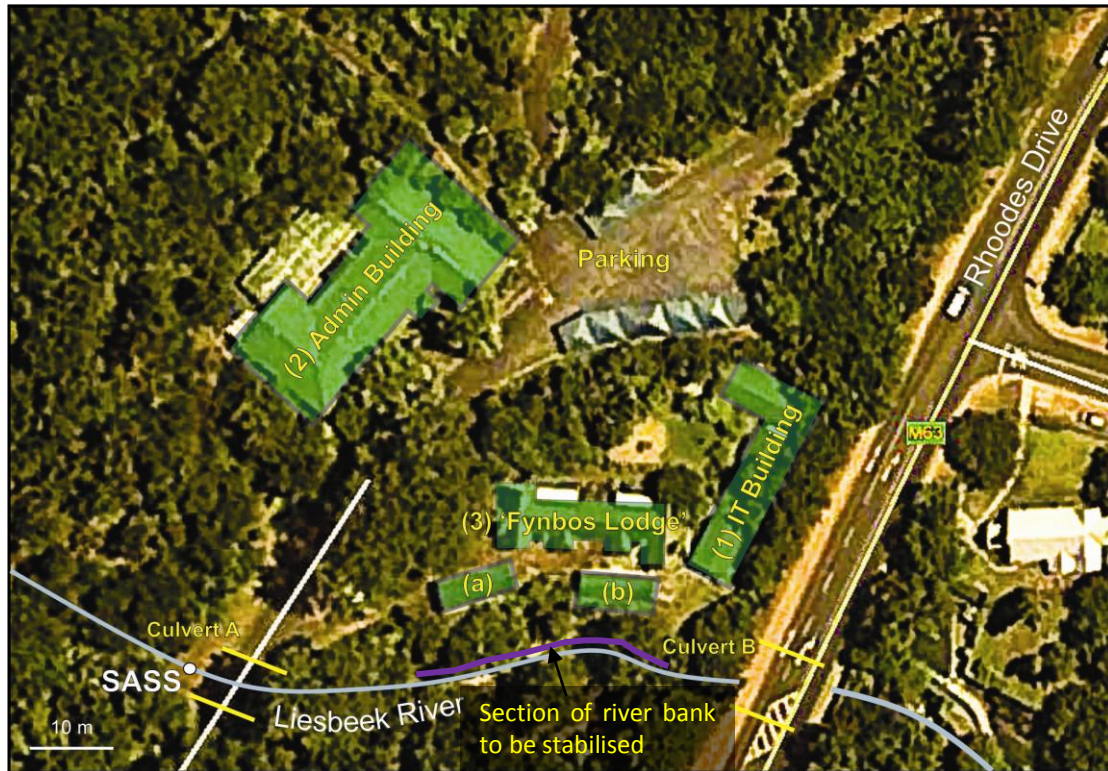
Figure 2 Site Plan showing the existing parking lot, together with: (1) the existing IT building, (2) the administration building and (3) the 'Fynbos Lodge'. The Liesbeek River flows to the south of the proposed development through two culverts between the entrance road to the administration buildings (Culvert A) and beneath Rhodes Drive (Culvert B). The white dot indicates where SASS aquatic invertebrate samples were collected.

A total of 13 aquatic invertebrate families were recorded instream at the site just upstream of Culvert A (see sampling point on map in Figure 2). Five of these taxa have a high SASS5 sensitivity score (10 and above), including notonemourid stoneflies and teloganodid mayflies (Table 2), suggesting that habitat and water quality conditions were relatively good.

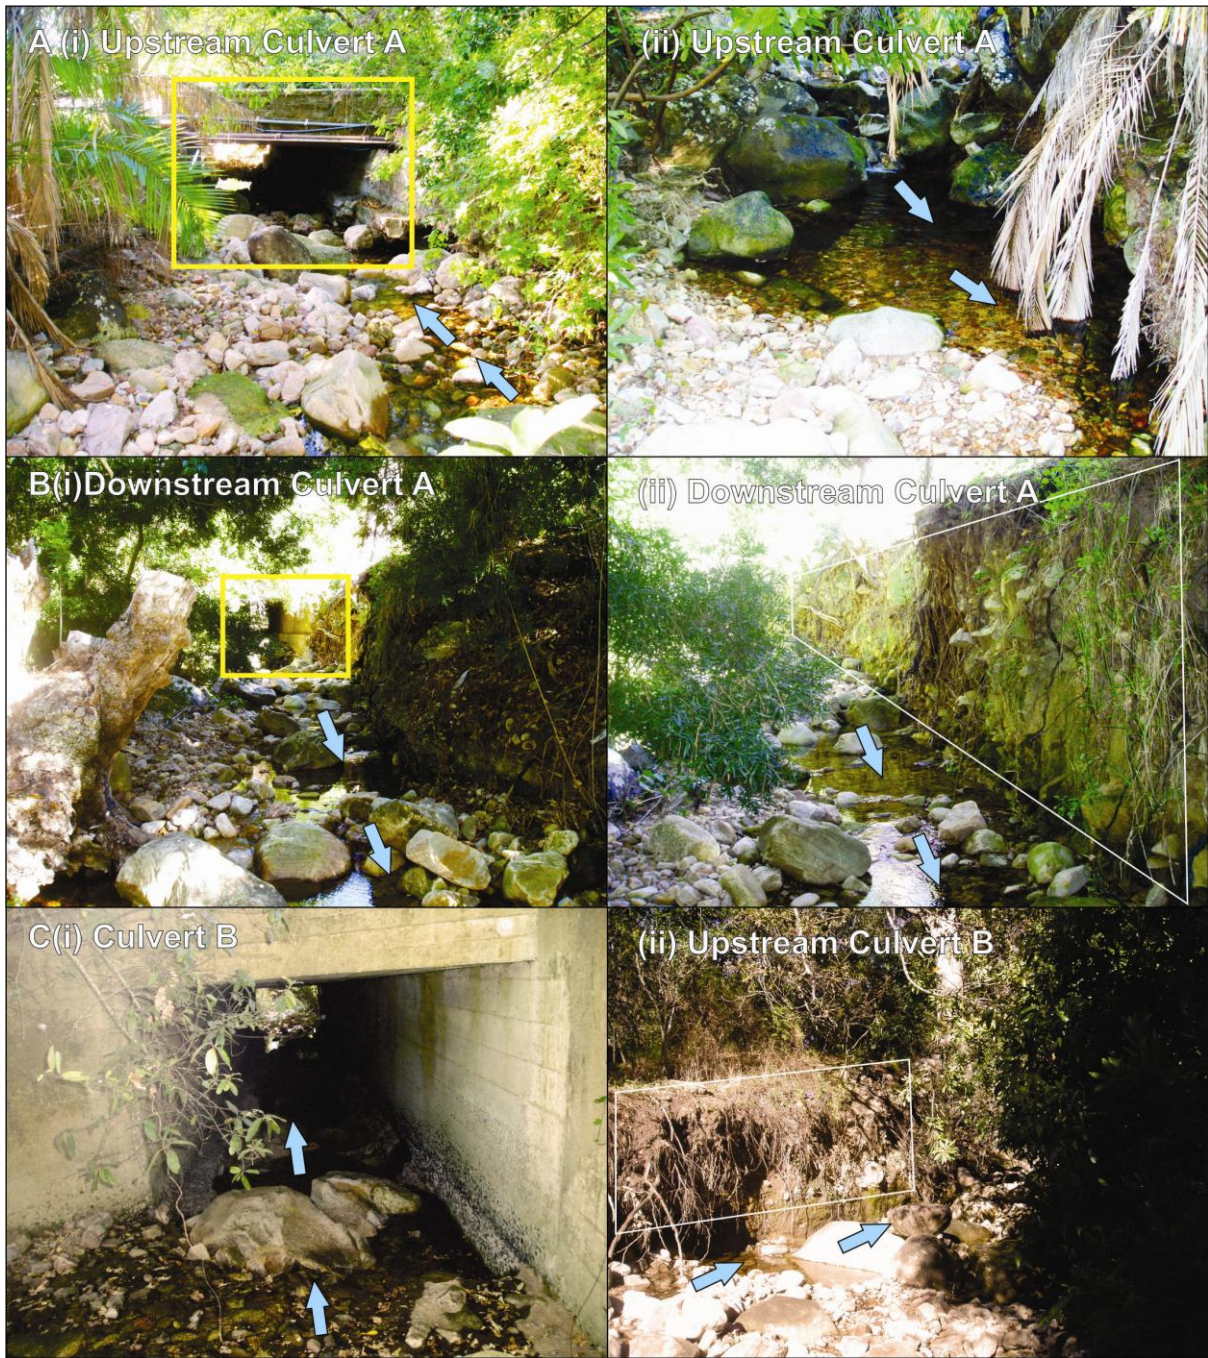
The upper reaches of the Liesbeek River where it passes adjacent the Administration buildings: A(i) upstream of Culvert A looking downstream (yellow box) that runs beneath the entrance road to the Administration buildings, A (ii) looking upstream from Culvert A, B(i) looking upstream towards Culvert A, B(ii) severe erosion immediately downstream of Culvert A, C(i) looking downstream towards Culvert B passing beneath Rhodes Drive, C(ii) bank erosion between the two culverts. Blue arrows indicate flow direction.

The existing administration and IT buildings are located between these two culverts on the northern bank of the river. The nearest existing built structure is c. 10 m from the river banks (Figure 2). The reaches of both Skeleton and Nursery streams upstream of the proposed development are relatively pristine and rise as typical Cape Floristic Region (CFR) mountain streams in Afromontane and riparian forest against the slopes Table Mountain. Further downstream in the vicinity of the existing administration building, however, the riparian zone has been colonized by a mix of alien species including oak, pine, poplar and palms. Downstream of the first culvert (Culvert A, Figure 3 – A(ii)), the channel banks are severely incised (down-cut). This is due to the fact that the channel cross-section of Culvert A is inadequate to cope with the volume of flows routed through it and no consideration has been given to reinforcing the banks immediately downstream. As a result, the increased velocities and erosive capacity of the water channelled through the culvert has led to gully erosion, washouts and disturbances to the riparian belt between Culvert A and B (Figure 3 – B (i), (ii) and C (ii)). Despite this erosion, the bed of the river itself has stabilised and instream habitat conditions are relatively good. During high flows, however, it is likely that large amounts of sediment are mobilized from the banks causing sedimentation downstream.

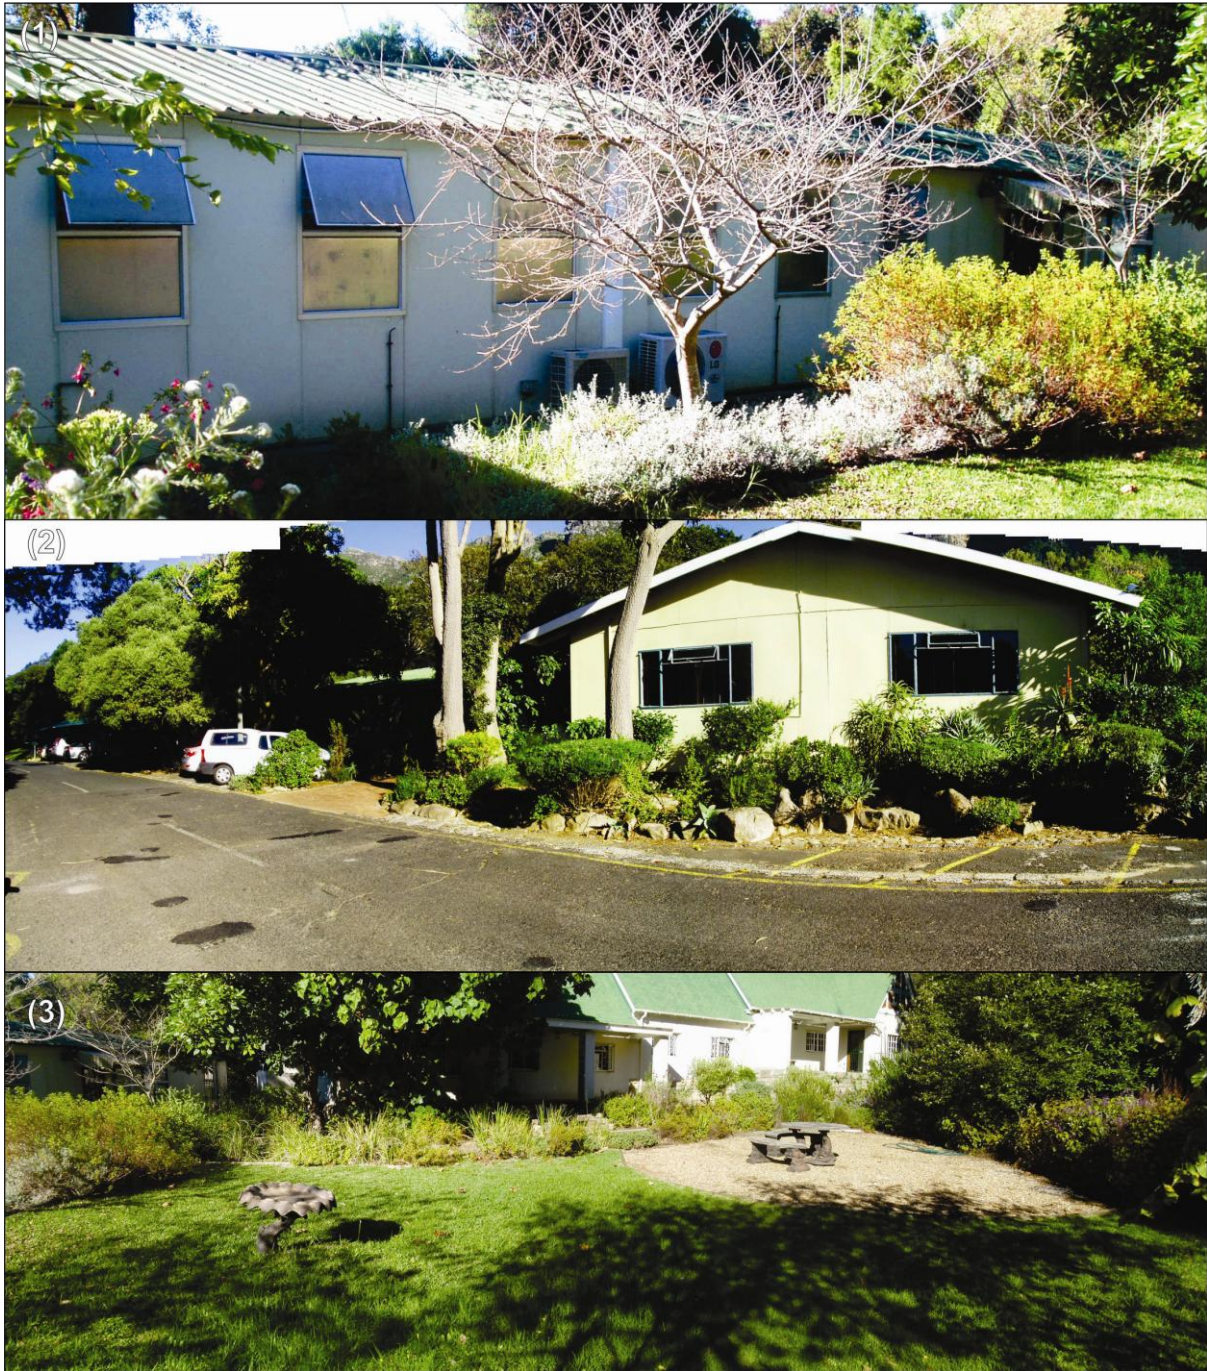
Figure 7 Existing administrative infrastructure in Kirstenbosch NBG: (1) IT Building, (2) Administration Building showing the existing parking lot and (3) the 'Fynbos Lodge'

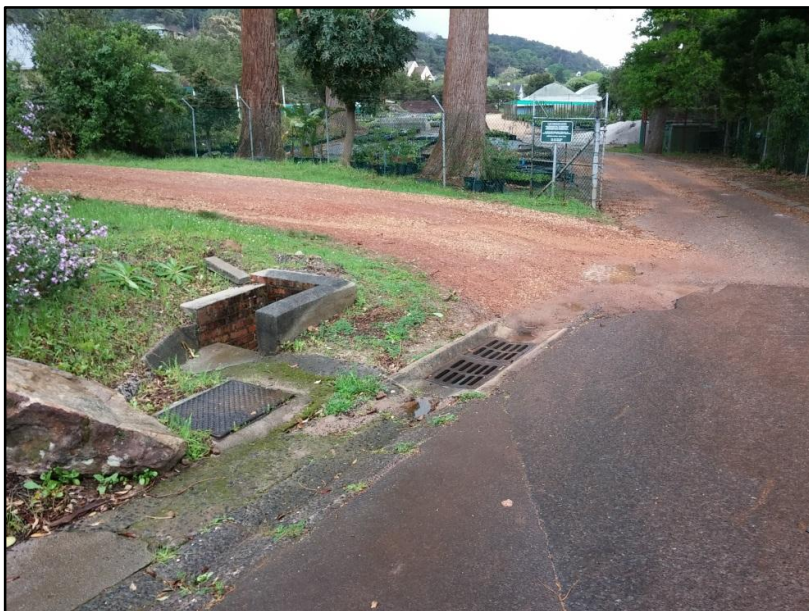
Figure 1: Typical Example of existing stormwater infrastructure.

The access road has a half round channel along the south eastern edge which terminates at a catchpit. The catchpit is drained with a 300mm \varnothing concrete pipe which in turn discharges onto the apron garden area located north east of the catchpit. A second Stormwater system is located along the north western side of the rest of the access road which in turn terminates at a catchpit.

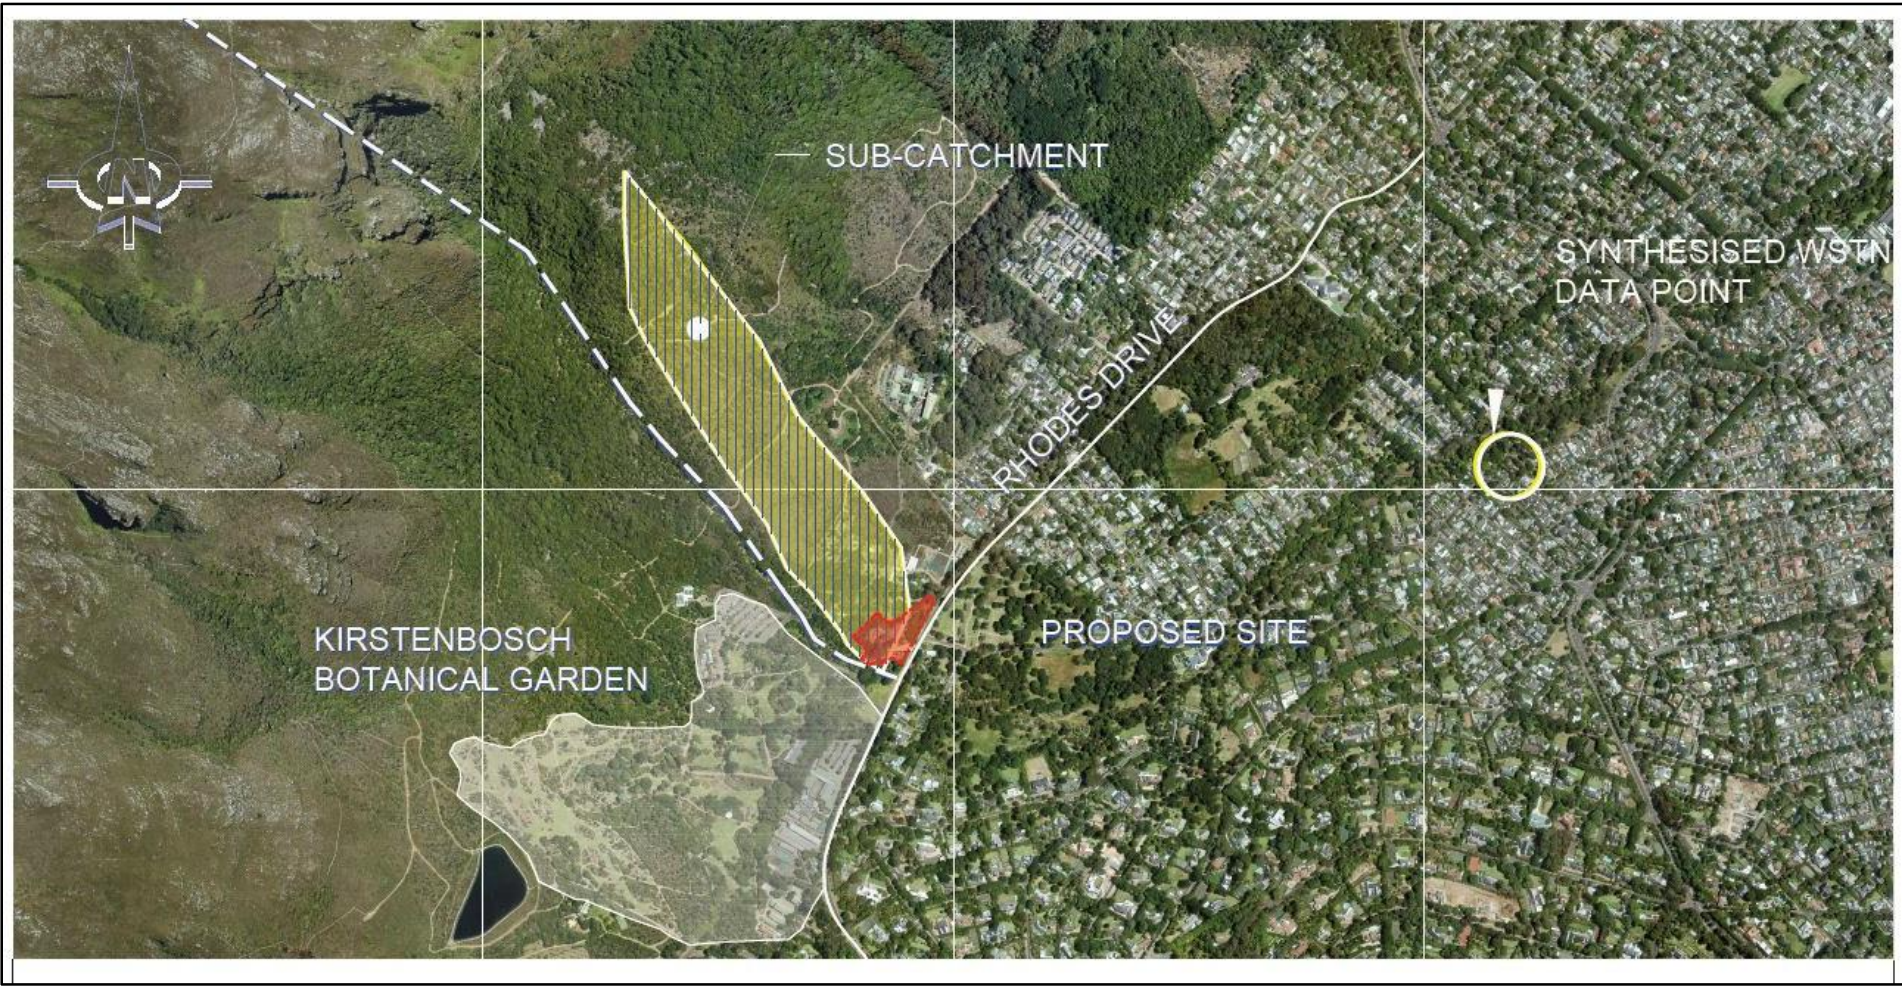
Storm rainfall depths for the 24 hour storm duration and different recurrence intervals (RI) were obtained from the City of Cape Town 2010 Rainfall Grid.

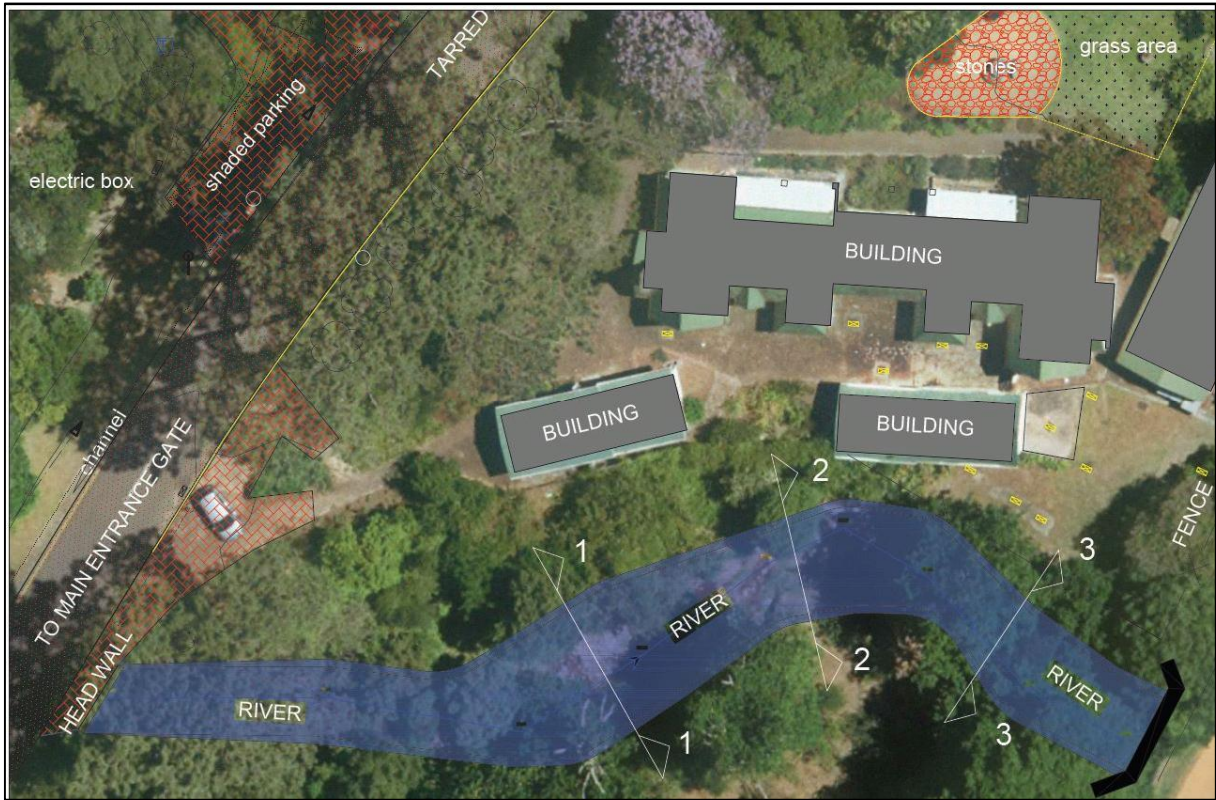
Figure 5.1: River Proximity to Existing Buildings
