**SITE VERIFICATION REPORT: REHABILITATION OF THE OLD TUG JETTY SHEET PILE WALL AT THE PORT OF PORT ELIZABETH**

THE PROPOSED REHABILITATION OF THE OLD TUG JETTY SHEET PILE WALL AT THE PORT OF PORT ELIZABETH, WITHIN NELSON MANDELA BAY METROPOLITAN MUNICIPALITY IN THE EASTERN CAPE PROVINCE

SITE VERIFICATION REPORT

ABANTU ENVIRONMENTAL CONSULTANTS (PTY) LTD

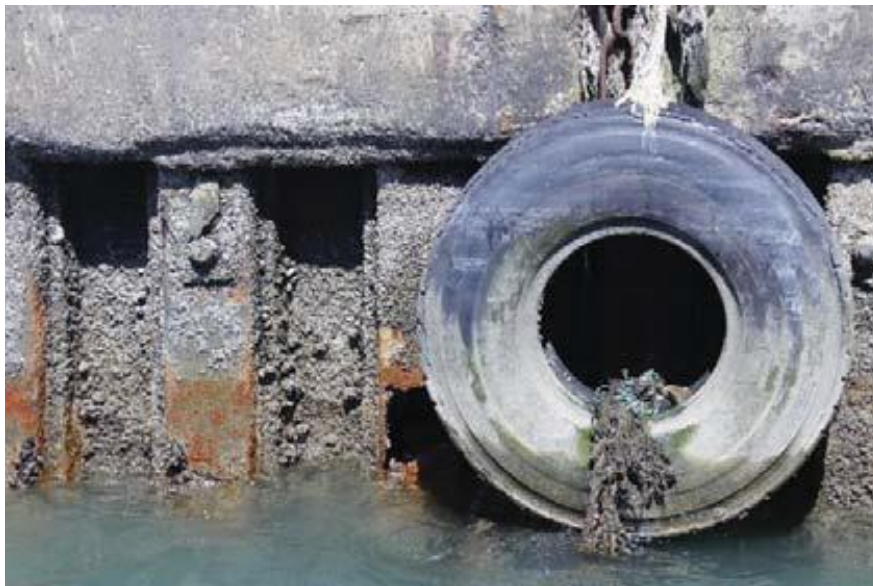
**Figure 2:** Close-up image indicating the extent of the sheet pile corrosion

As illustrated in **Figure 2**, the sheet piles have corroded significantly with large holes visible in the tidal zone. These holes have caused leaching of backfill material resulting in the subsidence of the back of quay area. Transnet National Port Authority (TNPA) has undertaken numerous repair campaigns involving filling holes with soilcrete. However, the continued deterioration of the sheet pile wall has resulted in an unsustainable maintenance regime.

Based on the outcomes of the optioneering and multi-criteria analysis, a counterfort wall and deck on pile hybrid structure was selected as the preferred rehabilitation option for the Old Tug Jetty sheet pile wall. This option comprises of 2 phases as illustrated in **Figure 3**. Phase 1 entails the construction of a counterfort wall with a berth depth of - 5.2m CD. The Phase 2 expansion entails construction of an adjoining deck on pile structure partially supported by the counterfort wall with a design berth depth of -6.5m CD. Both structures extend into the existing seawaters by 6 m each resulting in a total extension of 12 m from the existing structures.

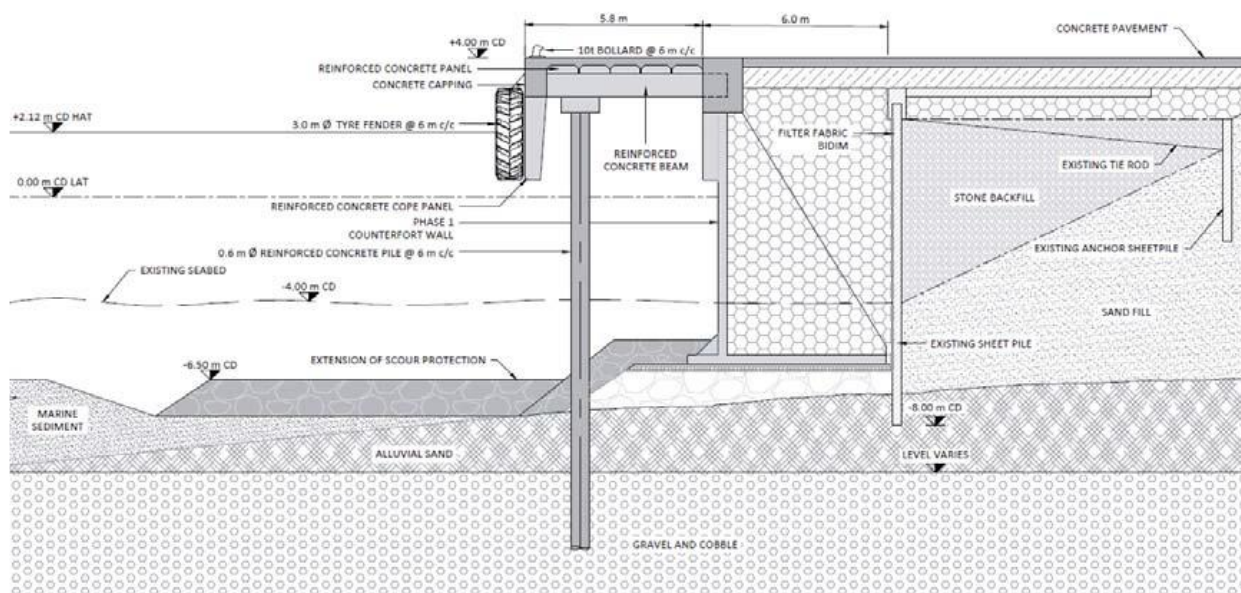
Figure 5: Phase 2 typical section

If there is sufficient demand for a deeper berth, the structure can be upgraded by implementing phase 2. Phase 2 of the project entails the construction of a deck on pile structure in front of the counterfort wall. The deck on pile jetty is 87.3 m long with further cope line offset of 5.8 m. The cope level is at +4 m CD with a berth depth of -6.5 m CD. The deck on pile length is limited to the extents illustrated in **Figure 3** because it is not possible to achieve the -6.5 m CD berth depth along the approaches to the slipways as the seabed needs to rise to suit the boat ramp geometry.

The construction process would commence with the dredging of marine sediment. Then the existing quay furniture on the counterfort wall affected by the deck on pile structure would be removed. Thereafter, steel tubular pile casings would be driven at the toe of the existing rock fill, excavated out to toe level and then the reinforced concrete pile cast inside. Precast pile caps would then be seated on top of the pile. Abutments will be constructed into the counterfort units which will house the precast beams and provide lateral support to the deck on pile structure. After placing precast beams, cope panels and planks the elements are stitched together with in-situ reinforced concrete. Finally, the quay furniture would be installed. **Figure 4** illustrates the typical cross section of the counterfort wall and deck on pile structure.

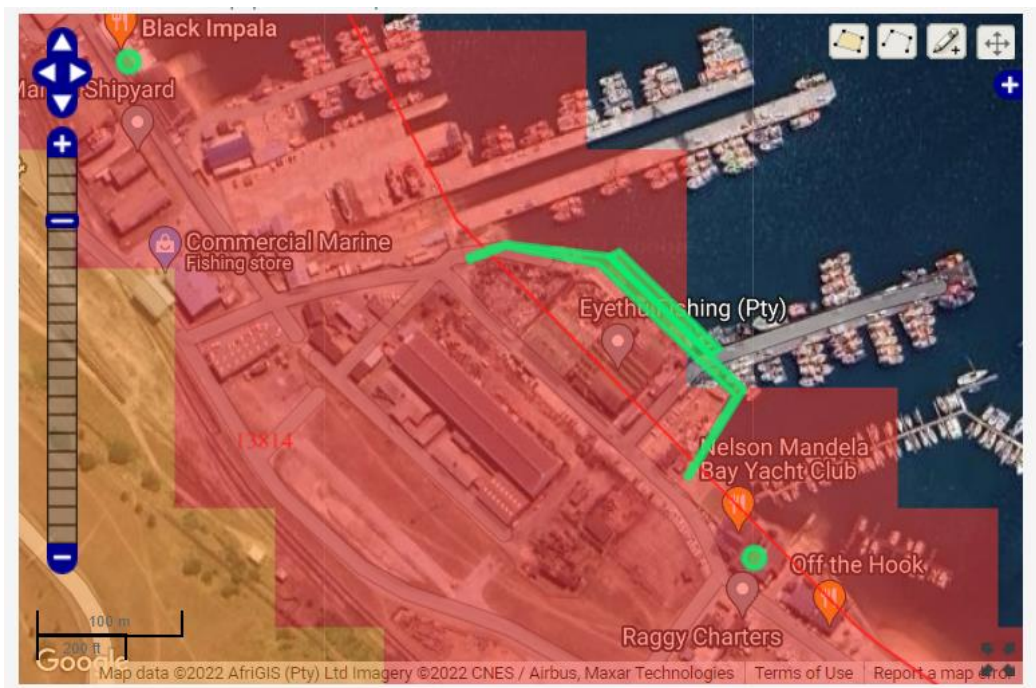
Figure 14: Palaeontological sensitivity

According to the SAHRIS Palaeontological sensitivity map, the site is located in a area of very high sensitivity (Figure 14) and requires a field assessment and a protocol for finds.
