**BIODIVERSITY PRE-CONSTRUCTION
WALKTHROUGH ASSESSEMENT:**

Final Layout

**140MW SUTHERLAND 2 WIND ENERGY
FACILITY (DFFE REF: 12/12/20/1782/3/AM5)
AND ASSOCIATED 132kV POWERLINE
LINKING TO THE SUTHERLAND WEF (DEA
REF: 14/12/16/3/3/1/1814/2), SUTHERLAND,
NORTHERN CAPE PROVINCE**

18 November 2022

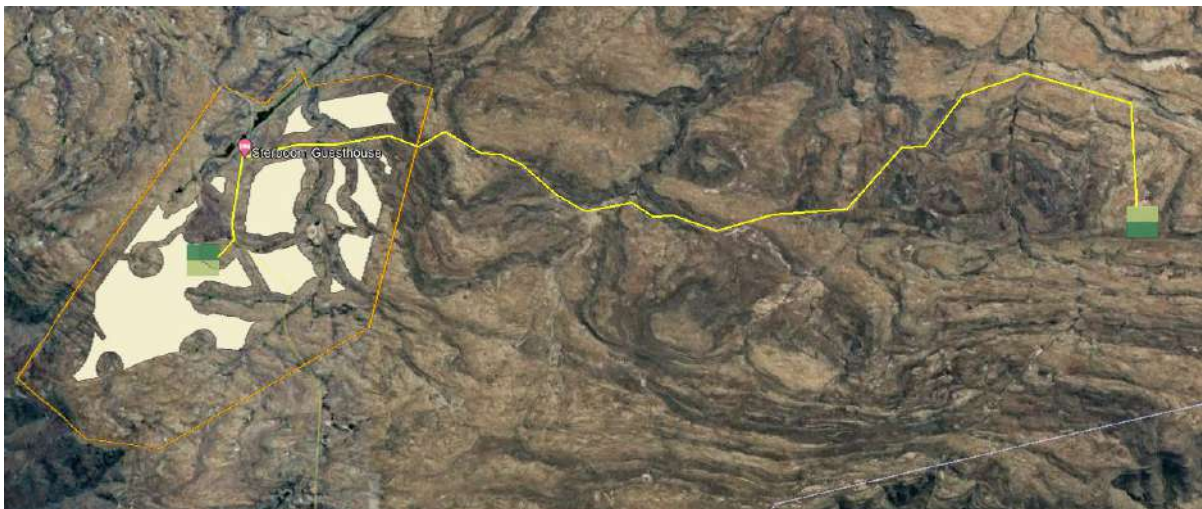
Figure 1.1: Buildable area of the proposed Sutherland 2 WEF (white shaded areas – as surveyed during the pre-construction walkthrough) with the proposed routing for the authorised 132kV powerline (yellow) between the substations.

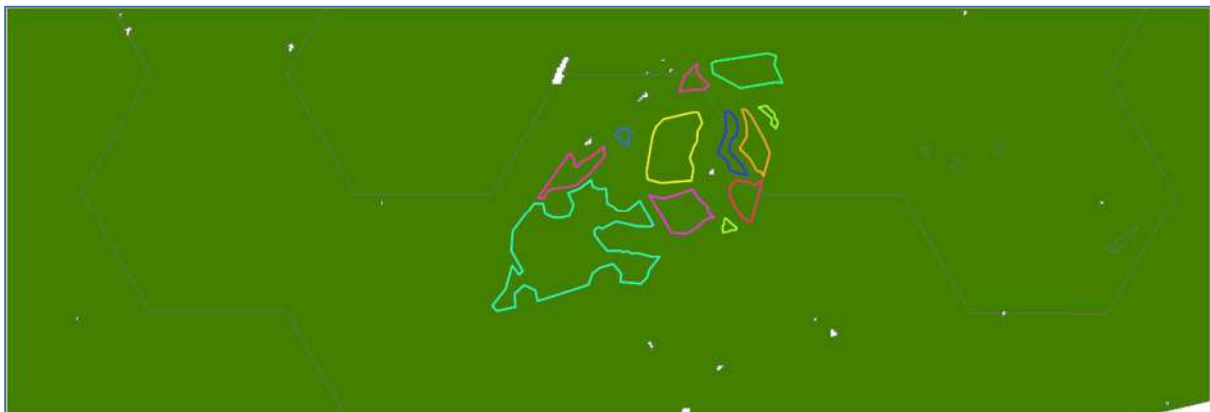
Figure 3.2: The map indicating the Northern Cape Conservation Plan. The CBA (green areas with the outline of the WEF (Buildable area) in coloured polygons).

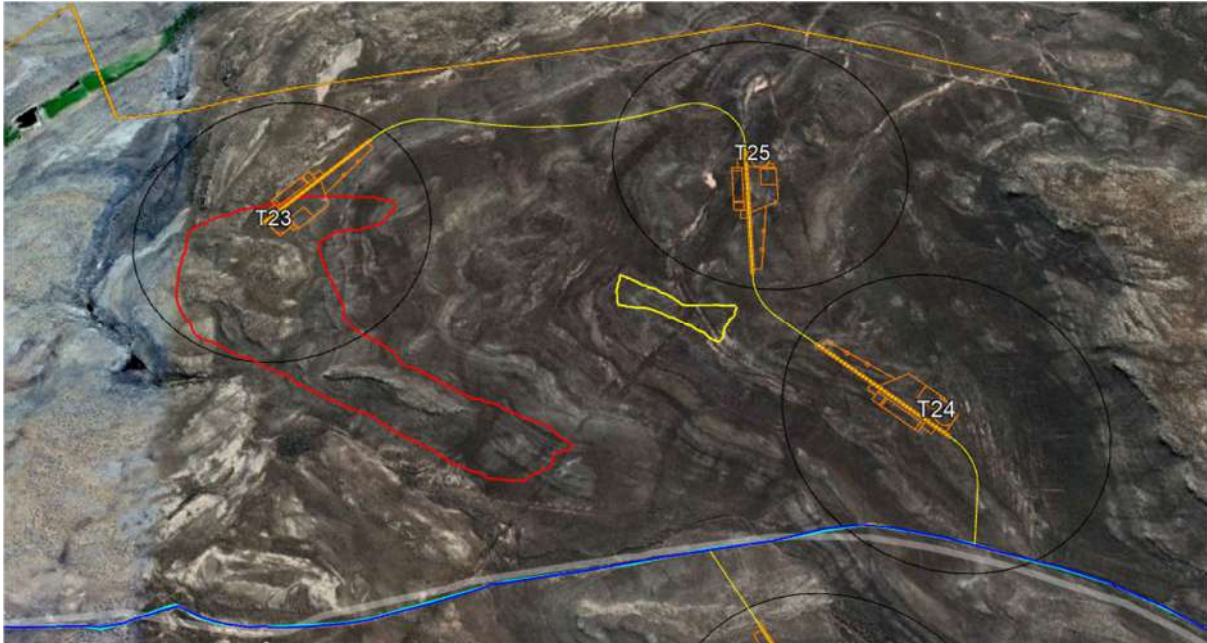
This area to the north of the proposed development footprint (Figure 4.2) is near the low hills and escarp to the Portugals River. The small area has sensitive areas, mostly associated with the “escarp” zones to the east, north and west. In the rest, some rocky areas are present and therefore the placement of roads and turbine must be carefully chosen. The steeper areas have a habitat sensitivity of moderate to high with a high erosion potential.

Figure 4.2: The areas of notice in Zone 1 – The sensitive areas to the west (red) and the depression and lichen field on the rocky area (yellow).

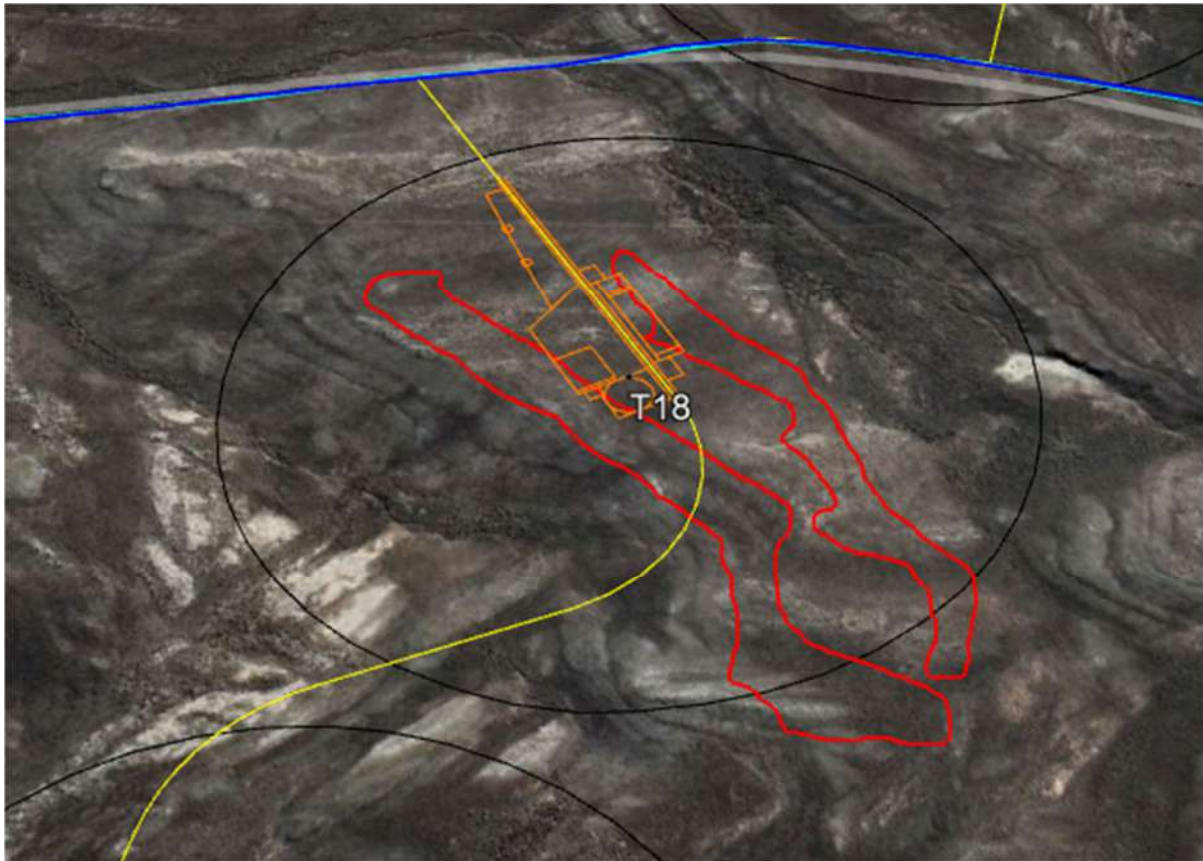
This zone is bordered by the drainage lines to the east and west and the areas near the crests are of moderate to high sensitivity (Figure 4.4). The erosion potential in this area will vary from low to moderate, depending on the sloped areas utilised. The vegetation on the flat plateau area is more uniform and impacts will be lower. It is recommended that the placement of turbines are on the central “spine” of the area between the deeper gullies to the east and west. Again, there are some rocky outcrops dispersed through the area and it will be important to avoid these areas with the final placement of the turbines.

Figure 4.4: The sensitive areas associated with the drainage areas in zone 3.

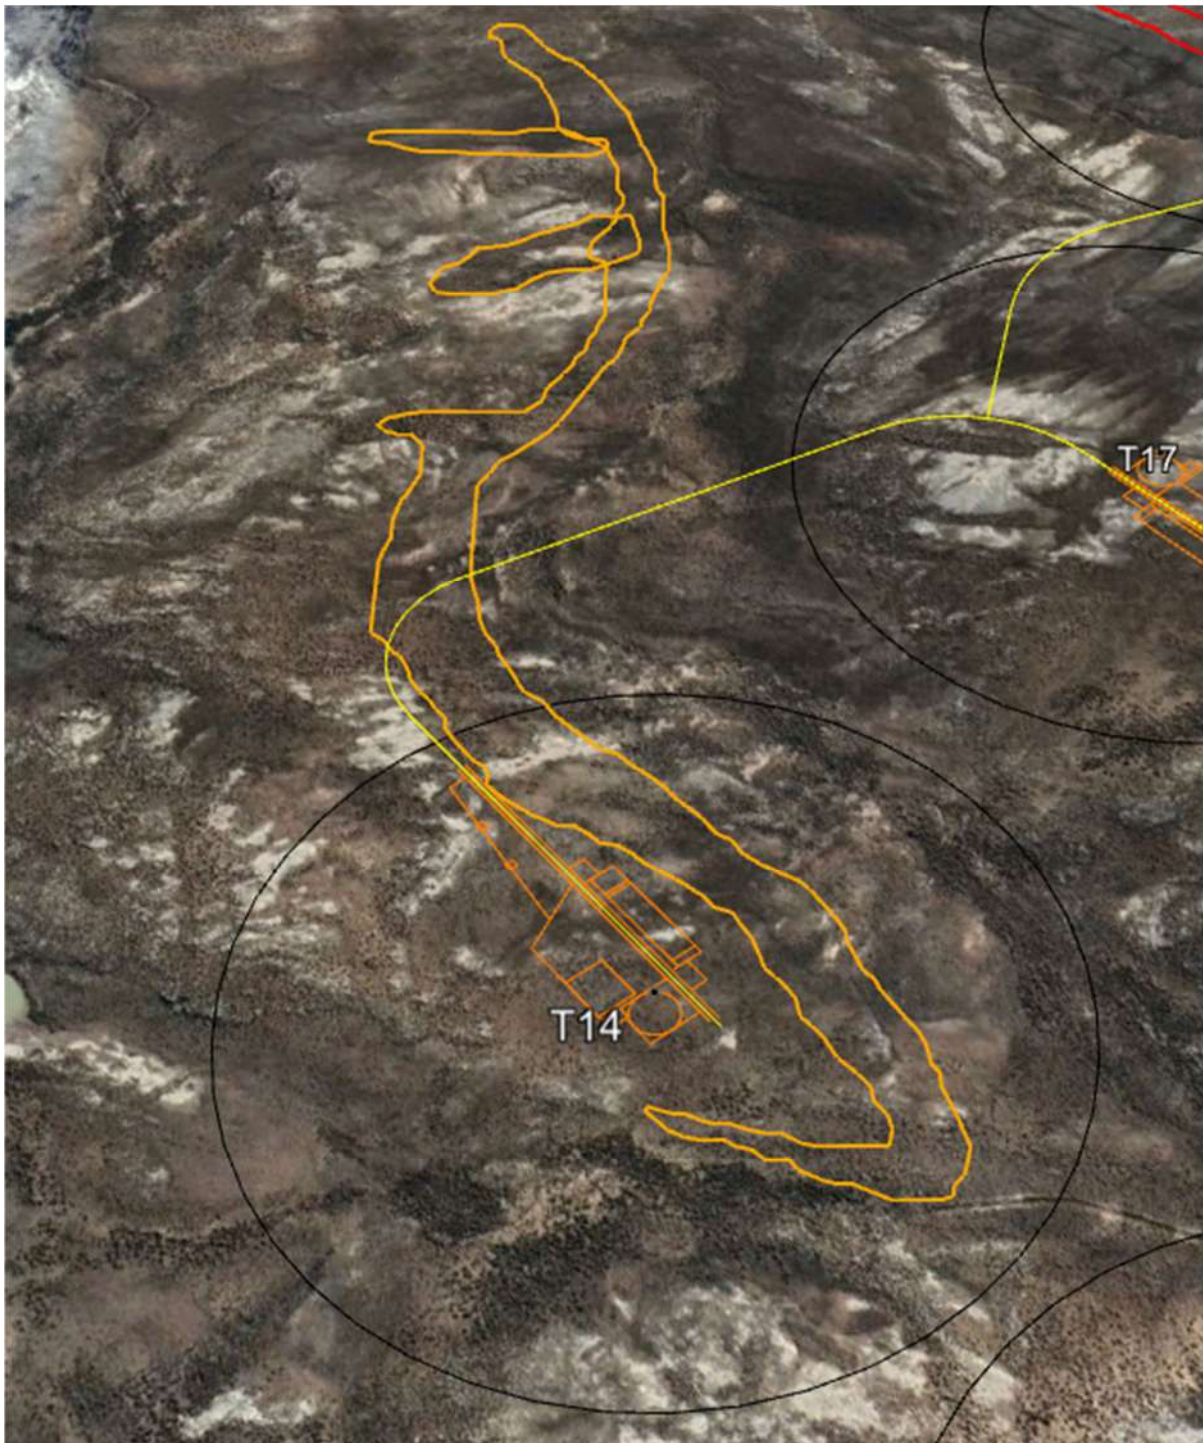
A long, narrow zone with a steep incline to the east and a more steady, but wide slope to the west (Figure 4.6). As noted with the previous areas, the slopes are more sensitive (moderate to high) and there are a number of bedrock sheets that are very sensitive areas (examples demarcated in Figure 4.6). These must be avoided with the placement of turbines and roads and no driving is allowed over these areas. The vegetation is low to moderately sensitive in relation to diversity and the area has a low to moderately high erosion potential (higher on steep slopes).

Figure 4.6: The steeper slopes and some bedrock sheets demarcated – noted to be sensitive areas.

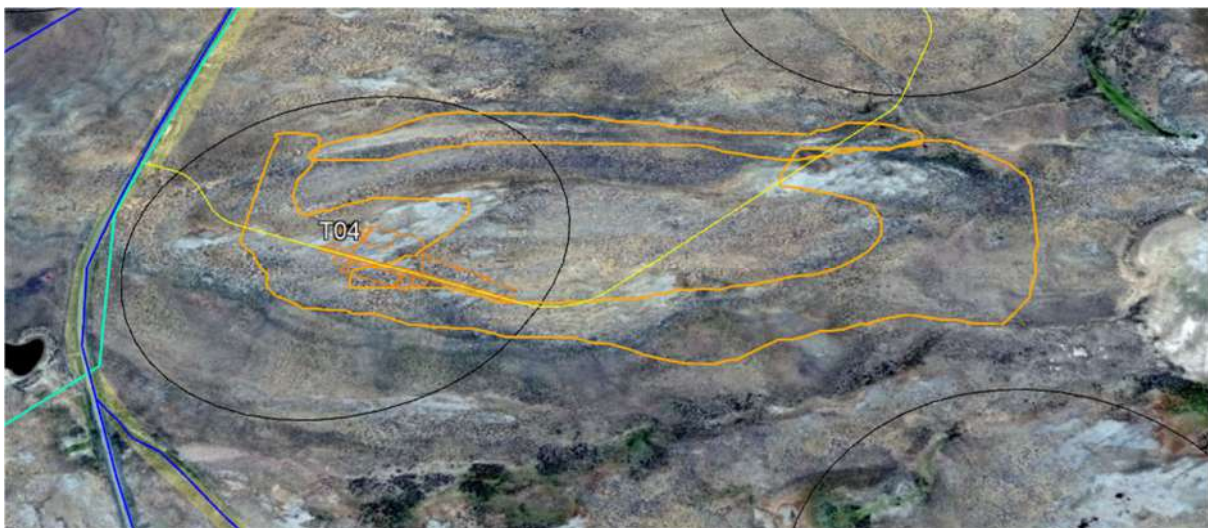
This area has a diversity of habitat types, ranging from the higher areas (low mountains and koppies) to the west, sloping east to the large drainage line associated with the large impoundment (Figure 4.7). On the southern boundary of this area, a steep slope is present and it will limit the extent of placement of turbines in the area. It include some rocky outcrops and bedrock sheets, considered as sensitive in relation to natural vegetation diversity and habitat for animals, birds and reptiles. There is a high plateau area (southern portion of the zone that drops to the northeast. This “escarp” area is sensitive and it is recommended to consider placement of turbines carefully. The lower area to the north east has sloped areas and drainage channels, but structures can be strategically placed without a huge compromise to the environment. The sensitivity range between low to high through the section with a low to moderately high (even high) erosion potential in areas. The natural vegetation sensitivity range between low to moderate (linked to habitat areas). Access roads must follow contours to limit the impacts to the habitat.

Figure 4.7: The area with the more sensitive areas to the south and west and the small portion in the northeast with possible protected plants in the wetted and rocky area.

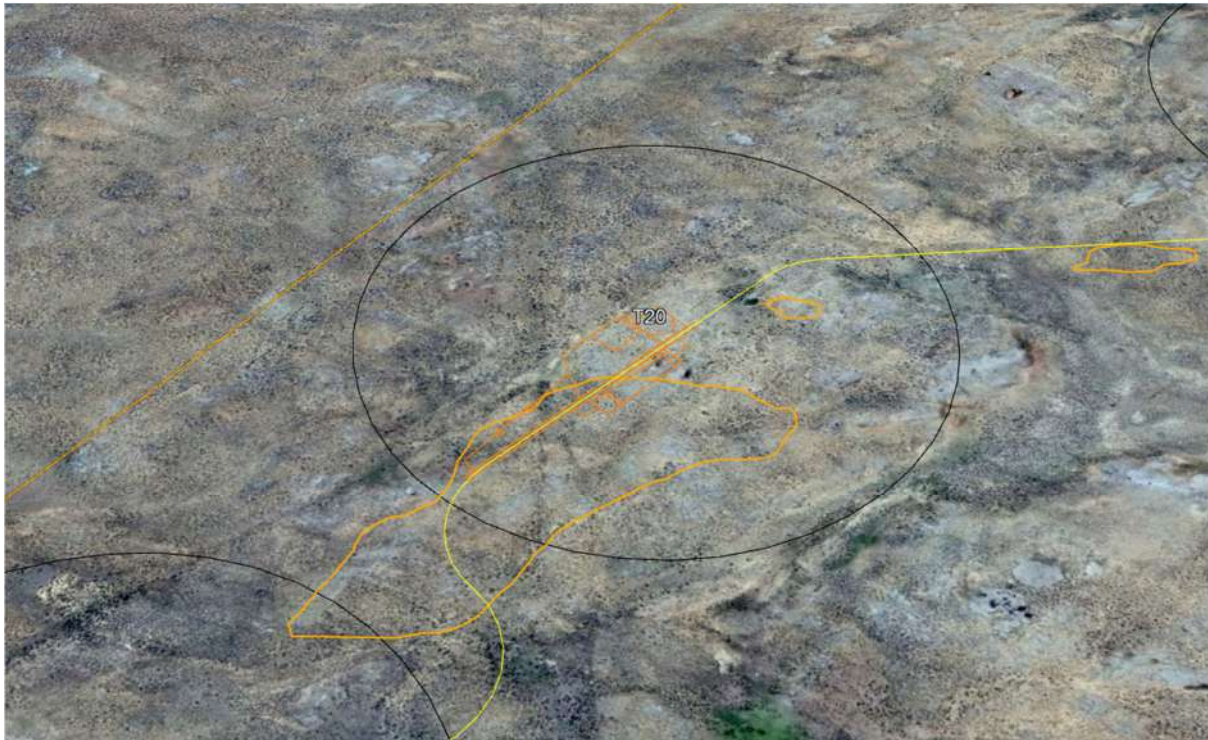
The zone (Figure 4.9) is an elongated area, with numerous sensitive habitat features that include the bedrock sheets, rocky outcrops and drainage lines. The eastern boundary of the proposed area is in close proximity to a prominent drainage channel (south to north) feeding the impoundment. The resident breeding pair of *Tadorna cana* at the impoundment seems to utilise the rocky habitat for a nesting site. Noted along the eastern side of the footprint area is the stone fence posts and the old shepherds hut (southwestern corner). The habitat sensitivity across the area varies (depending on the micro habitat) and ranges from low (i.e. the moderately undulating plateau areas) to high (i.e. the rocky ridges, outcrops and bedrock sheets).

Figure 4.9: The sensitive slopes to the south – some plateau areas present for a turbine – and examples of rocky outcrops and ridges to the north.

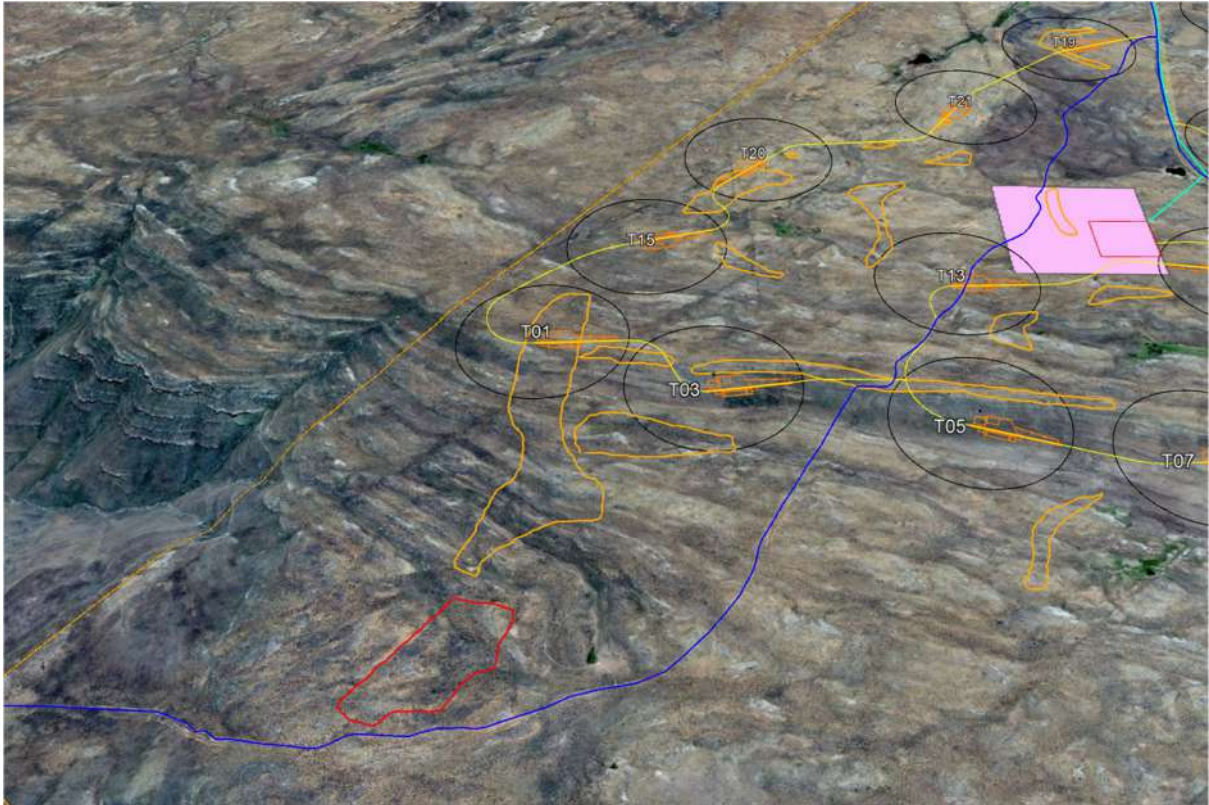
The middle portion of the zone have a number of flat plateaus to the centre and the east, which will be more suitable areas for the construction of turbines. The area associated with the eastern boundary north of the impoundment, has varied habitat. In general, the landscape slopes to the east with a number of ephemeral drainage lines present. It is possible to place the turbines between the rocky ridges and low points of the drainage lines. This will lower the potential impacts on the vegetation and habitat. It will be important to plan the internal road layout to take these sensitive areas into consideration and where possible, to use the contours to lower impacts on the sensitive sloped areas.

The area to the north and east of the two (2) impoundments are similar to the middle portion. The western boundary is steeper and sloped to the west (Tankwa River). The areas to the centre and the east have suitable plateau areas that can be used for the placement of turbines. However, the outcrops, ridges and rocky areas must be avoided.

Figure 4.10: The large zone to the south east with some of the sensitive areas highlighted. In red the sensitive area associated with the escarp. In orange, some of the ridges, sloped areas and rocky outcrops noted.

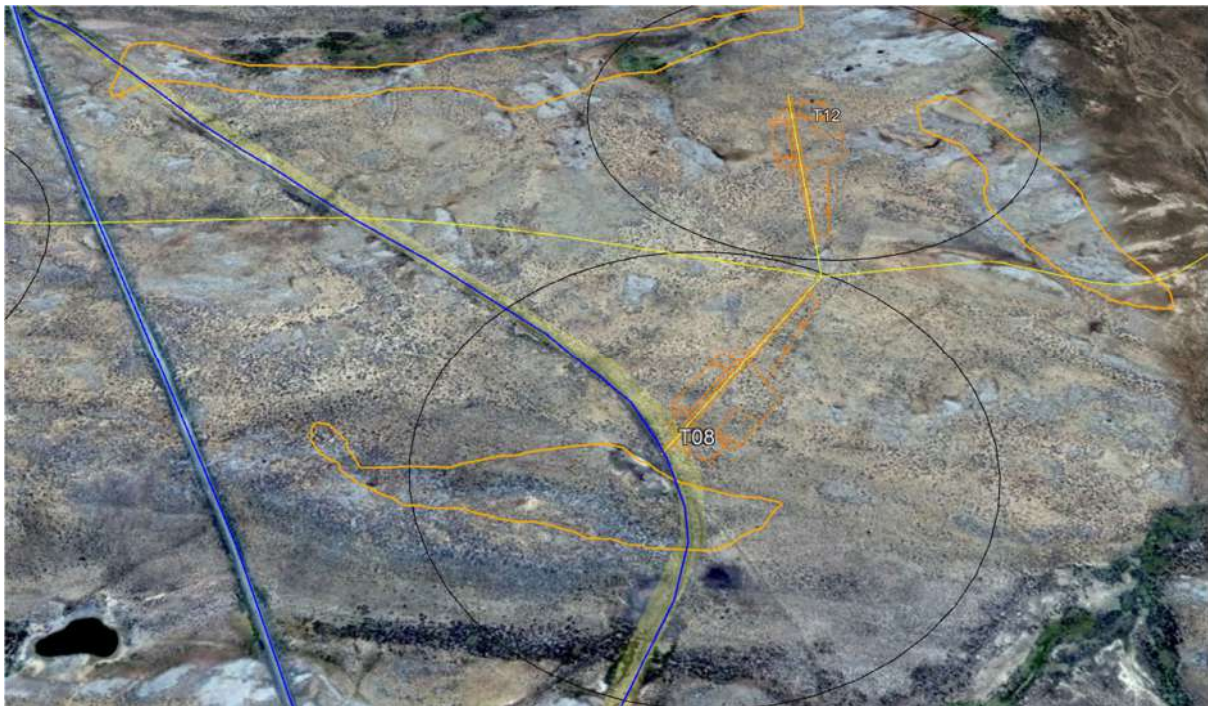
The area east of the main road (Figure 4.11) traversing the site from north to east, is associated with the low mountains sloping to the east and the larger drainage systems that form part of the upper catchment of the Portugals River. The area has a number of bedrock sheets and rocky outcrops, but included is larger areas that are more flat and suitable for turbine positions. The important aspect is to look at the possible footprint areas and access roads that will lower the impacts on the sensitive habitats and sloped areas that are more prone to erosion. The vegetation sensitivity range from low to moderate or moderately high. The sloped areas and drainage lines are considered more sensitive with the rocky outcrops and bedrocks sheets areas with a higher sensitivity (plant diversity, including the protected families and habitat for animals). Access to the area must take the contours from adjacent sites into consideration to ensure the impacts to the environment are minimised.

Figure 4.11: The southern section adjacent to the road with some of the prominent sensitive areas (as examples). Rocky outcrops and bedrock sheets are dispersed throughout the area and require selected placement of turbines and roads.

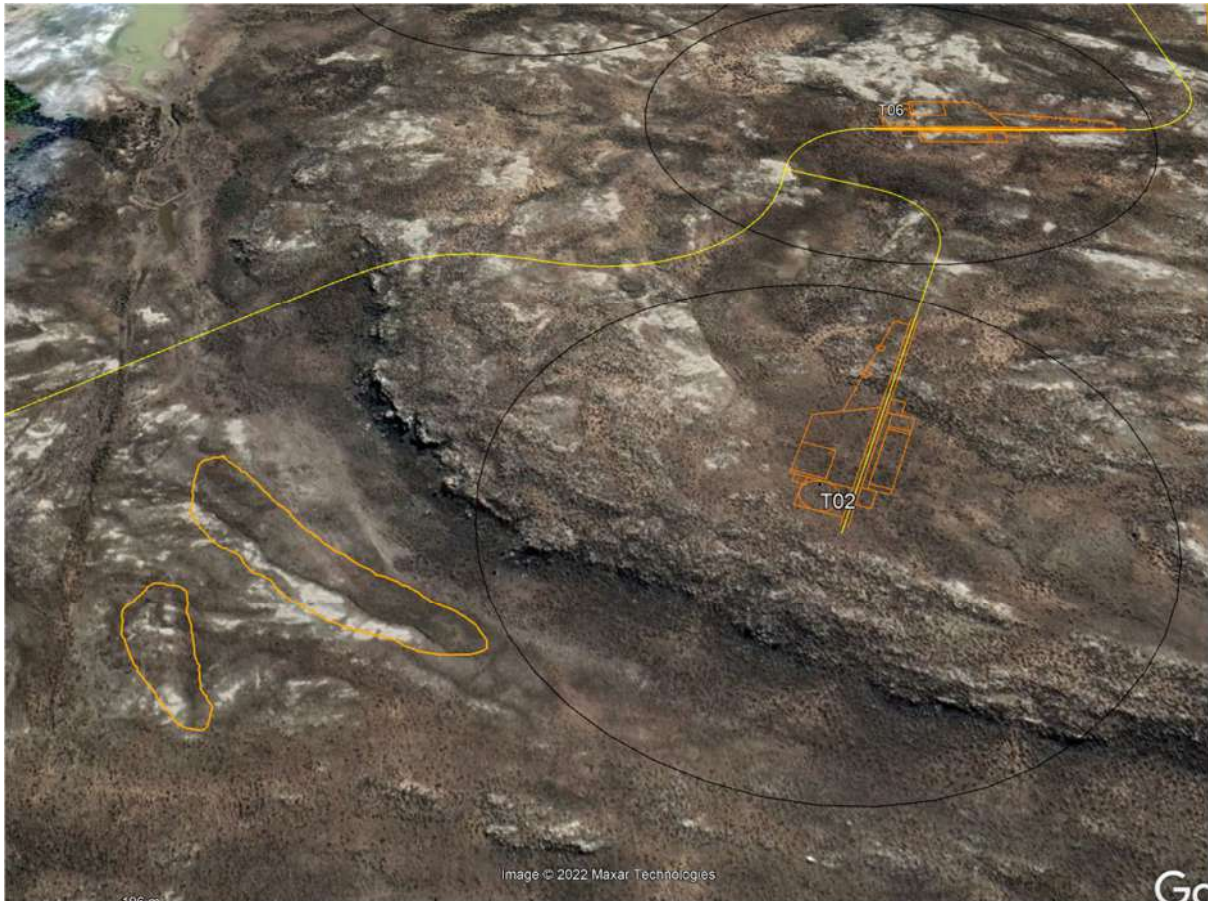
This small footprint (Figure 4.12) in the south-eastern corner of the proposed development is sloped to the west with drainage lines prominent to the north and west. The vegetation is modified close to the water point and on the slopes. Habitat is dominated by the rocky nature and small sections of bedrock sheets. It is possible to find a footprint for a turbine in an area that will have a small impact on the environment. The access road will be important, as drainage lines to the west are considered as sensitive. The habitat sensitivity range from moderately low to moderate and the erosion potential low to moderate.

Figure 4.12: The small area in the south east with slopes and drainage areas to the north and the rocky areas in the southwest.

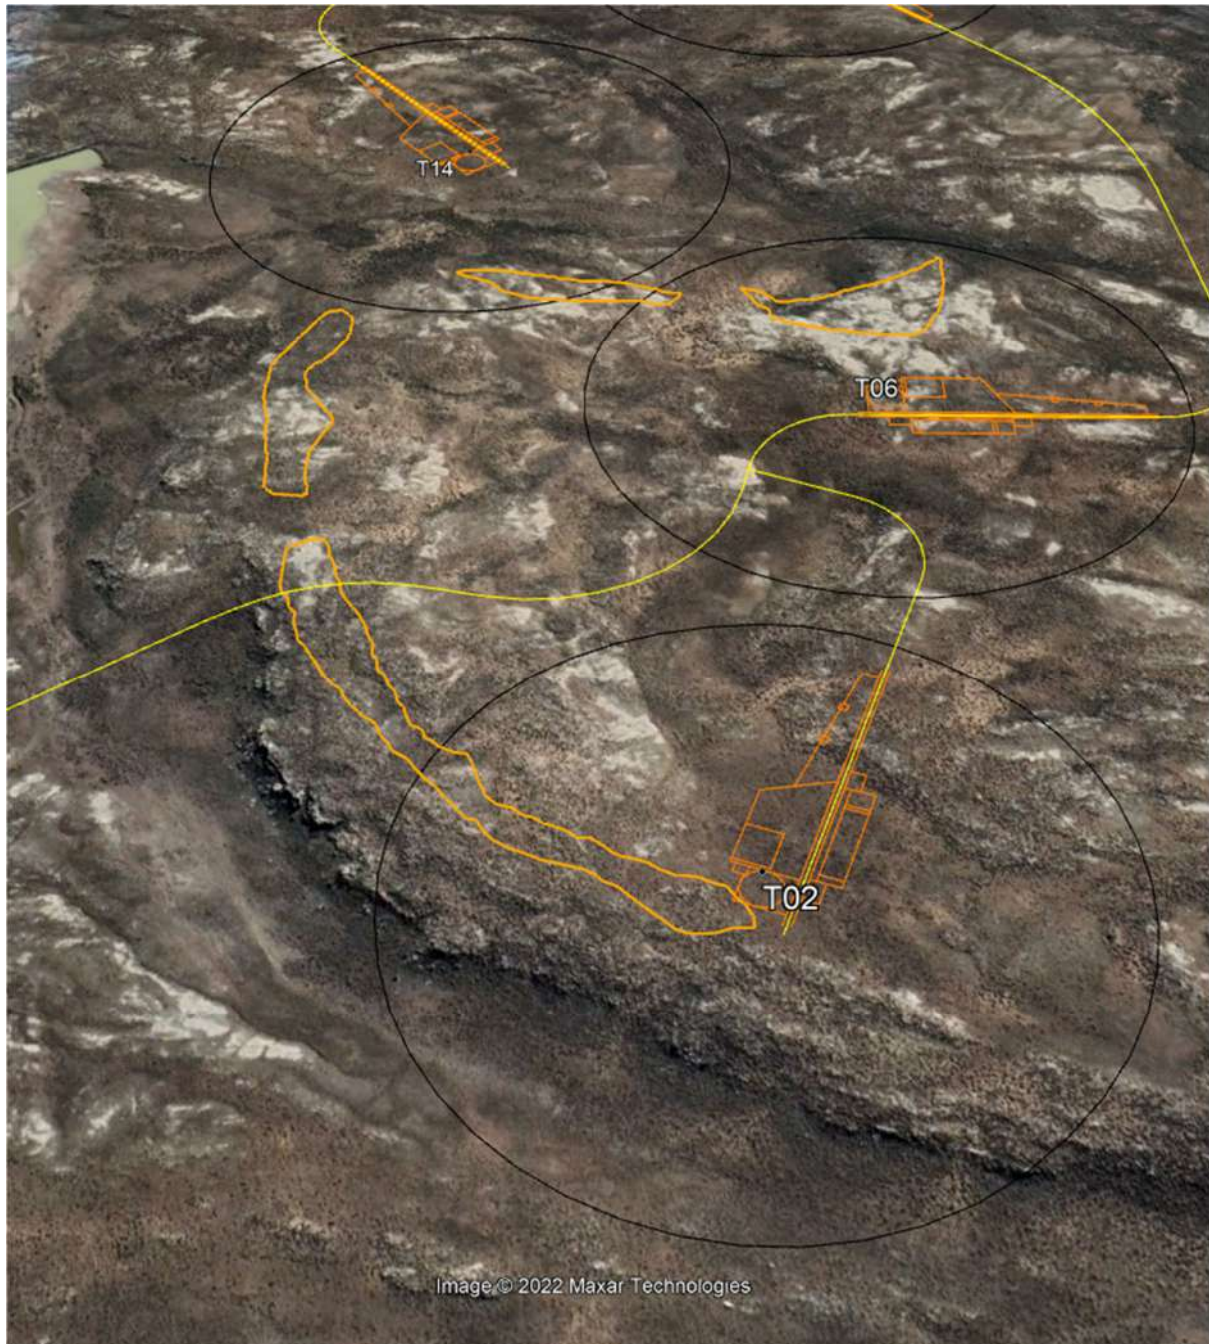
This area is on a plateau area with steep slopes to the south and west (Figure 4.13). On the plateau, there are potential sites (suitable footprint size) for the turbines and the vegetation in the flatter areas will have a low to moderate sensitivity (related to diversity). As was noted in the area, numerous rocky outcrops, crest and bedrock sheet areas are present. It will be important to ensure that the access road to the area follows the less steep contours. The sensitivity related to the habitat vary from moderately low to high (slopes, crests and bedrock sheets in the plateau landscape).

Figure 4.13: The area with the steeper slopes indicated (orange), but the plateau area has a number of drainage lines, rocky outcrops and bedrock sheets that must be avoided.

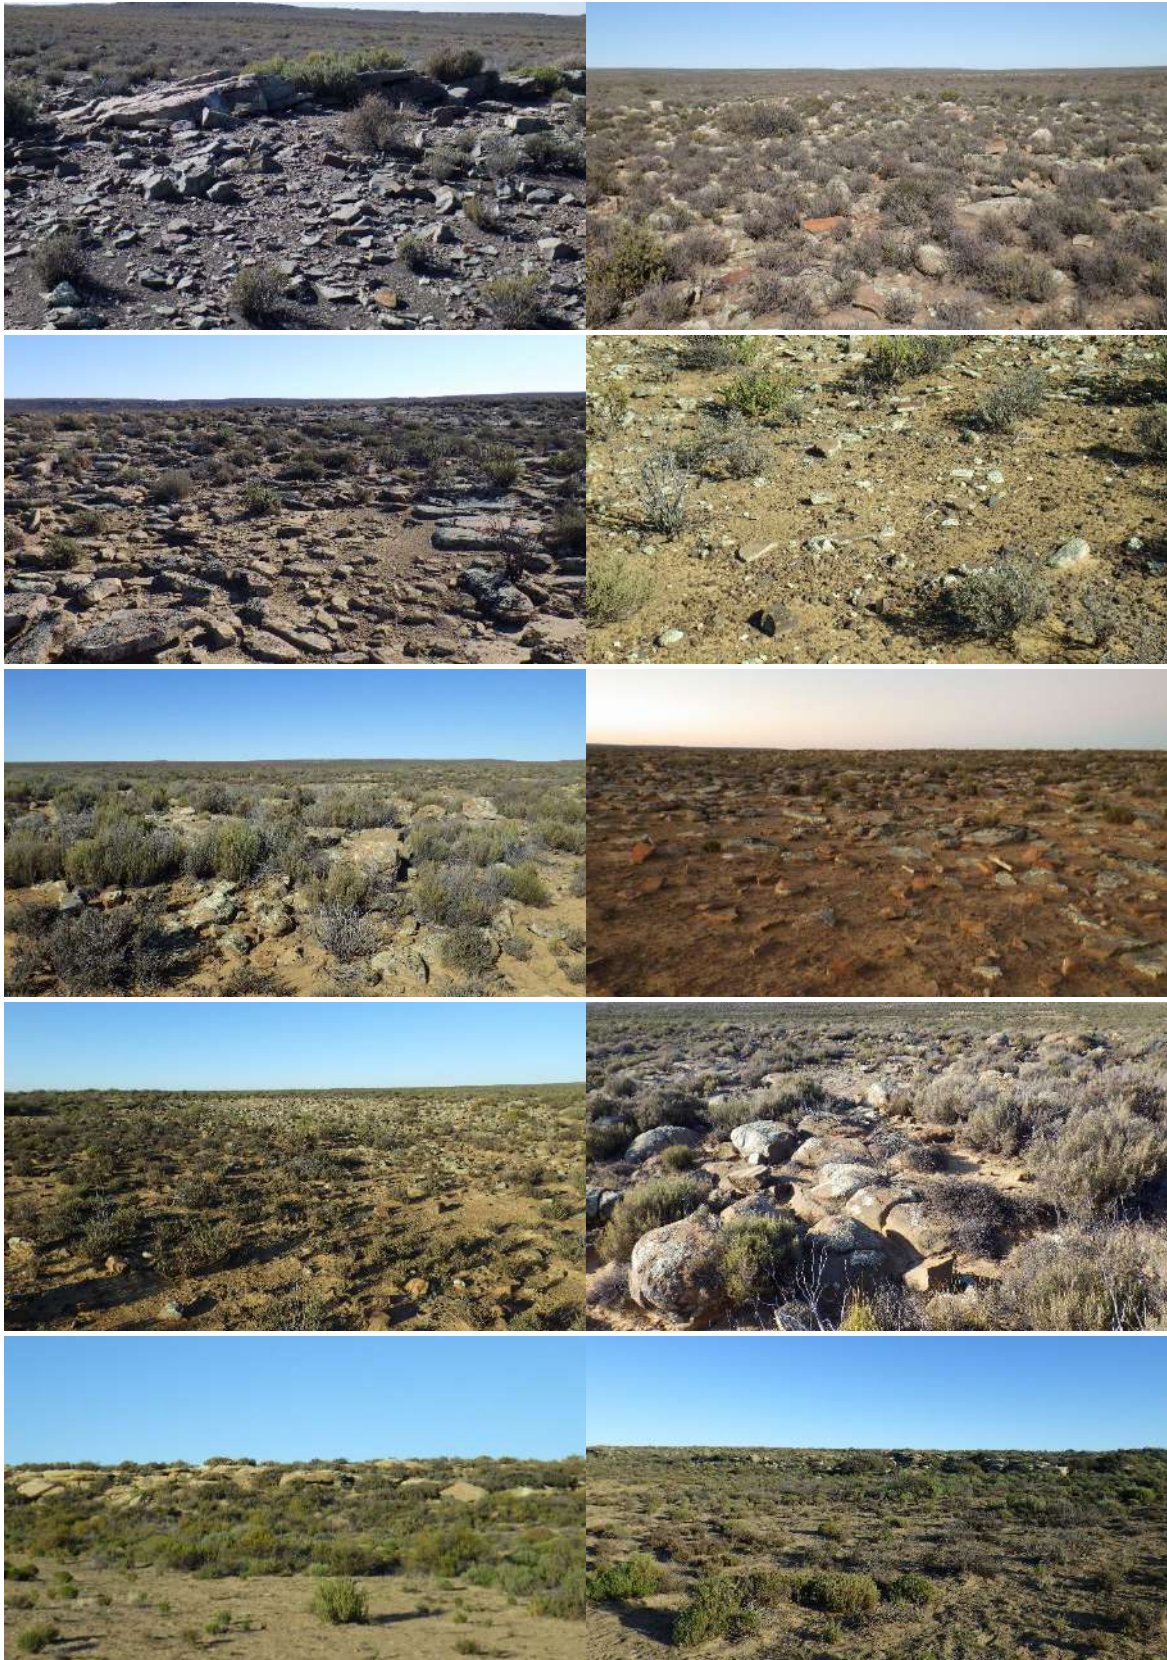
Figure 4.2: Selected images of some of the sensitive rocky areas in the study area.

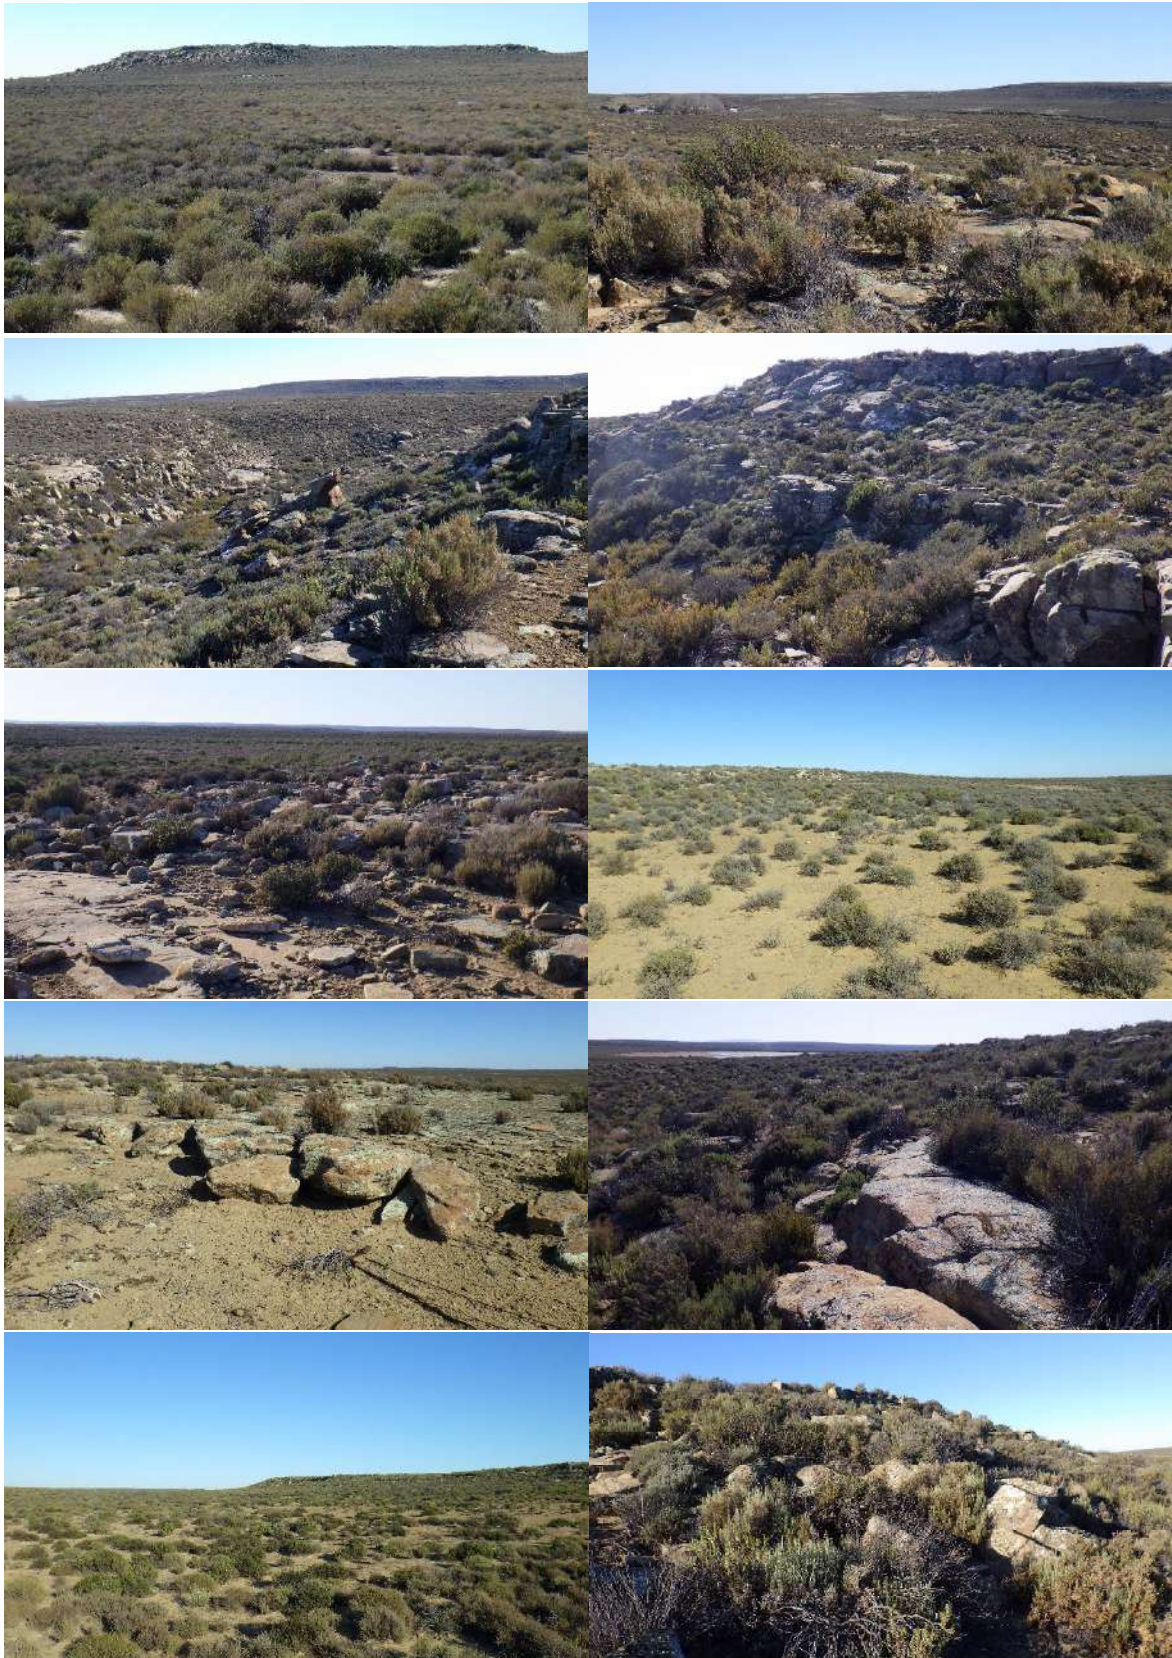
Figure 4.3: Examples of the sensitive ridges associated with the study area.

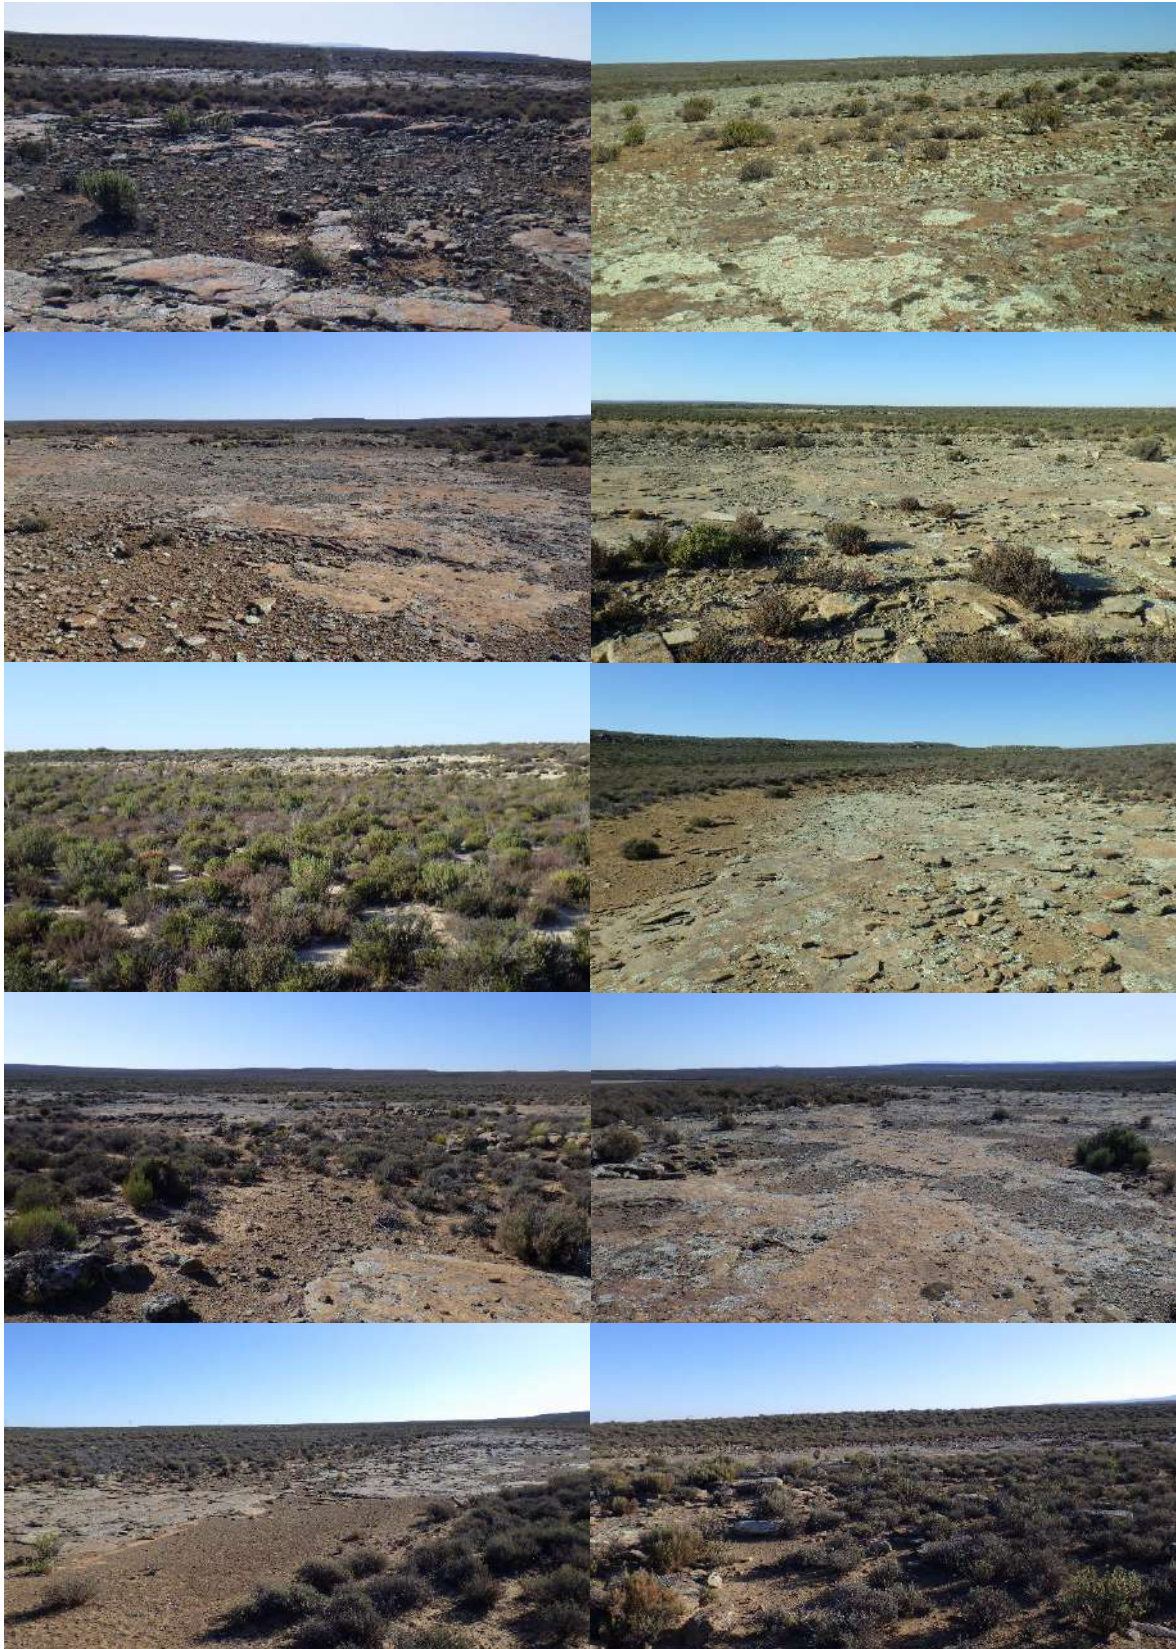
Figure 4.4: The sensitive bedrock sheets – high sensitivity with regards to the vegetation and animals associated with the habitat type.

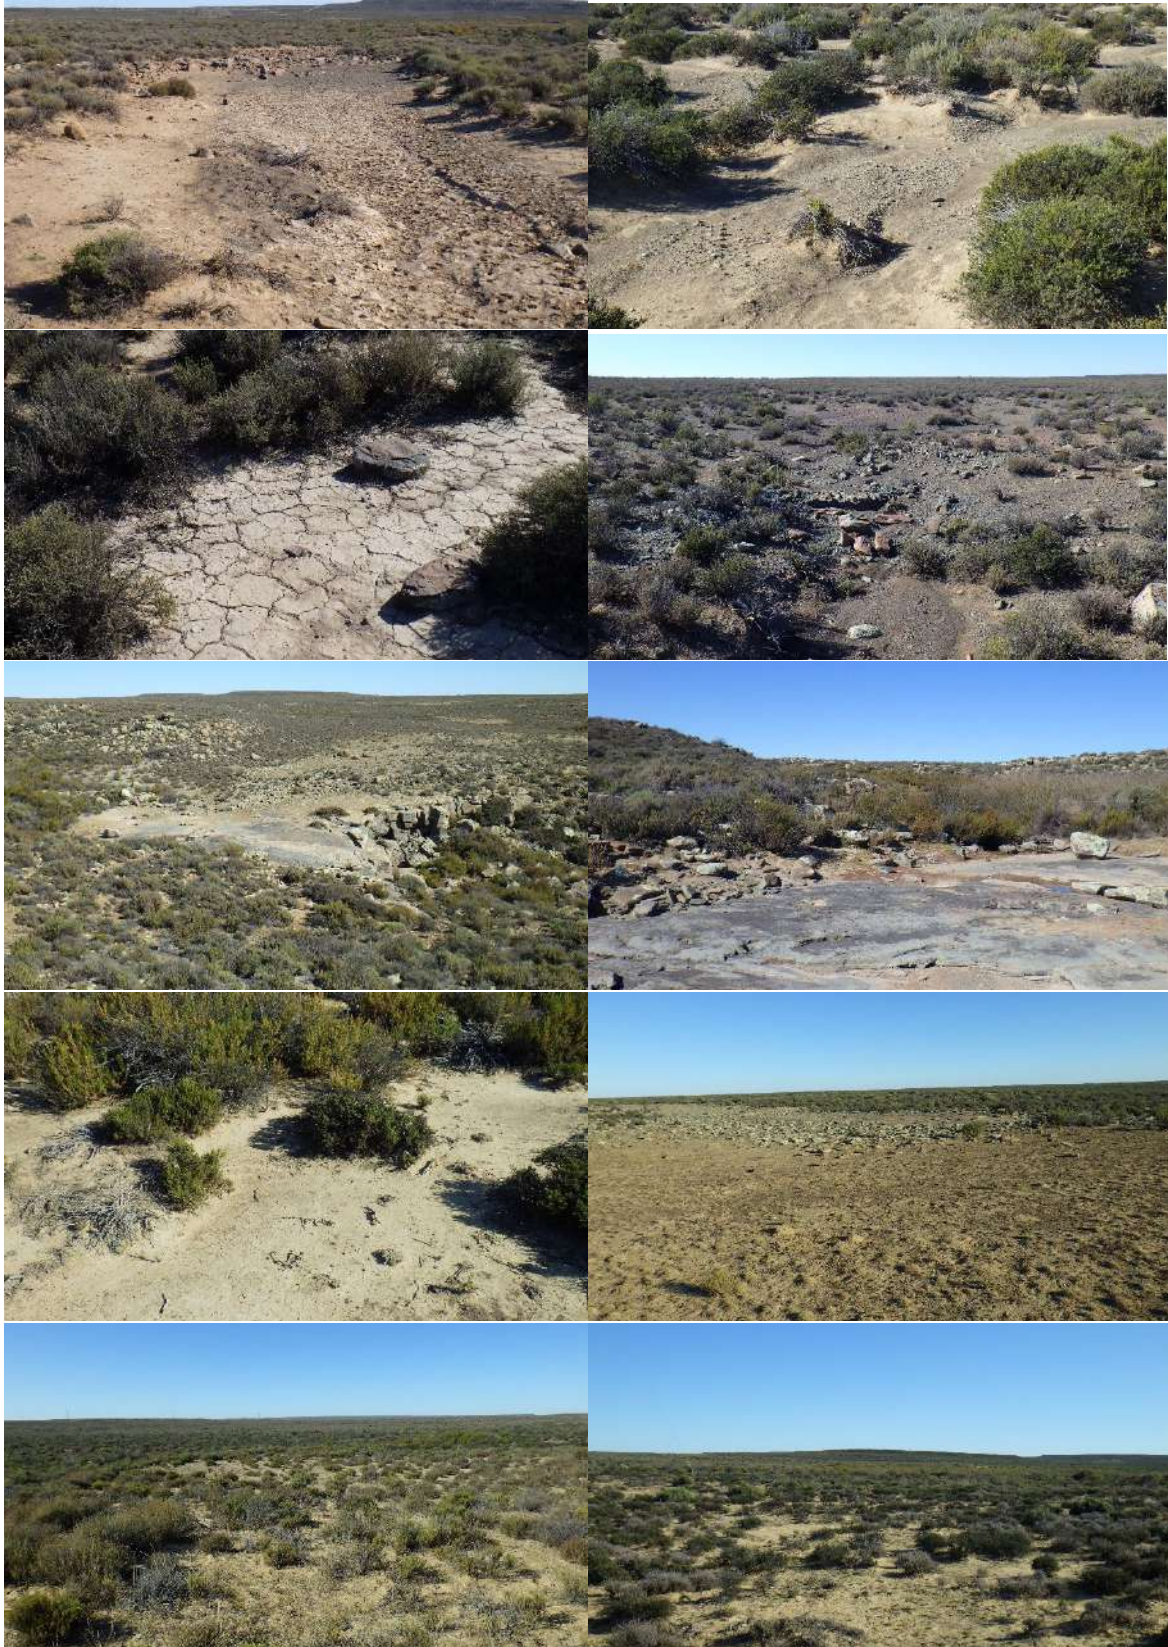
Figure 4.6: Stream, drainage lines and pans are some of the sensitive areas dispersed in the landscape.

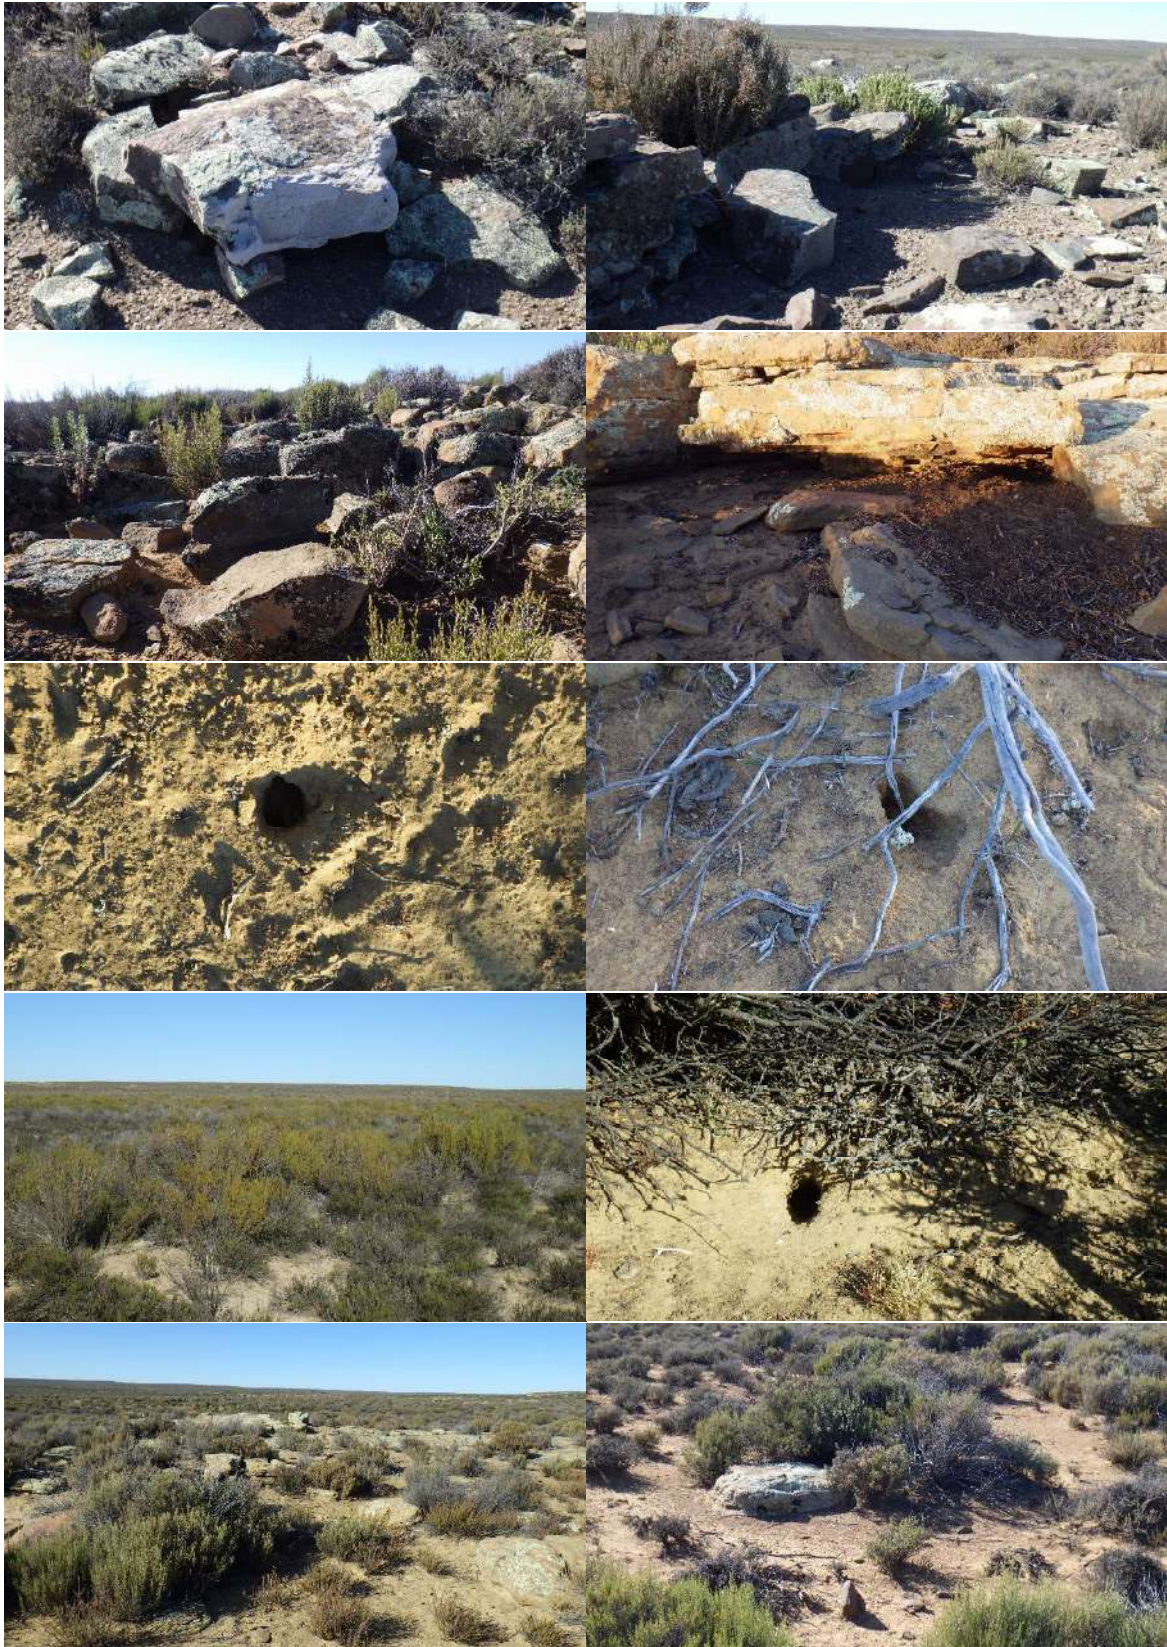
Figure 4.7: Examples of areas that the animals use as habitation in the study area (rocky areas, burrows in deeper soils and dense vegetation).
