**BIODIVERSITY PRE-CONSTRUCTION
WALKTHROUGH ASSESSEMENT:**

Final Layout

**140MW SUTHERLAND 2 WIND ENERGY
FACILITY (DFFE REF: 12/12/20/1782/3/AM5)
AND ASSOCIATED 132kV POWERLINE
LINKING TO THE SUTHERLAND WEF (DEA
REF: 14/12/16/3/3/1/1814/2), SUTHERLAND,
NORTHERN CAPE PROVINCE**

18 November 2022

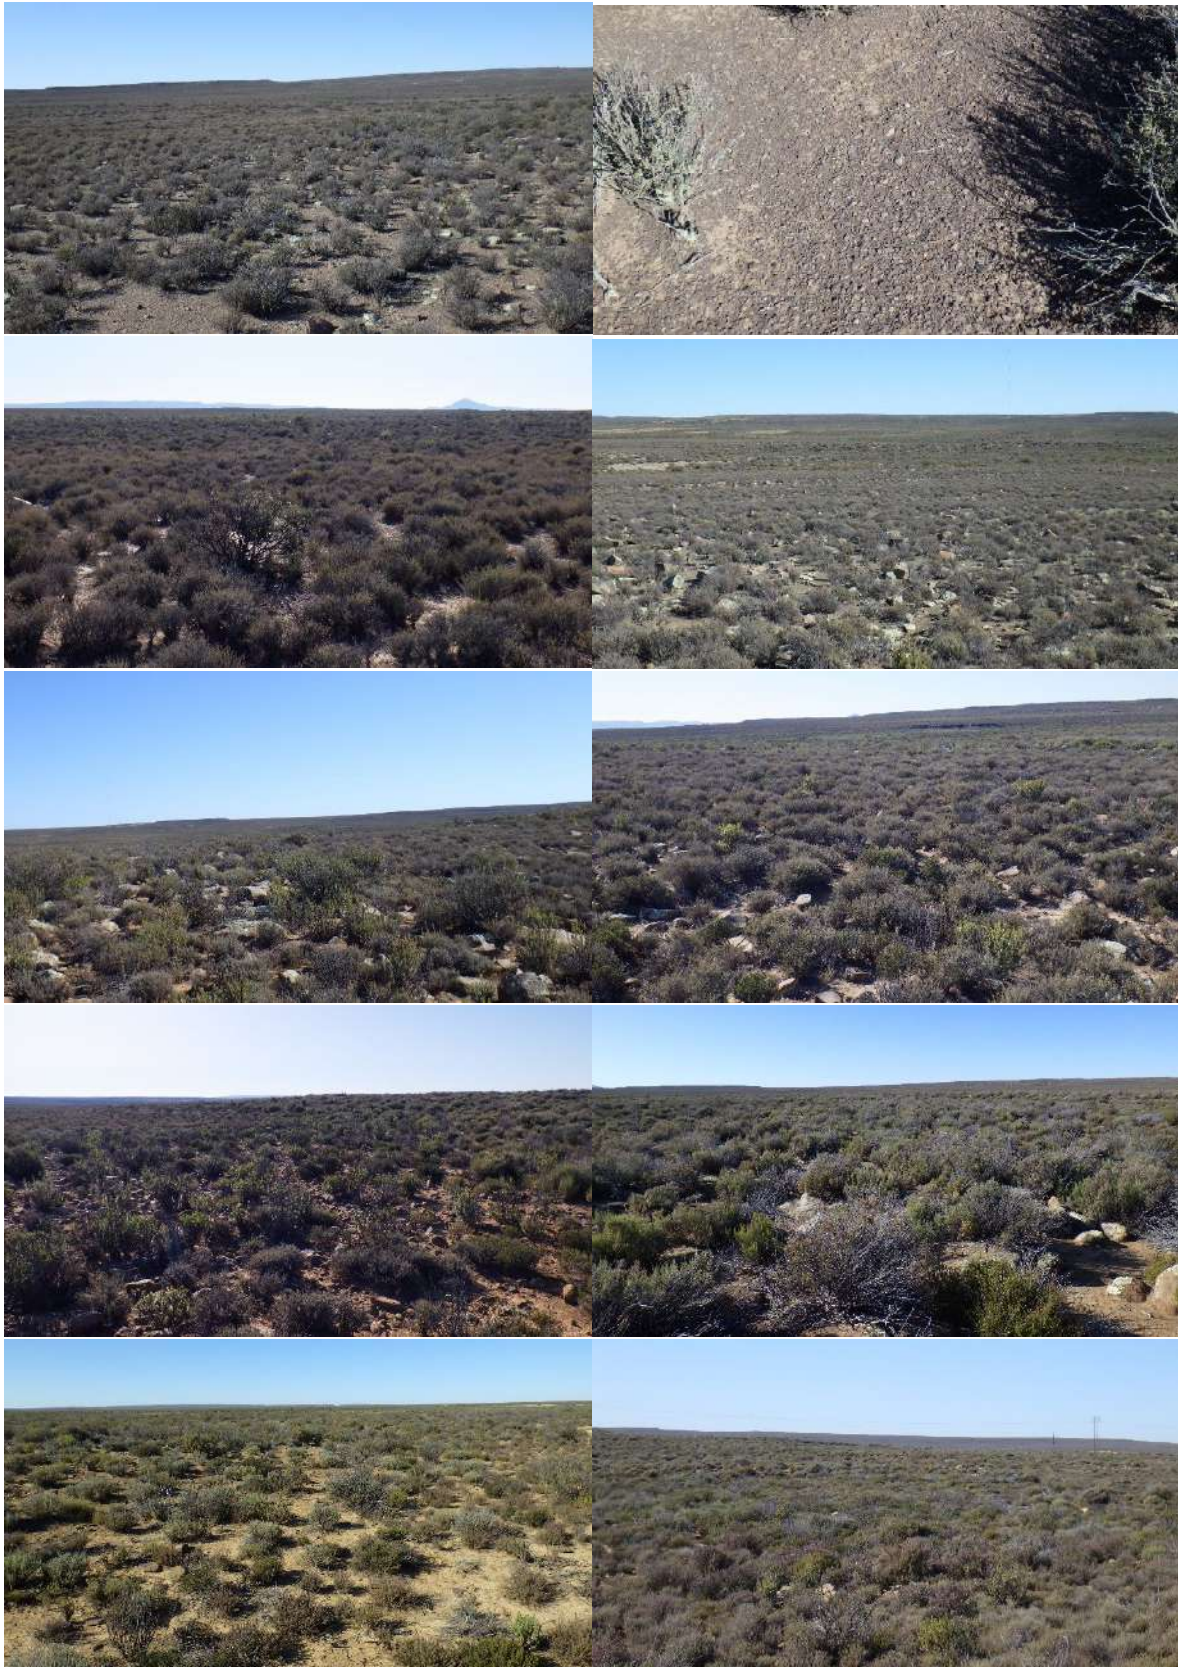
Figure 4.8: Examples of preferable foot print site for turbine positions on flat plateau areas.
