## SITE PHOTOGRAPH PLATE

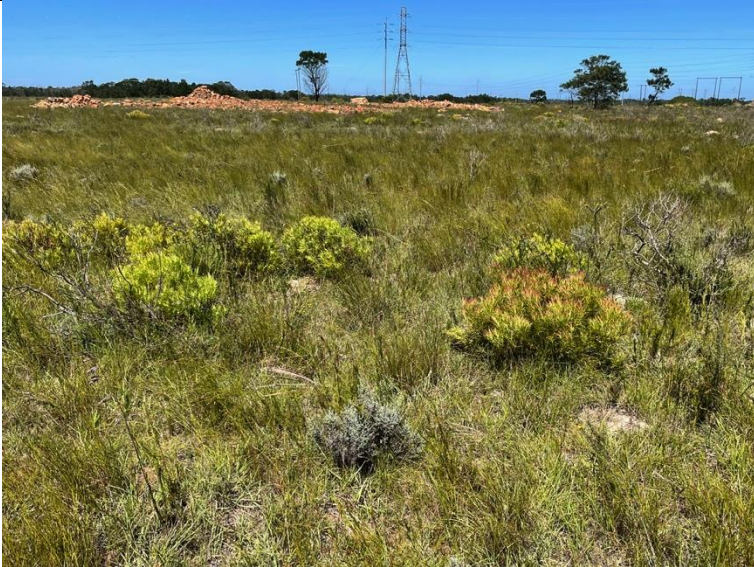
Study Site. Looking south. Showing some *Leucadendron* species (Conebush) – red and yellow small shrubs and *Stoebe* (Bankrupt Bush) – grey small bush in front.

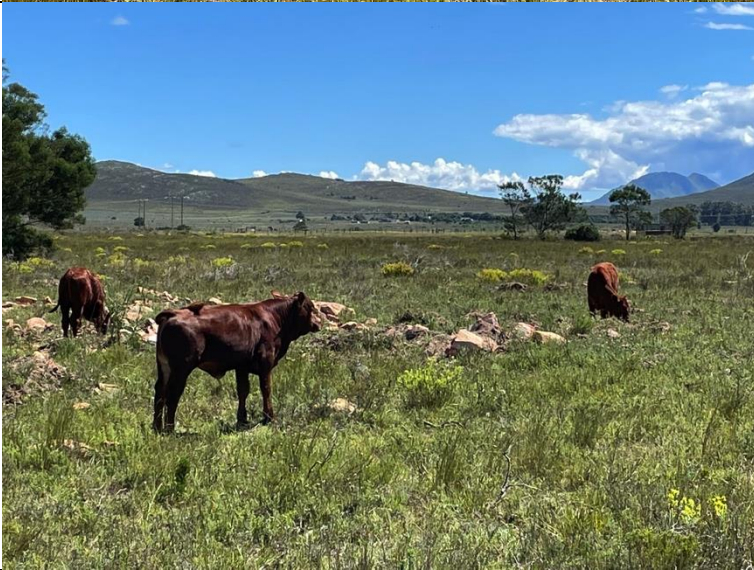
The veld is degraded and currently utilised as grazing for cattle. There are numerous other existing and historic disturbances of the site including diggings, and cultivation / ploughing.

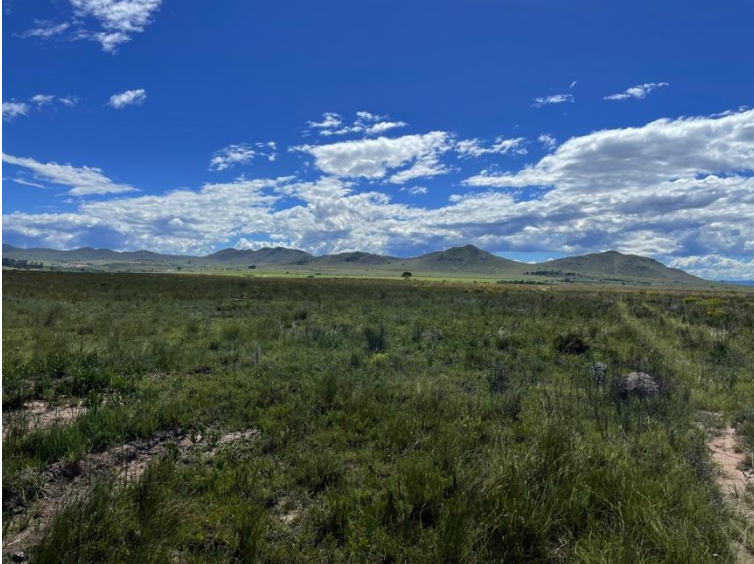
Study site looking north towards the mountains and Swart River. Notice the lack of the short shrub layer that is also characteristic of Kouga Grassy Sandstone Fynbos (i.e. degraded veld)

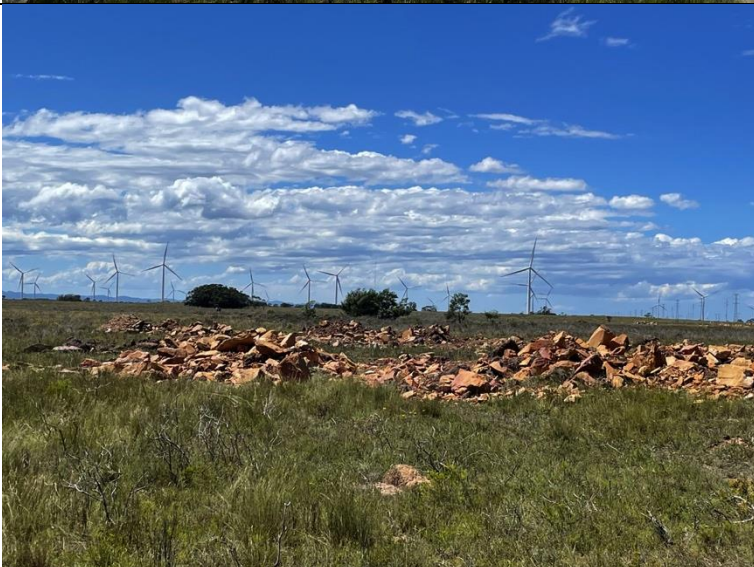
Existing disturbances on the study site. Appears that there were low levels of excavation of sand as well as removal of rocks from out the land for the purpose of cultivation. Also notice the wind farm in the background, which is close and situated to the east of the site.

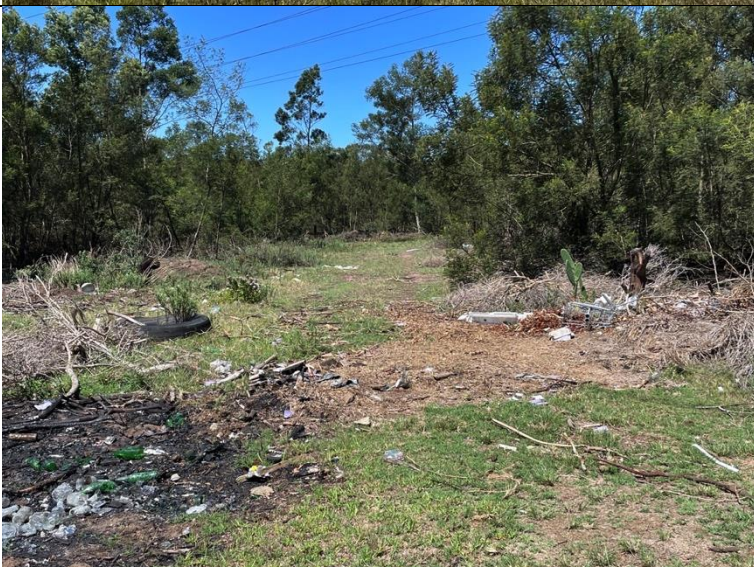
Highly disturbed and altered section in the extreme west of the site earmarked for the BESS and Switching station area of the Solar PV project. The trees in picture are all invasive alien species of blackwattle (*Acacia mearnsii*) and rooikrans (red-eye wattle) (*Acacia cyclops*). All of the trees and groves present on the site and adjacent lands / areas are various *Acacia* species and pine (*Pinus pinaster*) all of which are invasive weeds.

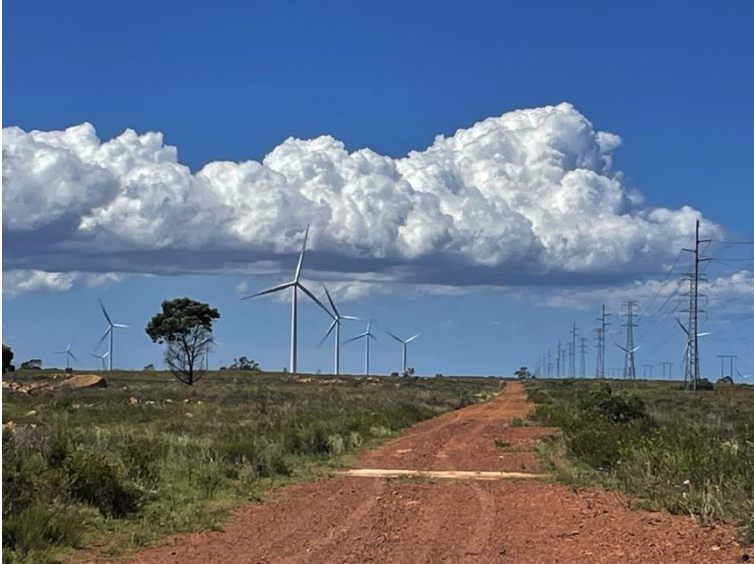
Gravel road bordering the study site in the south. Looking east towards the large existing wind farm and power lines along the road. Study site is to the immediate left.

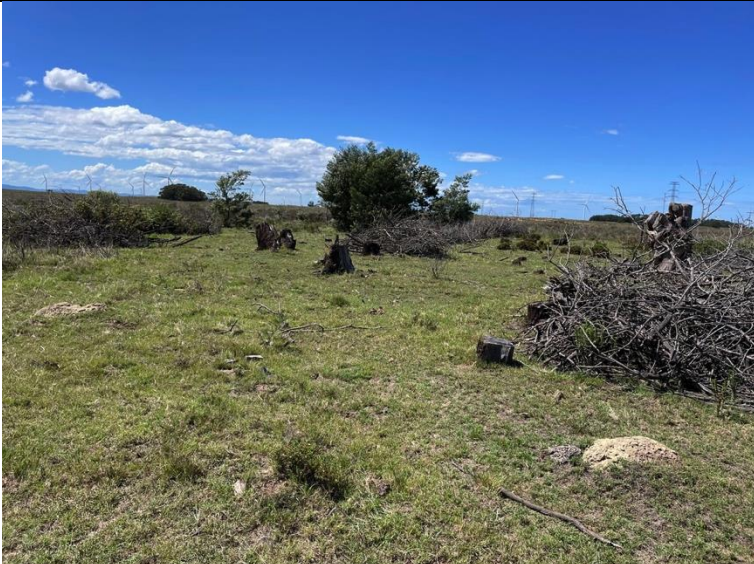
More areas on the study site invaded by alien Acacias. Here many have been cut down and removed, probably for firewood.

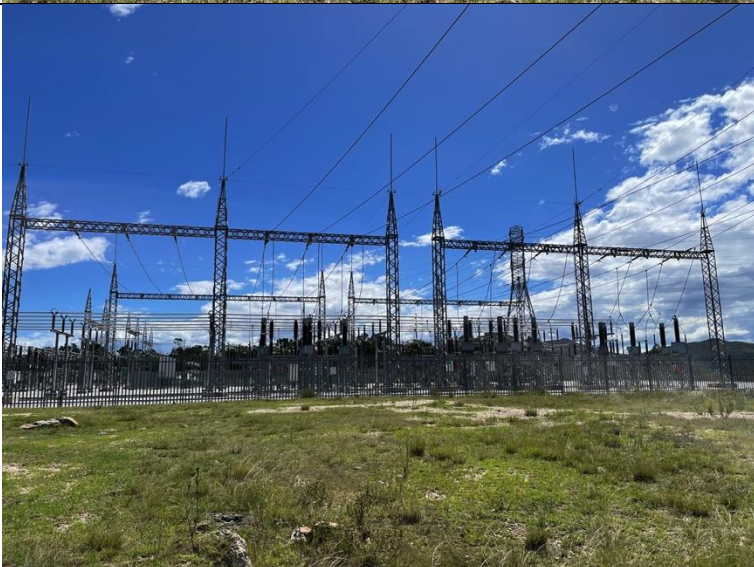
The Eskom (Humansdorp) Substation located on the southwest corner of the study site.

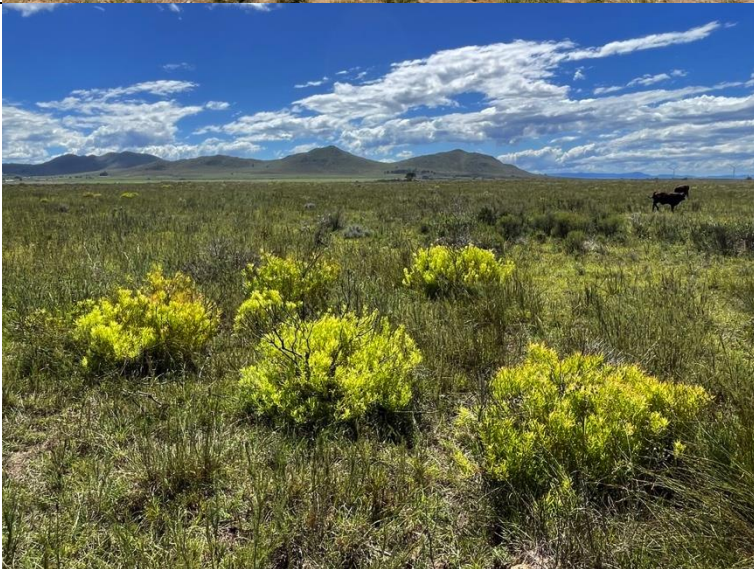
Geelbos (*Leucadendron microcephalum*) is a common proteoid species growing on the study site and region. The shrub is not threatened and as a status of 'Least Concern'.
